Re: **ServAll Laundry Site**  
**Bay Shore, Suffolk County**  
**Site No. 1-52-077, Work Assignment No. D003821-19**  
**Monthly Report May 2001**

Servall Laundry  
 Site No. 1-52-077  
 Groundwater Remediation -2001 Operation and Maintenance

Re: Servall Laundry  
Bay Shore, New York  
May 2001 Operations Report

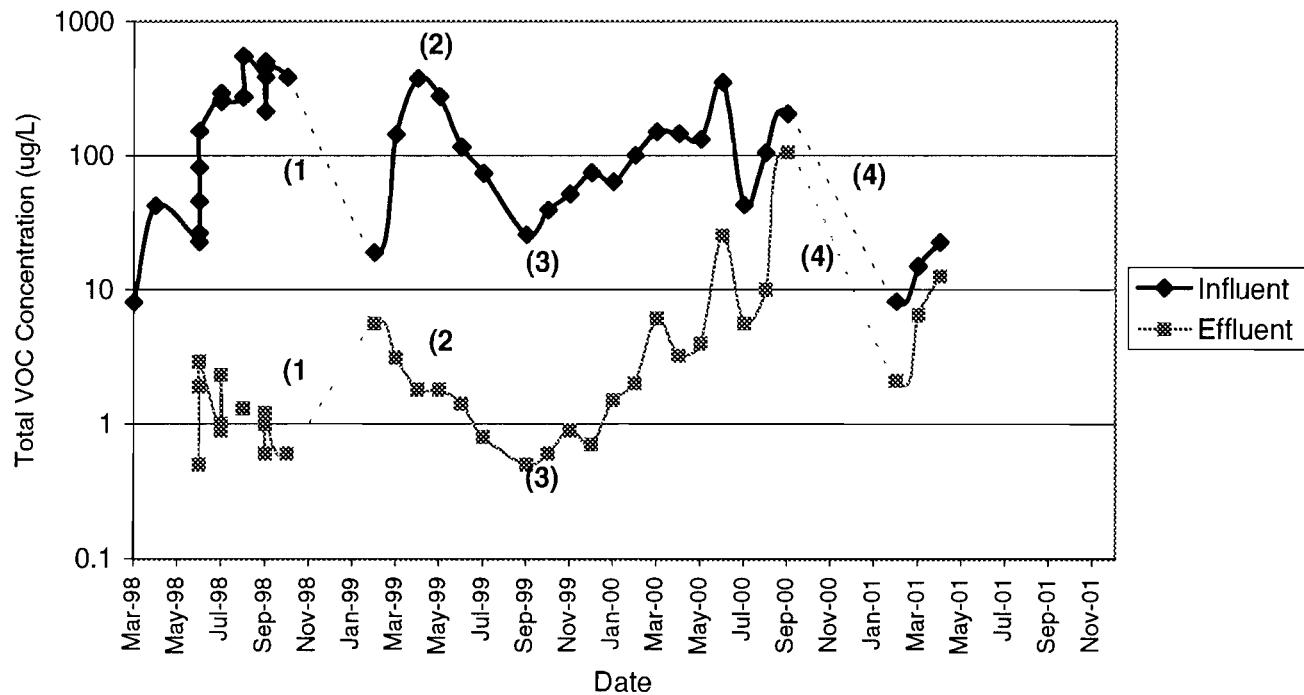
**Total Volatile Organic Compound (VOC) Influent and Effluent Trends**

1. Plant down due to reinjection well fouling (November 19, 1998 to January 23, 1999)
2. Brief Shut down in May: May 8 - May 10, 1999
3. Low influent flow due to reinjection well fouling.
