Boat Showroom 197 Main Avenue Wynantskill, NY Page 1 of 4

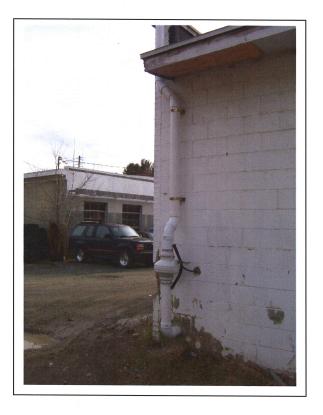
Photo #5: Extraction point and damper valve located in the addition.
