FPM Group, Ltd.  
FPM Engineering Group, P.C.  
*formerly Fanning, Phillips and Molnar*

Re: **UIC Closure Report**  
**I.W. Industries, Inc. Site**  
**NYSDEC Registry # 1-52-102**  
**FPM File No. 944-08-02**

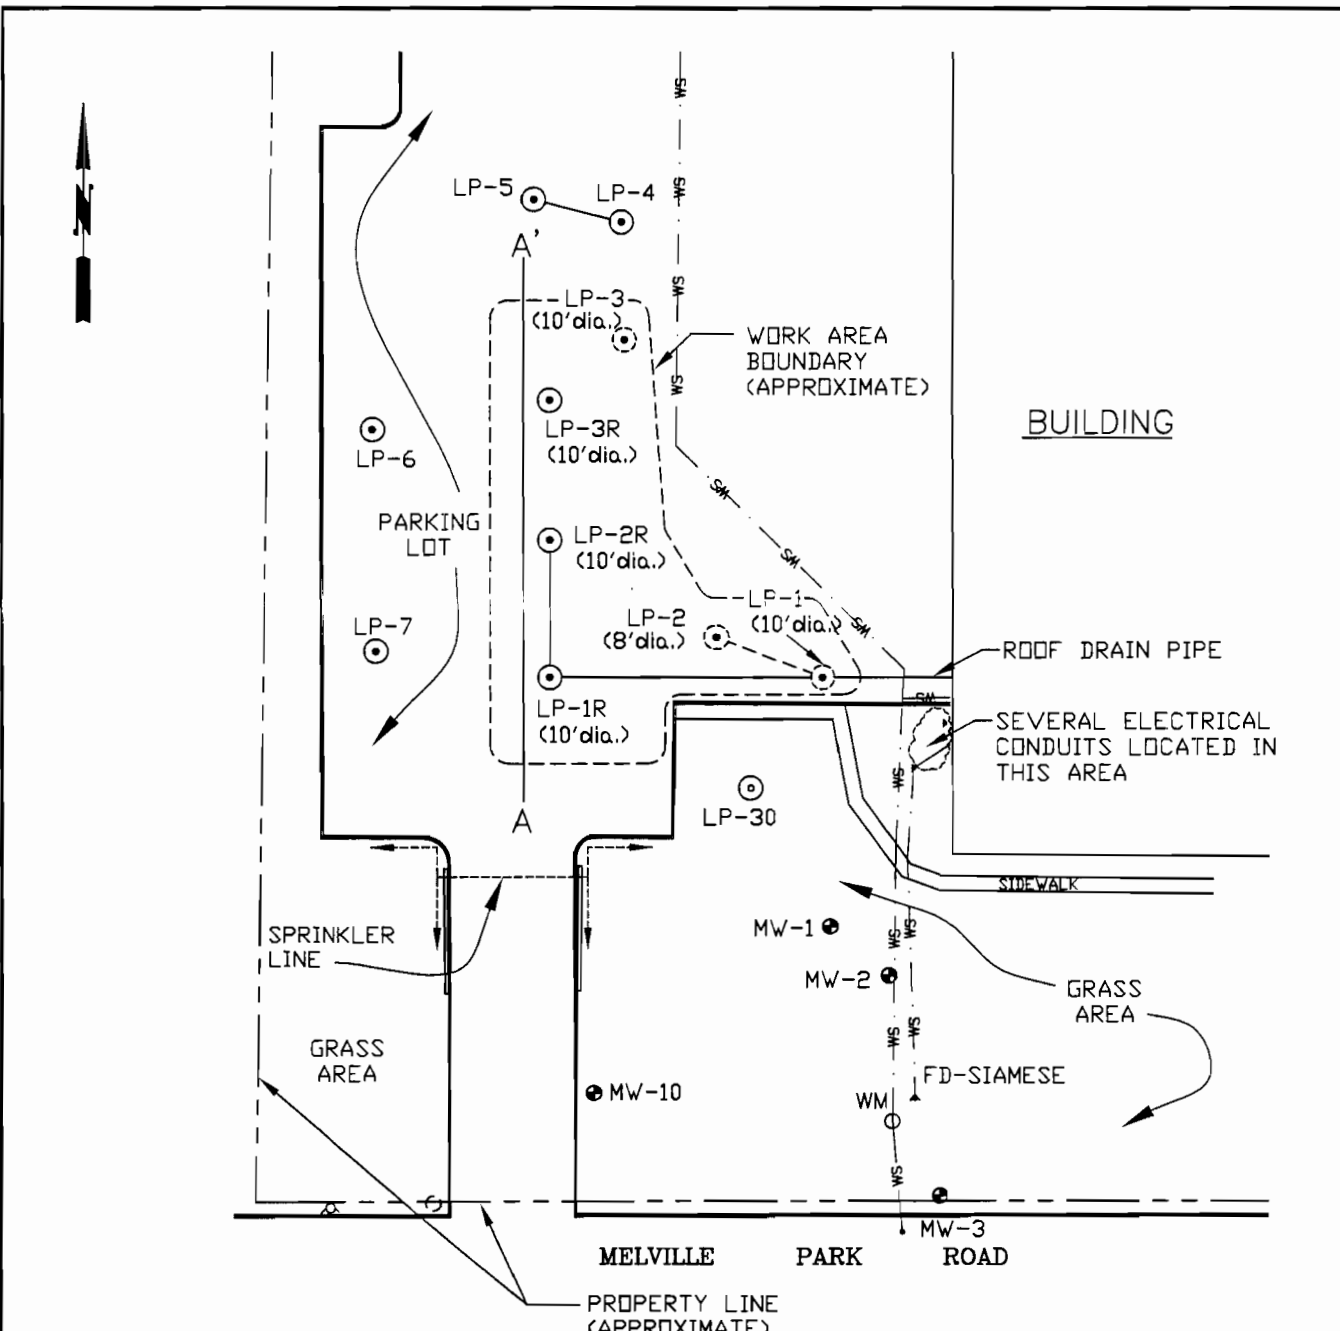
<b>FPM GROUP</b>		
<b>FIGURE 1 SITE PLAN</b>		
35 MELVILLE PARK ROAD MELVILLE, NEW YORK		
Drawn By: H.C.	Checked By: JB	Date: 1/24/10

As shown on Figure 1, leaching pools LP-1 and LP-2 were formerly situated southwest of the onsite building and received stormwater discharges from the southwest roof of the building. LP-1 was the primary structure and LP-2 was an overflow structure to LP-1. LP-3 was a slotted-cover leaching pool located to the west of a former interior loading dock. The former piping to this structure had been previously sealed and, at the time of abandonment, LP-3 received stormwater runoff from the parking lot. During the closure additional leaching pools (LP-1R, LP-2R and LP-3R) were installed to manage stormwater runoff previously directed to LP-1 through LP-3.

Replacement stormwater leaching pools LP-1R through LP-3R were installed to the west of LP-2, as shown on Figure 1. The area where LP-1R and LP-2R were to be installed was excavated to approximately 24 feet below grade and the area of LP-3R was excavated to approximately 20 feet below grade. As the excavations commenced, the excavated soil was stockpiled, visually examined for indications of potential contamination, and then placed into the structures to be abandoned, as further described below. It should be noted that no visual indications of potential contamination (odors, staining) were noted on any of the excavated soils. The replacement structures were constructed as designed and the slotted concrete rings were wrapped with filter fabric prior to installation. The top of LP-1R was fitted with a 12-inch-thick reinforced concrete cover at a depth of approximately two feet below grade and a concrete chimney connected to a solid access cover at grade. The tops of LP-2R and LP-3R were each fitted with a reinforced concrete dome. A solid at-grade access cover was installed for LP-2R and a slotted at-grade access cover was installed for LP-3R. The existing roof drainpipe formerly connected to LP-1 was extended using 6-inch Standard Dimension Ratio (SDR) 35 pipe and connected to LP-1R. A 6-inch diameter SDR 35 overflow pipe was installed between LP-1R and LP-2R. The excavated areas surrounding LP-1R through LP-3R were backfilled with the stockpiled soil to grade and compacted. The exposed surface area was finished with several inches of recycled concrete aggregate (RCA) for stabilization. Copies of photos showing the work performed are included in Attachment 2.

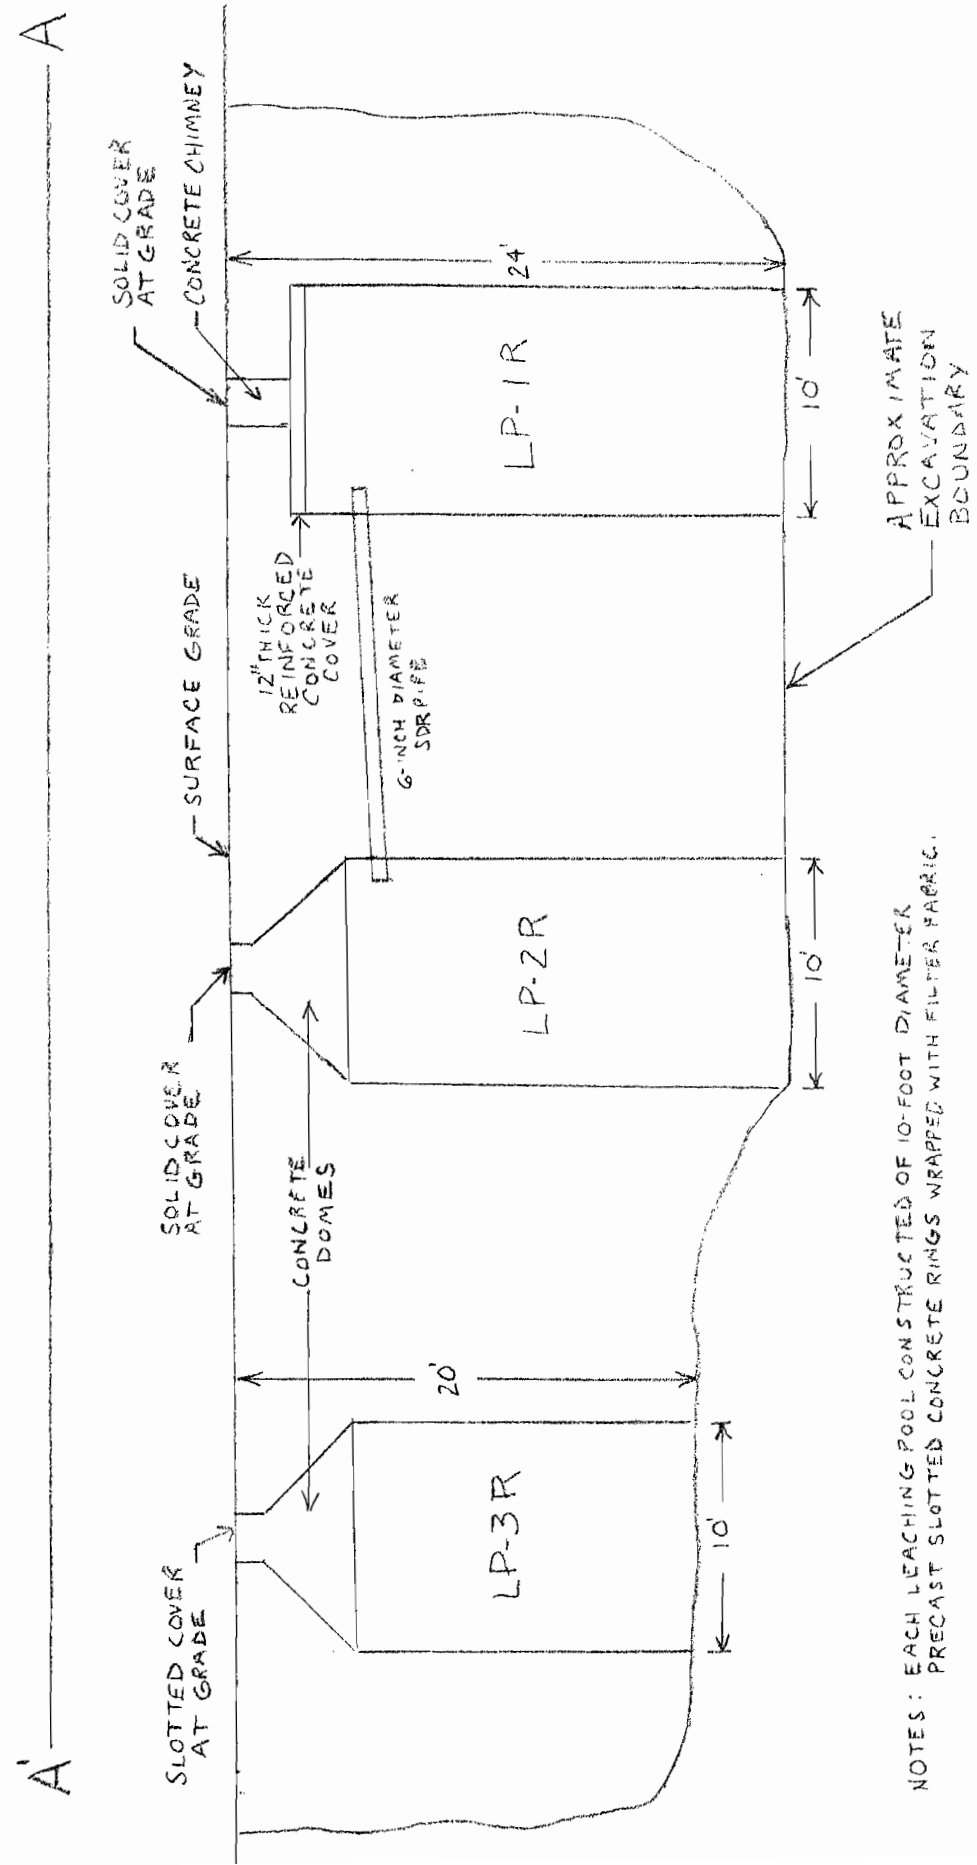
FIGURE 2  
 SCHEMATIC PROFILE OF LP-1R THROUGH LP-3R  
 35 MELVILLE PARK RD

structures ranging from 20 to 24 feet deep topped with manways and lids at grade, as required by the SCDHS. The planned and actual locations of each replacement pool and associated piping are shown on Figure 1. A profile showing the planned and actual construction of LP-1R through LP-3R is presented on Figure 2, included in Attachment 1.

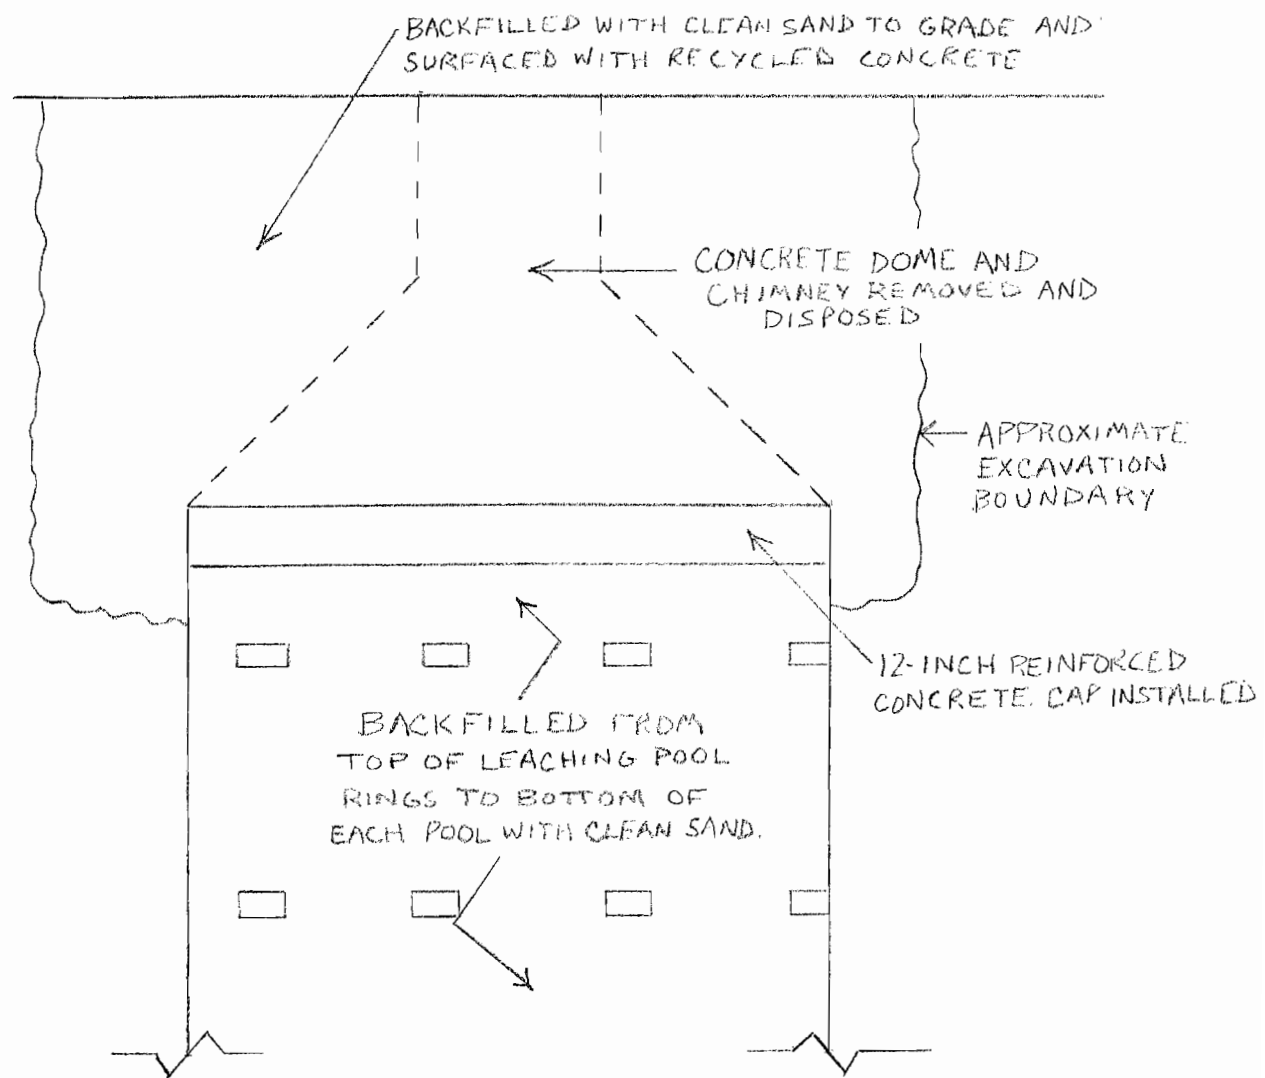
FIGURE 3  
DIAGRAM OF ABANDONMENT  
PROCEDURES FOR LP-1 THROUGH LP-3

To conduct the abandonment of LP-1 through LP-3, the concrete manways and domes of LP-1 through LP-3 were exposed by excavation and removed, and the existing piping was cut and removed from the immediate vicinity of the structures. As the excavations for the replacement leaching structures commenced (described above), the excavated and inspected soil was backfilled into the structures to be abandoned. Following backfilling, the top of each former leaching pool was sealed with a 12-inch thick reinforced concrete cover with a diameter corresponding to the diameter of each pool. The remaining exposed area above each concrete seal was backfilled with stockpiled soil and compacted. Several inches of RCA were added at grade for stabilization. Figure 3 in Attachment 1 shows the general abandonment and sealing procedures for LP-1 through LP-3.

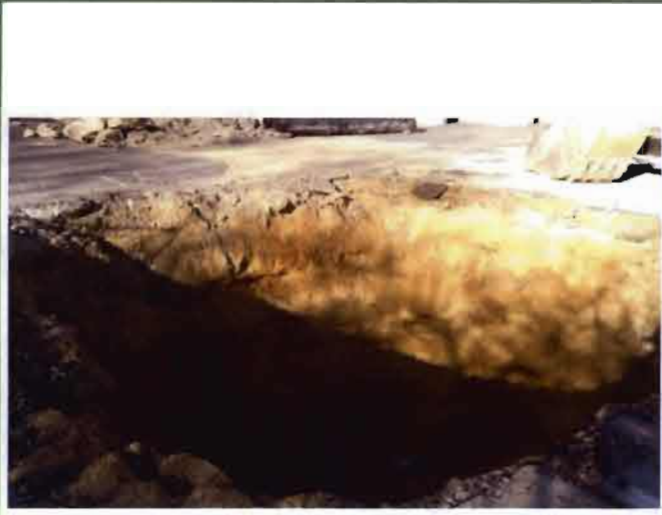
Photo #1 – View of the excavation for LP-1R.

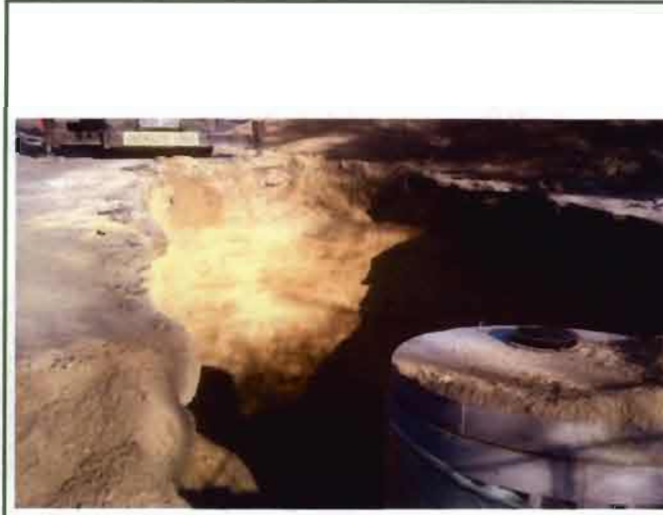
Photo #2 – View of LP-1R and the excavation for LP-2R.

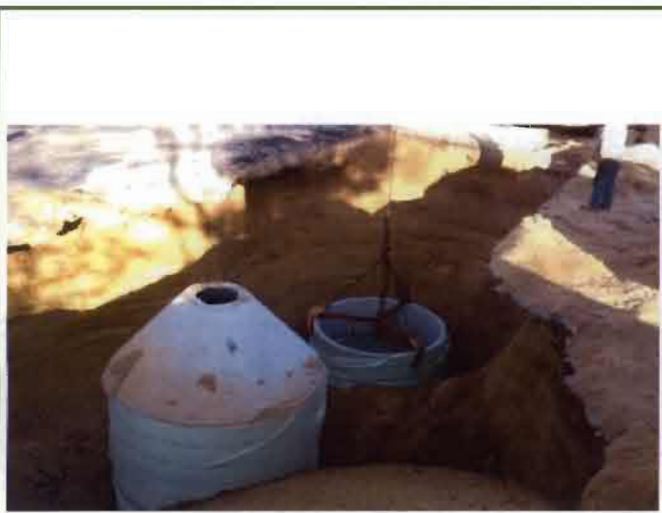
Photo #3 – View of the installation of the new leaching pools. LP-2R is shown on the left, LP-3R is being installed on the right.

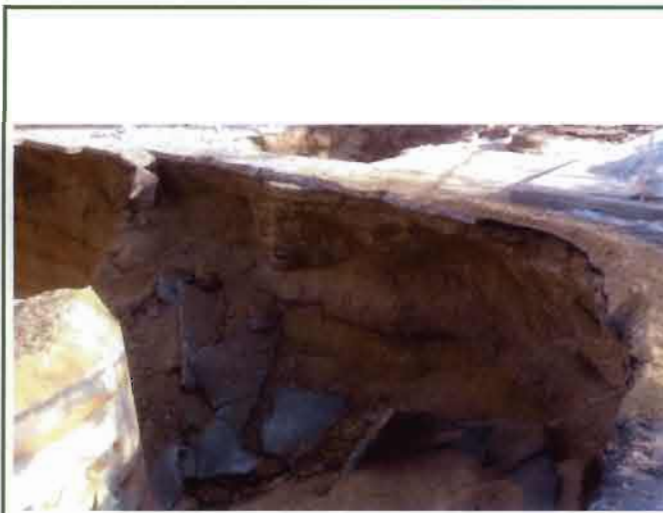
Photo #4 – View of the excavation for LP-1R (shown on the left). The excavation for LP-2 can be seen in the background.

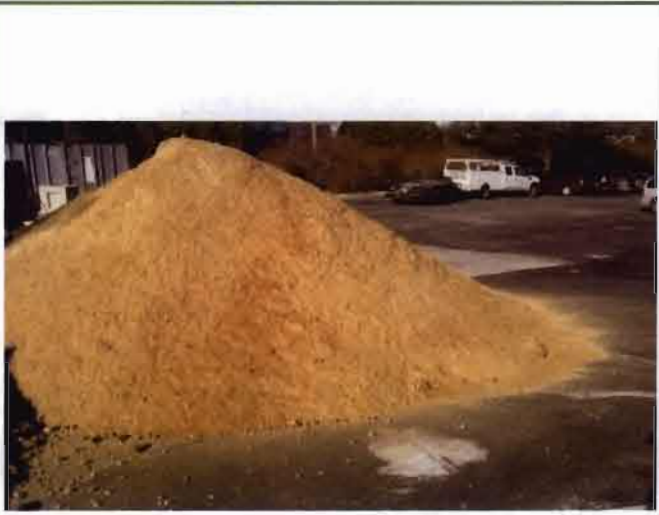
Photo #5 – View of the stockpiled material excavated during the installation of LP-1R through LP-3R.

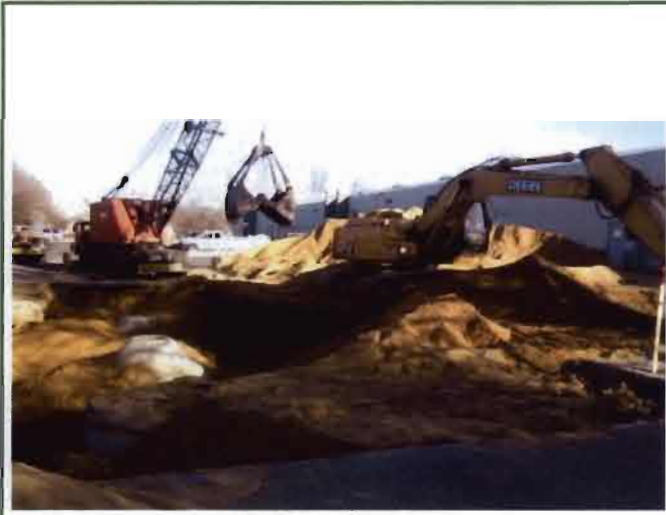
Photo #6 – View of the new leaching pool being backfilled. LP-1R is shown in the foreground, LP-3R in the background.

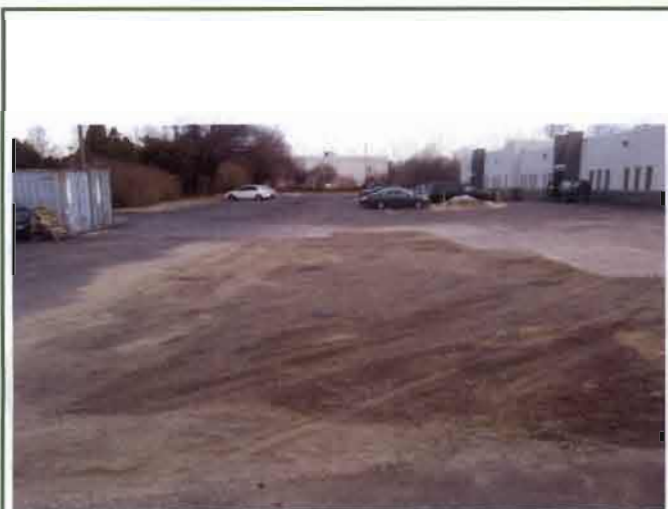
Photo #7 – View of the completed work area looking north.

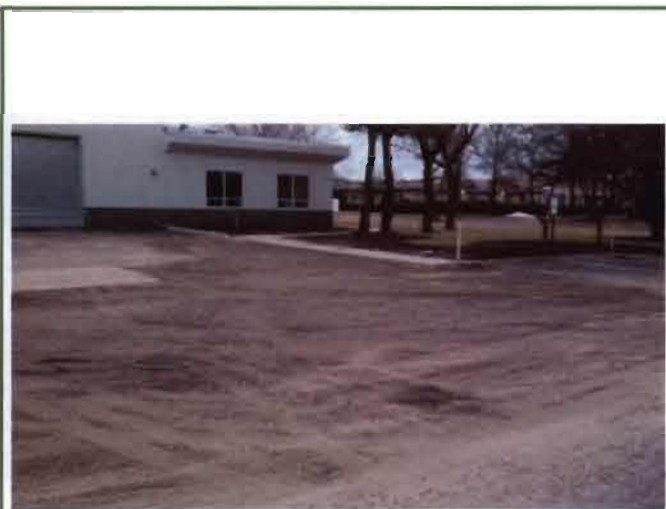
Photo #8 – View of the completed work area looking southeast.
