ACTIVE INDUSTRIAL UNIFORM GROUNDWATER EXTRACTION AND TREATMENT SYSTEM

Site Management Quarterly
Report No. 26

April 1, 2011 through
June 30, 2011

NYSDEC Site No. 1-52-125, Active Industrial Uniform Site Groundwater Extraction and Treatment System, Village of Lindenhurst, Town of Babylon, Suffolk County, New York.

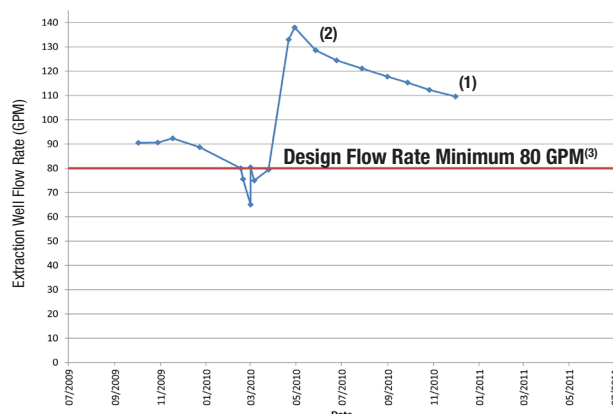
Extraction Well RW-1 Flow Rate Trend Line

1. Extraction well RW-1 did not operate the vast majority of this reporting period and the entire previous reporting period due to a carbon vessel bed screen failure and a continuous loud noise emitted by the treatment system exhaust stack upon start-up.
2. As described above, extraction well RW-2 was shut down in April 2010 based on low historic VOC concentrations, as per NYSDEC direction.
3. Note that, due to the fact that the treatment system was shut down for the majority of the previous two reporting periods, the total flow information for RW-1 and the system effluent provided in Quarterly Report Nos. 24 and 25 were based on estimates. The information presented above depicts actual total flow volumes collected during this reporting period.

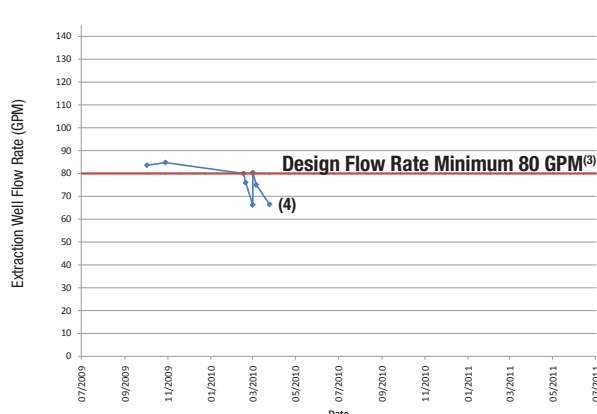
Extraction Well RW-2 Flow Rate Trend Line

2. RW-2 was shut down in April 2010 due to low historic VOC concentrations, as per the direction of the NYSDEC. Note that, based on recommendations provided by D&B, RW-2 is now sampled on a quarterly basis (starting on June 17, 2011) to monitor off-site VOC concentrations and to determine whether RW-2 should be restarted.

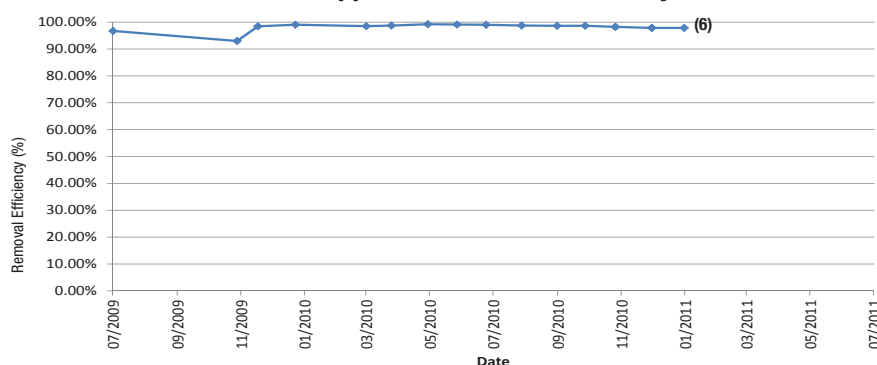
Air Stripper VOC Removal Efficiency⁽⁵⁾

- The packed-tower air strippers have operated at an approximate efficiency ranging from 92.65% to 99.47% since D&B assumed O&M duties in February 2005.
- As detailed above, the treatment system did not operate the vast majority of this reporting period due to a carbon vessel bed screen failure and a continuous loud noise emitted by the treatment system exhaust stack upon start-up.

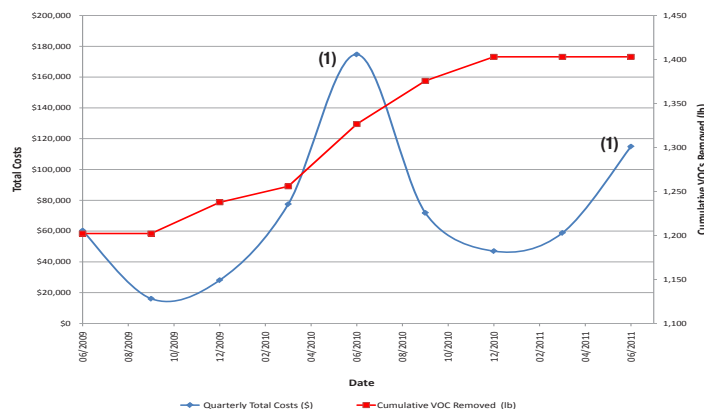
VOC Removal/Operational Cost Trend Line

1. Costs reflected for this period are primarily the result of contaminated soil excavation activities completed by the NYSDEC "call-out" contractor, per the approval of the NYSDEC.

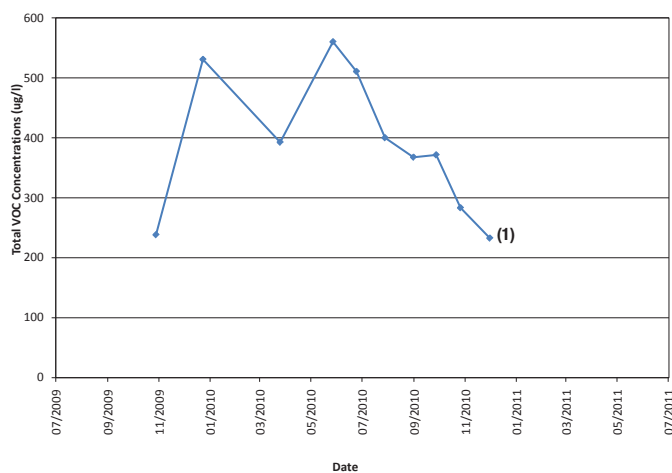
Extraction Well RW-1 Total VOC Concentration Trend Line

1. The treatment system did not operate during the vast majority of this reporting period and the entire previous reporting period due to a carbon vessel bed screen failure and a continuous loud noise emitted by the treatment system exhaust stack upon start-up.
