# DAILY OBSERVATION REPORT

Report No.: 26      EA Project File: 1447429      Date: January 30, 2012

Site No. 1-52-140

**NYSDEC Division of Environmental Remediation**  
**Site Location: Albany St., Babylon, NY (Site No. 1-52-140)**

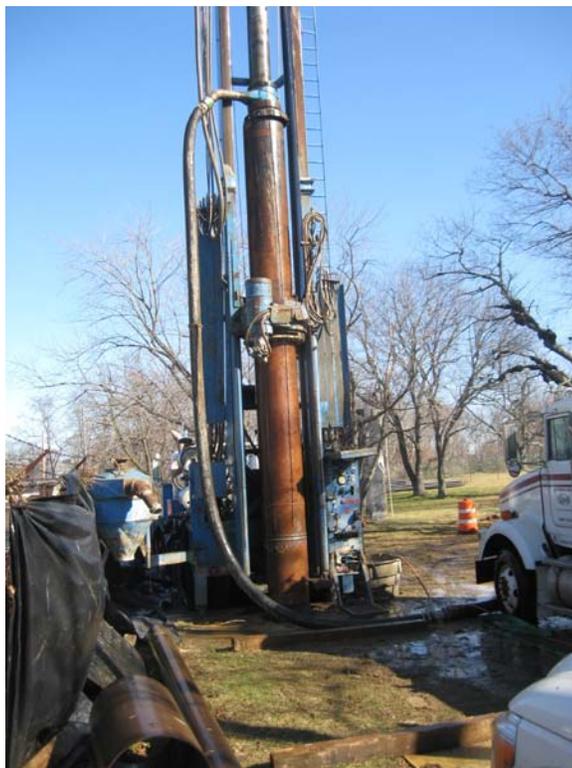
- Over the weekend 14-ft of sand infiltrated through the bottom of DDC-06 outer casing and buried the drill head. The drill rig lacked the power to remove the drill head. Layne directed high-velocity air and water down the borehole and ejected 7 ft of material through the annulus. At this point, Layne was able to remove the drill head and drill string components from the borehole. The remaining 7 ft of material was removed via 6-in. diameter steel bailer. All sand and water was discharged to a poly lined roll-off. Layne pumped water from the roll-off to the weir tank for settling. Once borehole was cleared to bottom of casing, Layne re-assembled drill string and welded additional casing. Layne advanced DDC-06 borehole to 61 ft below ground surface (bgs).

View of Layne drilling DDC-06.

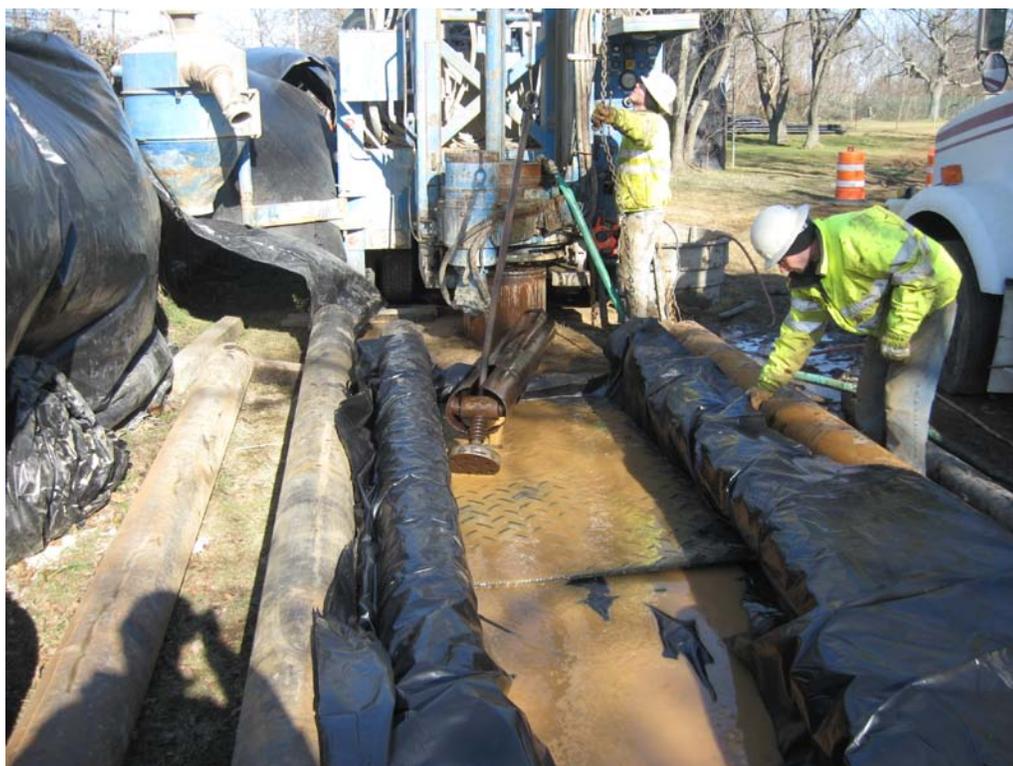
Layne using 6-in. diameter bailer to remove sands.

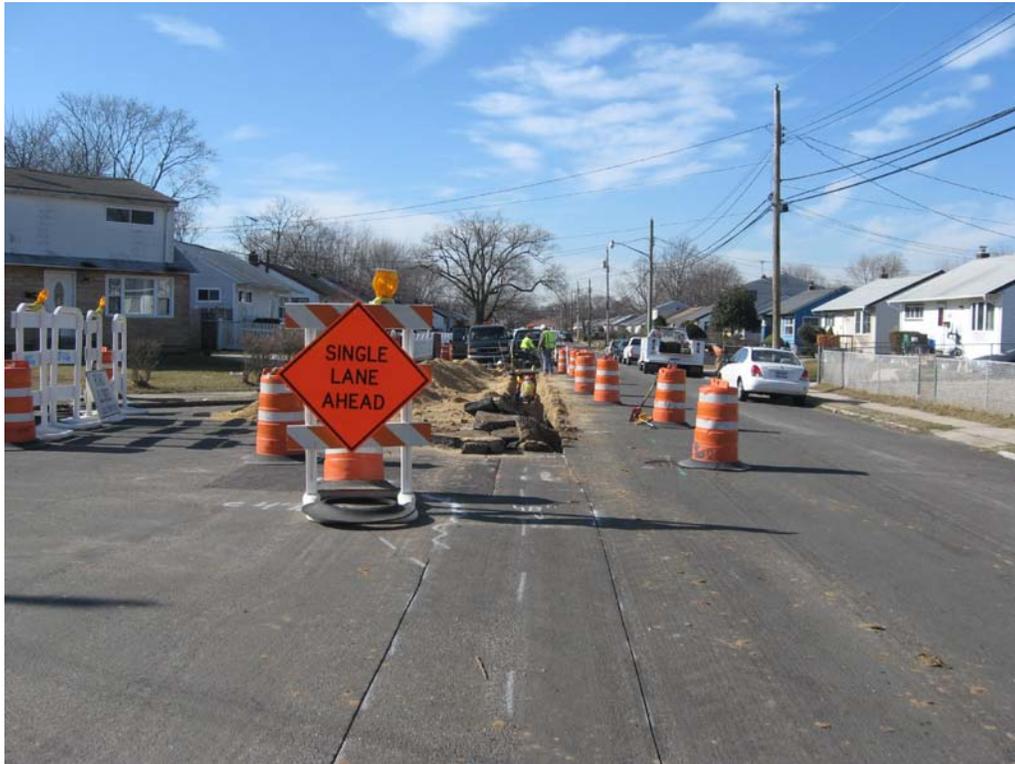
View of traffic controls along Benjoe Dr., at DDC-09 looking west.

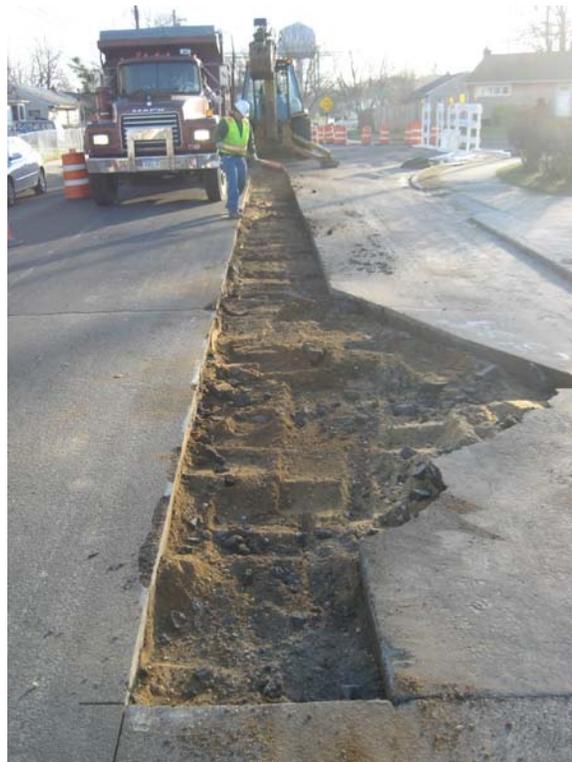
Posillico removing asphalt from trench line, at DDC-10 looking east.

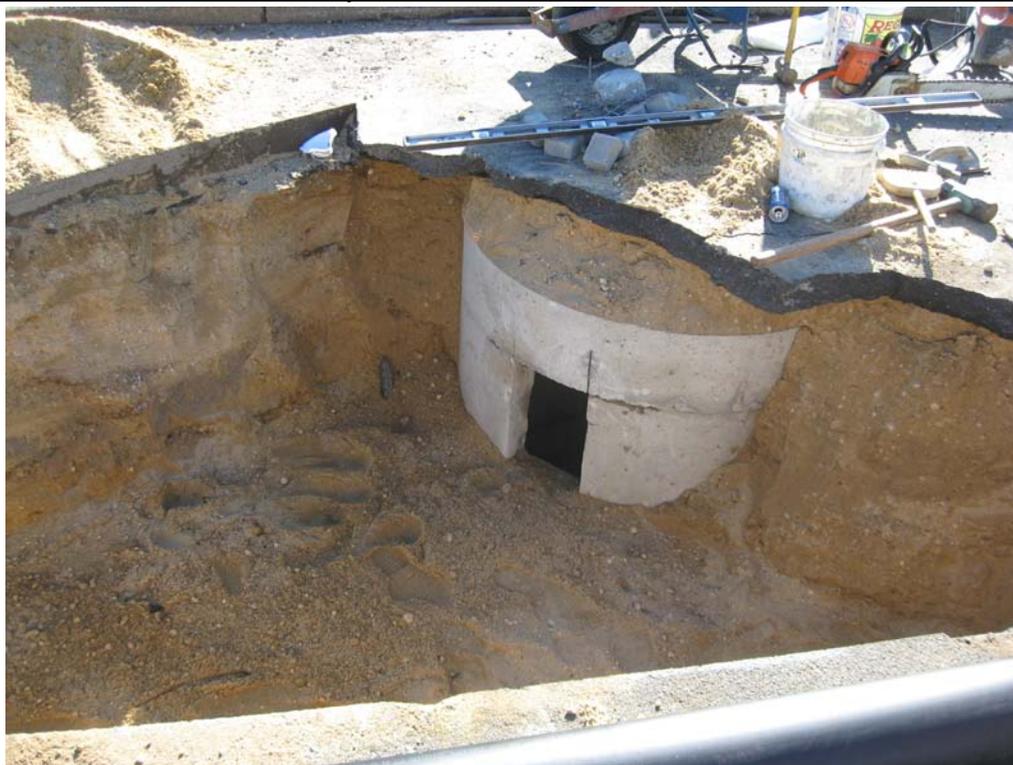
View of DDC-10 vault with piping inlet.

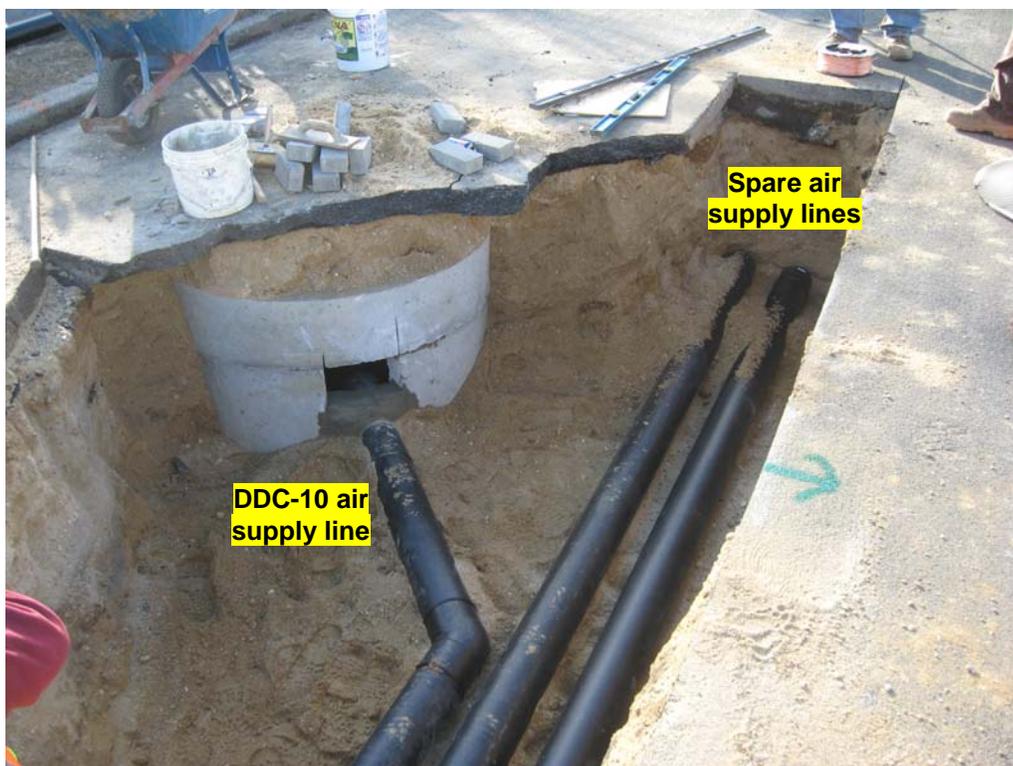
View of 6 in. supply lines at DDC-10 (one at DDC-10, two spares).

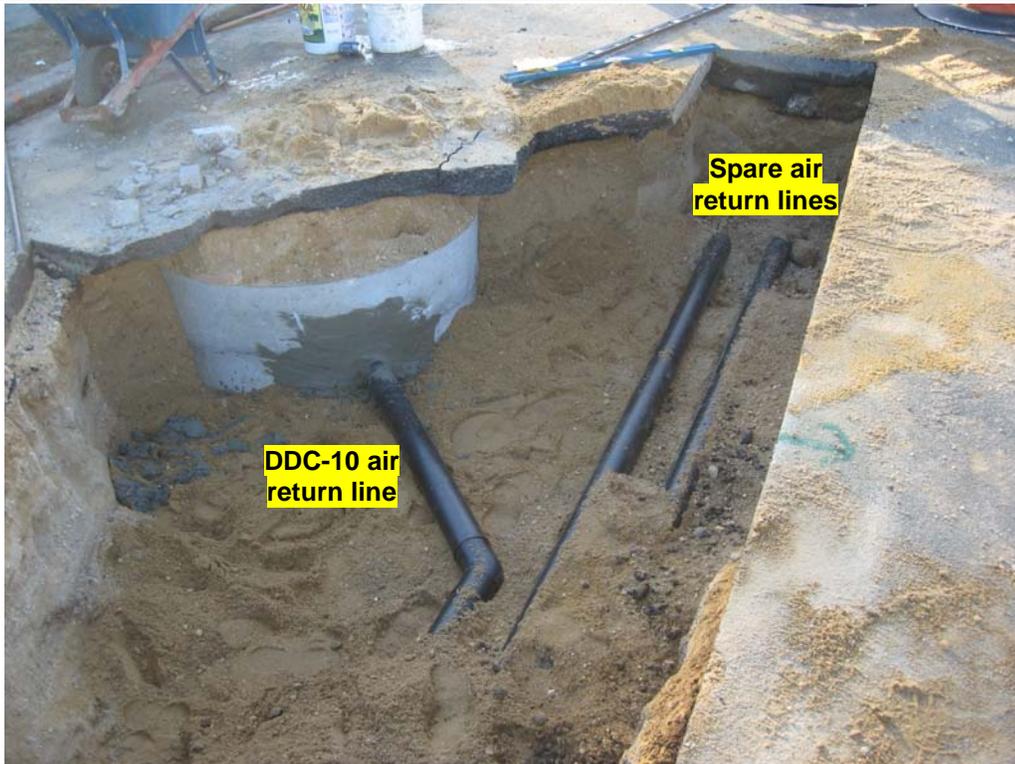
View of 4 in. return lines at DDC-10 (one at DDC-10, two spares).

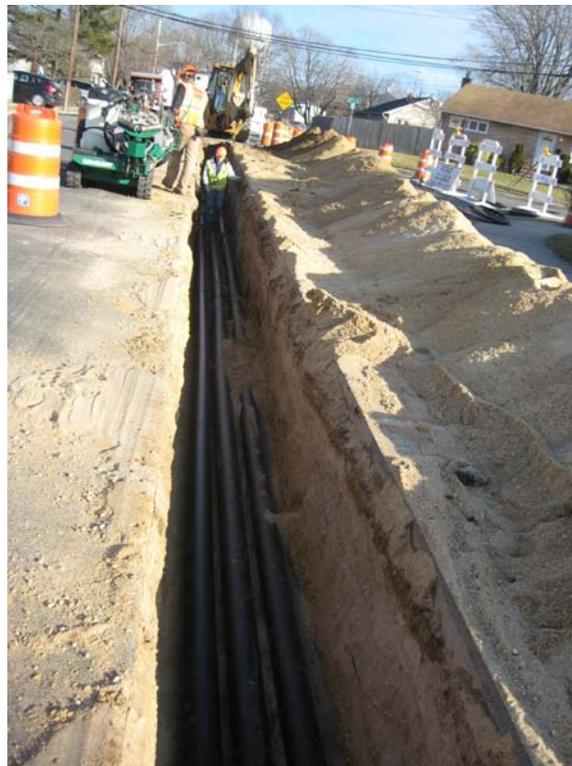
HDPE piping extending through trench line, at DDC-10 looking east.

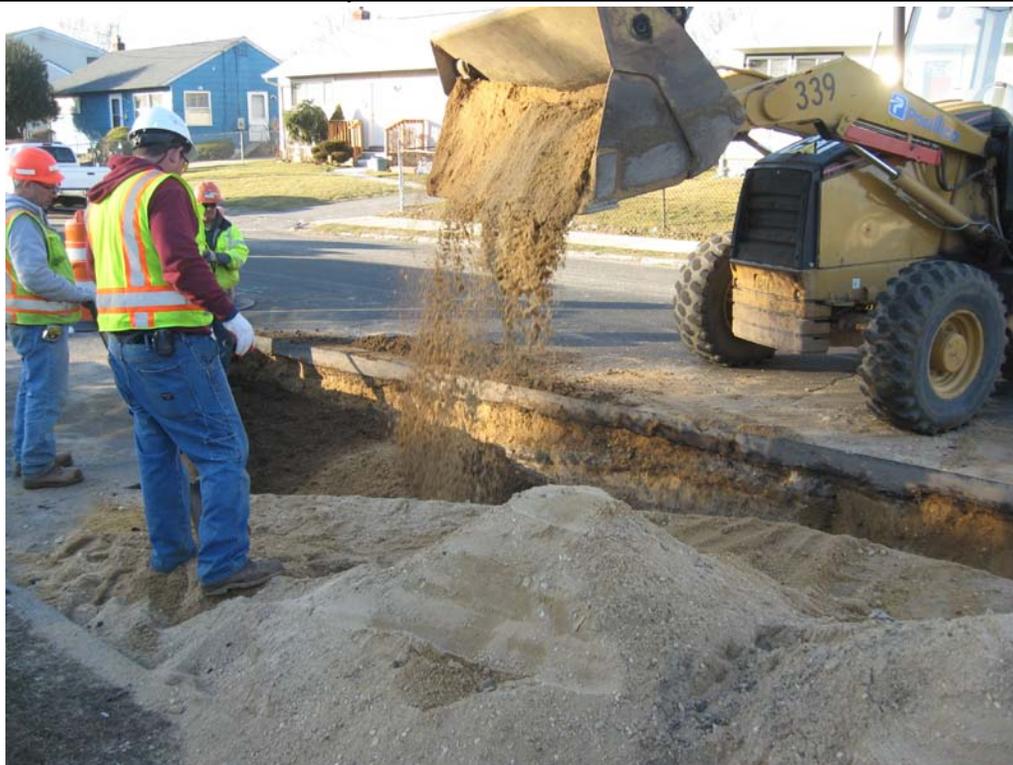
Posillico backfilling trench line from DDC-10 to DDC-09.

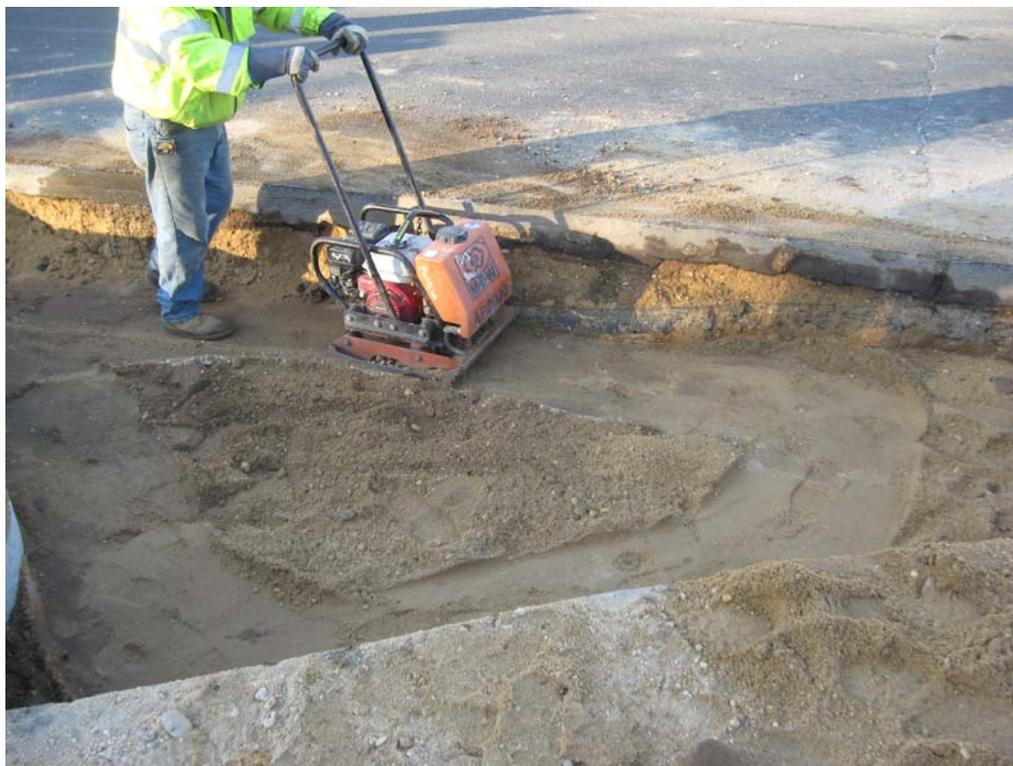
Posillico compacting native material near DDC-10.

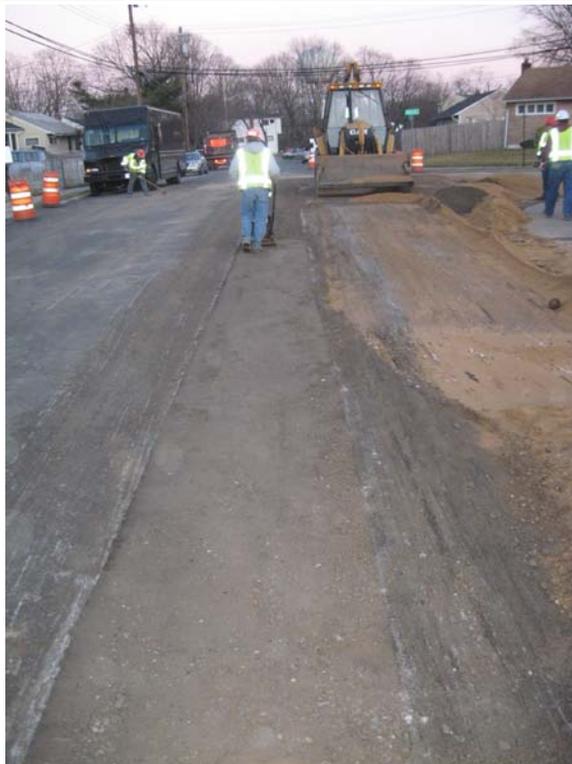
Posillico compacting crushed concrete at grade for road use.

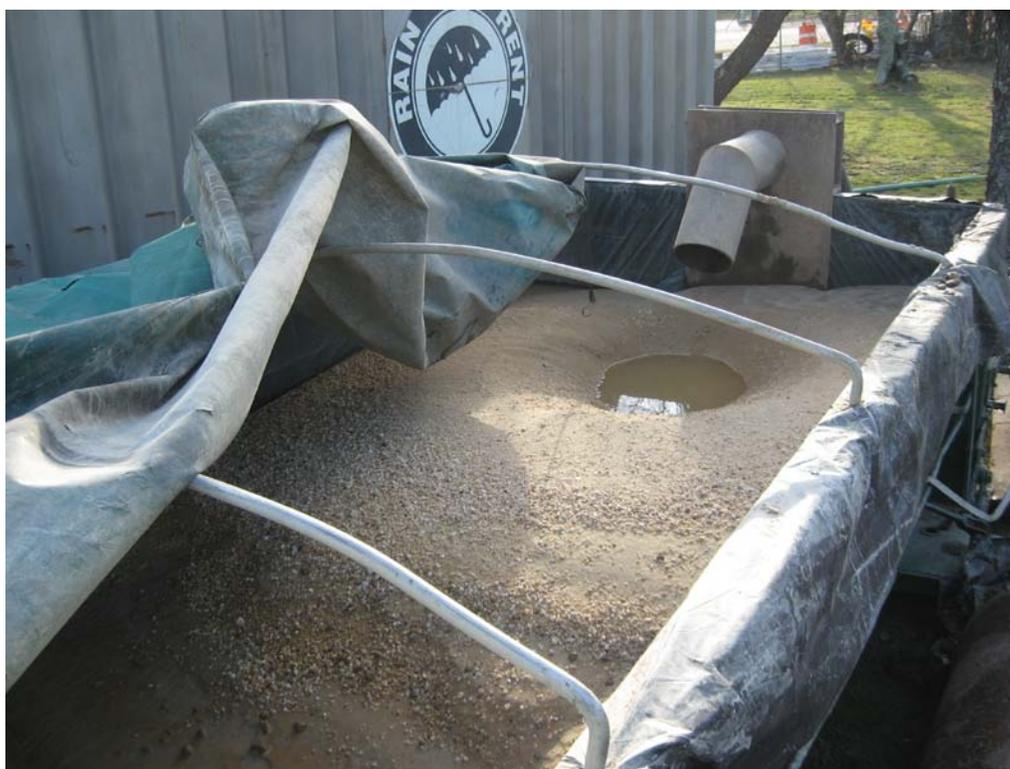
View of drill cuttings from DDC-06.

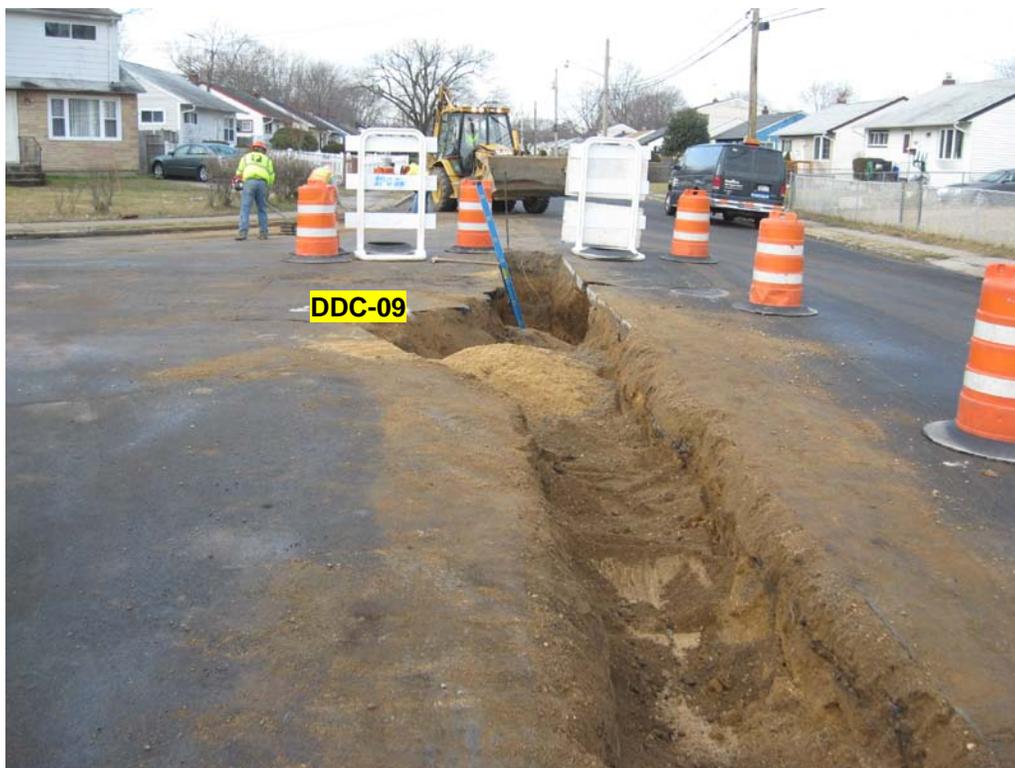
View of trench line during excavation and traffic controls.

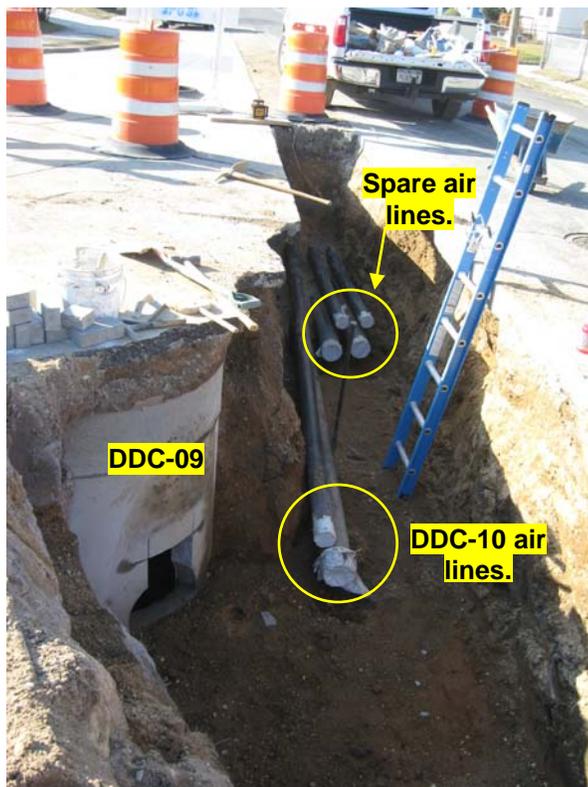
View of DDC-09 vault and air lines from DDC-10 and spares.

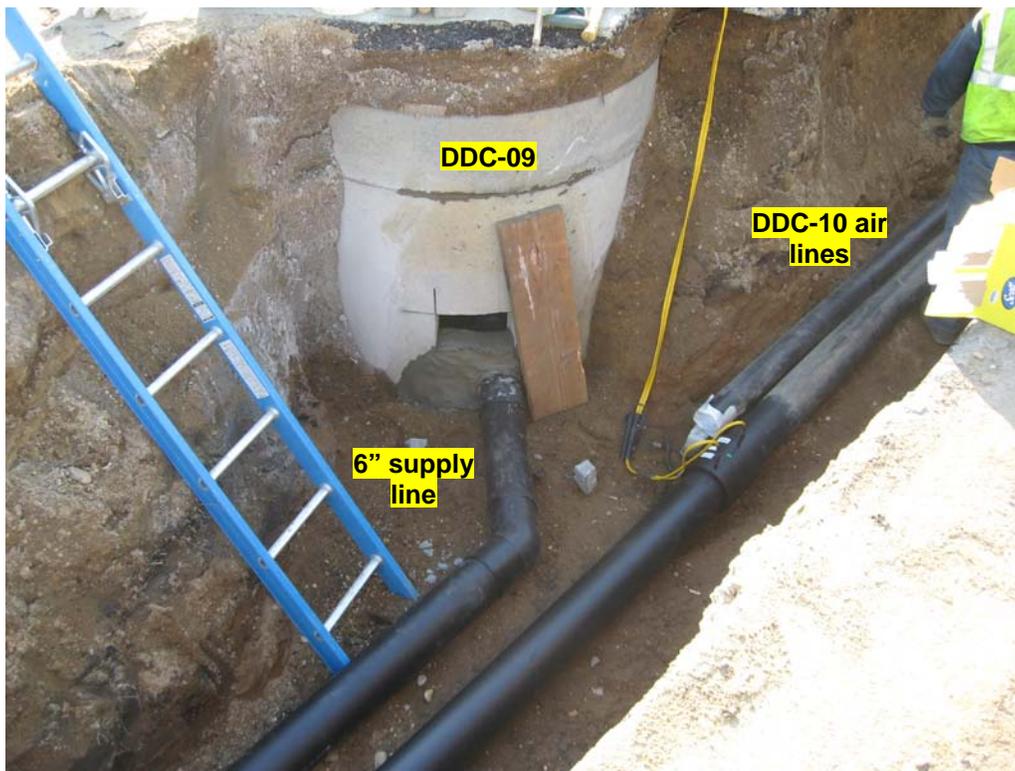
View of 6 in. air supply line inserted into DDC-09 vault.

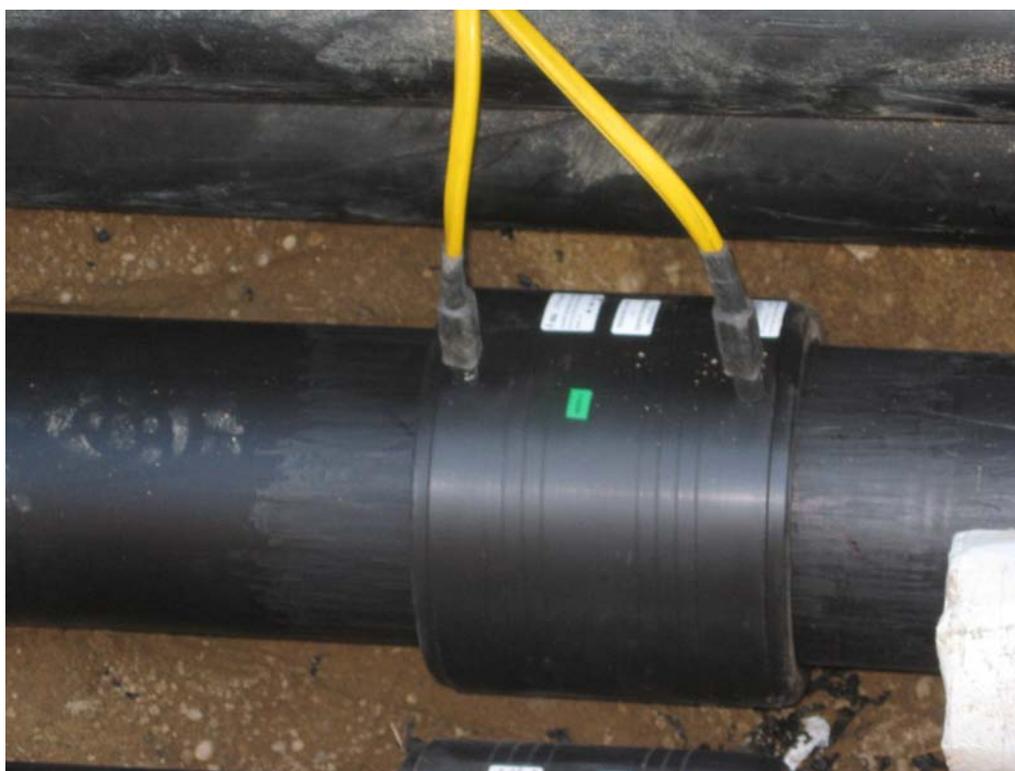
View of Type A Coupling and yellow electrofusion probes.

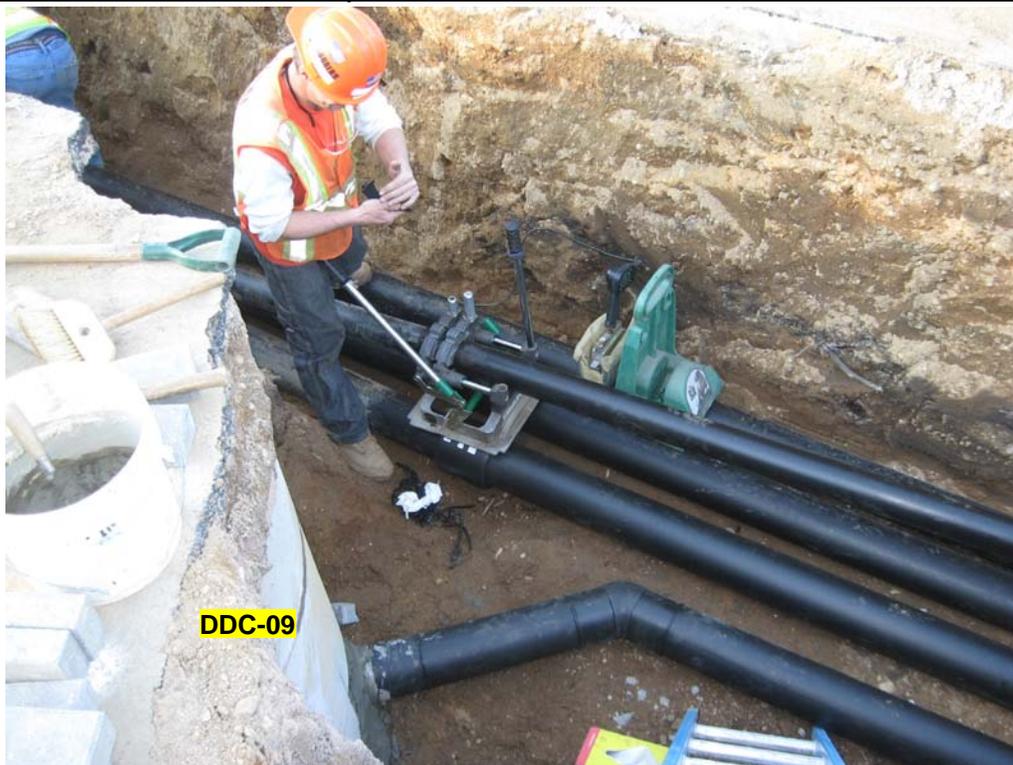
Posillico performing heat fusion weld in trench.

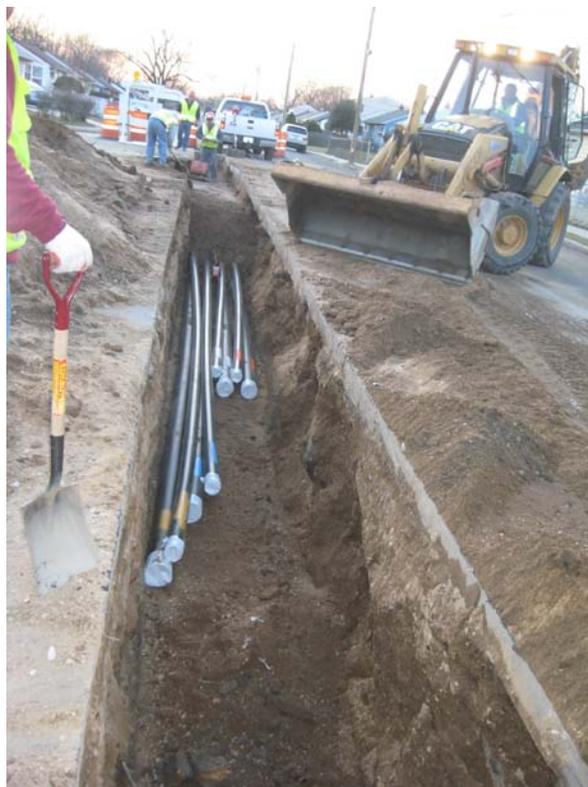
HDPE air lines extending through trench line, at DDC-08 looking west.

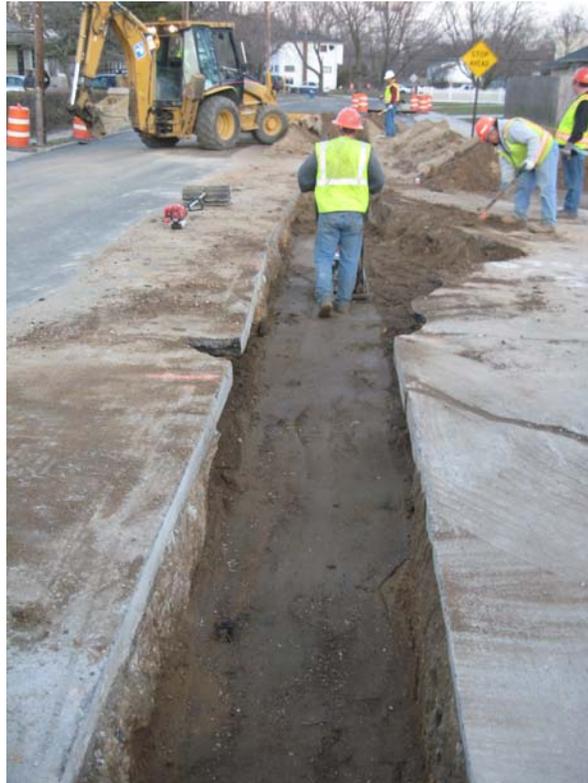
Posillico compacting backfill, at DDC-09 looking east.

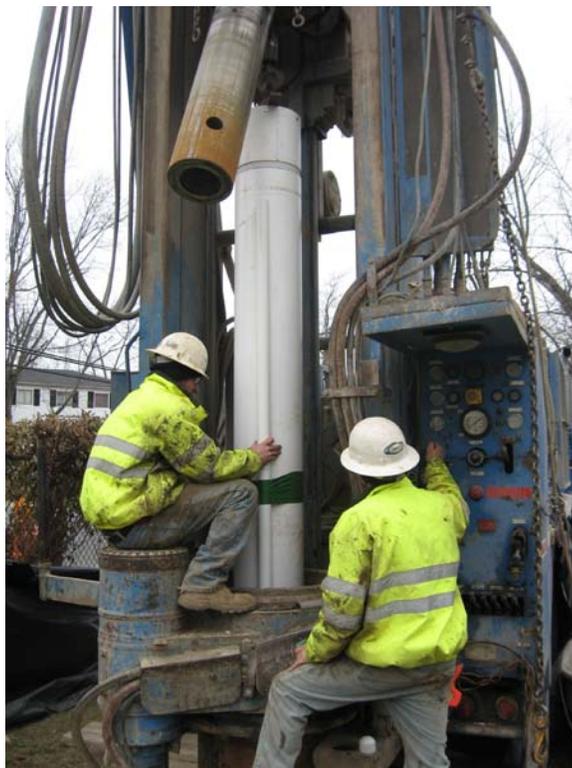
Layne installing DDC-06 recirculation well and piezometers.

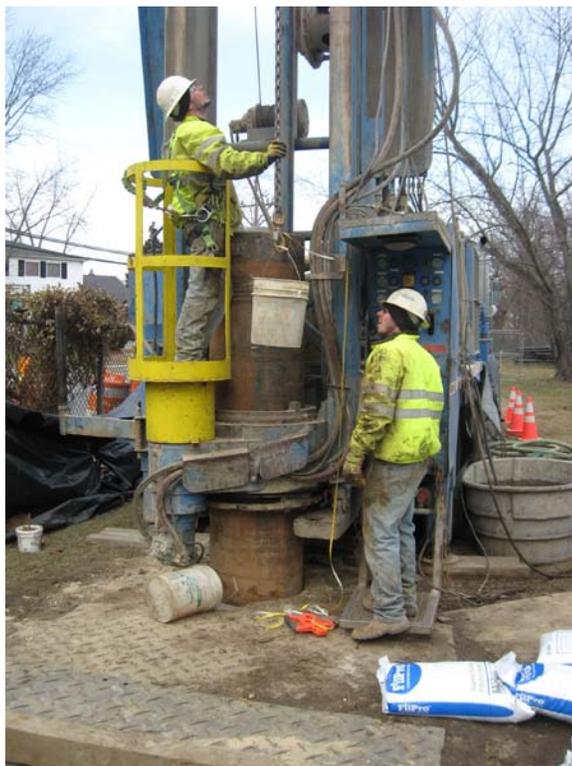
Layne adding sand to DDC-06.

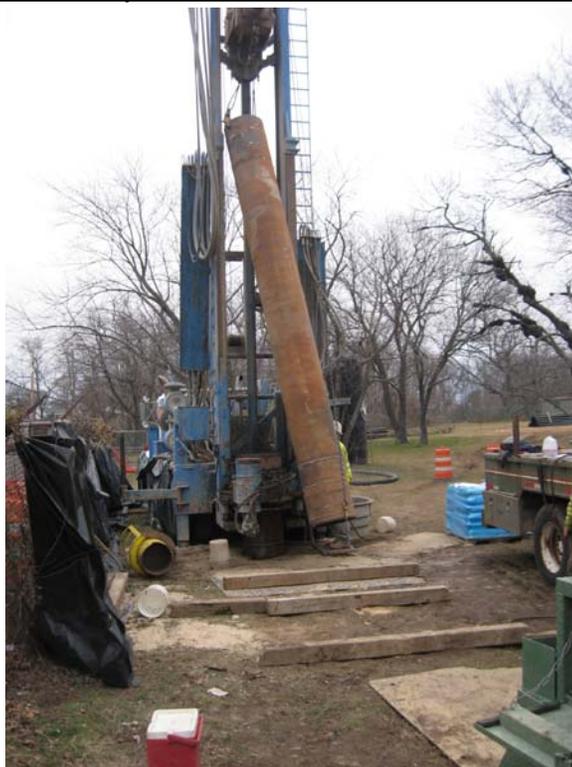
Layne removing 24 in. diameter outer casing from DDC-06.

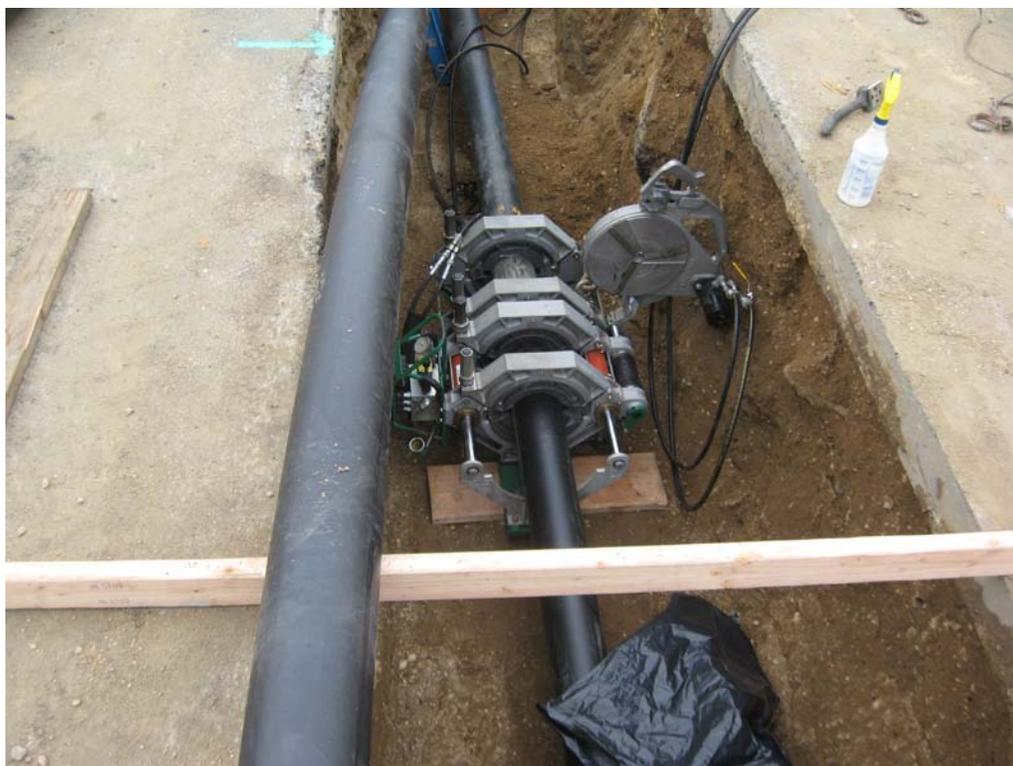
Posillico performing heat fusion weld in trench.

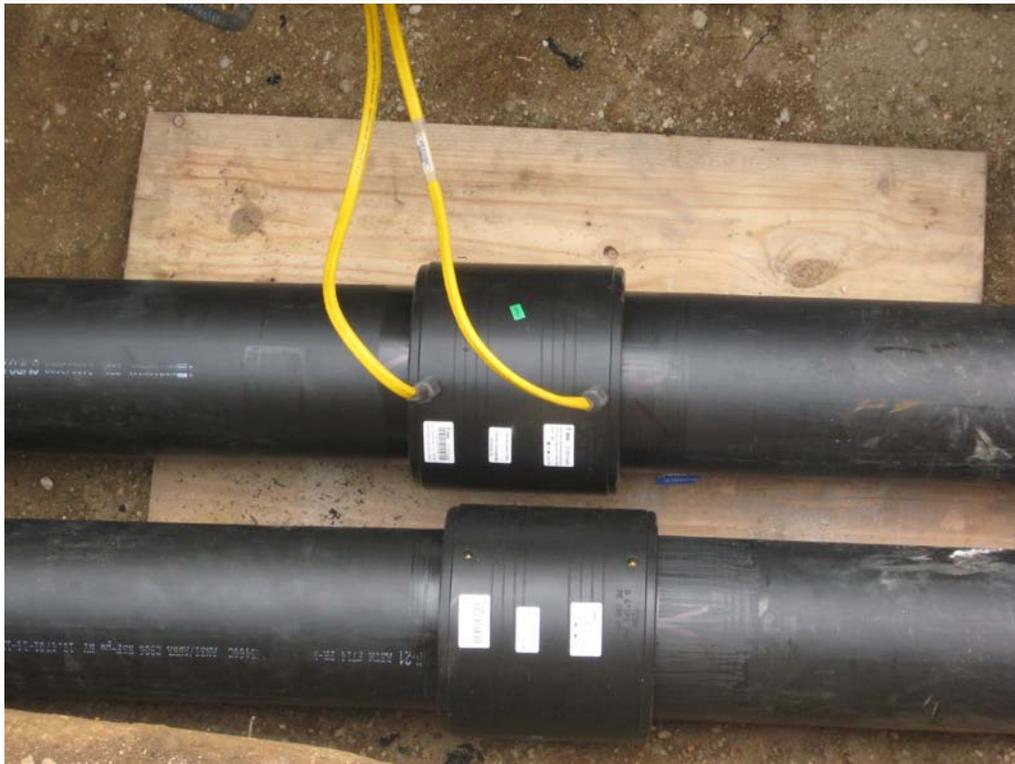
View of Type A Couplings and yellow electrofusion probes.

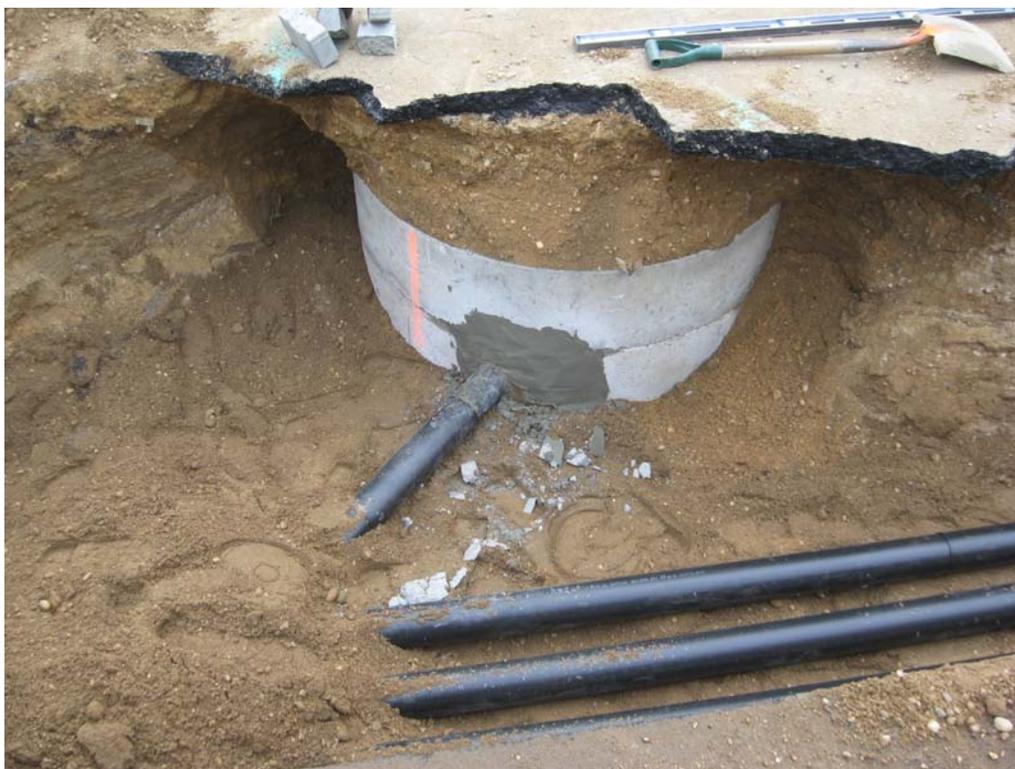
View of 4" air line attached to DDC-08 vault.

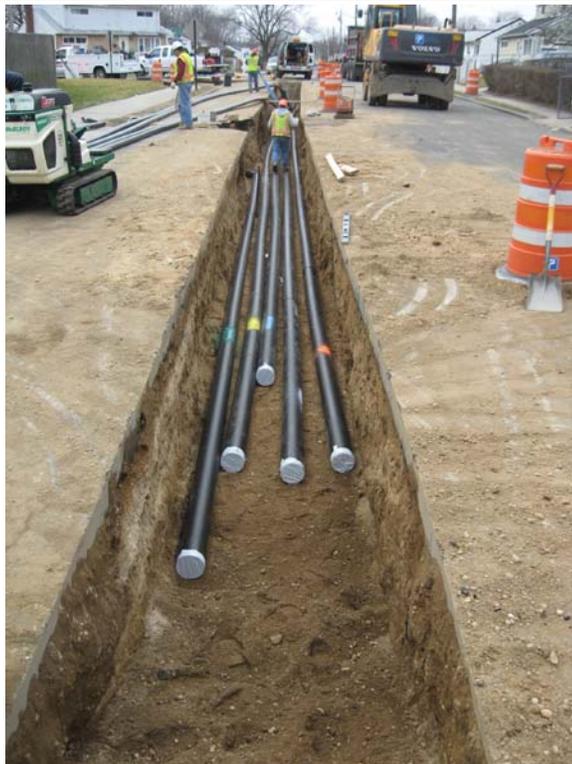
HDPE air lines extending through trench line, at DDC-07 looking west.

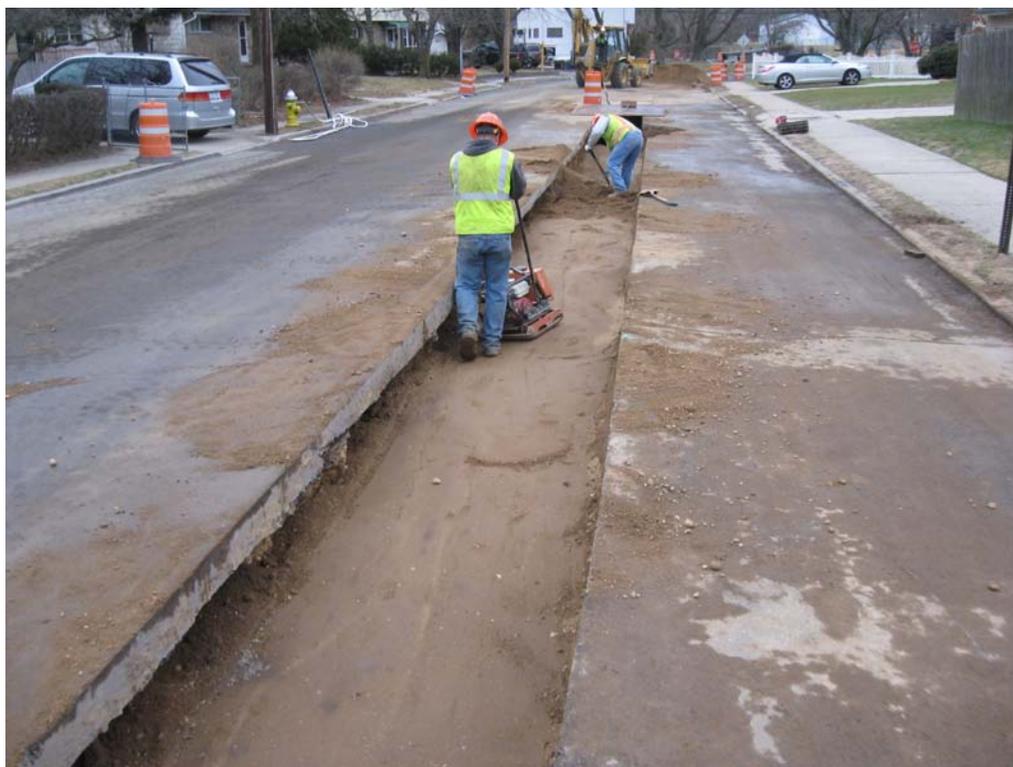
Posillico compacting backfill, looking east.

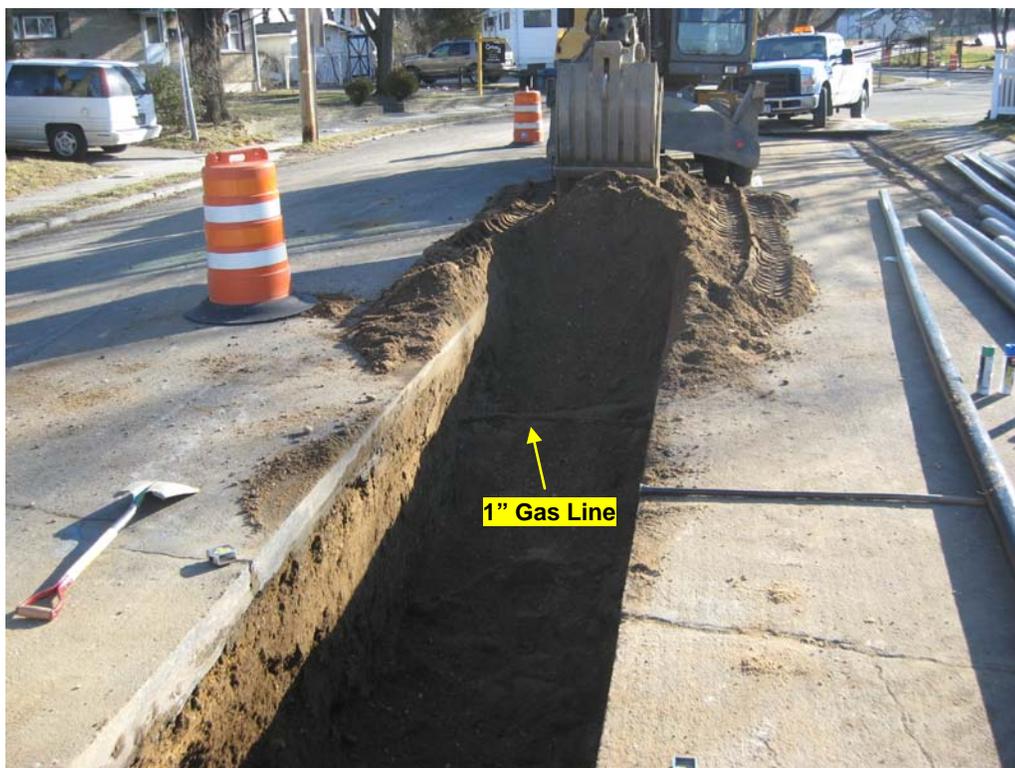
- 09:20 - National Grid unable to shut off gas service to 6 Benjoe Drive. Shut-off valve located 20-ft south of 6 Benjoe Dr. 10:00 - National Grid excavation crew arrives at Benjoe Dr. and begins excavating shut off valve. National Grid determined that 1-inch line and shut off valve were pulled to the south from the shut off access point. Furthermore, the line separated at a coupling 10-ft north of the shut off access point. 11:00 - National Grid excavated 1-in. damaged line and 4-inch gas main connection located 10-ft west of DDC-07. No damage or leaks discovered at connection. National Grid stopped flow of gas through damaged line by closing shut off valve at connection. 11:35 - National Grid excavated a 2 x 3-ft area in front lawn of 6 Benjoe Dr. to access separated line. Damaged piping removed and replaced with 1-in. poly line and tracer wire. National Grid restored service to 6 Benjoe Dr., notified resident, and backfilled all excavated areas. National Grid off-site at 14:45.

**View of trench line and damaged gas line, looking east.**

- Once National Grid restored damaged gas line, Posillico began backfilling trench line. Posillico used excavated material (fine-coarse sand) as backfill. Material contained no rock, asphalt, or sharp edged debris. Backfilled material was compacted in 12-in. lifts using plate compactor. Approximately 6-inches of material placed between lower 6-inch supply lines and upper 4-in. return lines (See RAWP Figure 6 for piping cross sections). Recycled concrete blend compacted at grade for temporary road use. Traffic controls removed from street overnight. Permanent asphalt pavement will be placed once trenching is complete. Backfilling was done in accordance with RAWP Sections 2.3.4, 2.3.4.1, and 2.3.4.2 and Contract Document Sections 02111, 02200, 02220, and 02225.

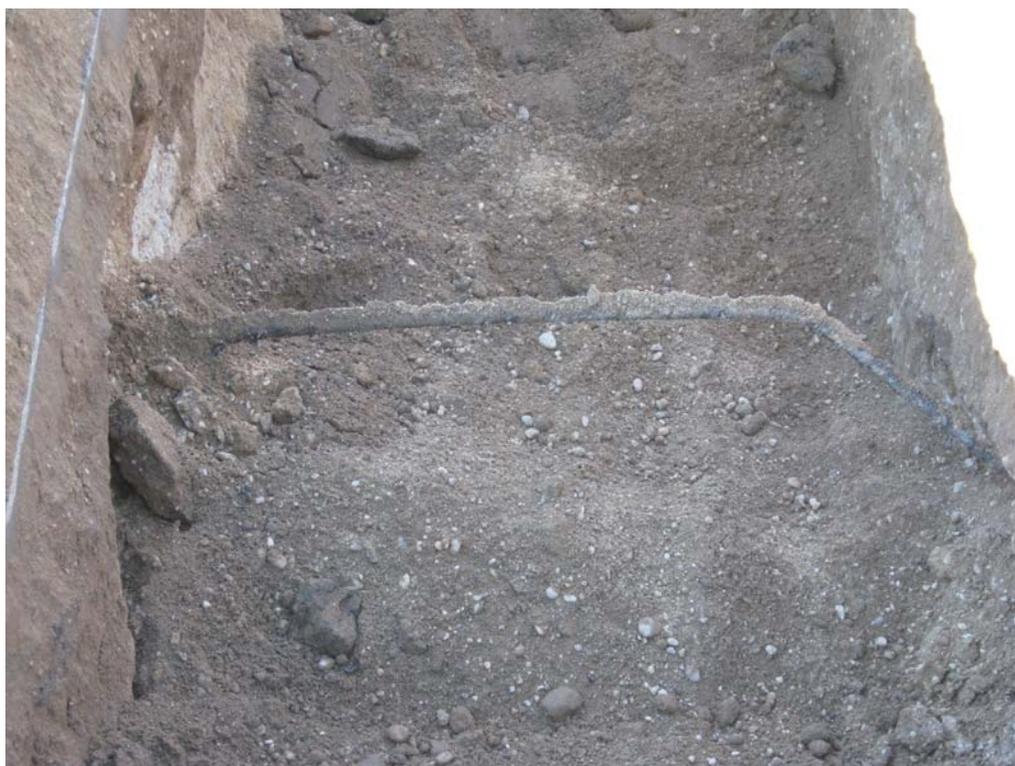
**View of damaged gas line.**

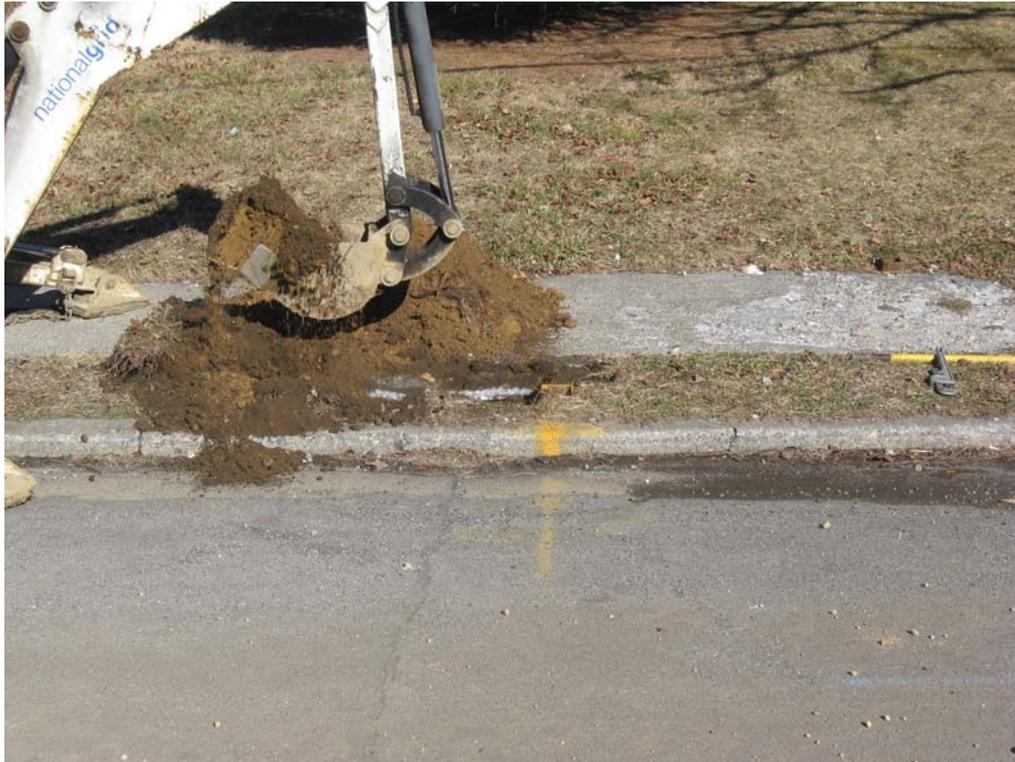
National Grid excavating shut off valve on north side of Benjoe Dr., looking north.

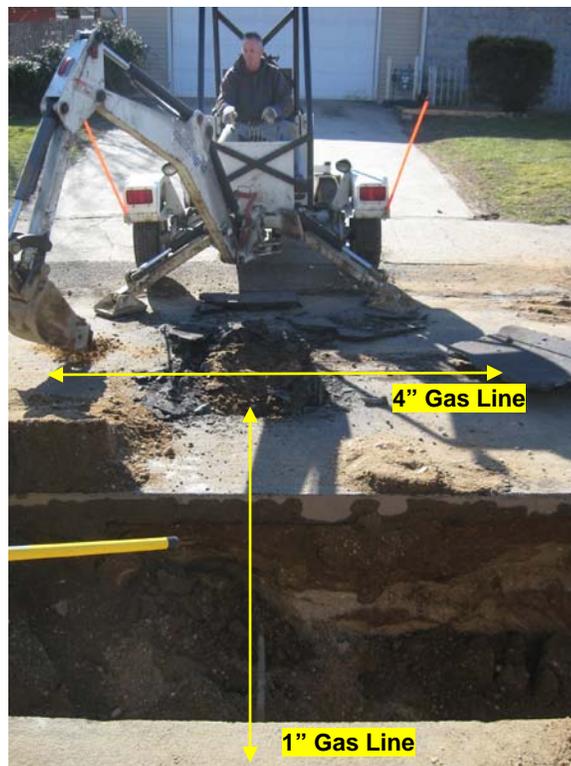
National Grid excavating 1 and 4 in. gas line connection points, looking south.

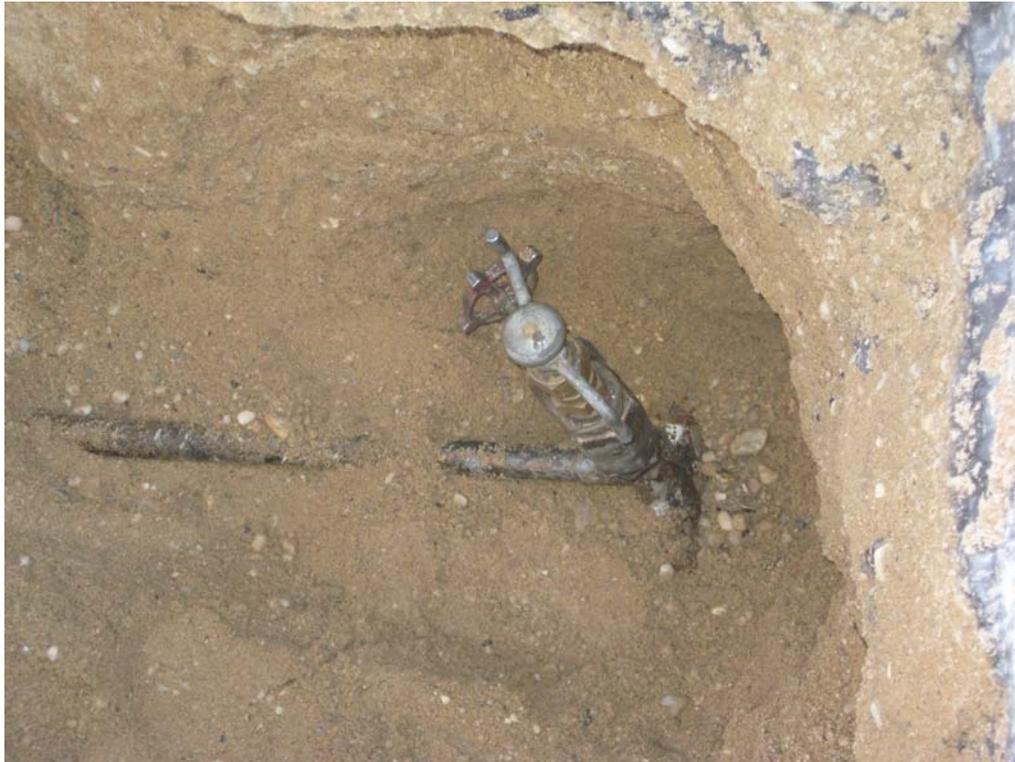
View of 1 and 4 in. gas line connection points with shut off valve.

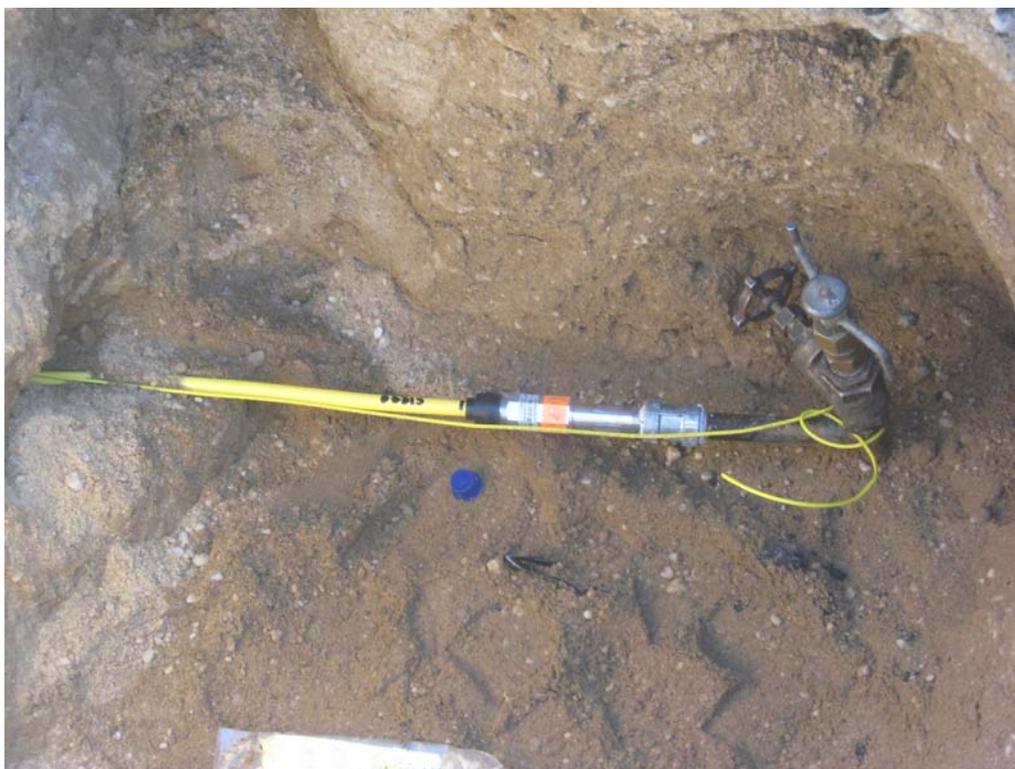
View of replaced 1 in. gas line at 4 in. main connection point.
