# DAILY OBSERVATION REPORT

Report No.: 26      EA Project File: 1447429      Date: January 30, 2012

Site No. 1-52-140

**NYSDEC Division of Environmental Remediation**  
**Site Location: Albany St., Babylon, NY (Site No. 1-52-140)**

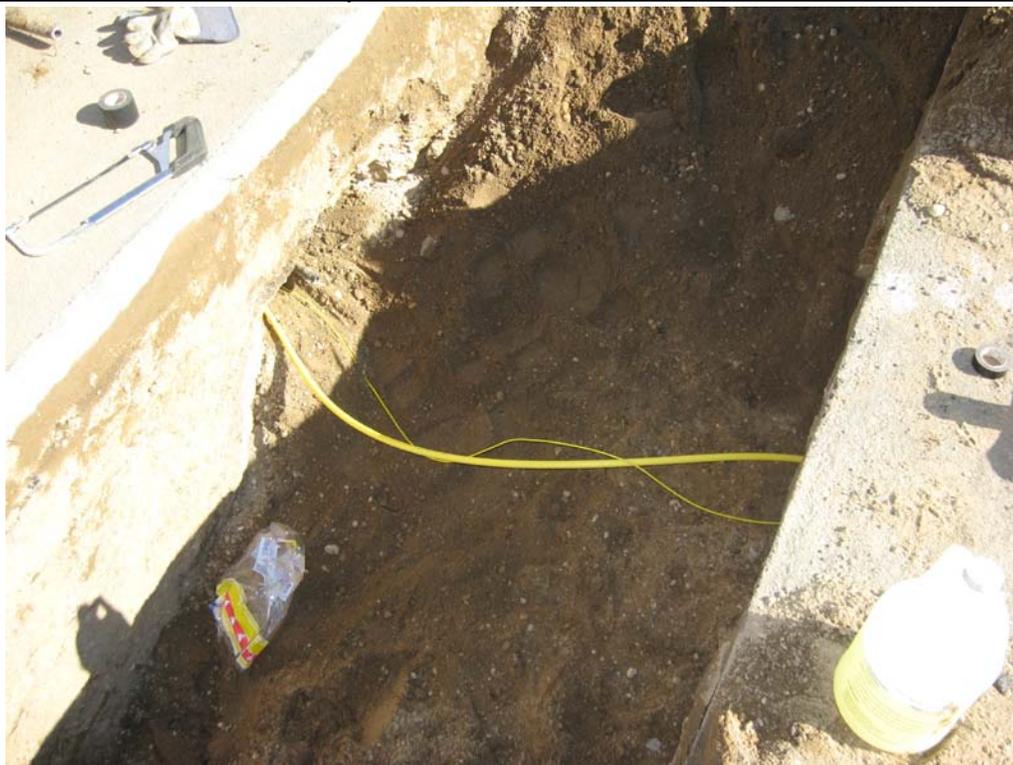
**View of replaced gas line transecting trench line.**

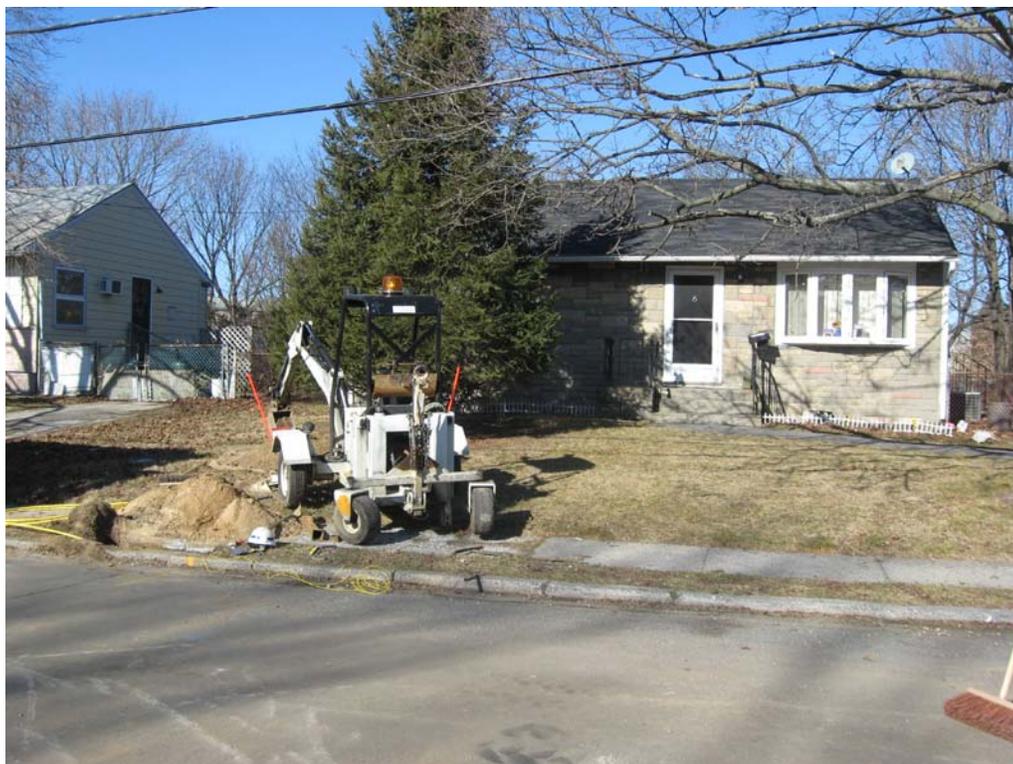
**National Grid excavating point of separation at 6 Benjoe Dr., looking north.**

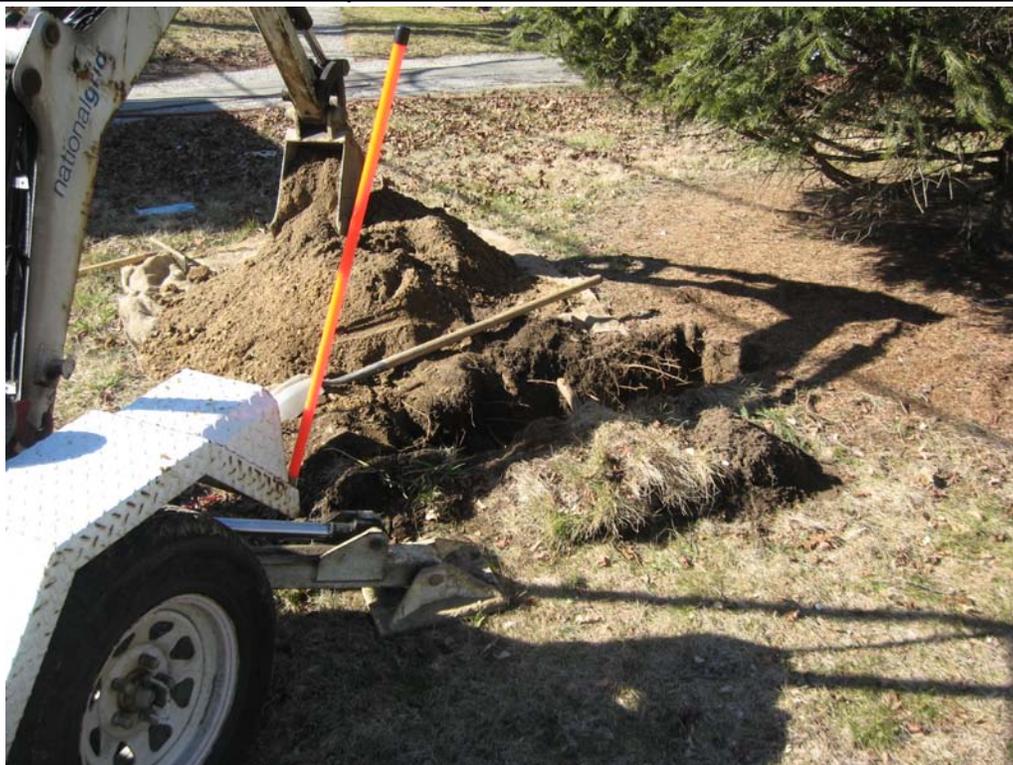
View of excavation area at 6 Benjoe Dr.

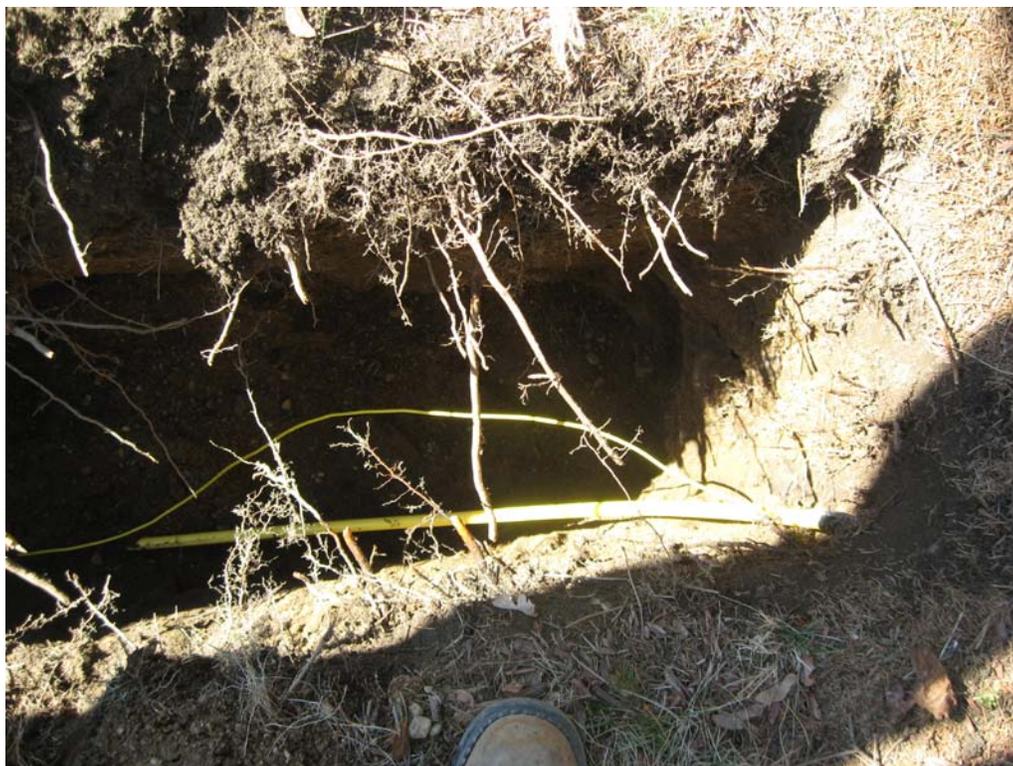
View of replaced gas line at point of separation.

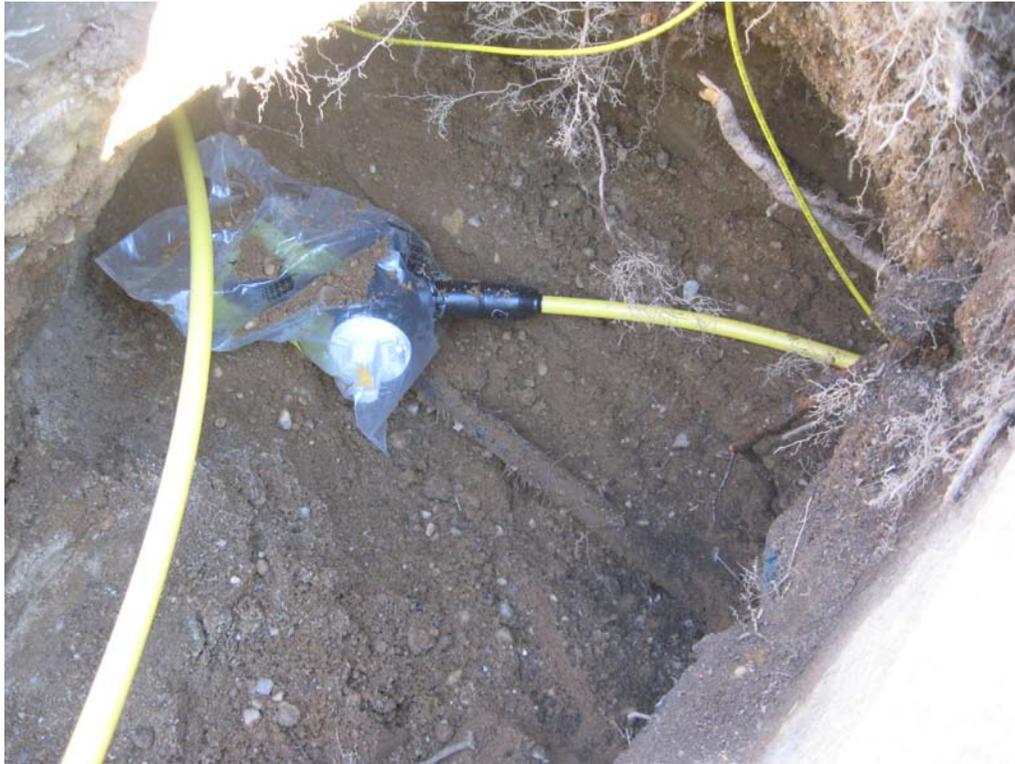
View of restored shut off valve on north side of Benjoe Dr.

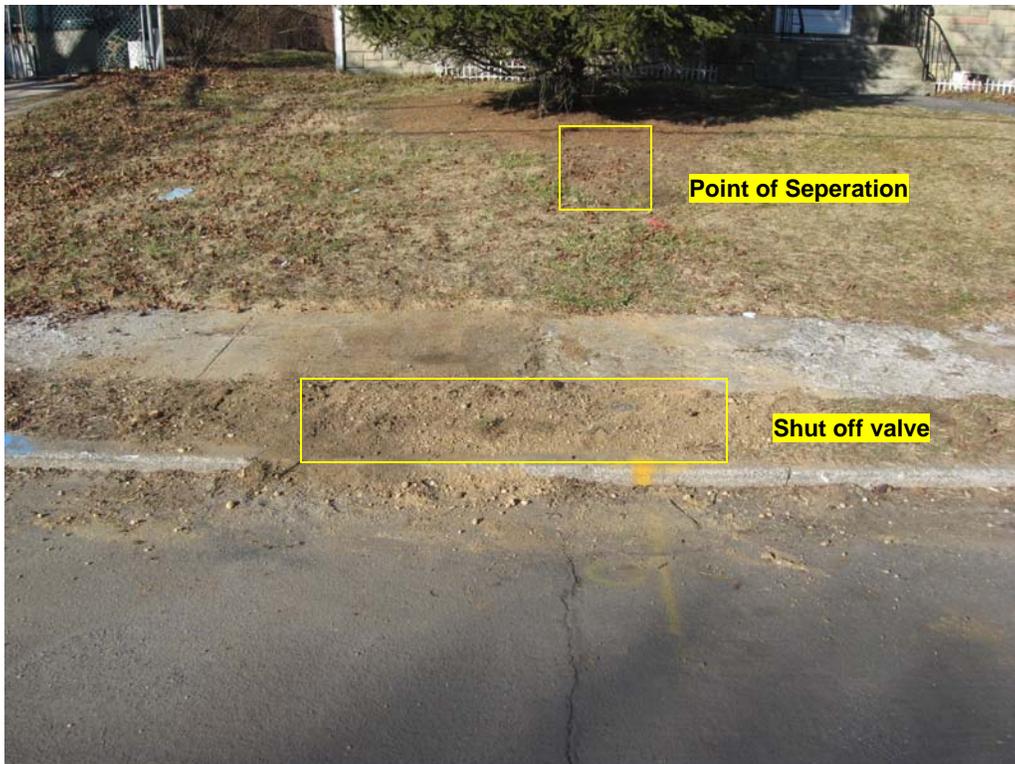
Backfilled point of separation and shut off valve excavation areas, looking north at 6 Benjoe Dr.
