Project: National Heatsheet Printing Site - Off-Site - Site Management
 Contractors: AECOM and Preferred Environmental Services
 AECOM Job No: _____
 Site No: _____
 AECOM Project Manager: Walt Howard

DAILY REPORT

Date: 27-Sep-12
 REPORT No. _____
 PAGE No. 1
 PREPARED BY: Thomas Fitzpatrick TITLE: Site Rep.

O&M DATA SHEET - NATIONAL HEATSET - OFF-SITE SYSTEM

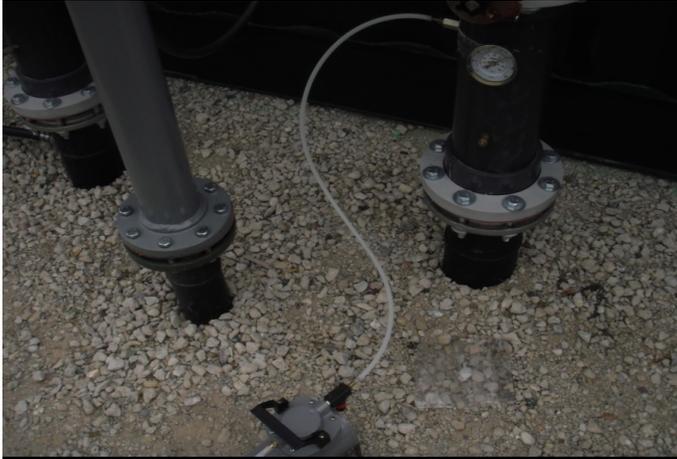
Picture 378- The air sample ports along the 6-inch extraction lines were sampled utilizing pumps and Tedlar bags.

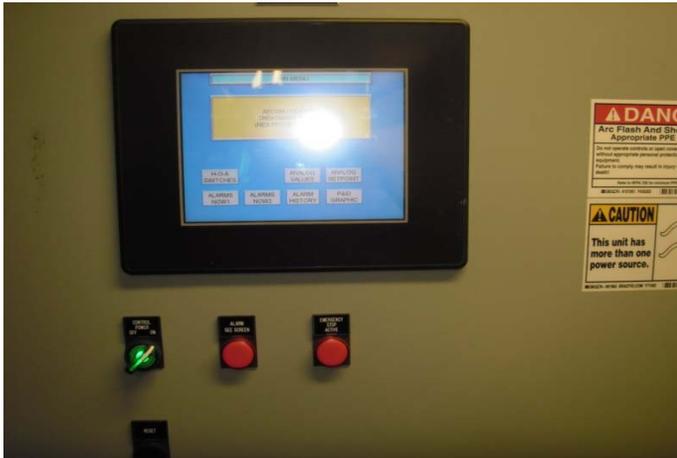
Picture 381- No alarms were triggered on the control panel upon arrival.
