Project: National Heatsheet Printing Site - Off-Site - Site Management
 Contractors: AECOM and Preferred Environmental Services
 AECOM Job No: _____
 Site No: _____
 AECOM Project Manager: Walt Howard

DAILY REPORT

Date: 3-Oct-12
 REPORT No. _____
 PAGE No. 1

O&M DATA SHEET - NATIONAL HEATSET - OFF-SITE SYSTEM

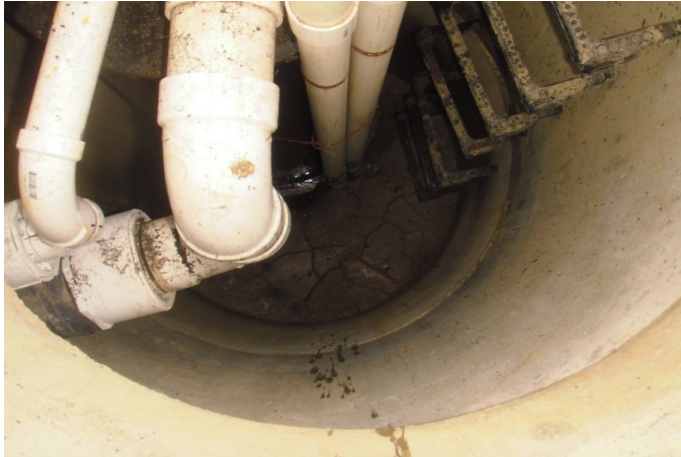
Picture 305- Some groundwater noted on vault floor beneath eductor for several DDC wells.

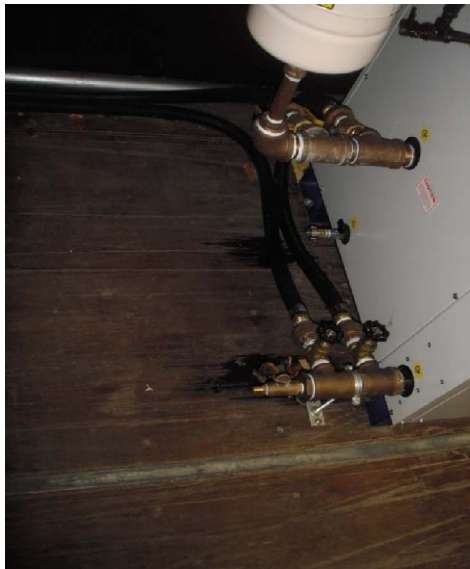
Picture 307- Minor pooled water was noted on the valve and hose beneath the chiller unit.
