Project: National Heatsheet Printing Site - Off-Site - Site Management  
 Contractors: AECOM and Preferred Environmental Services  
 AECOM Job No: \_\_\_\_\_  
 Site No: \_\_\_\_\_  
 AECOM Project Manager: Walt Howard

**DAILY REPORT**

Date: 10-Oct-12  
 REPORT No. \_\_\_\_\_  
 PAGE No. 1  
 PREPARED BY: Thomas Fitzpatrick TITLE: Site Rep.

# O&M DATA SHEET - NATIONAL HEATSET - OFF-SITE SYSTEM

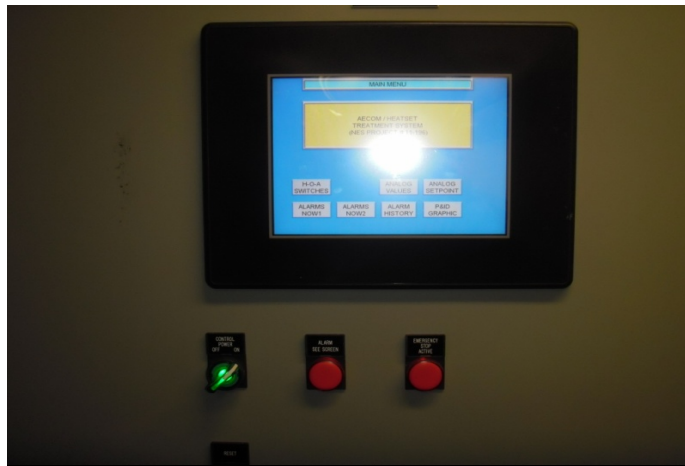
**Picture 303-** Both blower were up, with no alarms were triggered upon arrival.

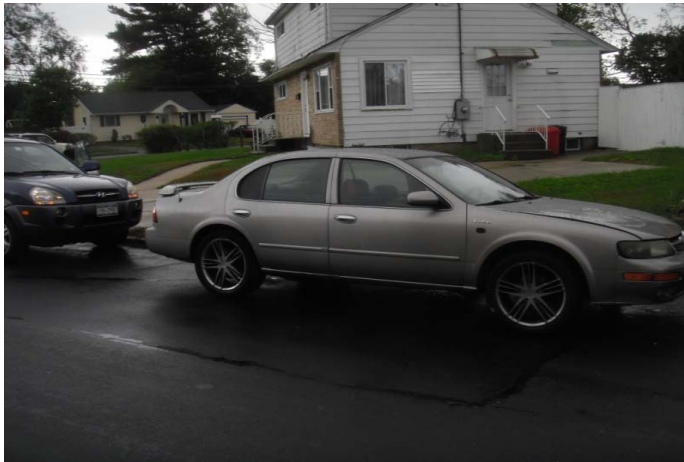
**Picture 309-** No access to DDC-10 well due to vehicle obstruction.
