Project: National Heatset Printing Site - 1 Adams Boulevard, Farmingdale, NY - Site Management  
Contractors: AECOM and Preferred Environmental Services  
AECOM Job No: 60135649  
Site No: 152140  
AECOM Project Manager: Walt Howard

### DAILY REPORT

**Monitoring Table February 08, 2013**

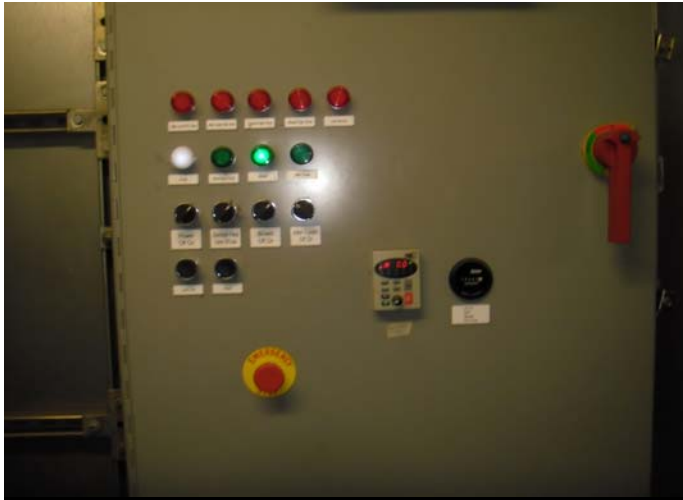
**Picture 452** - System #2 was on upon arrival with no alarms triggered on the control panel.

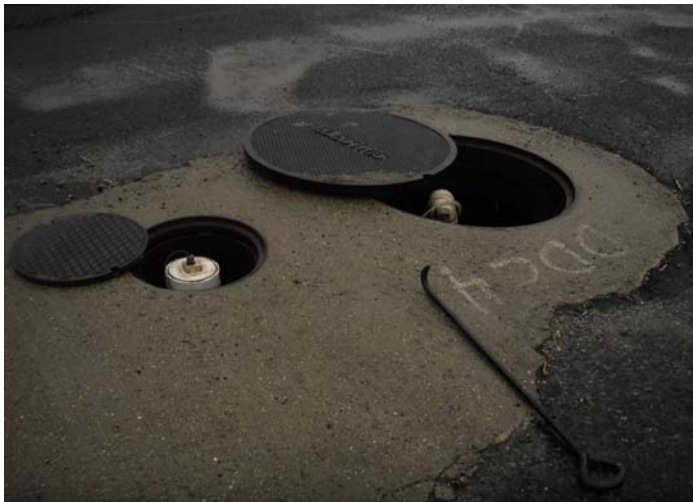
Well#	Comments
DDC-3	1-inch of water was observed in this sump.
DDC-4	About one (1) foot of water observed in sump. Sump pump not functioning and needs to be replaced.

***Sump pump associated with DDC-4 was not functioning and needs to be replaced. Vacuum gauge, BP-01, was also not functioning and needs to be replaced.***

**Picture 458** - DDC-4 and its associated sump was visually inspected. The sump pump has continued to be non-functioning since 1/17/2013.

replace sump pump. Evaluate BP-01 next event and monitor blower temp.
