Project: National Heatset Printing Site - 1 Adams Boulevard, Farmingdale, NY - Site Management
Contractors: AECOM and Preferred Environmental Services
AECOM Job No: 60135649
Site No: 152140
AECOM Project Manager: Walt Howard

DAILY REPORT

Date: 27-Feb-13
REPORT No. _____
PAGE No. 1
PREPARED BY: Thomas Fitzpatrick TITLE: Site Rep.

National Heatset Printing Site, Farmingdale, NY

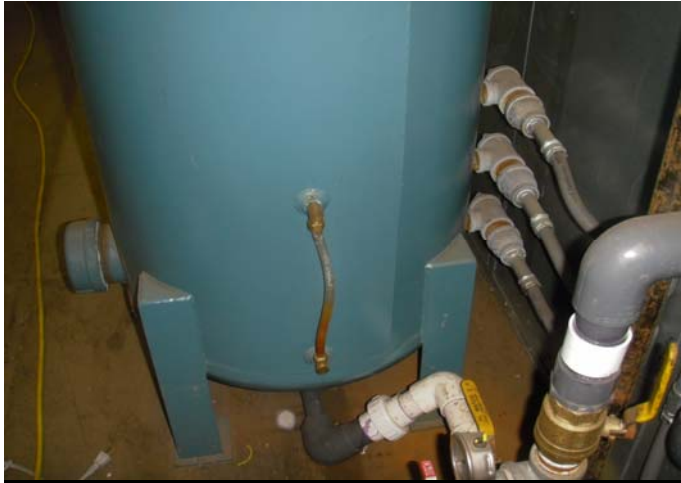
Comments: No water detected.

Picture 014 - No water was detected within the System #2's knock-out tank.

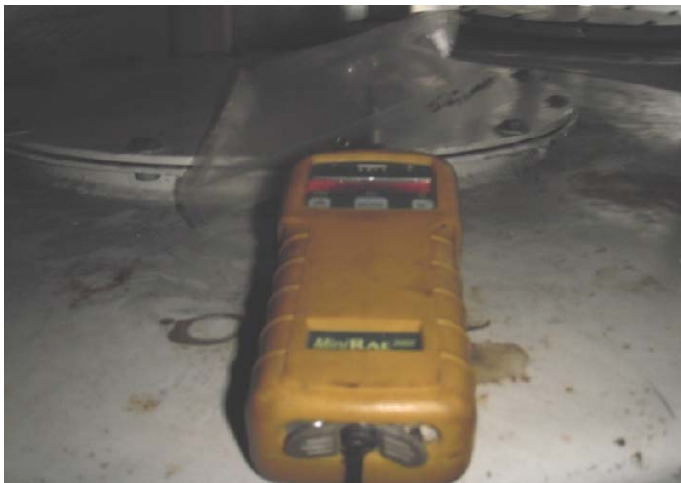
Picture 018 - The GAC sample ports were screened utilizing Tedlar bags.
