Project: National Heatset Printing Site - 1 Adams Boulevard, Farmingdale, NY - Site Management  
Contractors: AECOM and Preferred Environmental Services  
AECOM Job No: 60135649  
Site No: 152140  
AECOM Project Manager: Walt Howard

### DAILY REPORT

**National Heatset Printing Site, Farmingdale, NY**

**Monitoring Table March 14, 2013**

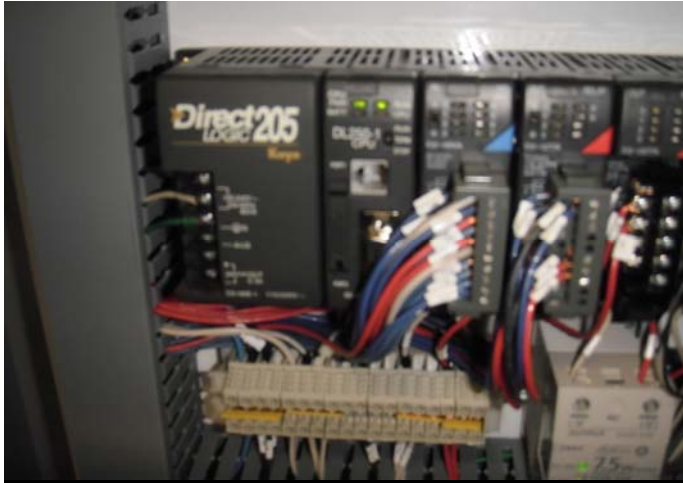
8:08 - Gray electric on-site to assess the relay associated with the auto-dialer within the System #2 trailer. The relay was determined to be functioning properly but the Direct Logic 205 unit was not powering the relay. Assessment of the unit must be made by the original installers of same.

**Picture 002** - View of the Direct Logic 205 unit within the control panel of System #2.

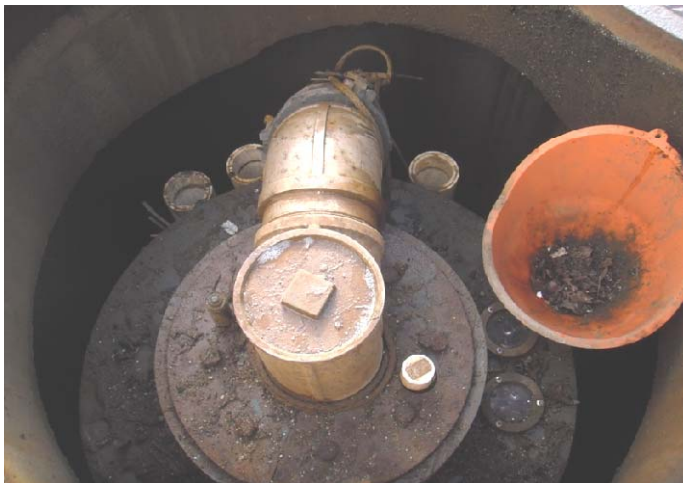
Well#	Comments
DDC-1	Bubbling in well is not sufficient.
DDC-2	Bubbling in well is sufficient.

**Picture 003** - Bubbling was observed on the well head of DDC-1.
