DAILY FIELD REPORT

Day: **Wednesday** Date: **11/11/2020**

Project Name

National Heatset Printing

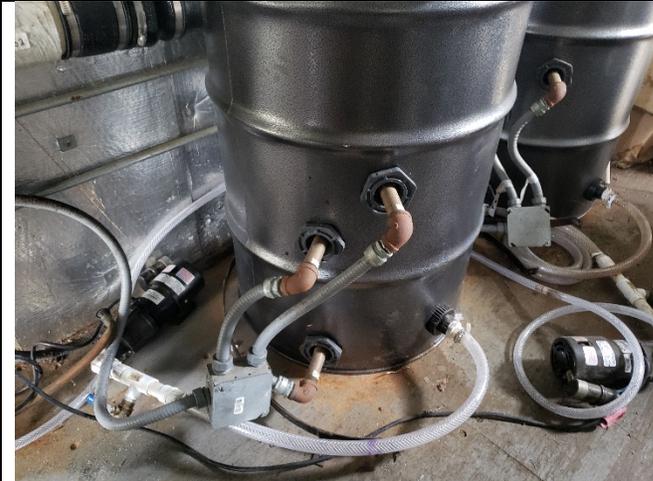
Electrical box covers replaced at System #1.

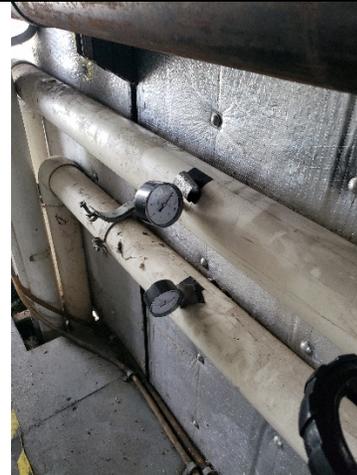
Pressure gauges installed in PVC influent lines at System #1

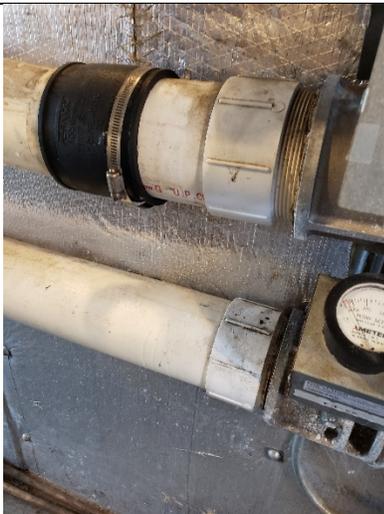
Fernco coupler loose and missing hose clamp at System #1.

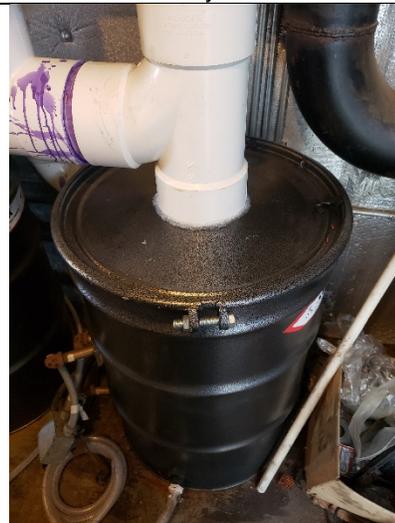
EA bumped System #1 to observe conditions described by EAR. EA also observed PVC (influent) lines within the system under pressure when they are intended to be under vacuum. Additionally, blower speed/power seemed to be cycling through a ramp up/ ramp down. Velocities within influent process lines were observed to swing between 1500 ft/min and 5500 ft/min as measured with Velocicalc, corresponding to the ramp up/ ramp down.

PVC to knockout seal leaking air. (System #1)

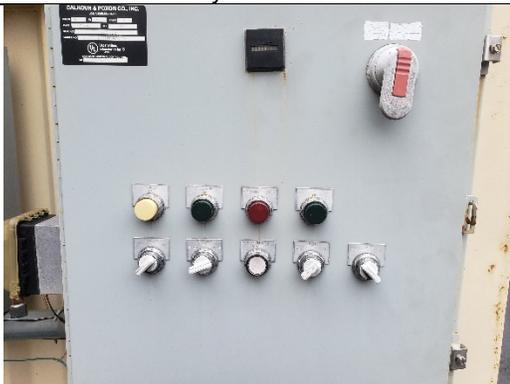
The onsite SVE system was observed to be off, the control panel on the exterior of the system did not have any power. EA turned the control panel power switch off and back on, but no power was restored to the panel. EA turned all control switches to OFF and left the system off.

SVE system control panel with no power.

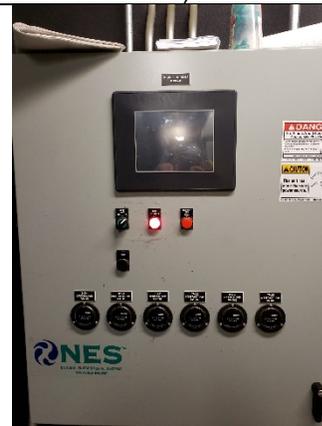
The off-site system was running upon arrival. The alarm light on the control panel was illuminated, but the screen was unresponsive, so EA was unable to view the alarm condition. The lock to the conex box with the carbon vessels was stuck and unable to be opened. EA also noticed a broken pressure gauge on PI-116 at the off-site system.

Offsite system display with alarm.

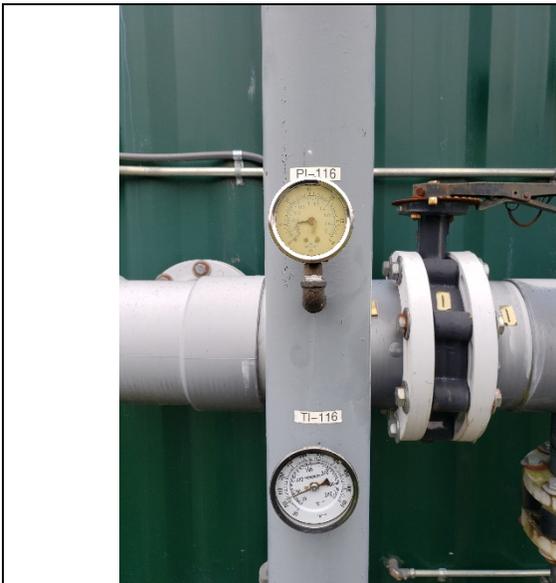
Broken pressure gauge PI-116.

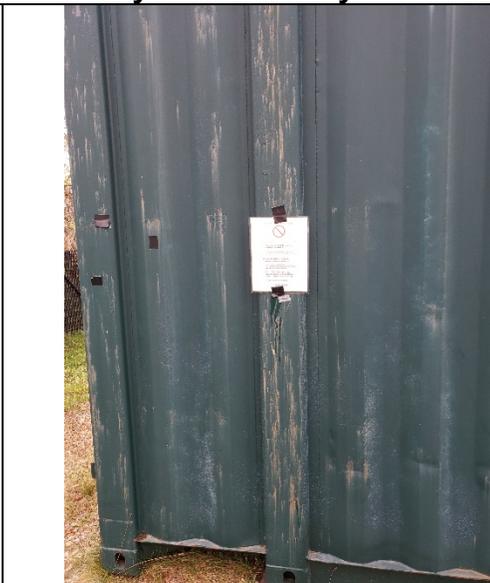
COVID sign replaced on off-site system.
