3 January 2022

RE: Contract/WA No: D009806-18  
Site/Spill No./Pin: National Heatset Site  
Babylon, New York, Suffolk County  
Site No. 152140

This Corrective Measures Work Plan (CMWP) describes the corrective measures proposed for the National Heatset Site (Number [No.] 152140) (Site) in Babylon, Suffolk County, New York (**Figure 1**). EA Engineering, P.C. and its affiliate EA Science and Technology (EA) is currently performing site management under New York State Department of Environmental Conservation (NYSDEC) Work Assignment No. D009806-18, which was approved on 18 November 2020 (EA performed site management for the site from 2007 to February 2020 under prior contracts; Environmental Assessments and Remediation [EAR] performed site management for the site from March to December 2020). EA's assignment includes monthly/quarterly visits for the density driven convection (DDC) systems and the soil vapor extraction (SVE) system, quarterly system air sampling, and quarterly groundwater sampling. Remedial system details are presented in the NYSDEC-approved Site Management Plan (EA 2013a), which includes the Operation & Maintenance (O&M) Manual for each system. In addition to syst

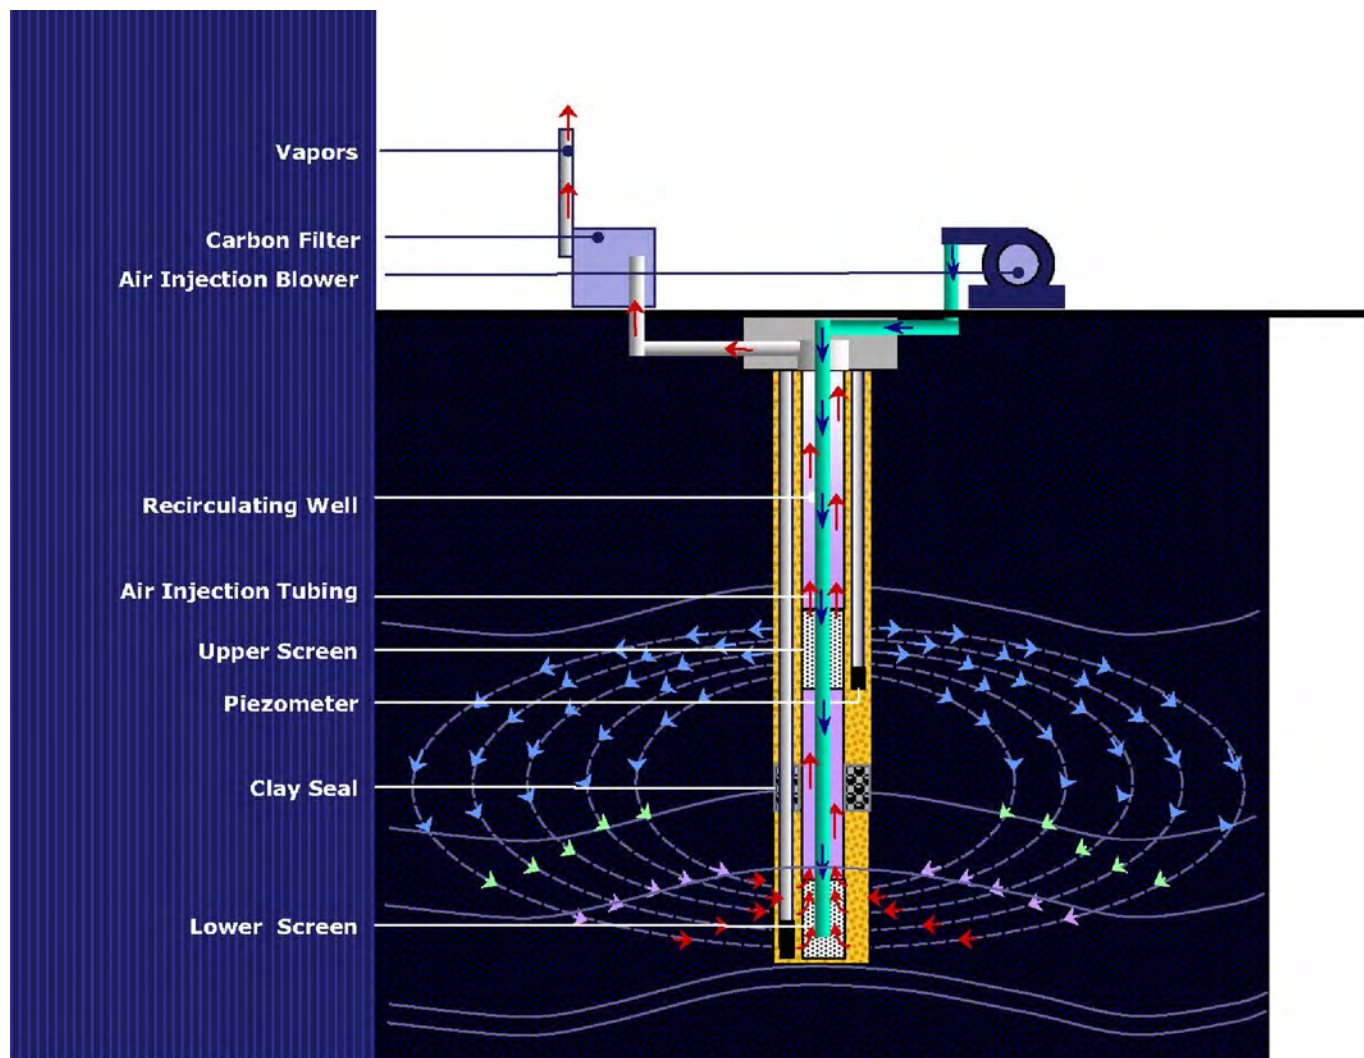
Figure 3  
TYPICAL DDC WELL CONSTRUCTION  
AND OPERATION DIAGRAM  
NATIONAL HEATSET SITE (152140)  
BABYLON, NEW YORK  
SUFFOLK COUNTY

A DDC in-well stripping well is constructed with two 10-inch diameter stainless steel, 0.020-inch slot well screens, separated by 10-in diameter schedule 40 PVC riser pipe; from the top of the upper riser pipe up to ground surface, the PVC expands to 12-in diameter (**Figure 3**). The upper screen is intended to intercept the groundwater table, while the lower screen is intended to intercept the contaminated groundwater zone, just above the Gardeners Clay unit, which is a confining layer. The upper screen for DDC-1 is 15 ft long from 13 to 28 ft bgs; groundwater was identified at 14 ft bgs at the time of installation. The lower screen is 12 ft long and was installed from 72 to 84 ft bgs; the Gardeners Clay unit was identified at 83.7 ft bgs. The borehole annulus was backfilled with sand pack and three 5-ft thick bentonite pellet annulus seals in the interval between the upper and lower DDC well screens to adequately seal the borehole and prevent short circuiting of groundwater during operation of the DDC well. An eductor pipe is installed within the 10-in riser. The eductor is constructed using 6-in PVC with two 6-in by 10-in packers installed between the upper and lower DDC well screens to provide hydraulic separation

between the two screens. During operation, air is injected into the lower screen, and contaminants are lifted through the water column. Volatilized contaminants are removed from the well and the effluent air is treated with GAC.

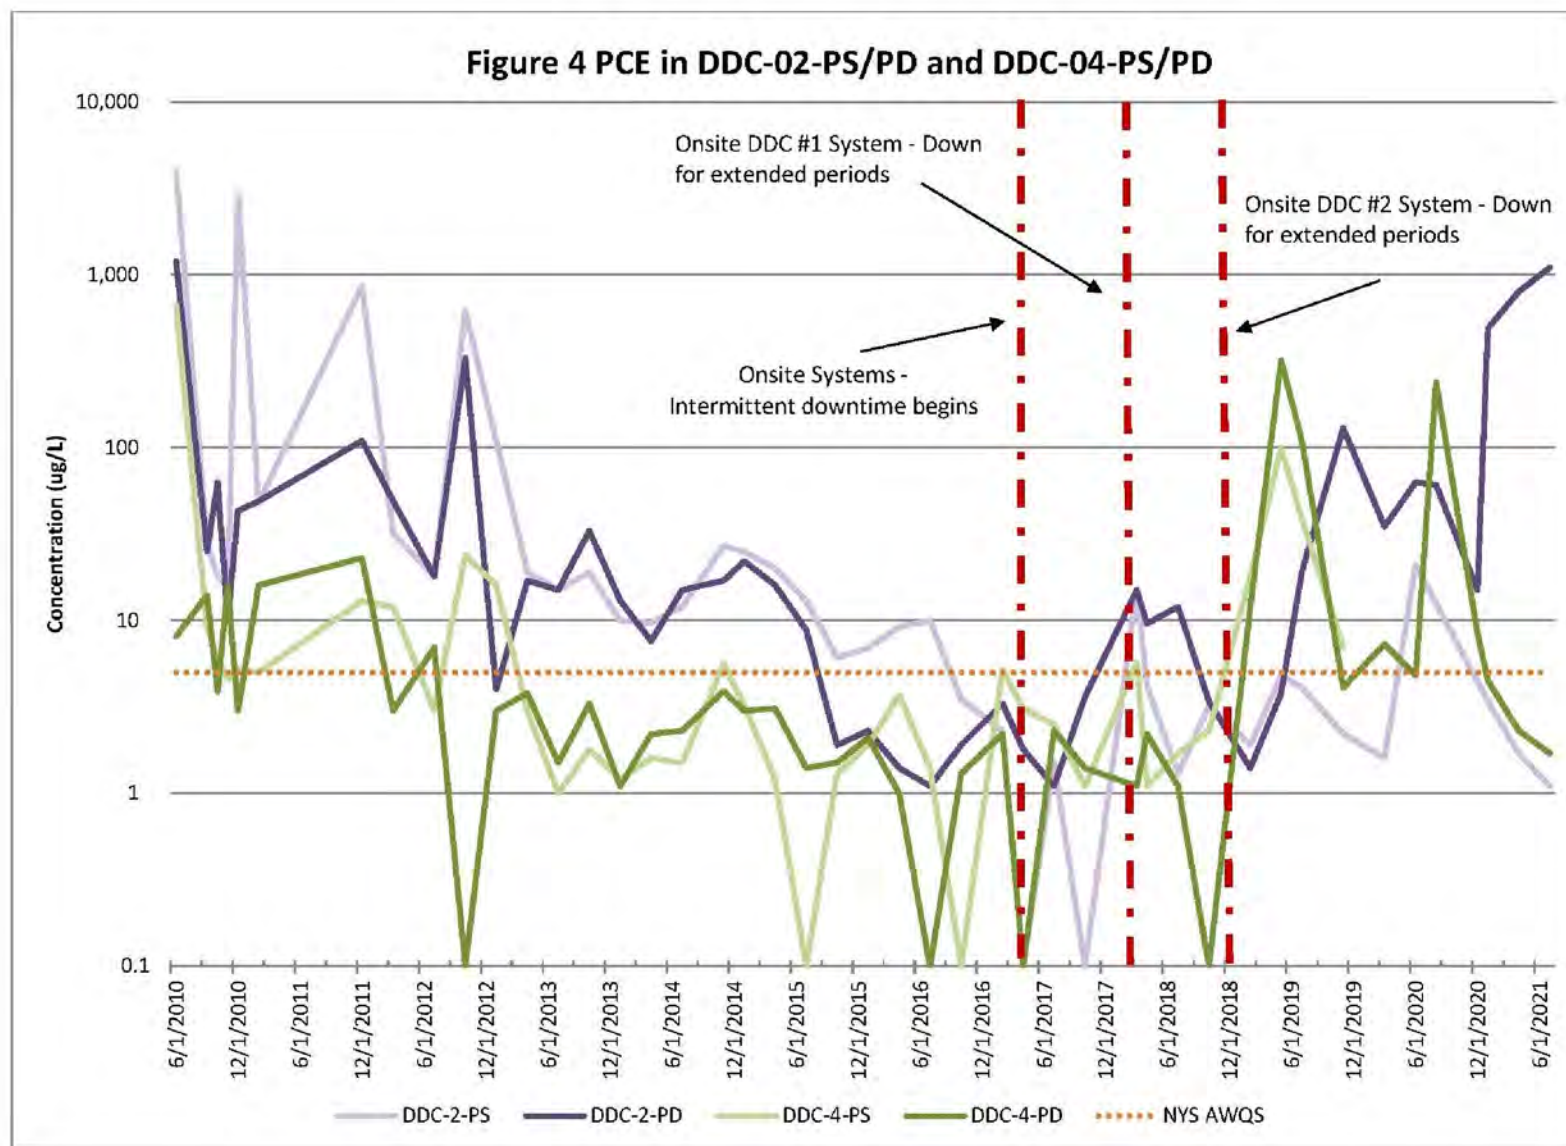
Figure 4  
DDC-02 and DDC-04  
CONCENTRATION TRENDS  
NATIONAL HEATSET SITE (152140)  
BABYLON, NEW YORK  
SUFFOLK COUNTY

As noted in section 3.2.1 and shown in **Figure 4**, the rebound of PCE concentrations observed in deep piezometers DDC-02-PD and DDC-04-PD after the onsite DDC systems shut down in 2018 could indicate that the decreasing concentrations previously observed was not due to mass removal from the system operation, but rather a slower rate of desorption of CVOCs from contaminated soil into the water column than the rate of removal of volatilized contaminants by the onsite DDC systems. Rebound of PCE concentrations may also be evidence that there is a remaining source with high concentrations close to the onsite DDC systems. Contaminant rebound is commonly observed when implementing pump and treat technology.

up to the shallow aquifer. As shown in **Figure 4**, instead of seeing lower groundwater concentrations in the shallow aquifer while the system was running from 2010 – 2018 from each pair of wells, shallow concentrations were elevated, higher than deep concentrations during many sampling events. It is possible that the onsite DDC systems are transferring contamination from deep to shallow screens, preventing cleanup of the shallow aquifer.

The effectiveness of the systems when they are operational was evaluated in Section 4.1. Rebound in contaminant concentrations in deep piezometers DDC-02-PD and DDC-04-PD associated with onsite DDC systems when the systems were off for an extended period provides evidence that a source with high concentrations is close to the onsite DDC systems that the systems have been unable to reduce consistently over time (**Figure 4**). Even if the onsite DDC systems would continue to run as they did from 2010 – 2018 with minimal downtime, there is no evidence that there would be sufficient mass recovery within a reasonable timeframe to warrant continuing to run the existing systems (e.g., MW-15D [**Figure 7**]). Evidence was also introduced that onsite DDC systems could be transferring contaminated groundwater from deep to shallow screens and thus preventing cleanup of the shallow aquifer because shallow concentrations continued to stay elevated above deep concentrations during many sampling events at DDC-02-PD and DDC-04-PD (**Figure 4**).

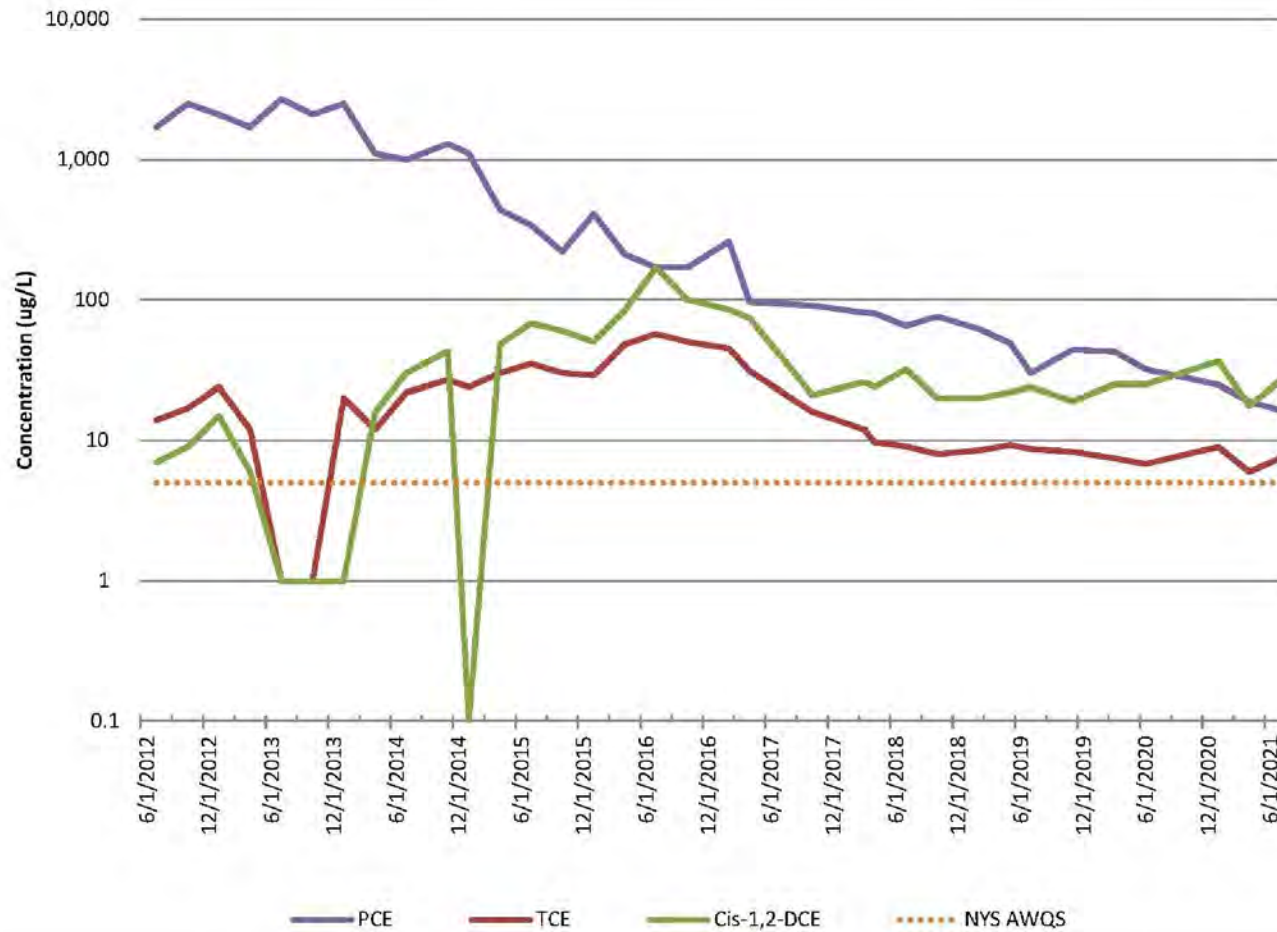
Figure 5  
MW-1D OFFSITE (UPGRADIENT  
FROM OFFSITE DDC SYSTEM)  
NATIONAL HEATSET SITE (152140)  
BABYLON, NEW YORK  
SUFFOLK COUNTY

At MW-1D OFFSITE, which is upgradient from the Offsite DDC System, the concentration of PCE has decreased while the concentrations of TCE and *cis*-1,2-DCE have fluctuated above the AWQS (**Figure 5**). Downgradient from the Offsite DDC System at MW-3D OFFSITE (**Figure 6**), the concentrations of PCE, TCE, and *cis*-1,2-DCE generally increased even while the Offsite DDC System was running. When the Offsite DDC System was restarted in January 2020, concentrations of these contaminants decreased.

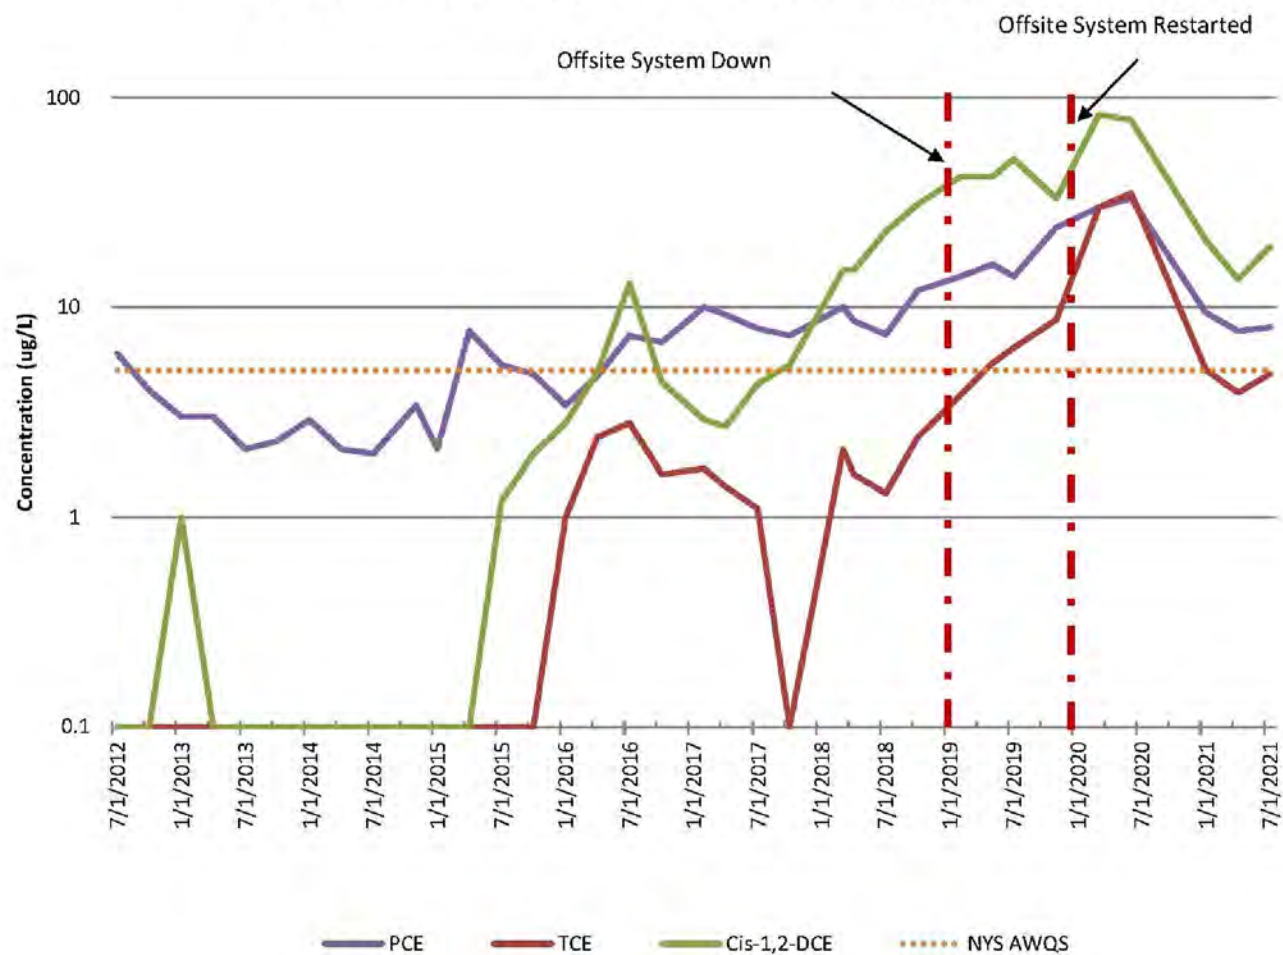
Figure 6  
MW-3D OFFSITE  
(DOWNGRADIANT-NEAR DDC-6)  
NATIONAL HEATSET SITE (152140)  
BABYLON, NEW YORK  
SUFFOLK COUNTY

In general, offsite shallow groundwater CVOC concentrations are consistently below AWQS; however, contaminant concentrations in the deep groundwater are elevated. As presented in Section 3.2.2, downgradient of the Offsite DDC System (DDC-7-PS/PD, DDC-8-PS/PD, DDC-9-PS/PD, and DDC-10-PS/PD) concentrations of PCE, TCE, and *cis*-1,2-DCE in MW-3D OFFSITE near DDC-6-PD (**Figure 6**) generally increased even while the Offsite DDC System was running, indicating that contamination is still moving through the area and not being captured by the Offsite DDC System. When the Offsite DDC System was restarted in January 2020, concentrations of these contaminants decreased; however, it is not certain if they would continue to decrease, given the previous trend prior to the extended downtime.

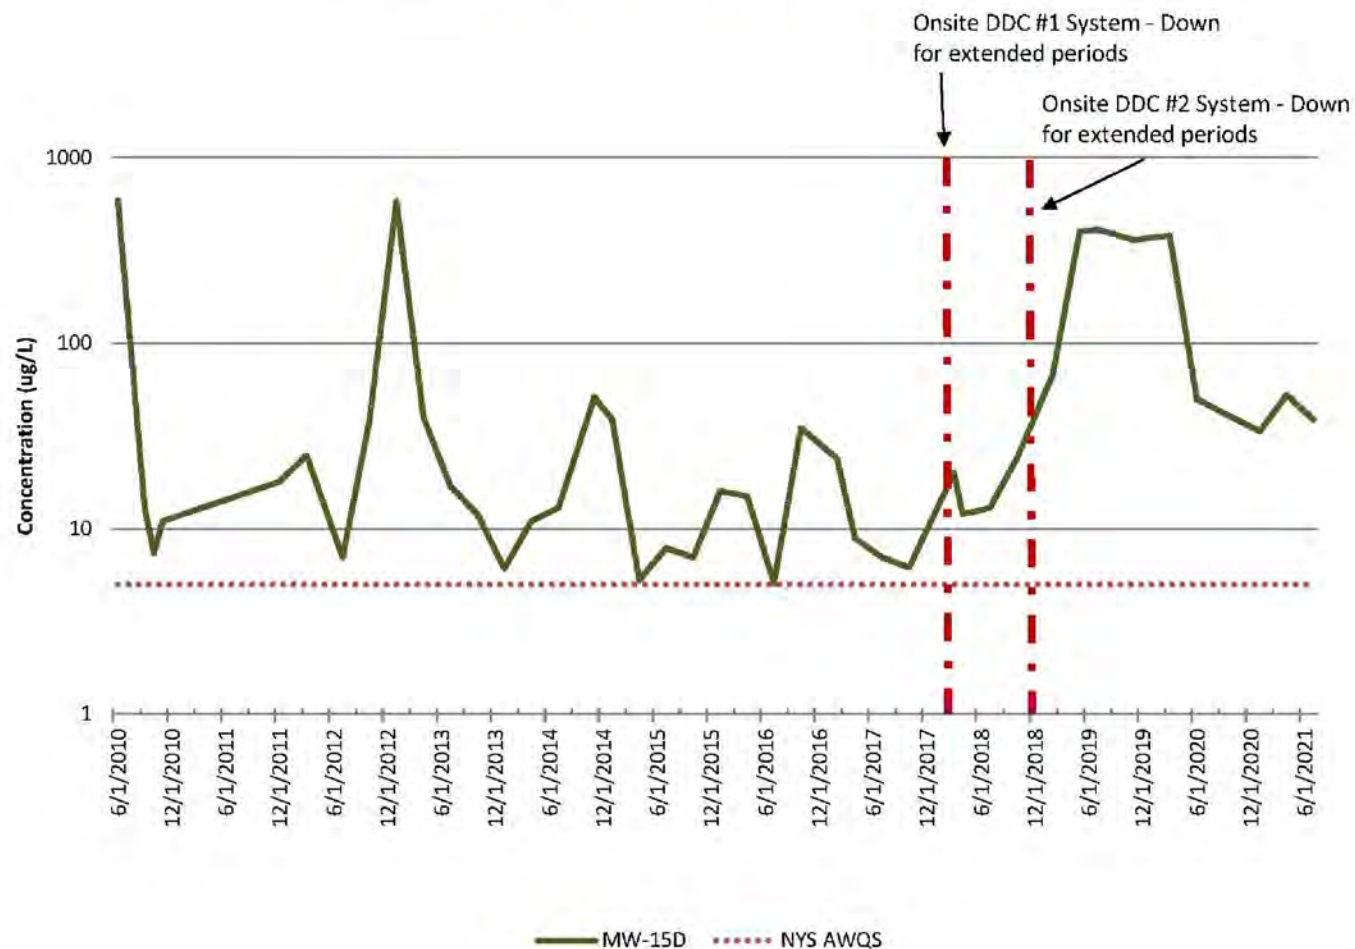
Figure 7  
MW-15D (DOWNGRADIENT  
ONSITE DDC 2 SYSTEM)  
NATIONAL HEATSET SITE (152140)  
BABYLON, NEW YORK  
SUFFOLK COUNTY

Even if the onsite DDC systems would continue to run as they did from 2010 – 2018 with minimal downtime, there is little evidence that there would be sufficient mass recovery over a reasonable timeframe to get concentrations below AWQS by running the existing systems. This is particularly evident in wells like MW-15D, downgradient of Onsite DDC #2 System, which did not show much of a decrease in PCE concentrations from 2010 – 2018 when the systems were running more consistently (**Figure 7**).

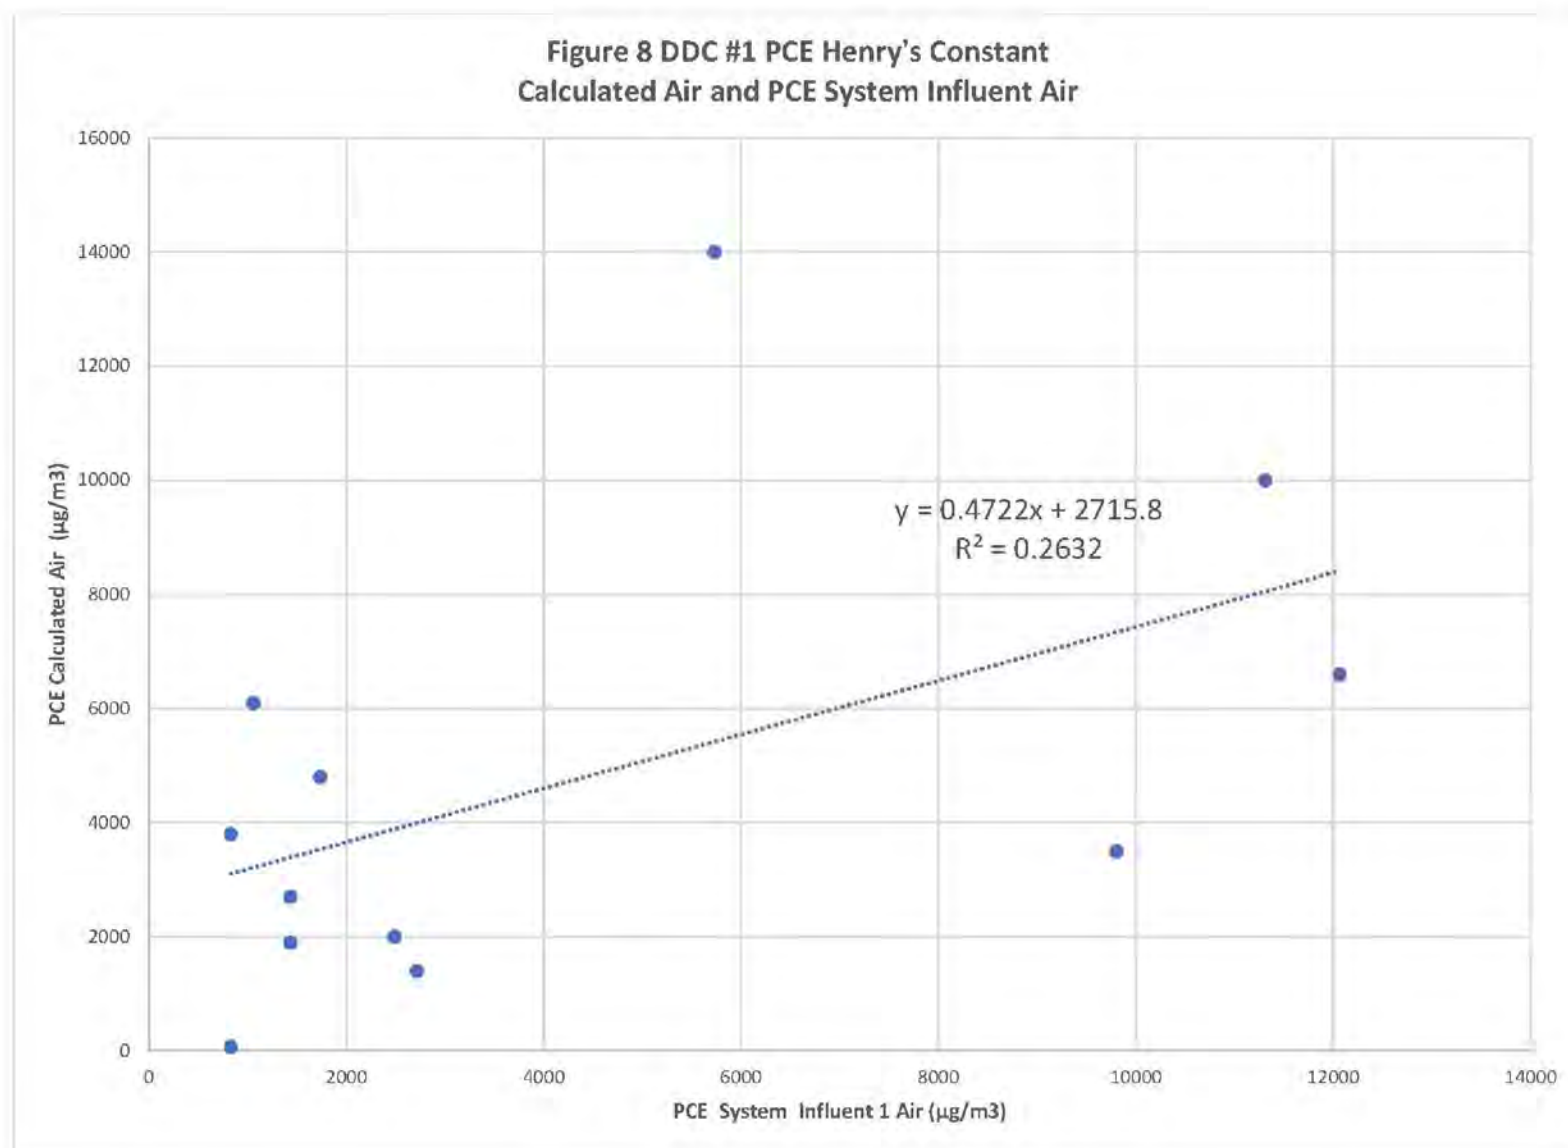
Figure 8  
DDC #1 PDC HENRY'S CONSTANT  
NATIONAL HEATSET SITE (152140)  
BABYLON, NEW YORK  
SUFFOLK COUNTY

The calculated concentration of PCE in air above the liquid (x-axis) was plotted against the Onsite DDC System's air influent concentrations from analytical lab data (y-axis). At DDC-2-PD, the  $R^2$  value (statistical measure that represents the proportion of the variance for a dependent variable that is explained by an independent variable or variables in a regression model) was 0.26 (**Figure 8**) while at DDC-4-PD the  $R^2$  value was 0.01 (**Figure 9**).

Upon comparing the calculated PCE air value to the lab PCE air value, neither Onsite DDC System has a strong positive relationship and therefore does not appear to be in equilibrium. This tells us the DDC Systems may not be efficiently removing PCE from the groundwater because the calculated and lab PCE air numbers are not strongly correlated. The calculations were completed at one location at Onsite DDC #1 System and one location at Onsite DDC #2
