**Summary Report  
Utility Pole Upgrades  
Halesite Former Manufactured Gas Plant Site  
Halesite, New York  
Site No. 1-52-173**

**Summary Report  
Utility Pole Upgrades  
Halesite Former MGP Site**

Halsette Former MGP Site  
Halsette, New York

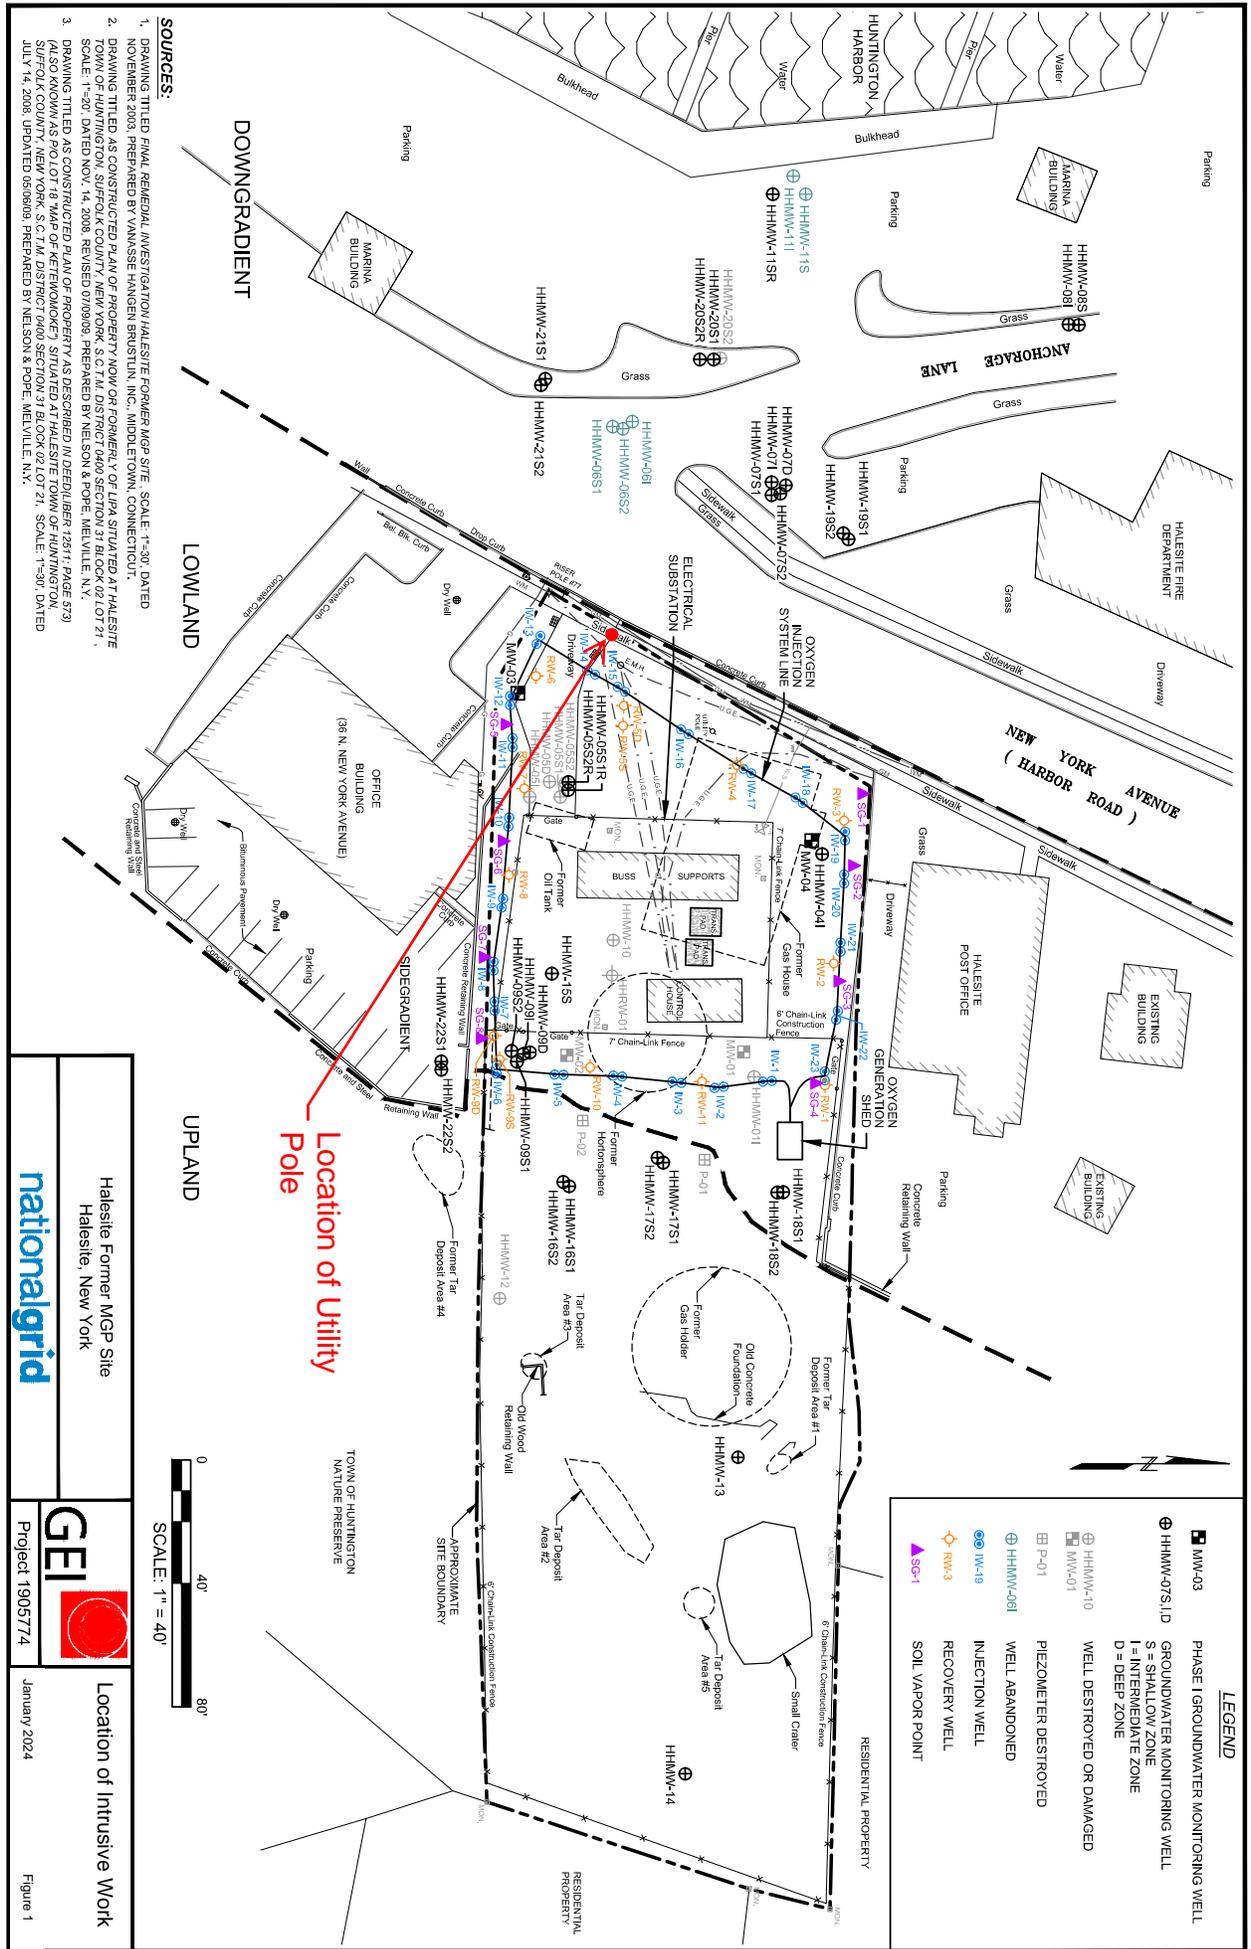
Project 1905774  
January 2024  
Figure 1

SEL Underground Utilities (SEL) was procured by TCG to install anchors adjacent to a utility pole on the east side of New York Avenue. **Figure 1** depicts the location of the work. SEL utilized hand tools to excavate a hole approximately 1 foot in diameter and approximately 3 feet deep to install the anchors. The work was completed on January 15, 2024.

Location of Intrusive Work
