## DAILY FIELD REPORT

Job Name	<u>Patchogue Former MGP Site</u>	Date	<u>Thursday June 27, 2019</u>
Report	<u>Site Remediation</u>	Report No.	<u>2</u>
Job No.	<u>451820</u>	Sheet	<u>Page 1</u>
Location	<u>Patchogue, NY</u>	Weather	<u>Sunny, 70-85° F</u>
Client	<u>NYSDEC</u>	Wind	<u>N 0-10 mph</u>

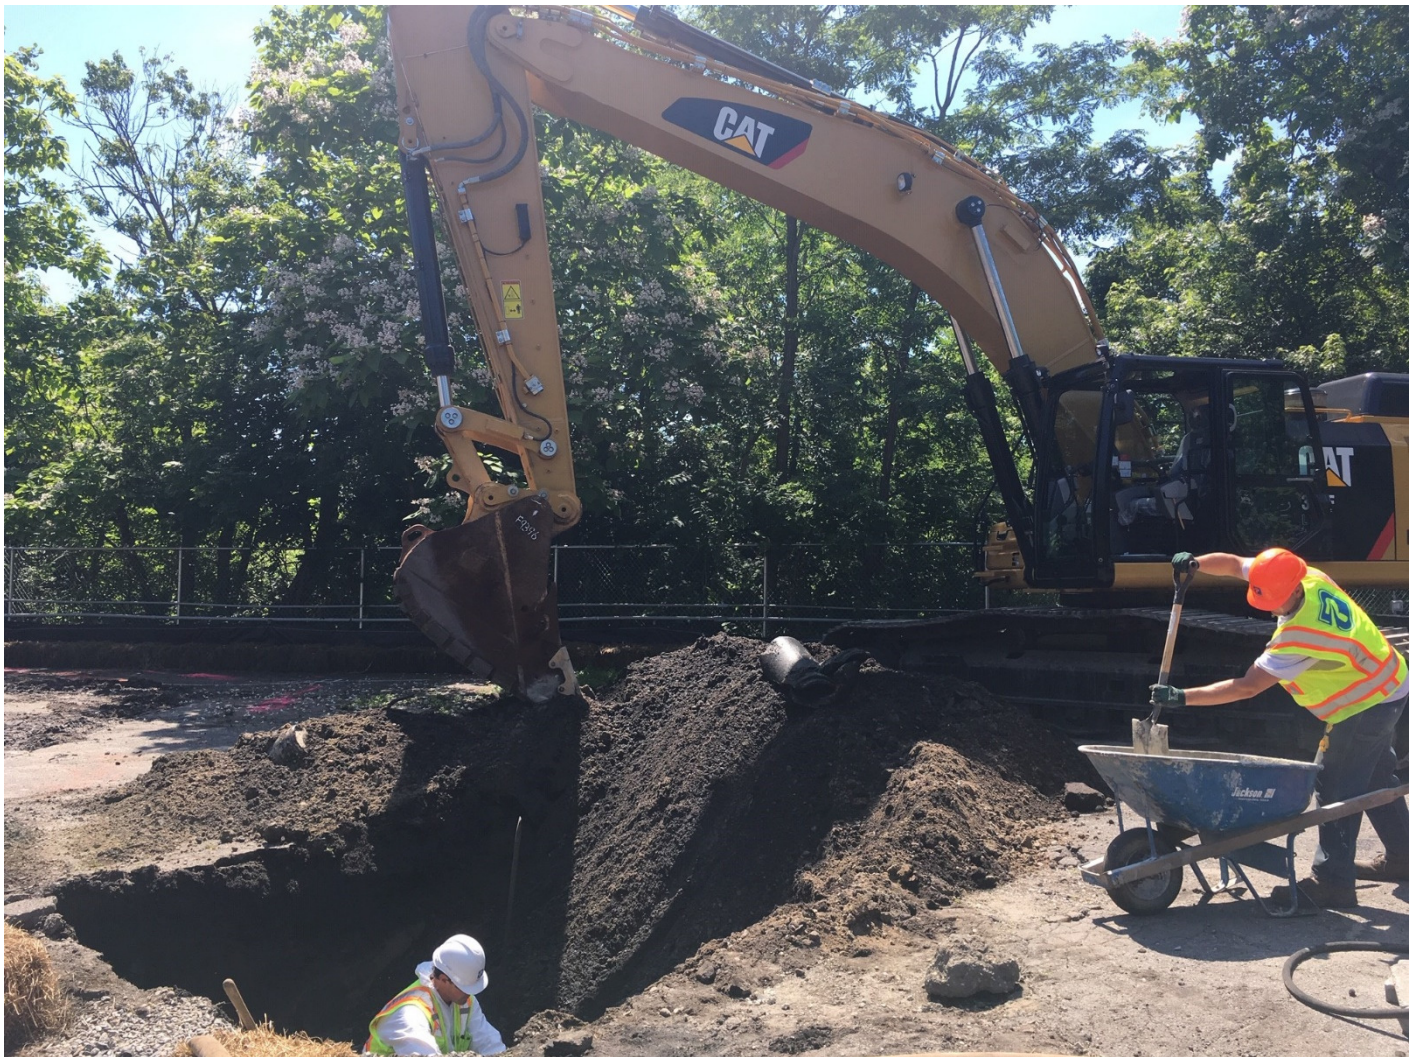
Photo 1: Plugging clay pipe outflowing from southern catch basin (located at the bottom left corner of the picture).

- A separate trench was dug south of the catch basin and the clay pipe outflow from the catch basin was plugged with hydraulic cement.
- The two ends of the East-West running pipe were surveyed.

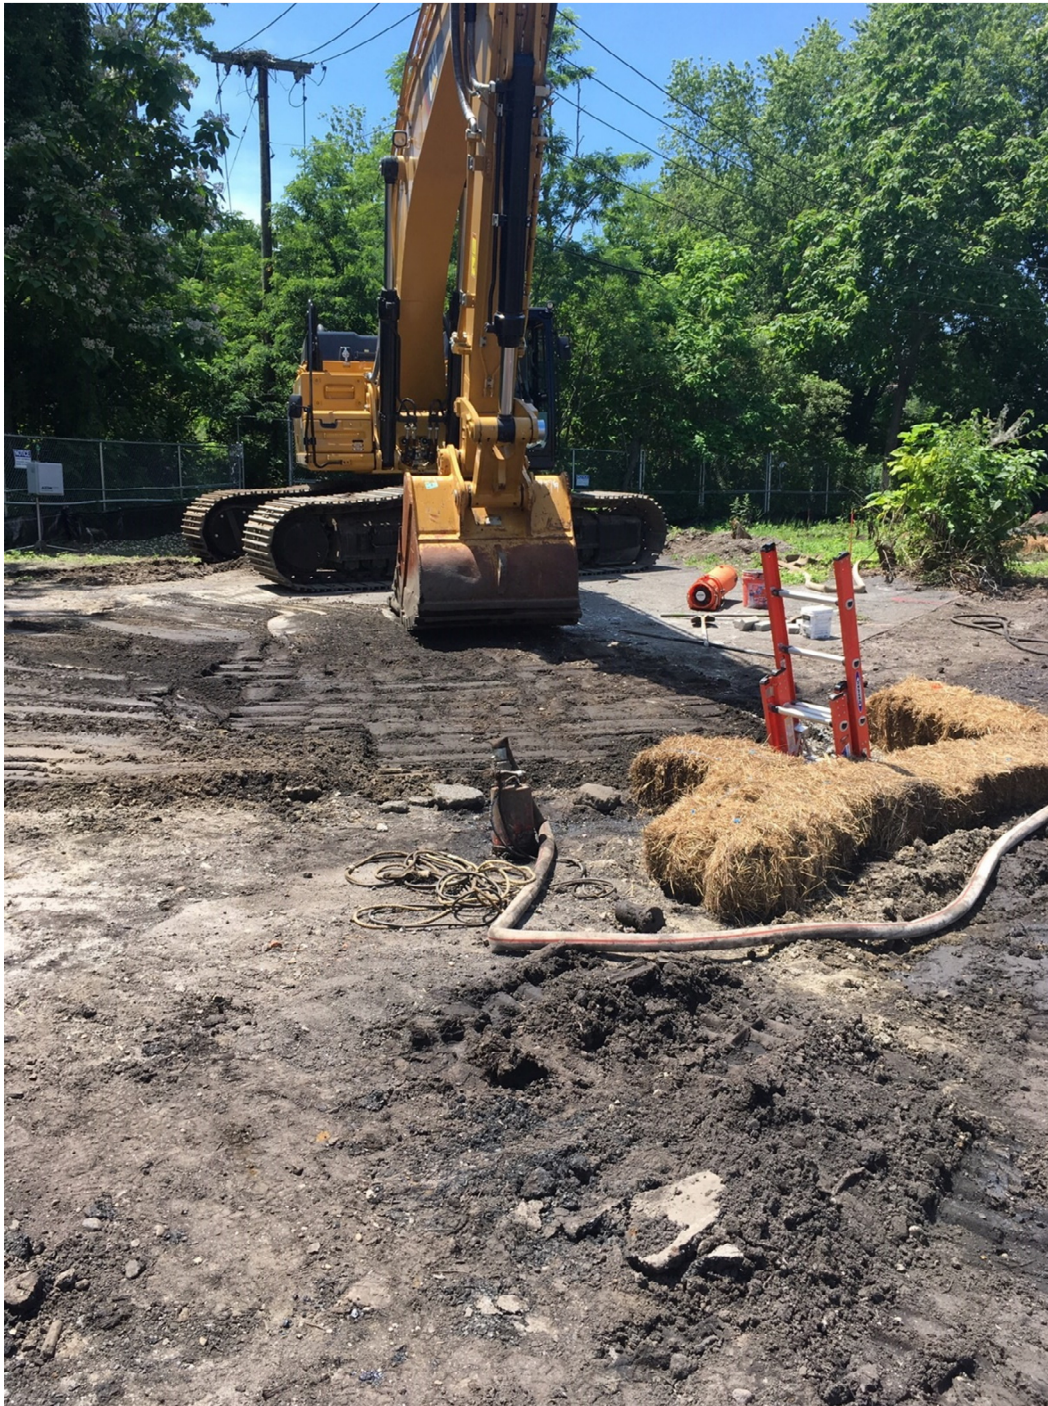
Photo 2: Backfilled trench used for plugging clay pipe

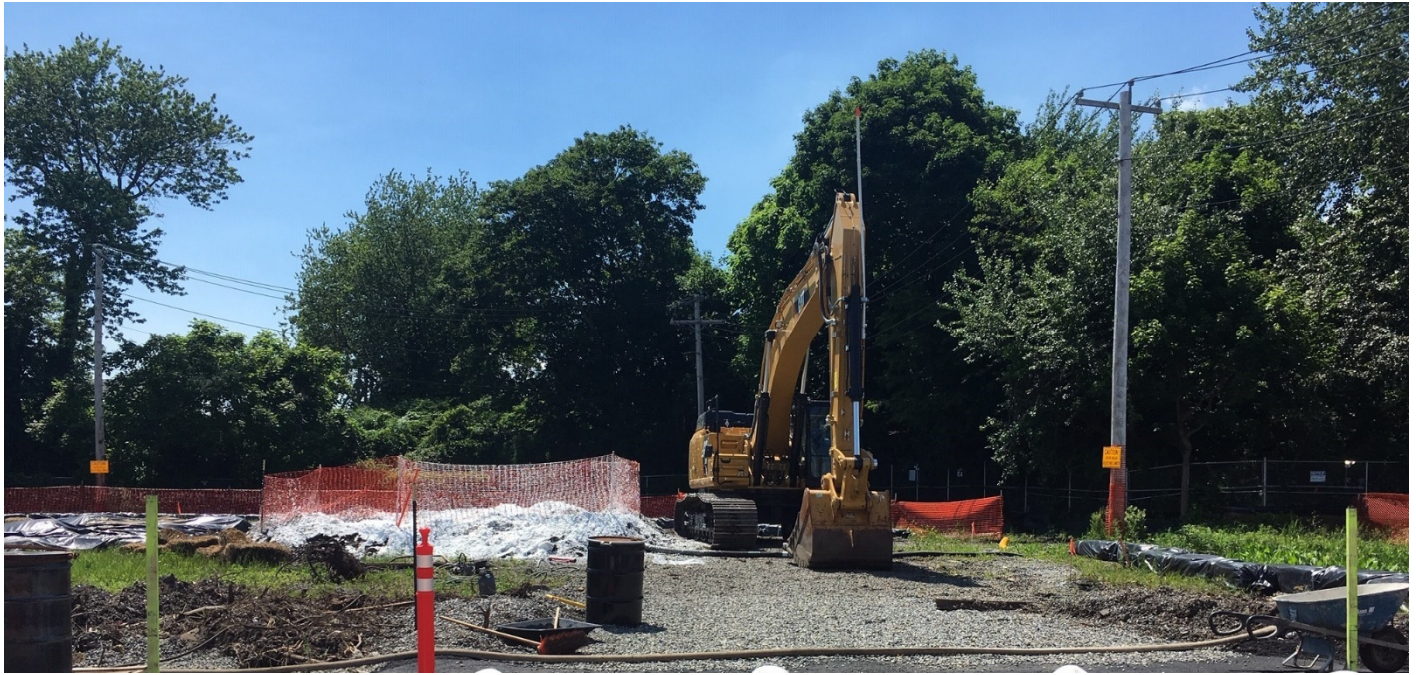
Photo 3: Pilot test area at end of work day. Excavation area is fenced and covered with foam to prevent odors.
