RCRA FACILITY ASSESSMENT
VISUAL SITE INSPECTION REPORT

Hazeltine Corporation
Commack, New York
EPA ID# NYD980773691

Report - December 27, 1988
Revised - July 7, 1989

Prepared by the NYSDEC

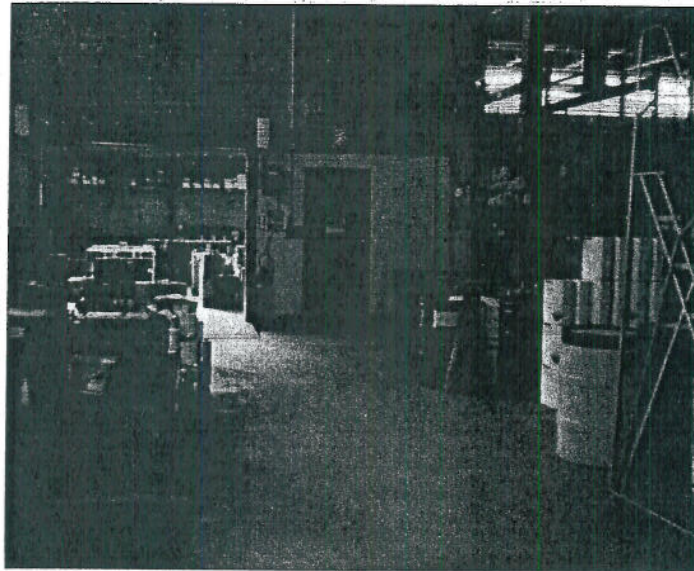
This is a room located inside Building No. 6. It is bounded by the outside building wall on one side, a block masonry wall with an overhead door and a doorway on two sides, and a fence and berm opposite the outside wall. The fence and berm separate it from an electronic component storage and manufacturing area.

This room is located adjacent to the Toxic and Corrosive Chemical Storage Area. It is shown in the background of Figure 3. It is bounded on two sides by exterior walls of Building 6 and on the other two sides by block masonry walls.

Figure 3 Toxic and Corrosive Chemical Storage Area
(Chemical and Ignitable Materials Storage Room
in background through overhead door)

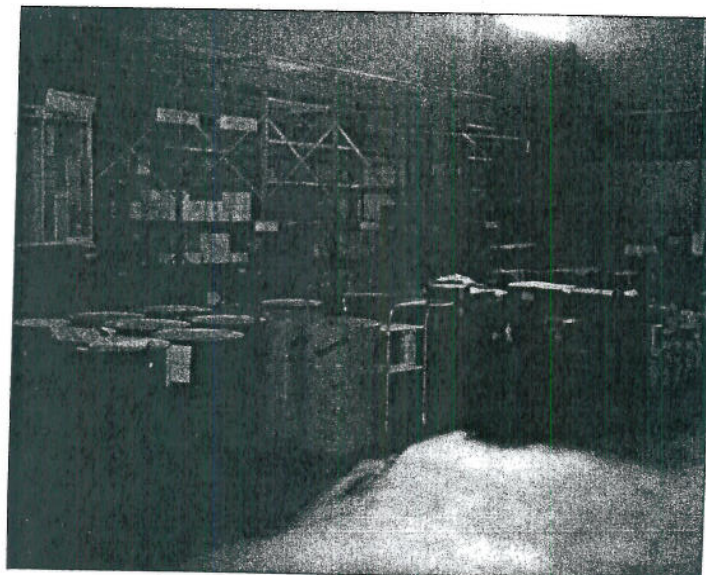
The room stored more raw materials than waste materials at the time of the VSI. The hazardous wastes stored at that time were waste ammonia (D002), waste chlorinated solvents (F001), and small containers of miscellaneous adhesives, resins, silicone sealants, etc. These small containers will be packed into 55-gallon drums and shipped off-site for land disposal or incineration. The ammonia and solvents will be shipped off-site to be reclaimed. The production of waste ammonia by Hazeltine has ceased. The waste ammonia stored at the time of the VSI is expected to be their last. Figures 3 and 4 show photographs of this container storage area.

Figure 4 Toxic and Corrosive Chemical Storage Area

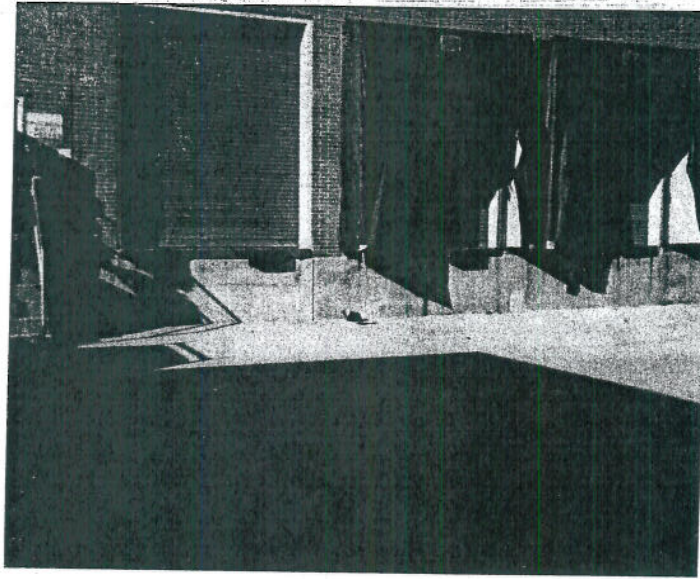
materials at the time of the VSI. At that time there were also several 55-gallon drums of ignitable waste materials and numerous small cans of flammable paints, adhesives, resins, etc. The small cans had been recently rearranged to comply with local fire codes. All of the hazardous wastes stored in this room were to be incinerated off-site or used as fuel in an industrial furnace. Figure 5 shows the loading/unloading area for the facility which is adjacent to the two container storage areas.

Figure 5 Loading/Unloading Area
