**HDPE GEOMEMBRANE CONTRACTOR DESTRUCTIVE SEAM STRENGTH TESTING
PELHAM BAY LANDFILL CLOSURE AND FINAL REMEDIATION**

B-9 Backup Information on Damaged HDPE Geomembrane Area

Re: Repair at Pelham Bay Landfill
Revision to (8 April) Procedure

SUBJECT: Geomembrane Damage to the Top of Landfill

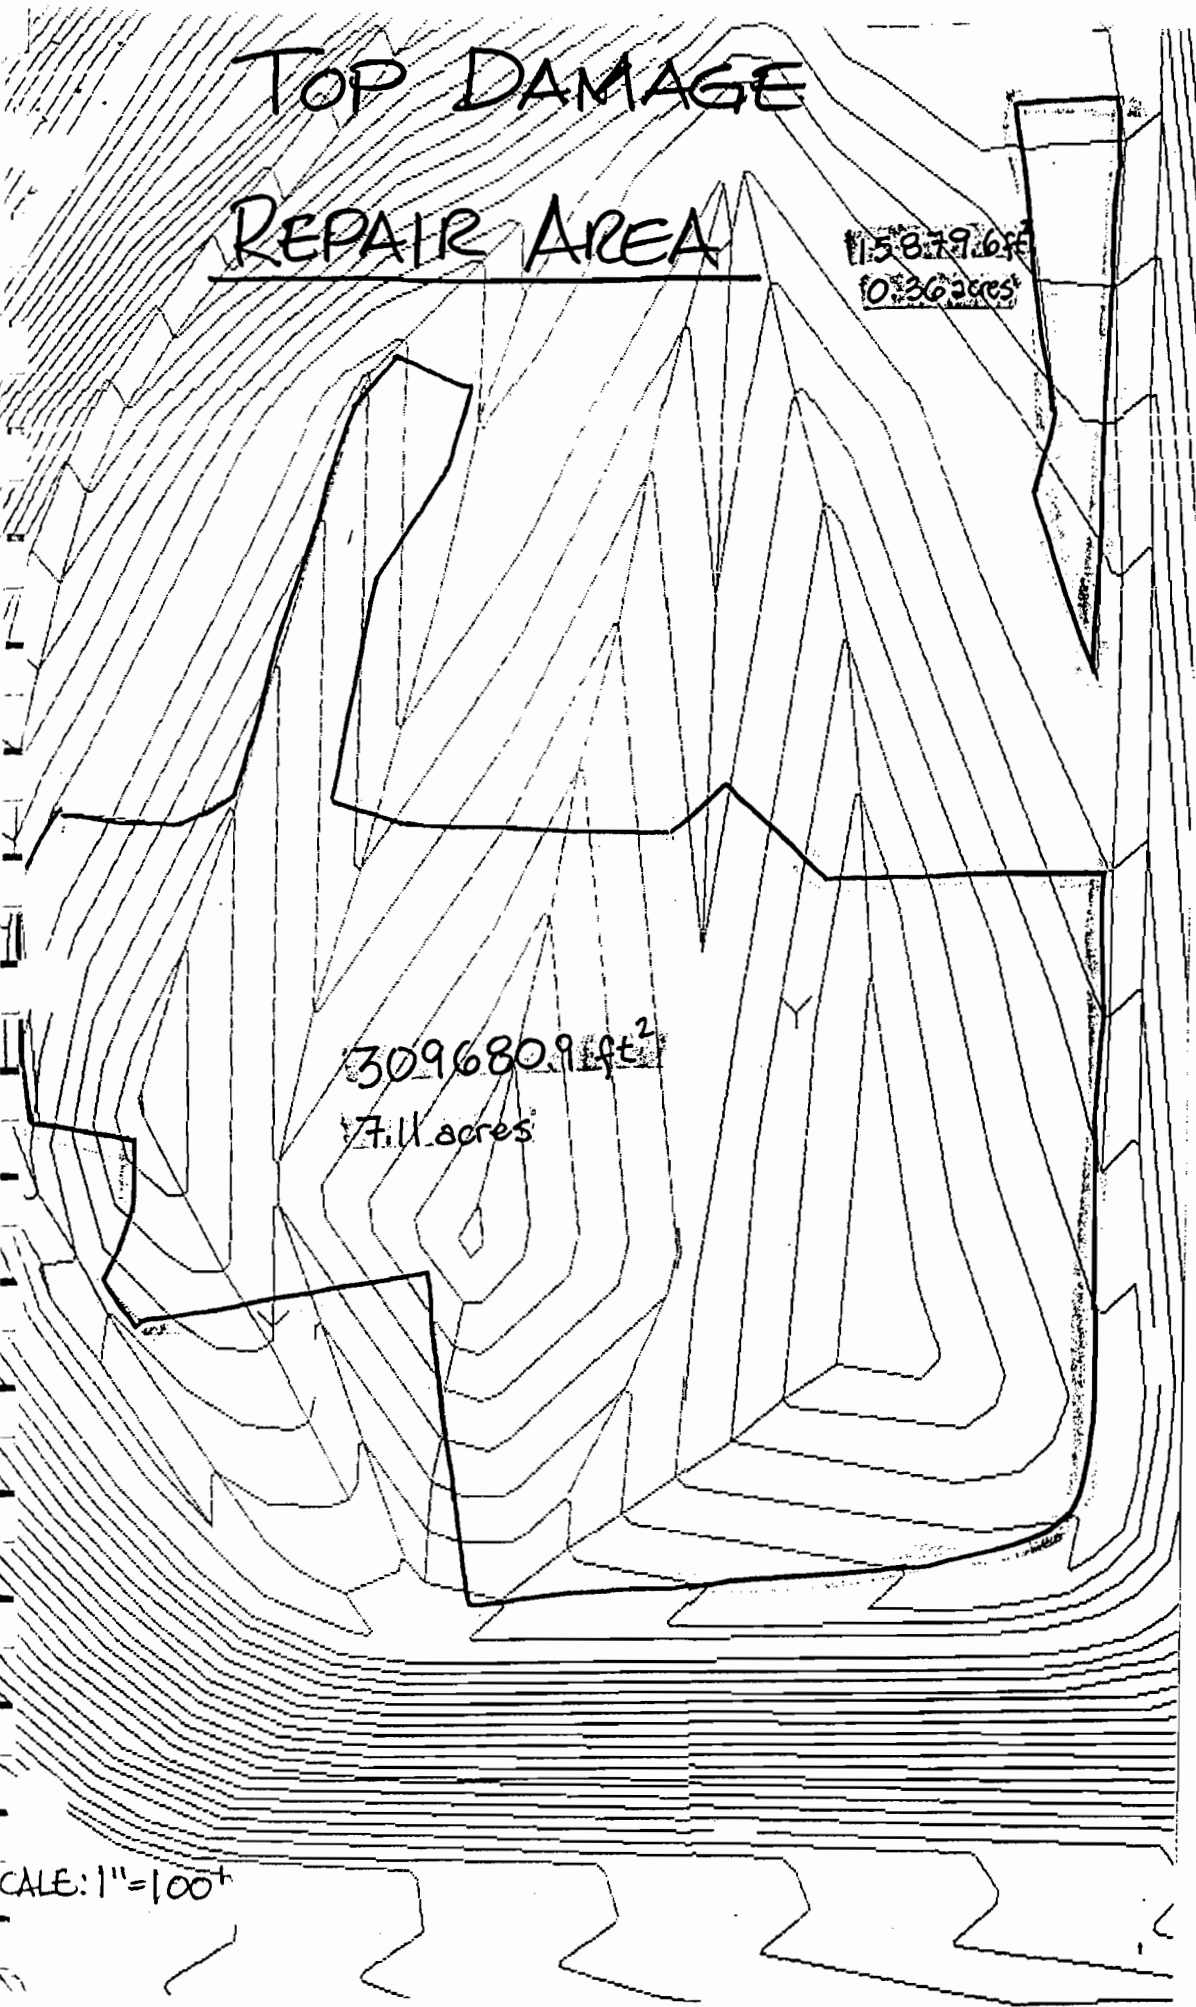
- Shop drawings Prints Plans Samples Specifications
 Copy of letter Change order TOP DAMAGE / REPAIR AREA

TOP DAMAGE

REPAIR AREA

309680.9 ft²
7.11 acres
