**PELHAM BAY LANDFILL
CLOSURE AND FINAL REMEDIATION
CONSTRUCTION CERTIFICATION REPORT**

October 23, 2002

New York City Department of Environmental Protection
96-05 Horace Harding Expressway
Corona, NY 11368-5105

URS Corporation
363 Seventh Avenue, 11th Floor
New York, New York 10001

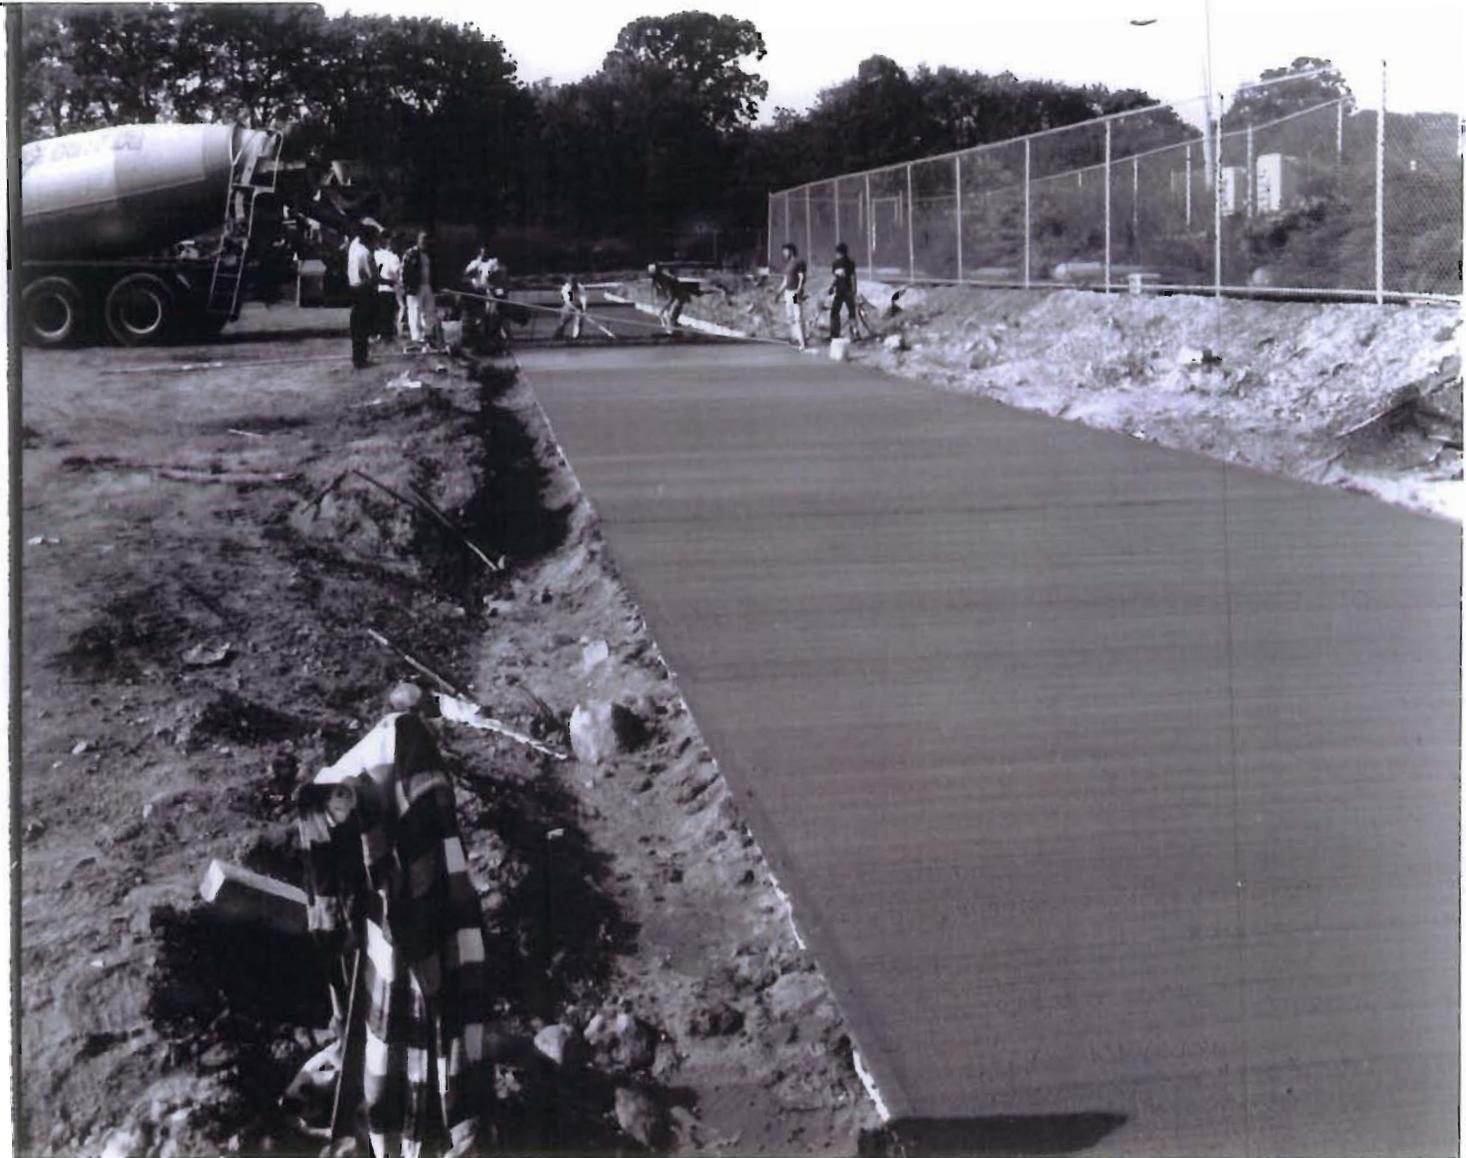
Photo No.1. Construction of Concrete Slurry Wall Cap. (October 14, 1994)

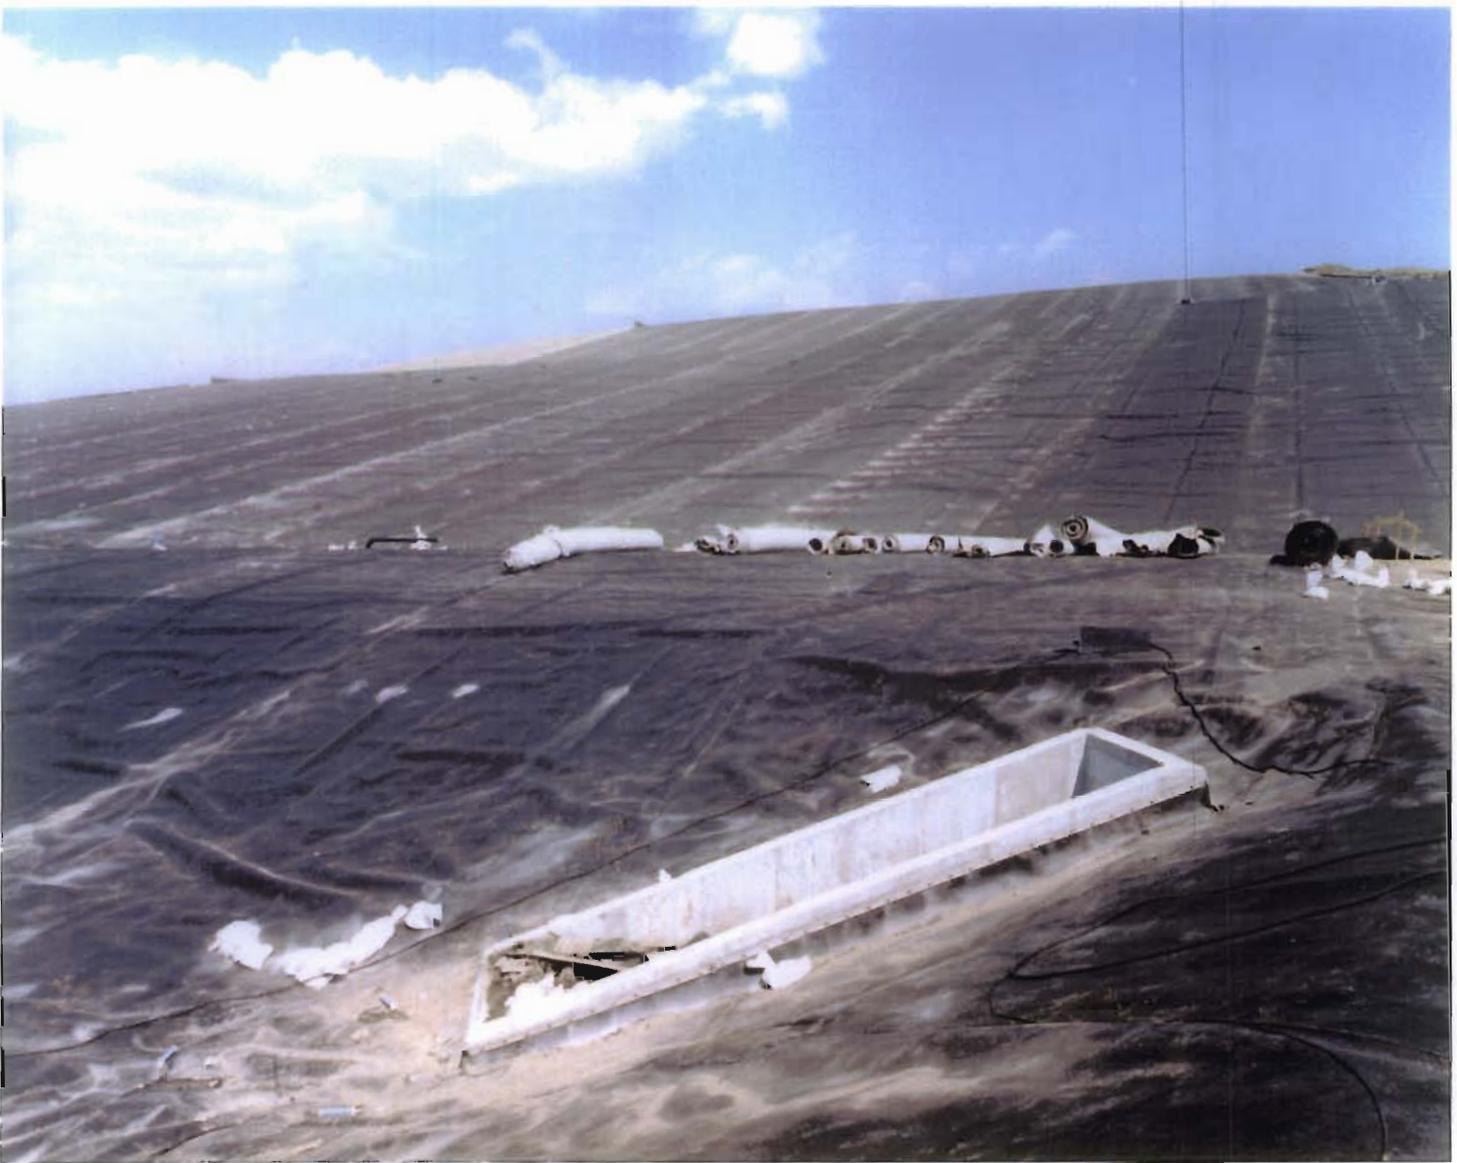
Photo No. 2. View of Pond B and Landfill Geomembrane Layer. (August 18, 1995)

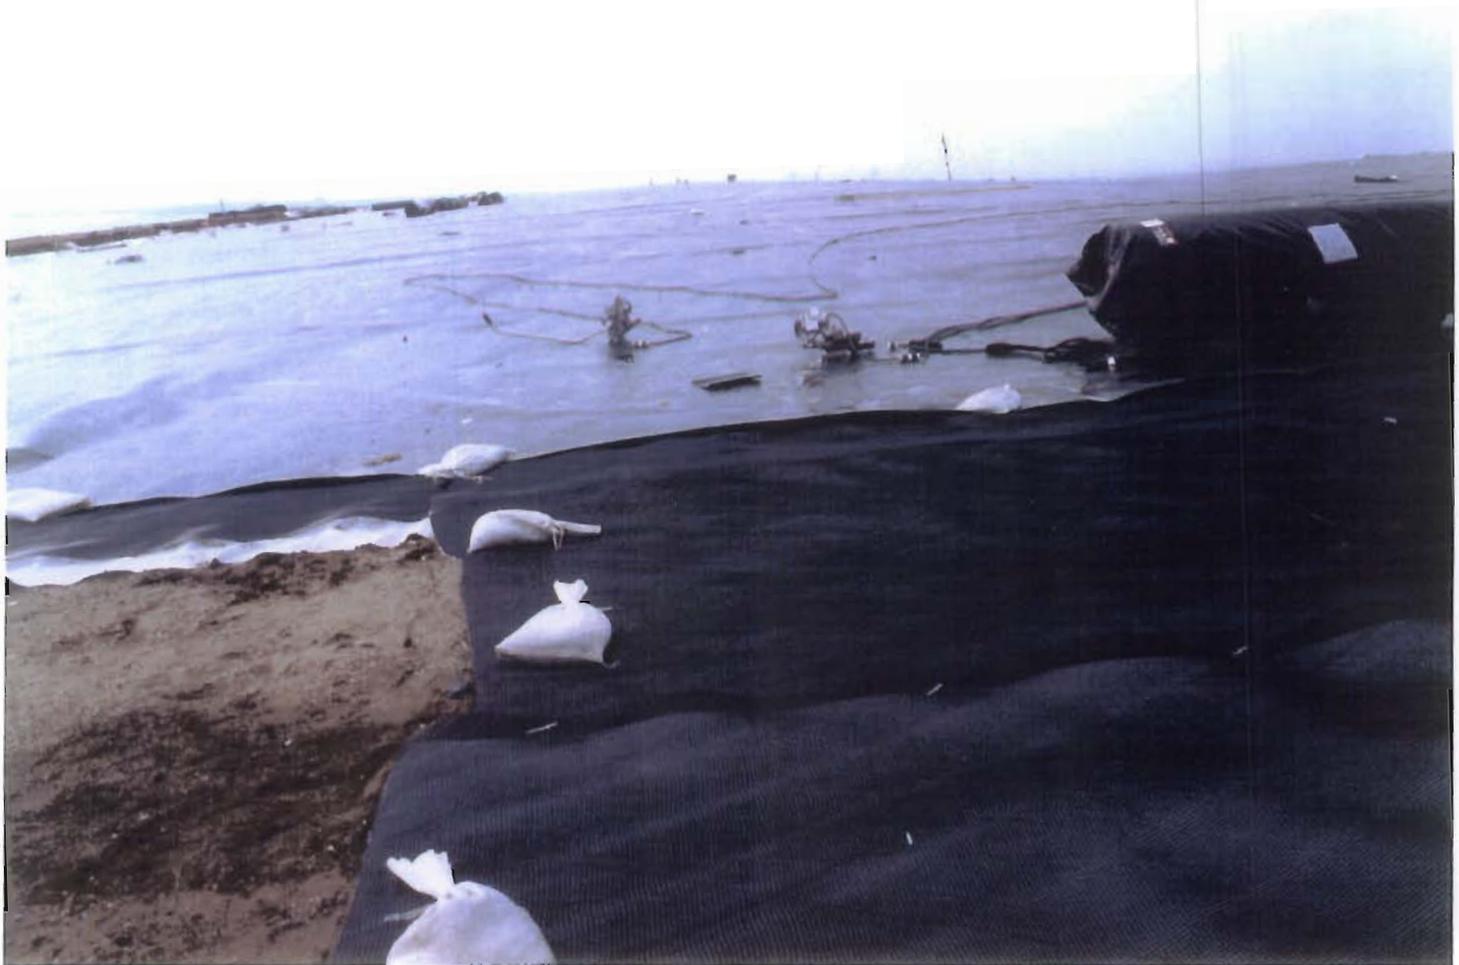
Photo No. 3. Installation of Smooth HDPE Geomembrane at Top of Landfill
(November 1, 1995)

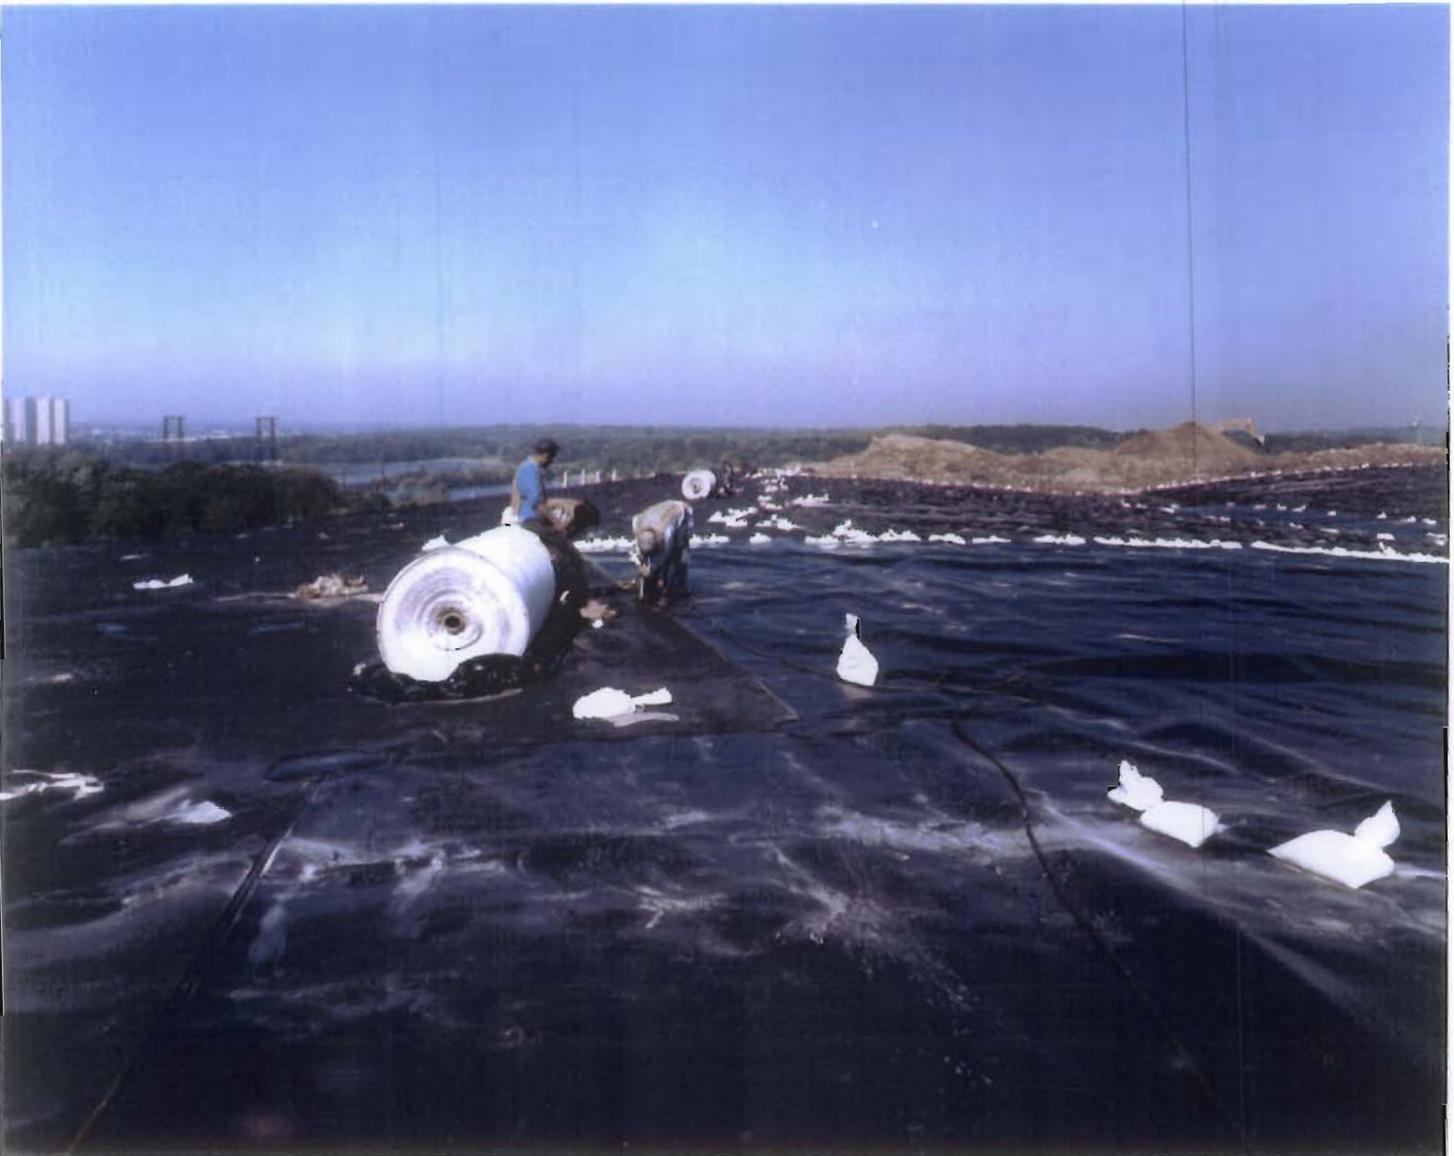
Photo No. 4. Seaming of Textured and Smooth HDPE Geomembrane at Top of Landfill
(September 27, 1995)

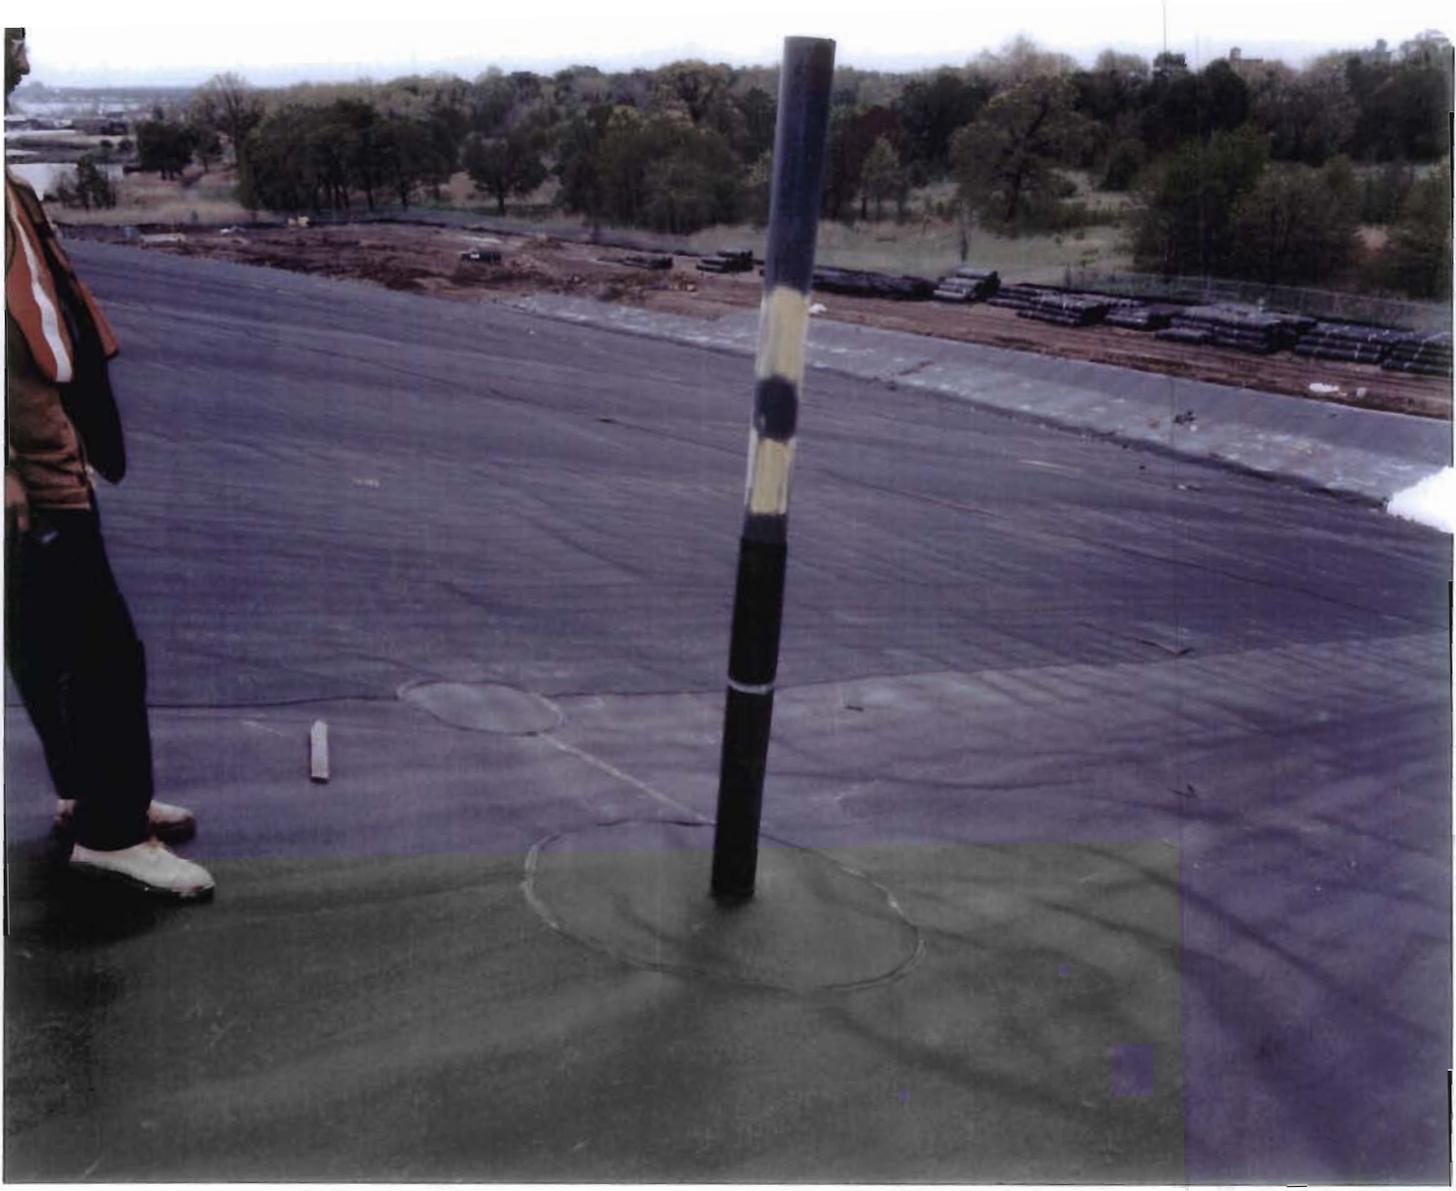
Photo No. 5. Detail of LFG Vent Boot. (May 11, 1995)

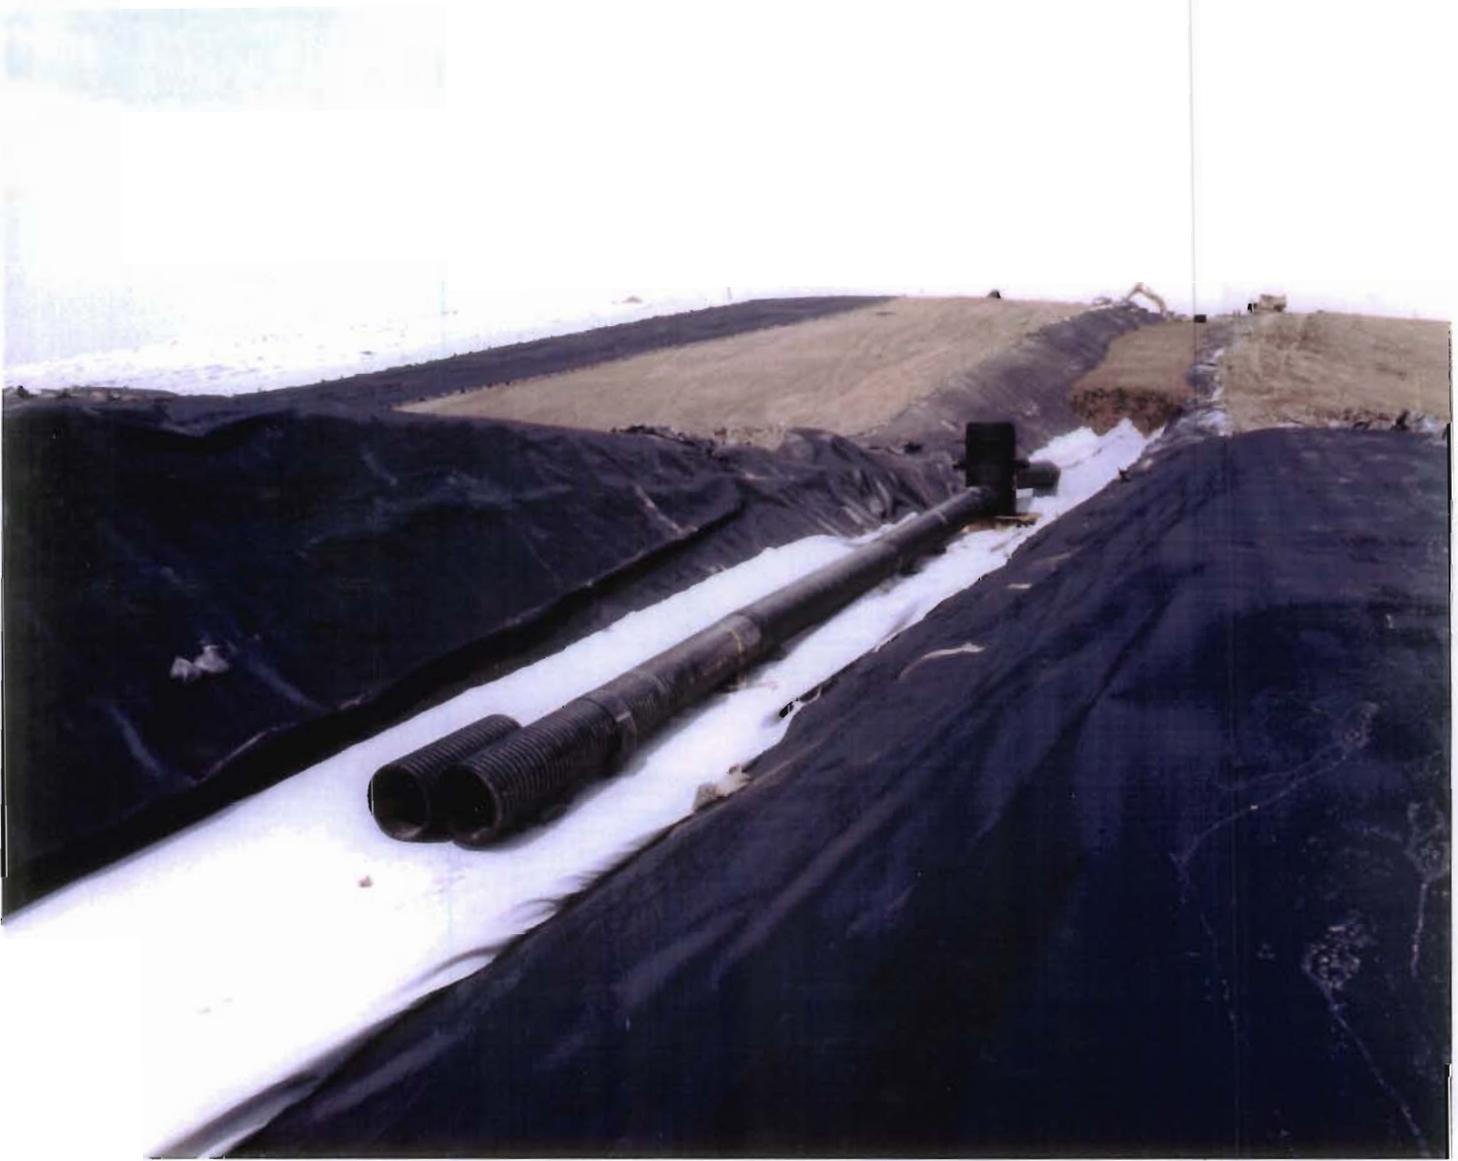
Photo No. 6. Installation of 24" Diameter Pipe Downchute. (June 7, 1995)

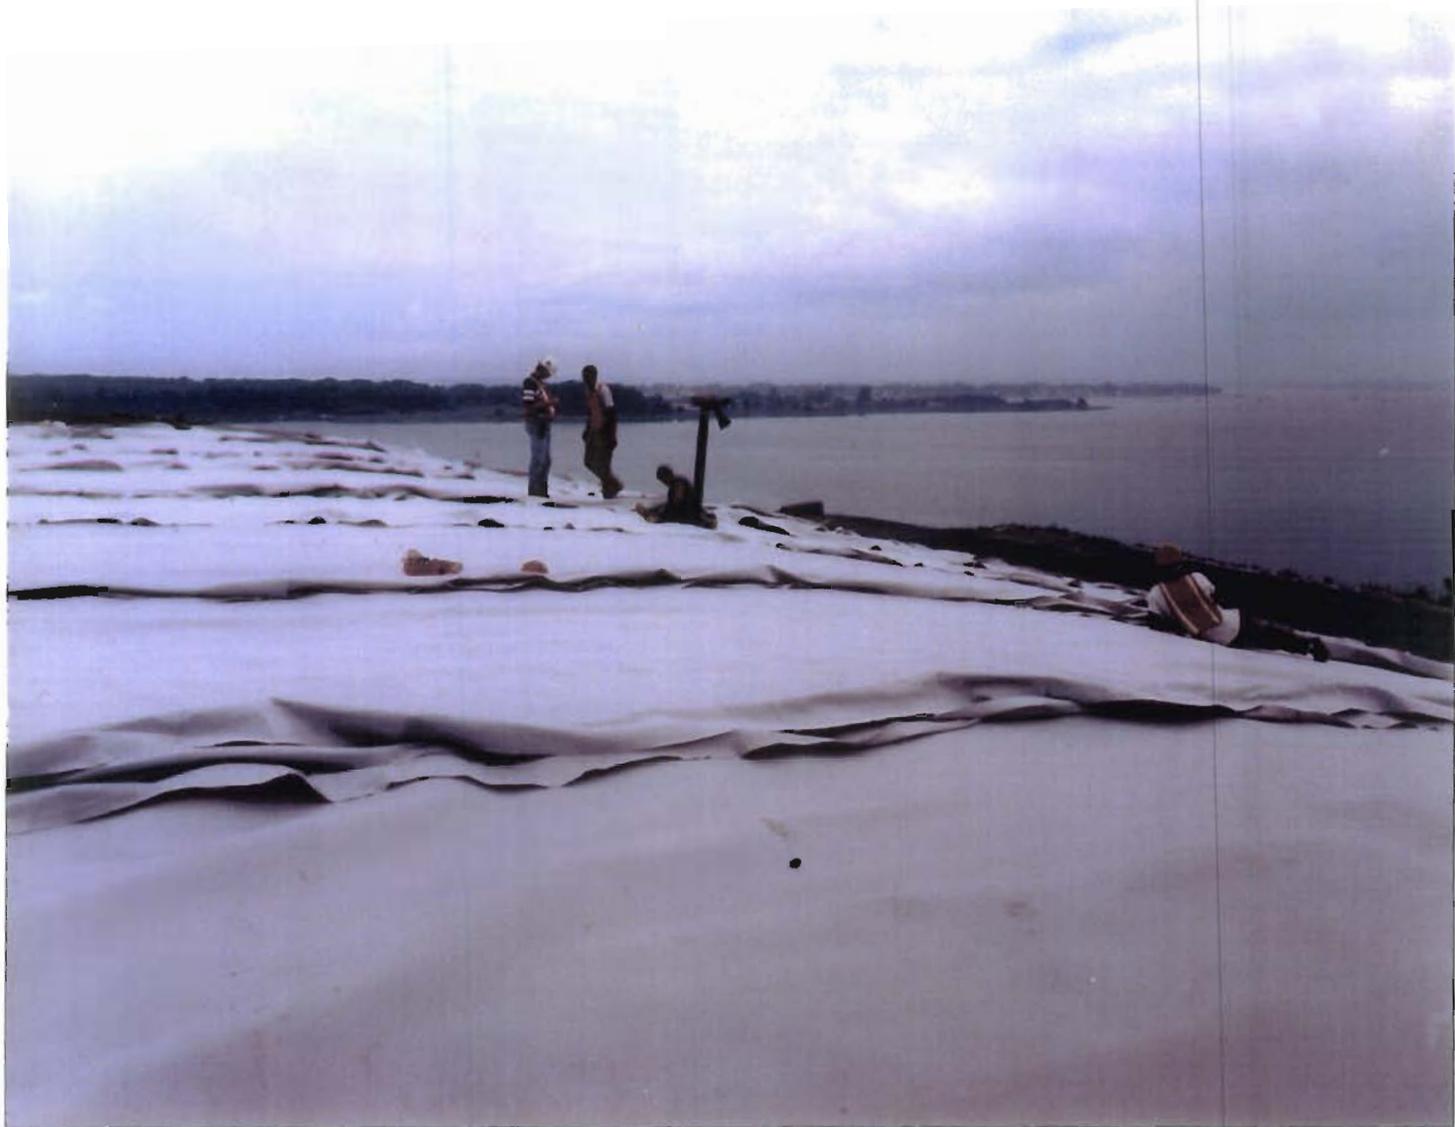
Photo No. 7. Geocomposite Layer. (June 26, 1995)

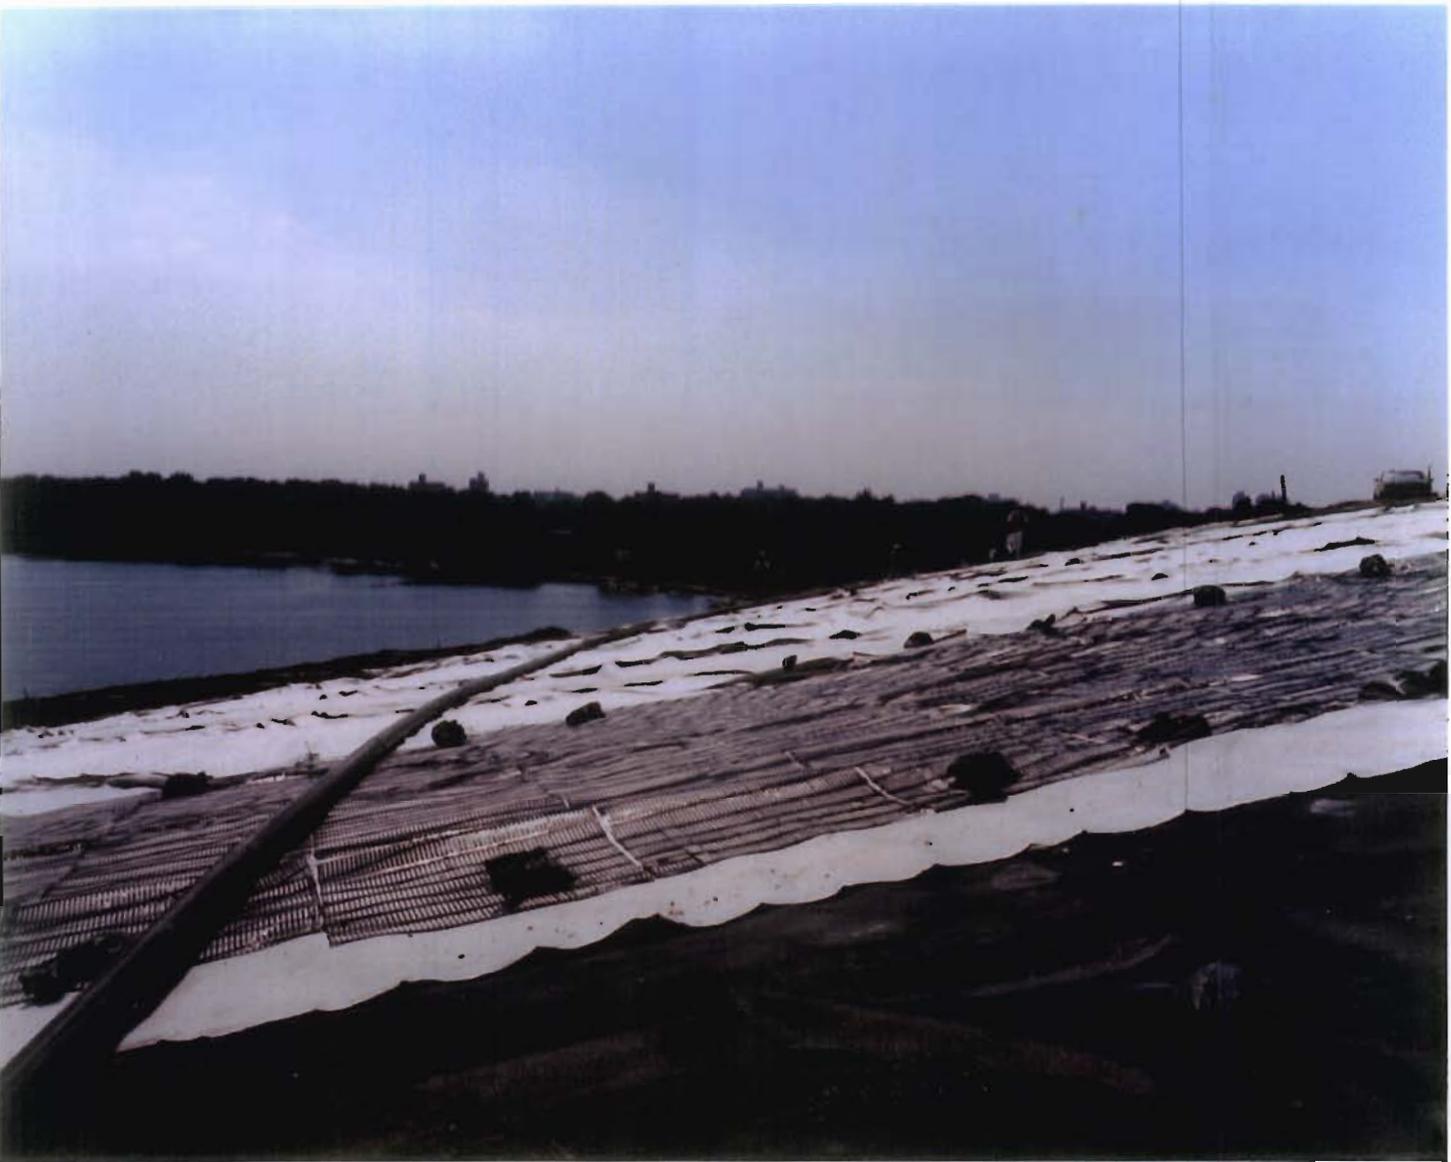
Photo No. 8. LFG Collection Pipe Installation over Geocomposite Layer
(with Geogrid Reinforcement). (August 1, 1995)

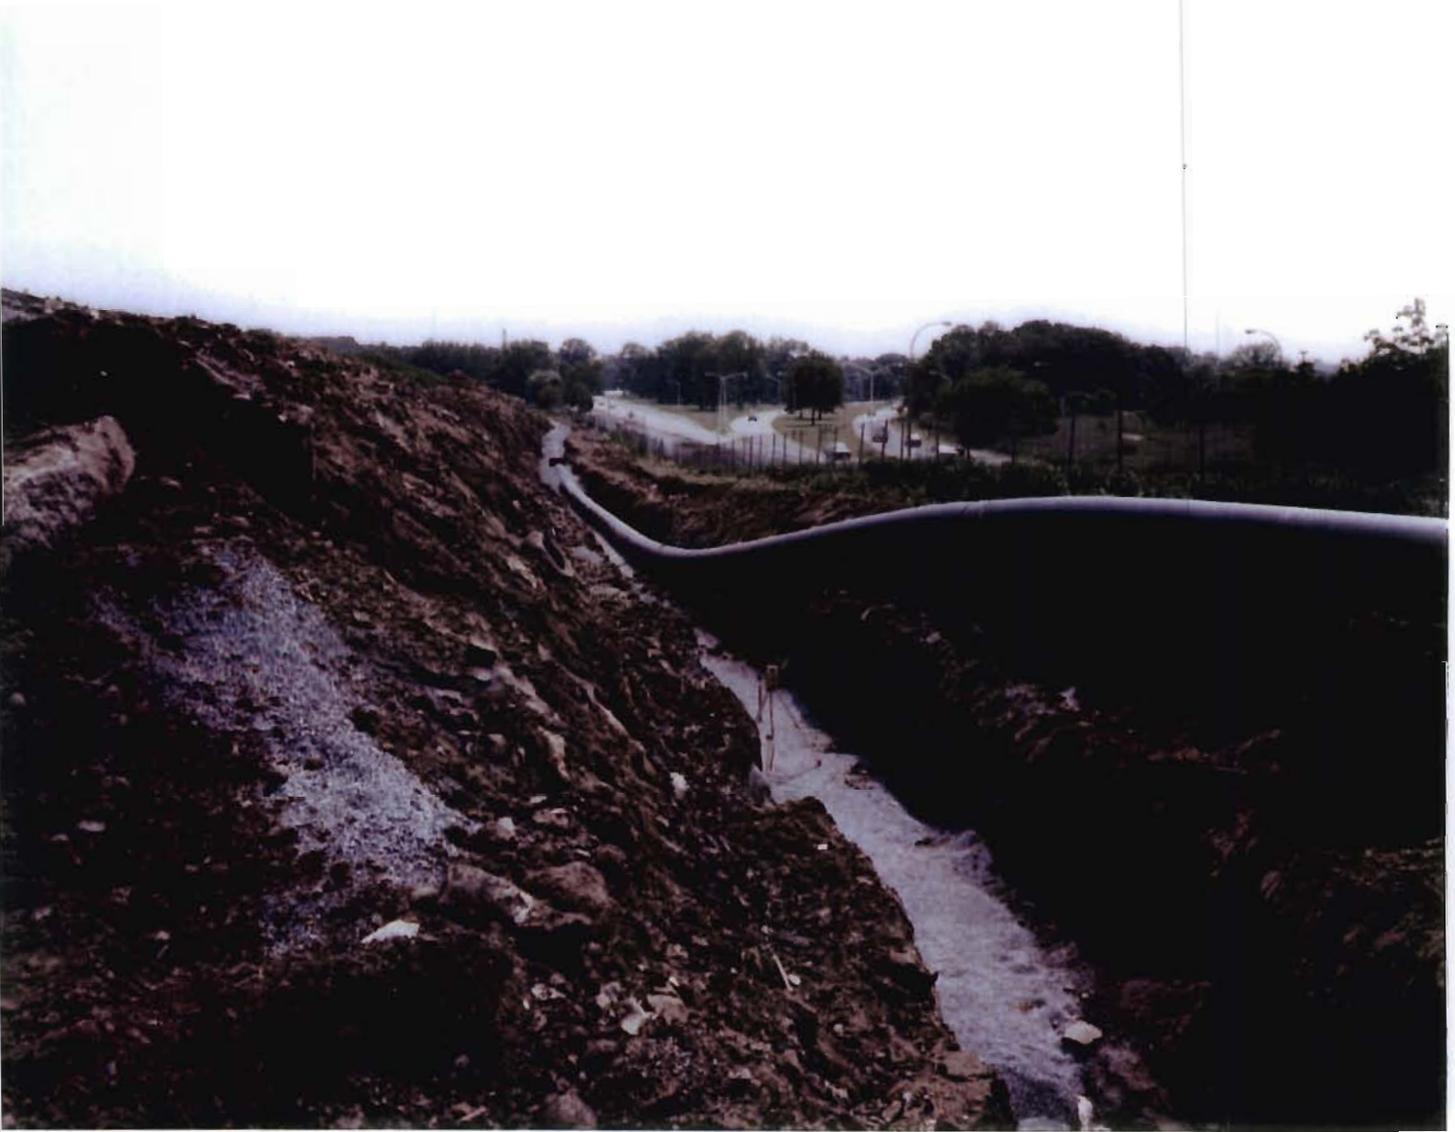
Photo No. 9. Installation of 30" Diameter HDPE Pipe Connection between Ponds B and C. (June 7, 1995)

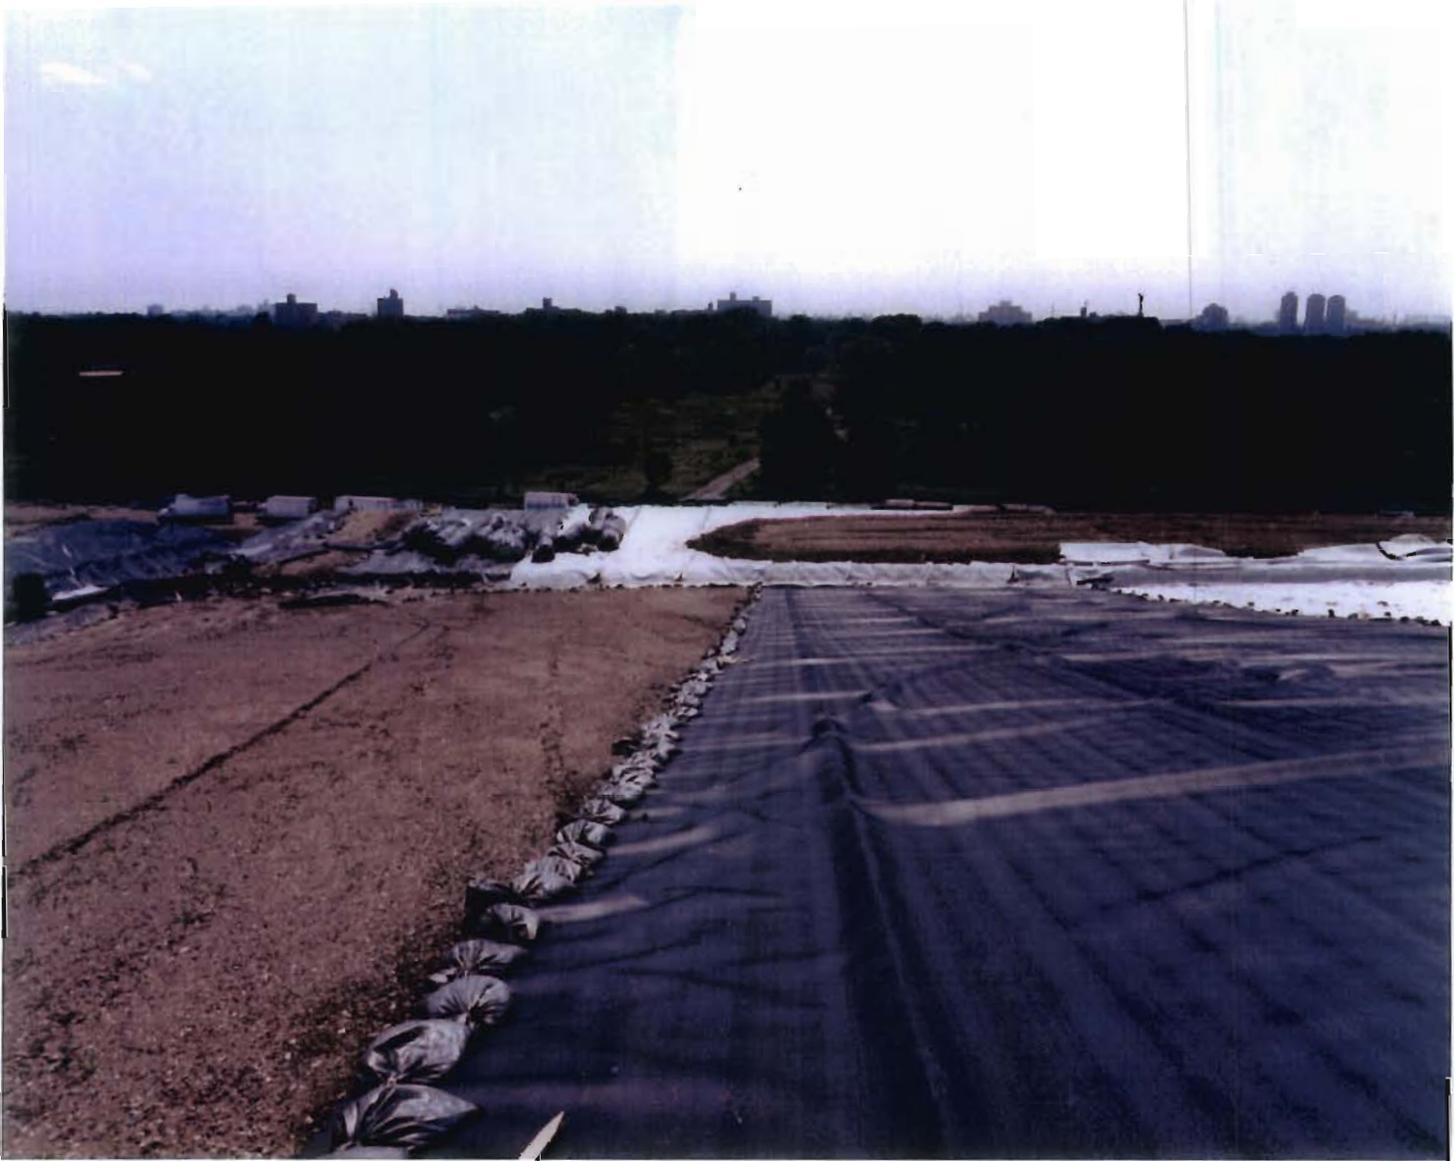
Photo No. 10. Roadway Construction. (June 7, 1995)

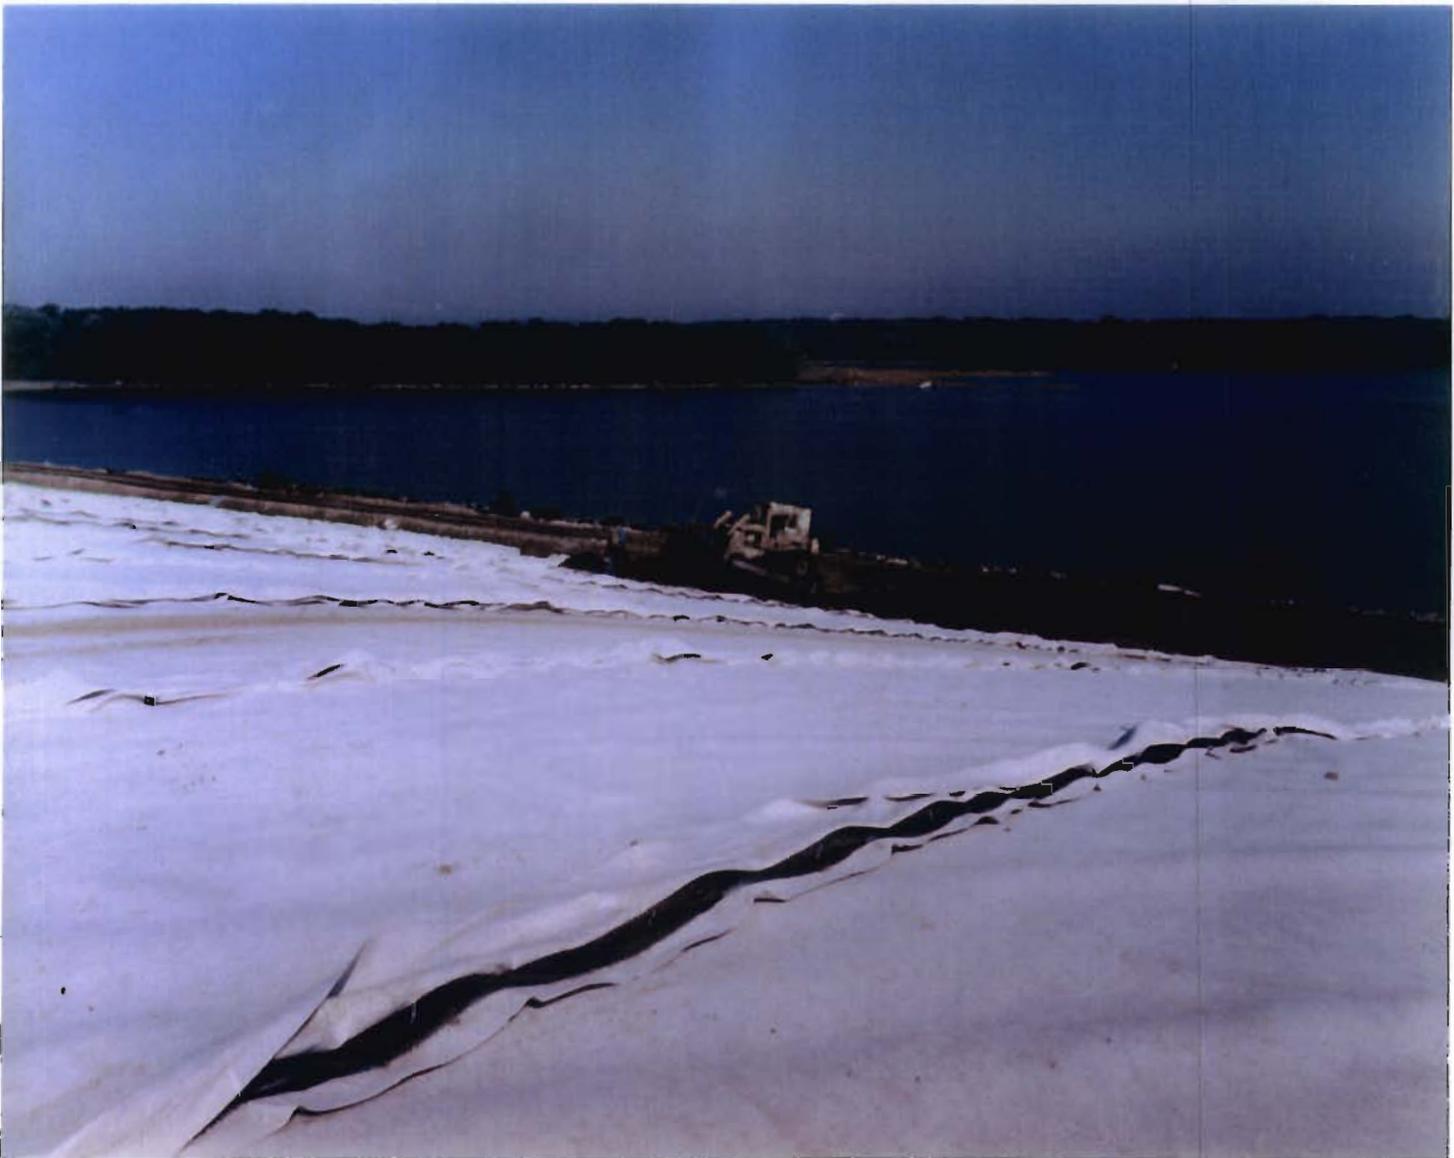
Photo No. 11. Installation of Barrier Protection Material over Geocomposite Layer.
(September 27, 1995)

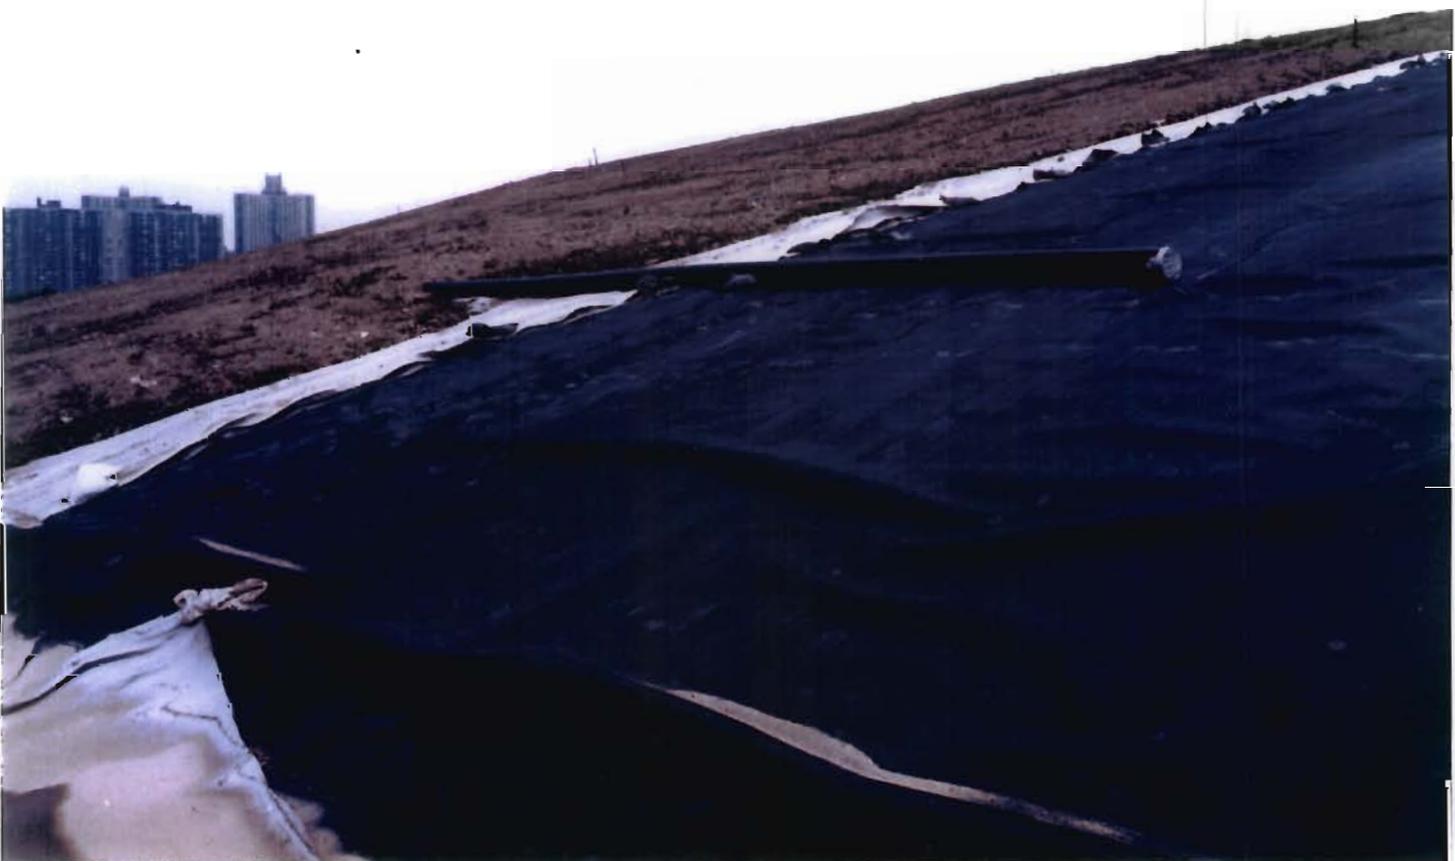
Photo No. 12. Covering LFG Collection Line with Barrier Protection Material.
(July 12, 1995)

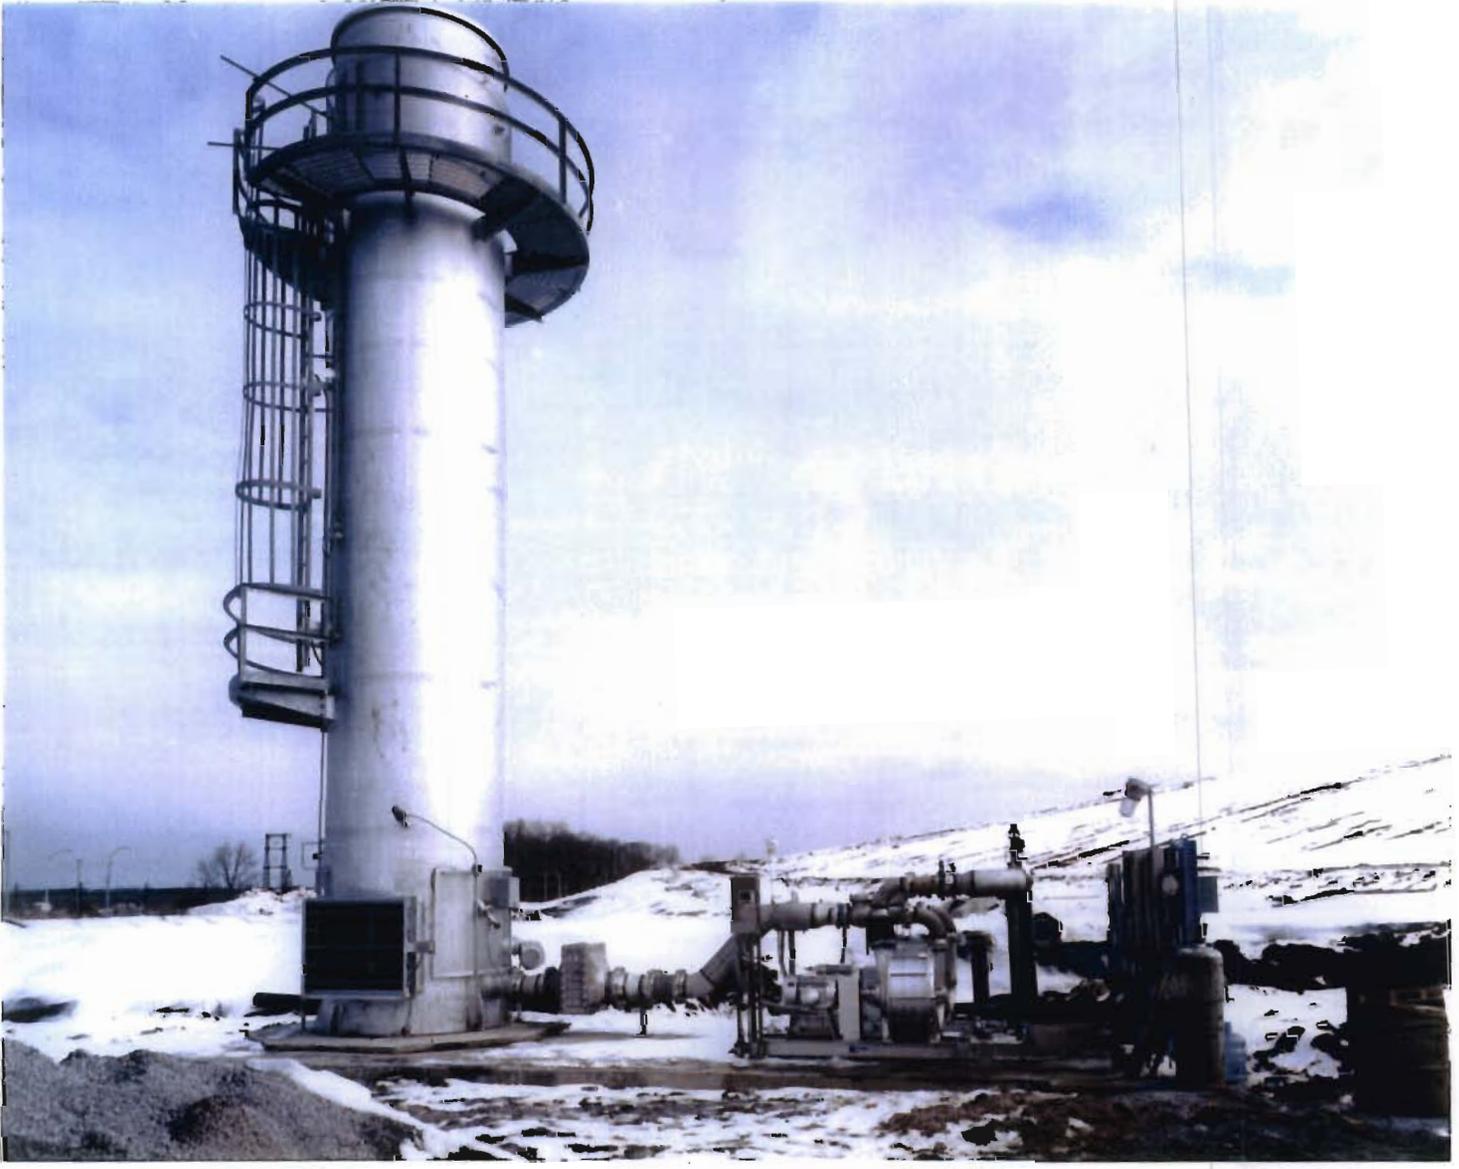
Photo No. 13. Installation of LFG Flare Station. (February 15, 1996)

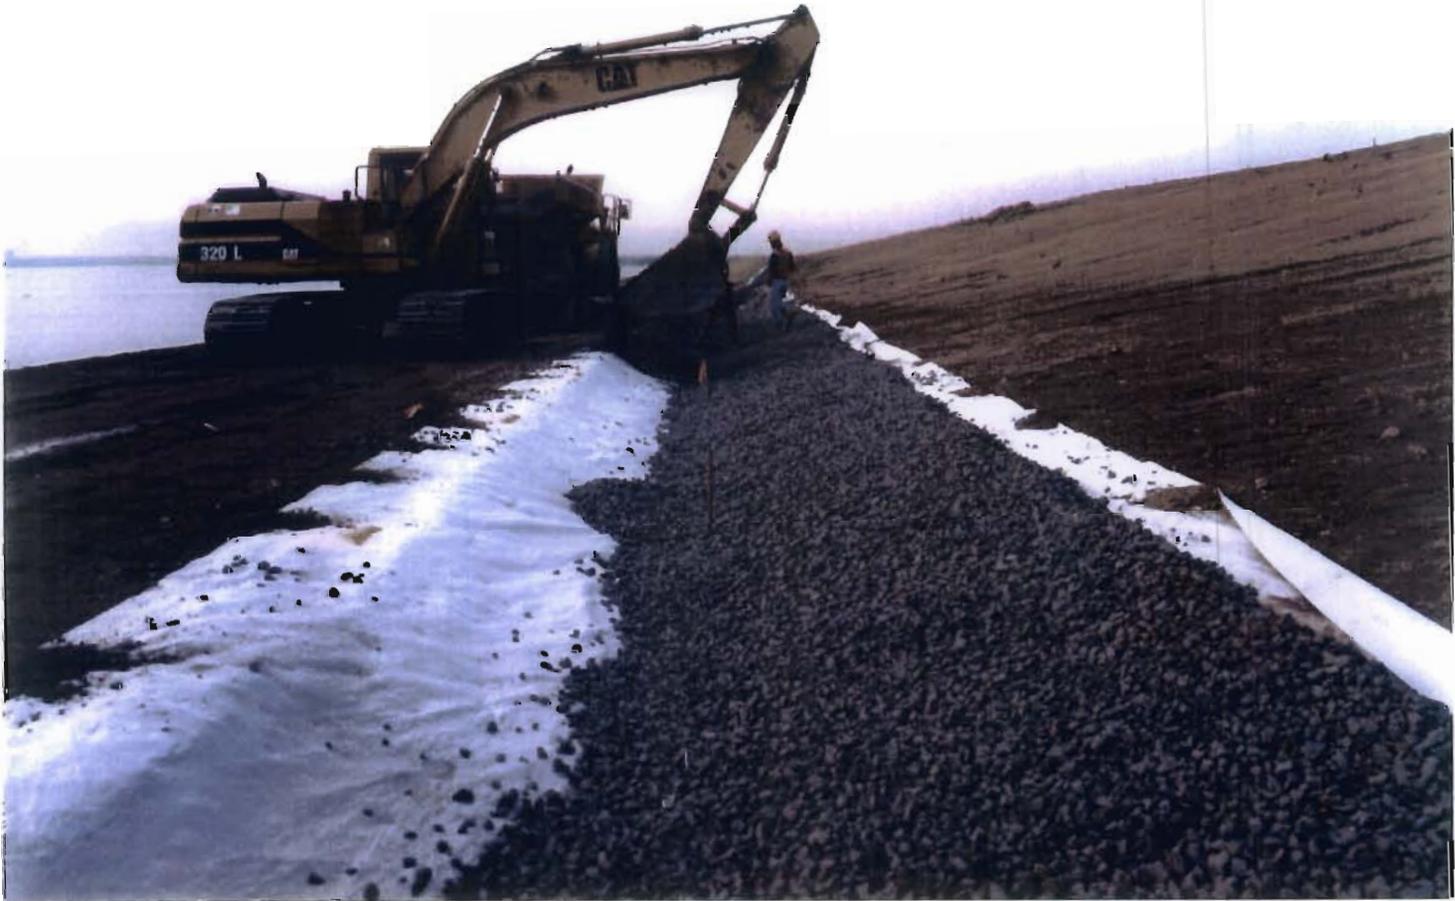
Photo No. 14. Construction of Swale E. (August 21, 1996)
