**PELHAM BAY LANDFILL
CLOSURE AND FINAL REMEDIATION
CONSTRUCTION CERTIFICATION REPORT**

October 23, 2002

New York City Department of Environmental Protection
96-05 Horace Harding Expressway
Corona, NY 11368-5105

URS Corporation
363 Seventh Avenue, 11th Floor
New York, New York 10001

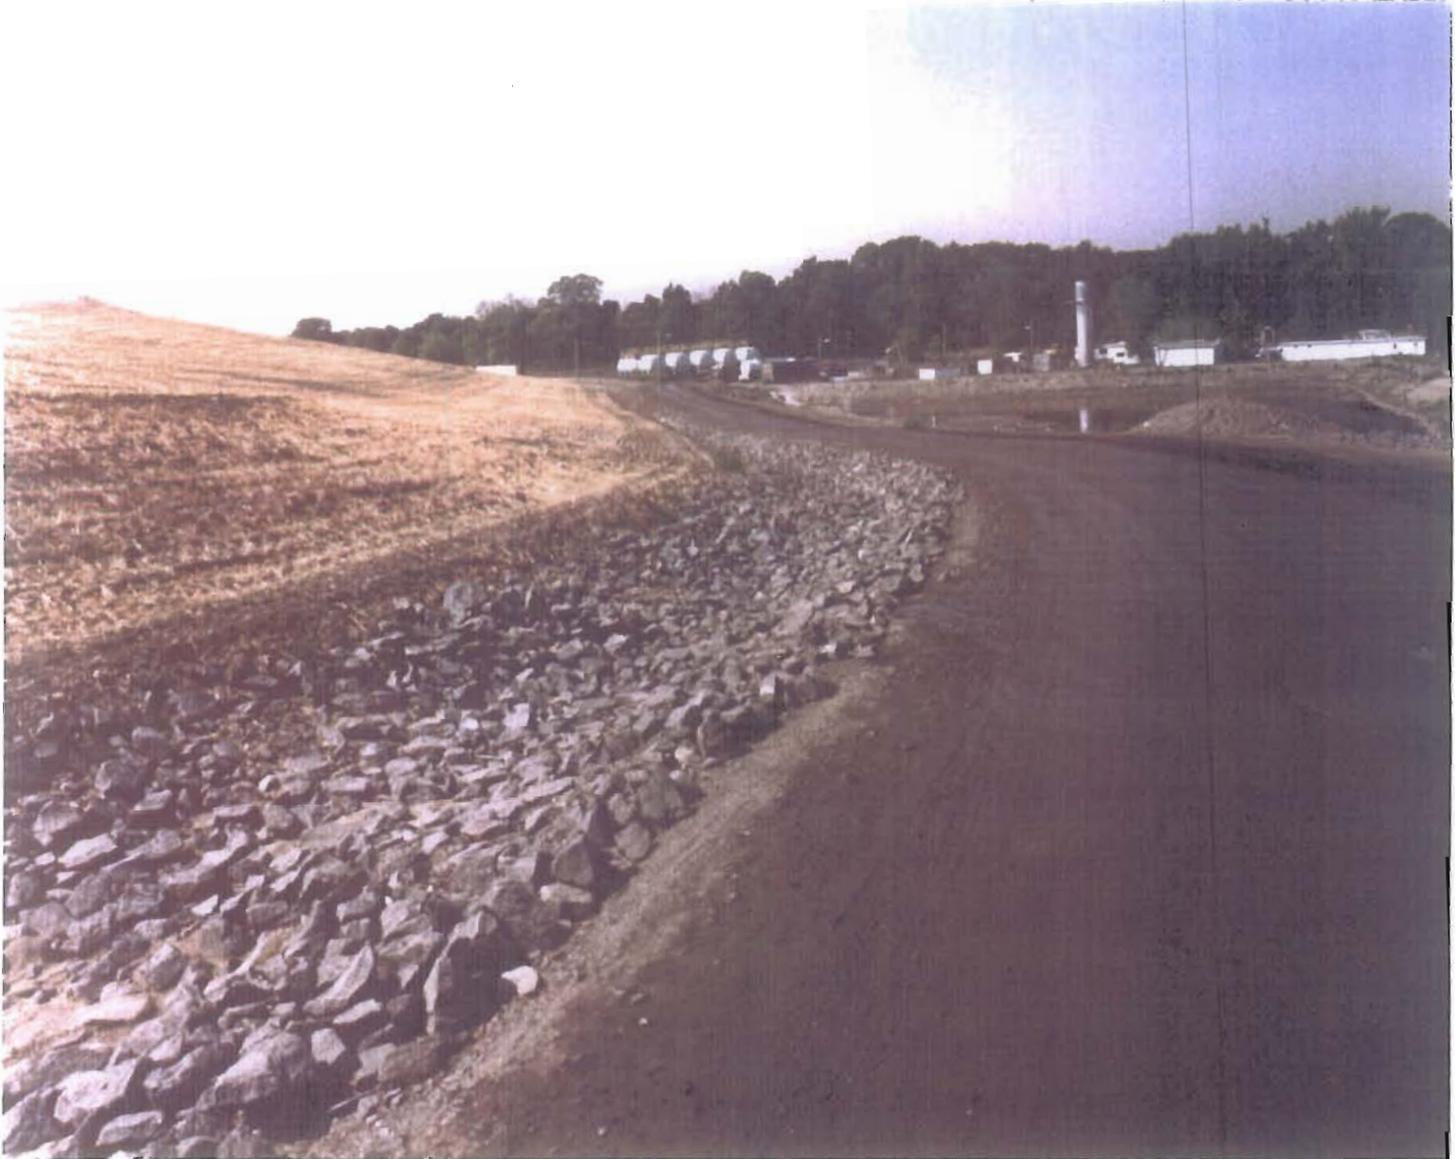
Photo No. 15. Access Roadway and Drainage Swale. (May 20, 1998)

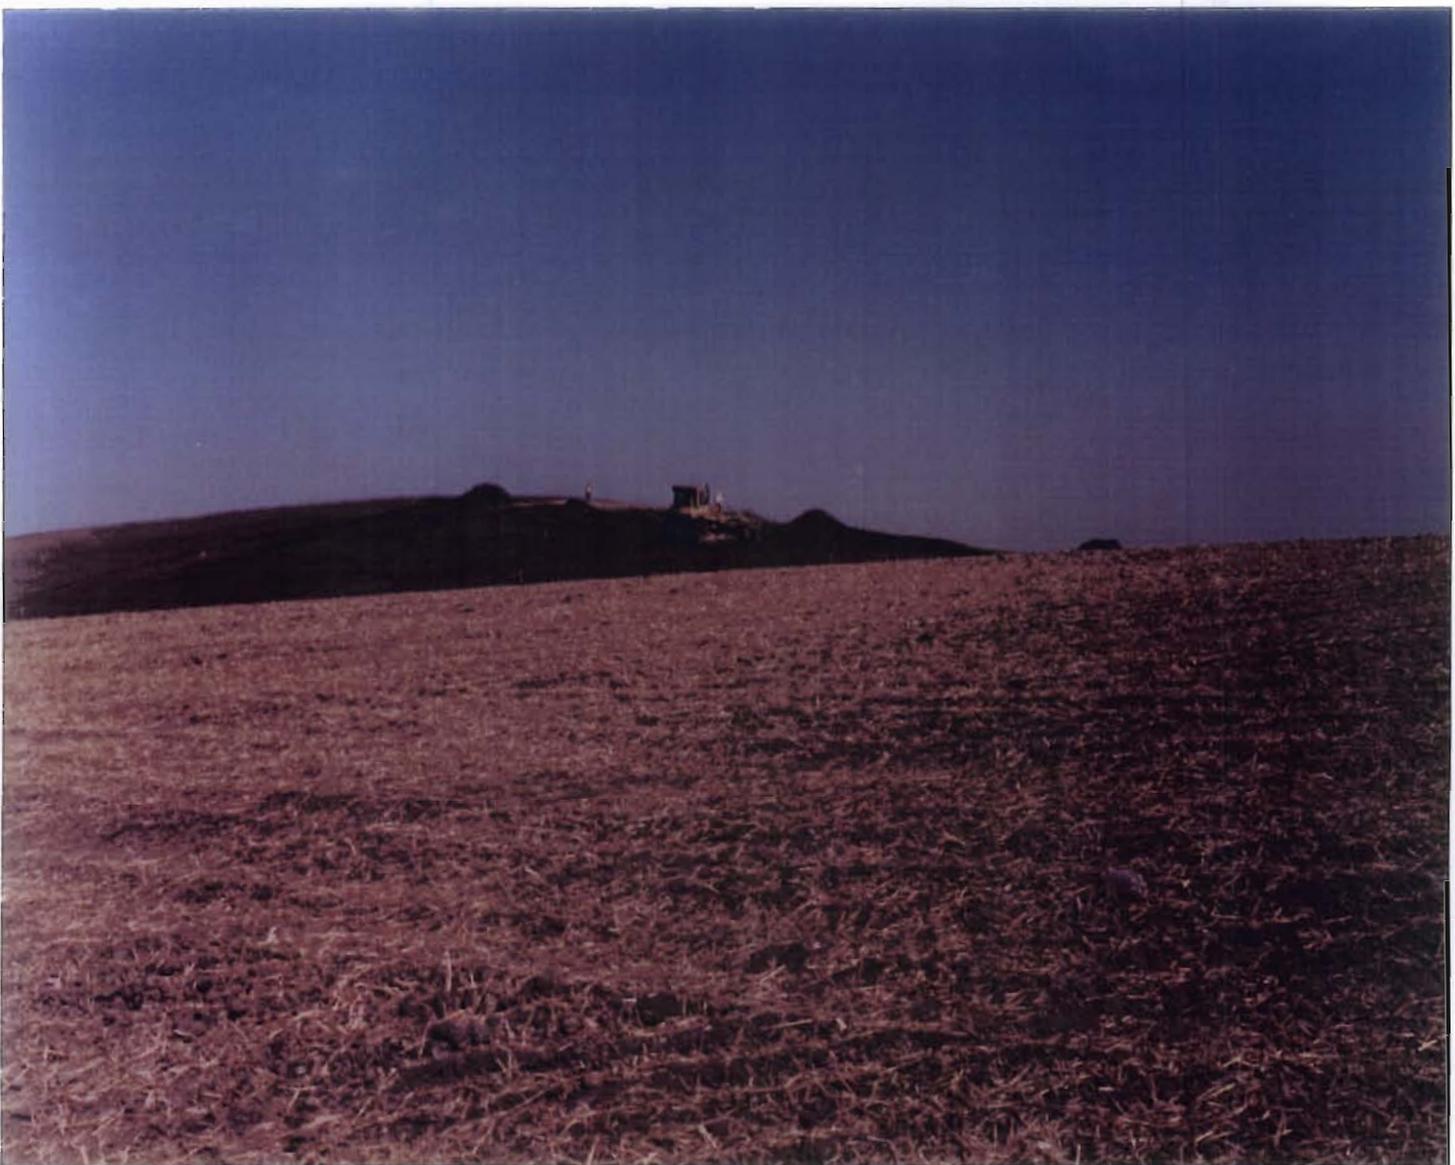
Photo No. 16. Construction of Topsoil Layer. (May 20, 1998)
