**Corrective Measures Work Plan for
Landfill Cover System Restoration**

Pelham Bay Landfill, Bronx, NY

December 2012

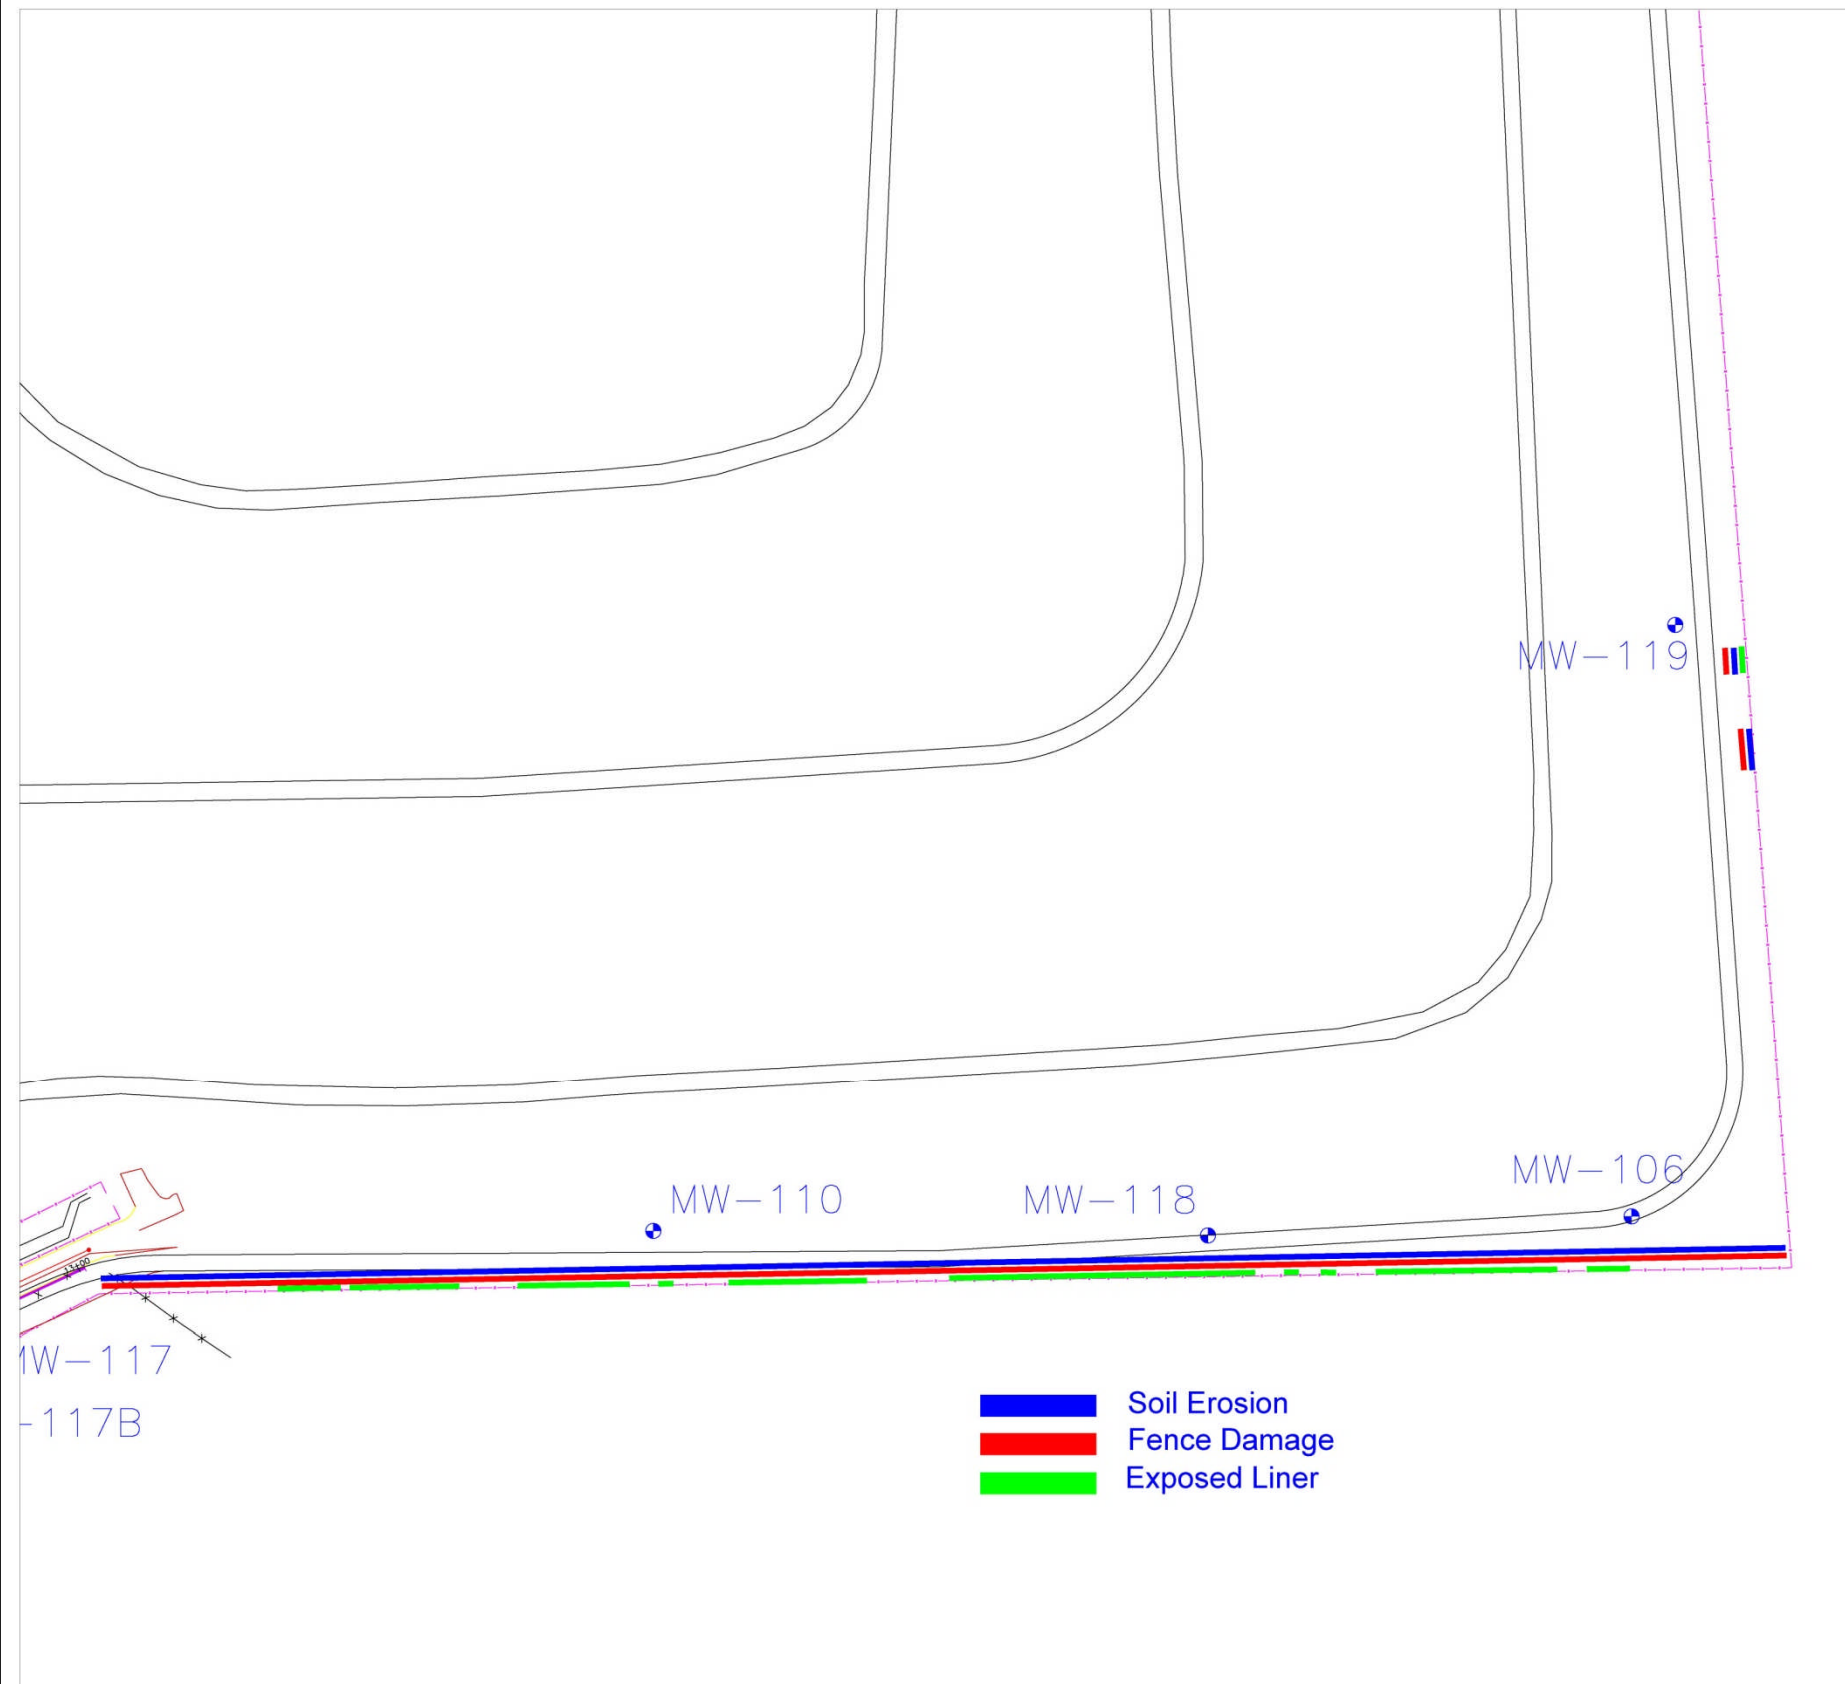
**Figure 1
LOCATIONS OF
PERIMETER FENCING
AND LANDFILL COVER
SYSTEM DAMAGE**

Based on the information provided by Stratis, it appears that approximately 1,700 linear feet of seawall has been impacted. Damage includes the loss of rip rap and erosion of the landfill cover (soil) behind the seawall. In addition, erosion in many areas along the seawall has also exposed the chain link fence post foundations and portions of the landfill's liner system. Storm-related impacts were observed along the landfill eastern and southern boundaries that border Eastchester Bay (Figure 1).

For the eastern portion of the Site, approximately 600 linear feet of seawall, fencing and landfill cover system has been impacted. Repairs needed for the eastern portion of the Site include replacement of seawall riprap, removal and replacement of chain link fencing, and placement of fill/topsoil (landfill cover material) in eroded areas behind the seawall.

For the southern portion of the Site, it appears that the majority of the seawall, fencing and landfill cover system has been impacted and is in need of repair. The estimated length of damage is approximately 1,100 feet. Again, repairs would include replacement of seawall riprap, removal and replacement of chain link fencing, and placement of fill/topsoil in eroded areas behind the seawall.

Of particular importance for the landfill is that erosive storm surge forces appear to have exposed the landfill's liner system. As observed in the field, the black HDPE geomembrane is visible along with the overlying gray-colored geocomposite and underlying geotextile. It is estimated that approximately 800 feet of landfill liner is exposed behind the south seawall. The liner is also visible in a several locations along the eastern wall; the total footage however is not known at this time.

The approximate locations of the soil cover erosion and areas where the geocomposite liner is exposed are shown on Figure 1. As shown on Figure 1, soil has been eroded along the entire southern side of the landfill and in limited areas along the eastern side. The geocomposite liner has been exposed in the majority of the areas where soil has been eroded. The precise volume of soil that has been eroded and the precise areas where the geocomposite is exposed is not known at this time, however these volumes and areas will be determined as part of the topographic survey and site inspection discussed in Subsection 2.3 of this Work Plan. If the topographic survey results show that there are more widespread potential slope stability issues (away from the landfill

The scope of work proposed herein includes conduct of a site inspection, topographic surveys, permitting, and landfill cover system restoration. Figure 1 shows the locations where restoration work is required. The various tasks associated with this work are described in Subsections 2.1 through 2.5 below.
