**1120 WESTCHESTER AVENUE, BRONX, NEW YORK**

**PERIODIC REVIEW REPORT**

**NYSDEC BCP Number: 203083**

DECEMBER 31, 2022 – FEBRUARY 14, 2024

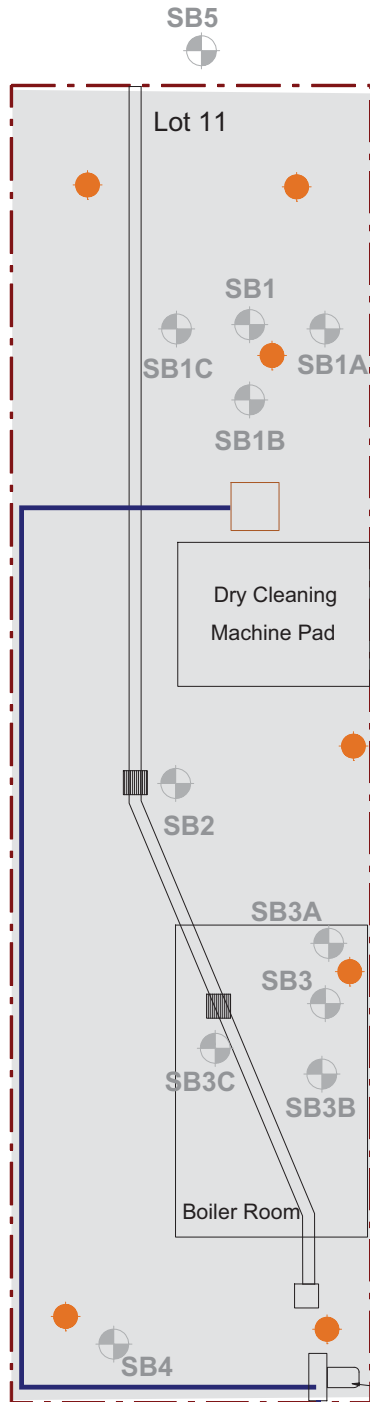
**FIGURE  
2**

2-inch Discharge Line  
to 3' above roofline.

1.0 HP Regenerative  
Blower

TIGG Econosorb or equivalent  
GAC Vapor Phase Carbon Canisters

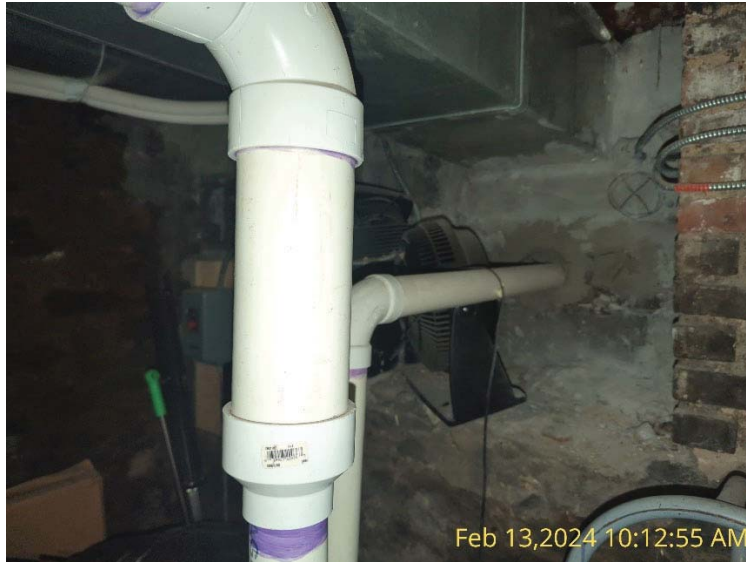
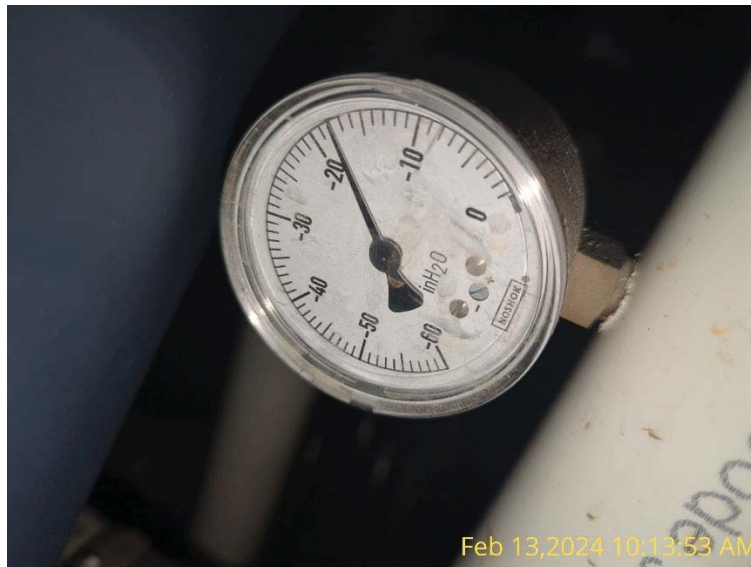
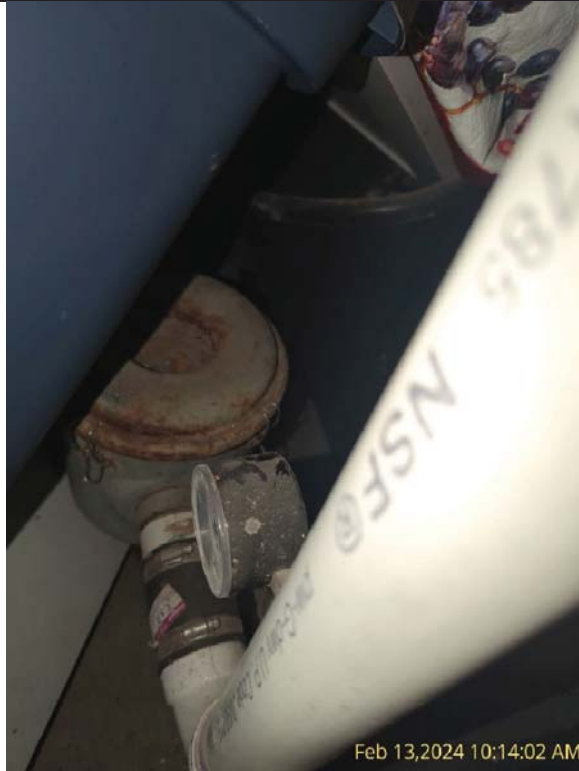
Photo 1 - SVE  
System

PID readings did not indicate presence of VOCs in the air stream
