PROJECT:	Former Fulton MGP – Parcels III and IV (Site No.: 224051)
ADDRESS:	545 Sackett St., Brooklyn, NY
PREPARED BY:	Roux Environmental Engineering and Geology, D.P.C.
DATE:	May 2nd, 2023
WEATHER:	Temp: 50 – 56°F Overcast, RH: 48% Pressure: 29.40" Hg Wind: W @ 14 mph
TIME:	07:00 – 15:30

Remedial Action Work Summary

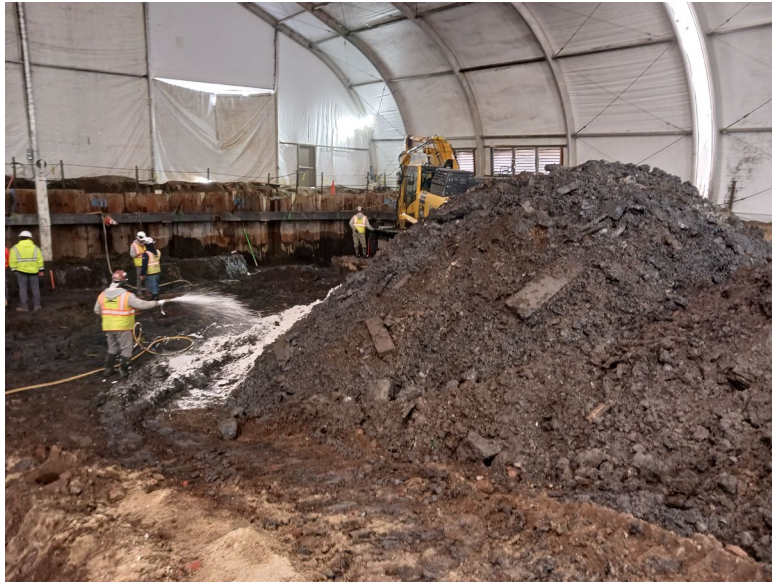
Photo 1:

Excavation, stockpiled of soil material from waste characterization grids WC-11. CEI applying odor suppression foam inside the TFS.

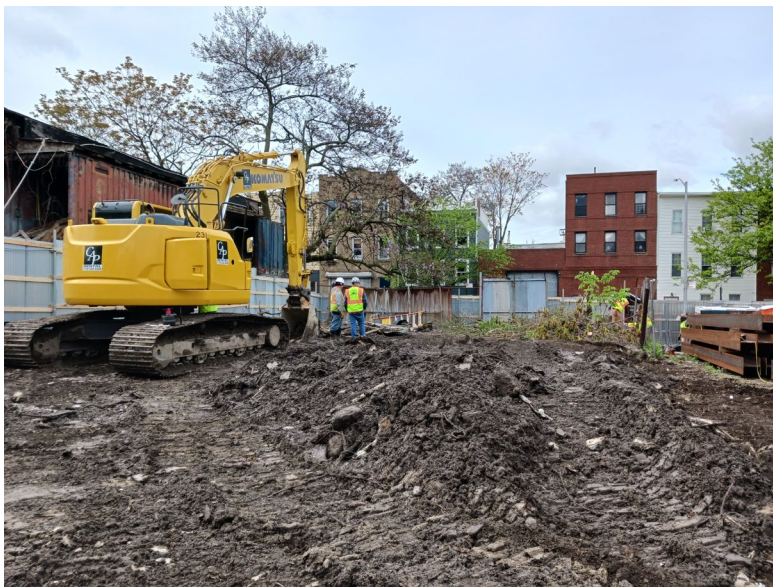
Photo 2:

CEI soil grading in the neighboring property east of lot 49.
