PROJECT:	Former Fulton MGP – Parcels III and IV (Site No.: 224051)
ADDRESS:	545 Sackett St., Brooklyn, NY
PREPARED BY:	Roux Environmental Engineering and Geology, D.P.C.
DATE:	February 14, 2024
WEATHER:	Temp: 31-39°F, Sunny, RH: 53% Pressure: 30.19" in Hg Wind: NW @ 9 mph
TIME:	07:00 – 15:30

DAILY STATUS REPORT

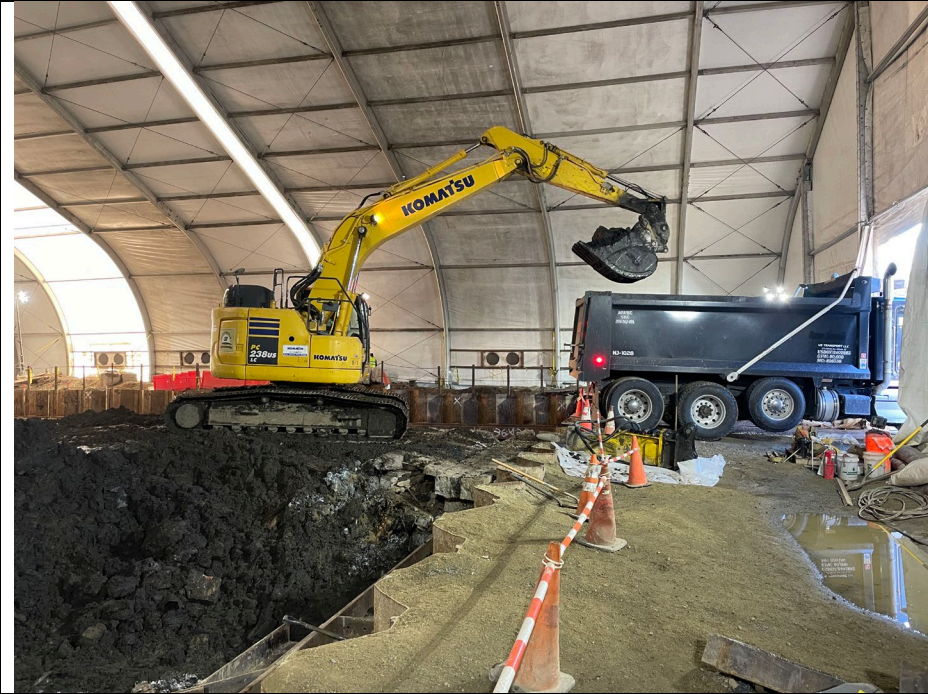
**Photo 1:**

Looking east, view of CEI loading a truck with material from WC-GHW(0-5) for offsite transport and disposal.

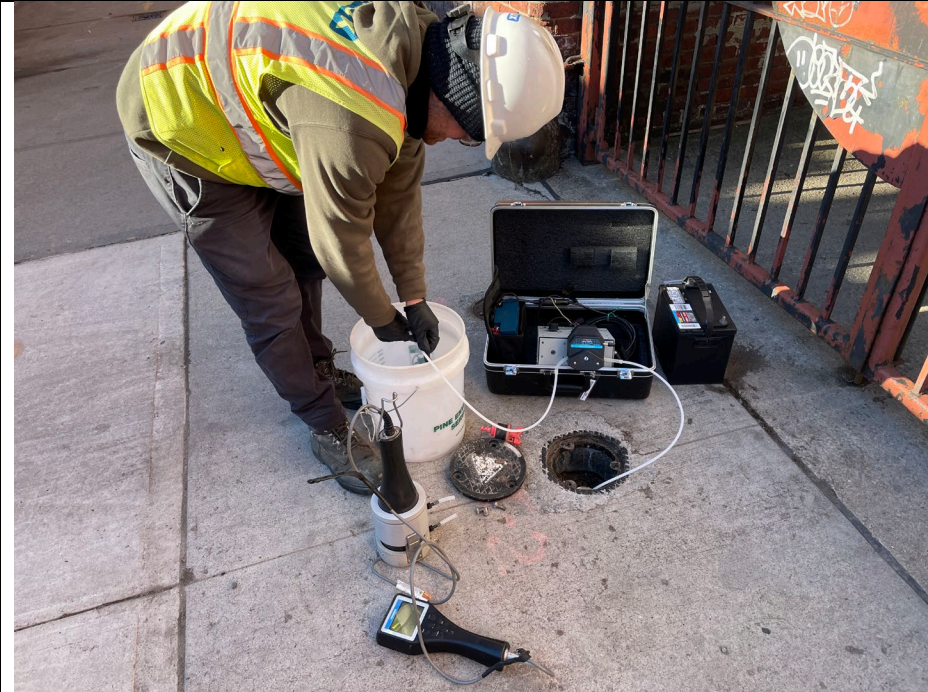
**Photo 2:**

Looking southwest, view of Roux collecting groundwater samples from SW-06S.
