**NYS Department of Environmental Conservation**  
**Division of Environmental Remediation**  
**Remedial Bureau C**

**Site No.:** 224063

**Site Name:** 218 Front Street (K. Front St. Station)

**Phase:** Soil Vapor Intrusion Evaluation

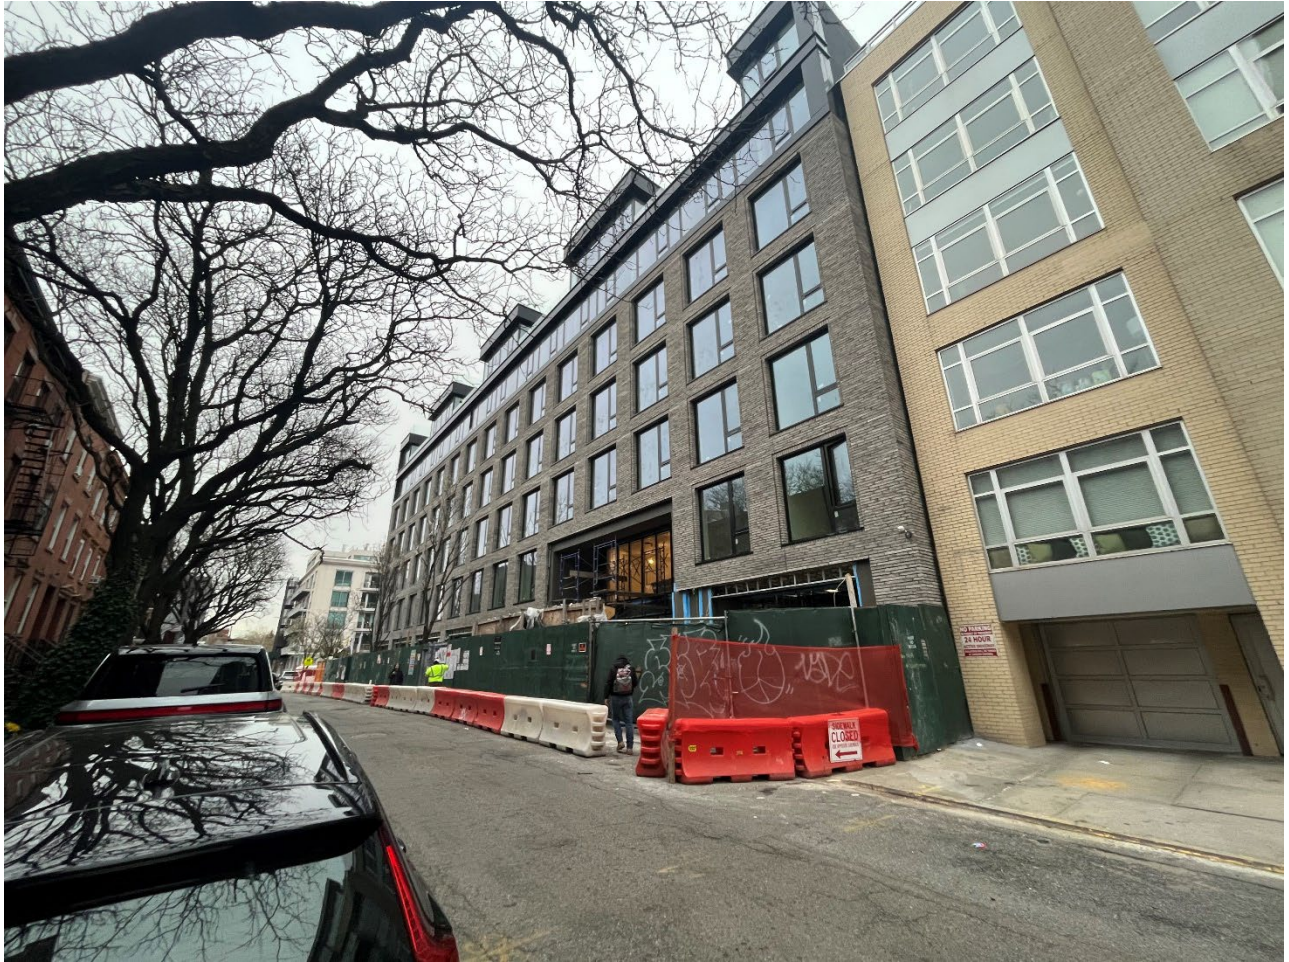
View of the building from Front Street, facing east.

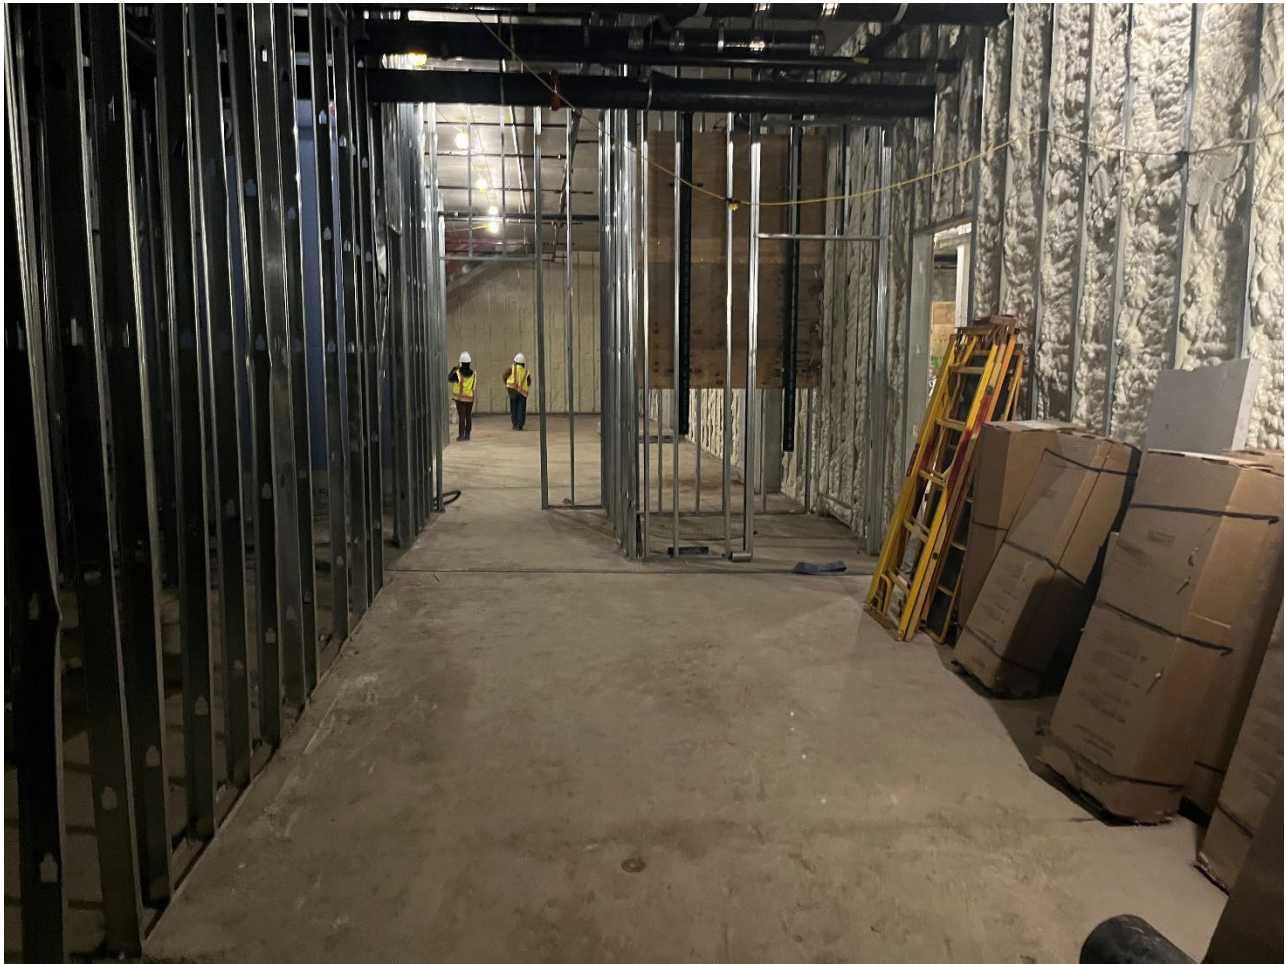
Inside the Corridor connecting the Retail Storage Room and Main Electric Room, which was the proposed location for samples IA-2 and SS-2. Facing west towards the Retail Storage Room.

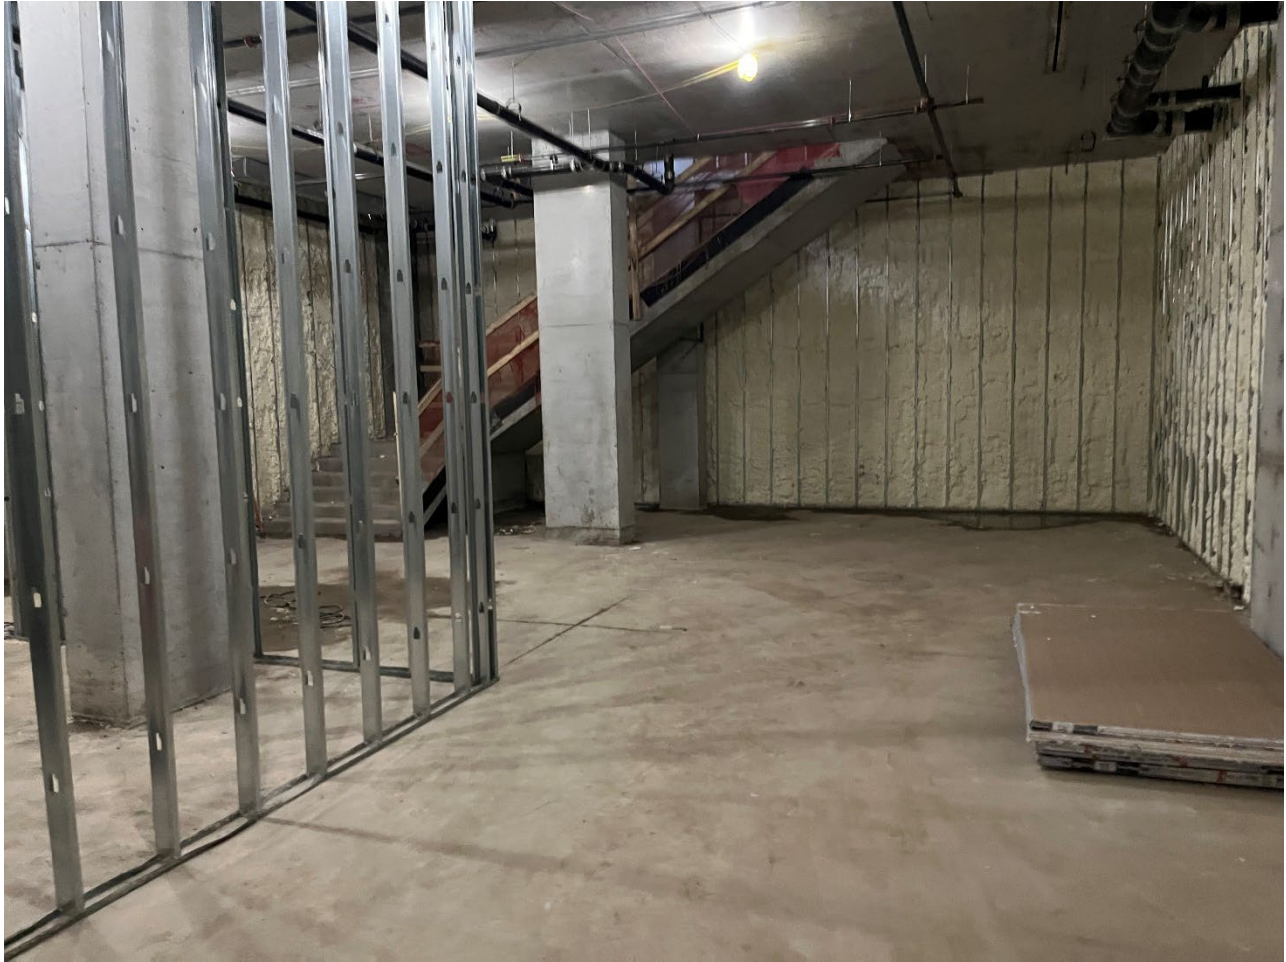
Inside the Retail Storage Room, which was the proposed location to relocate IA-2 and SS-2. Facing west.

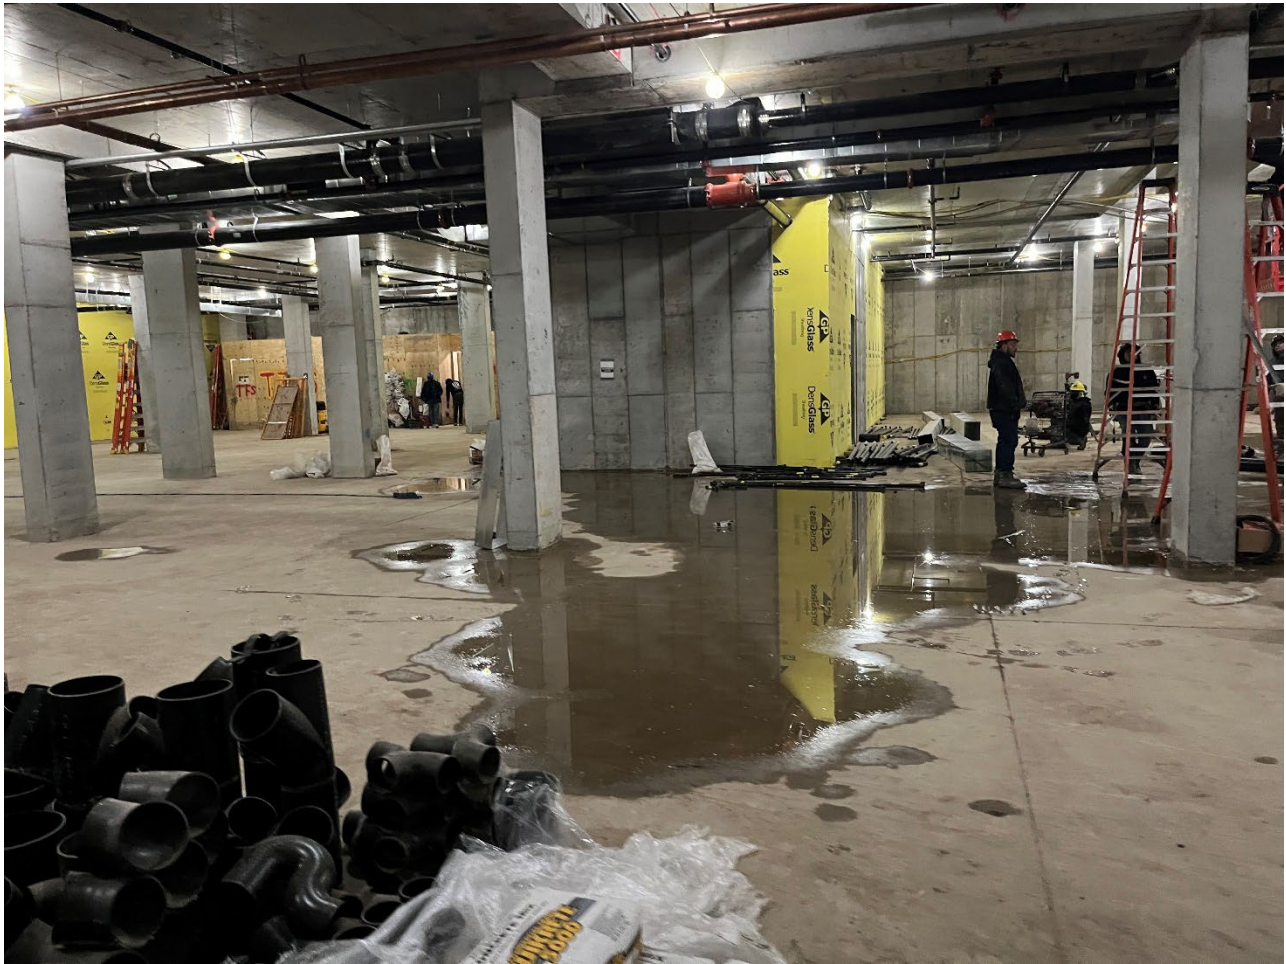
Inside the Parking Garage, central area, facing west.

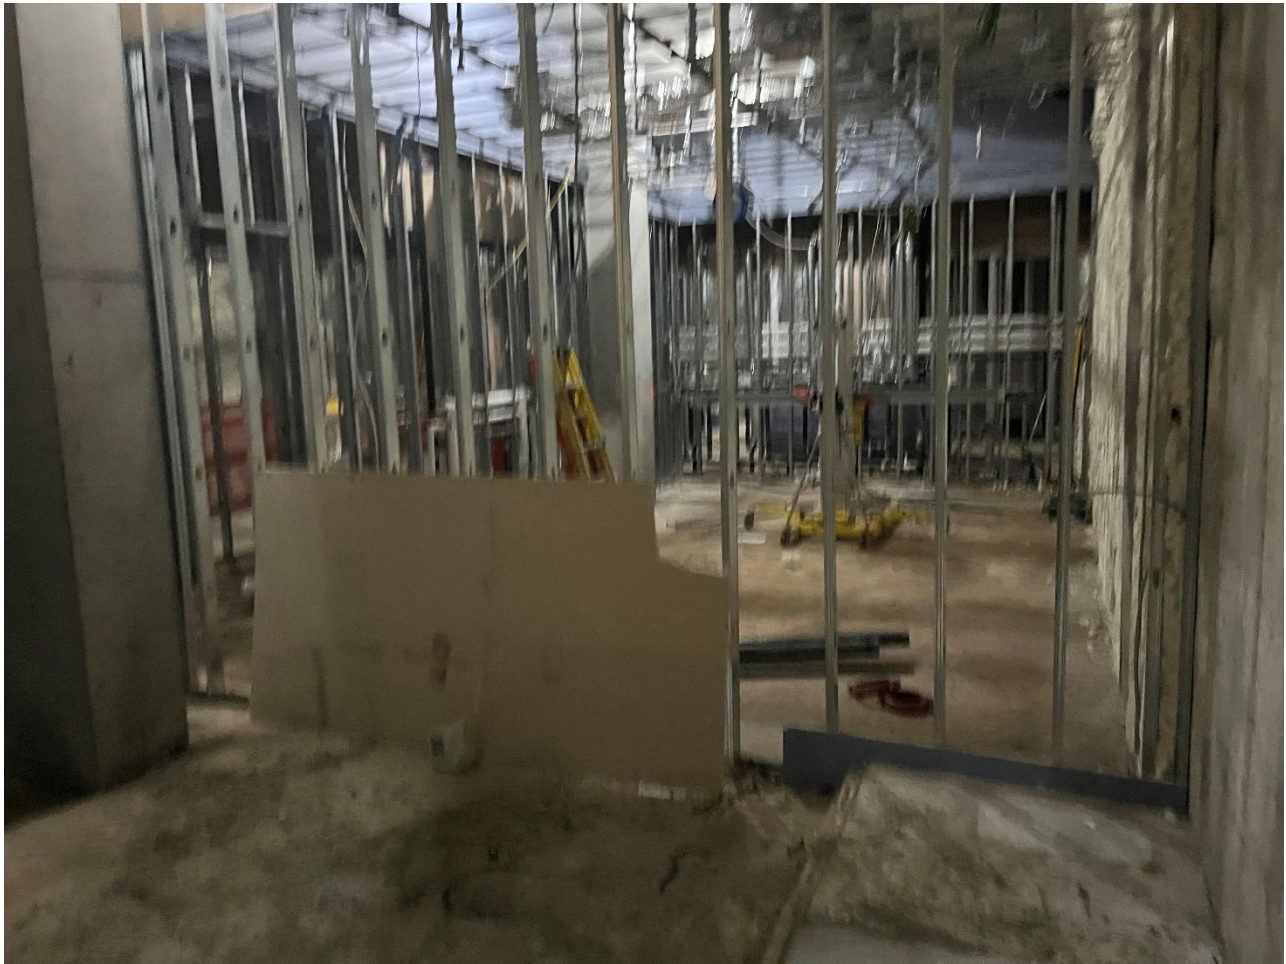
View of the DIY Art Room from the Electrical Room, which is the proposed location of sample IA-4. Facing west.

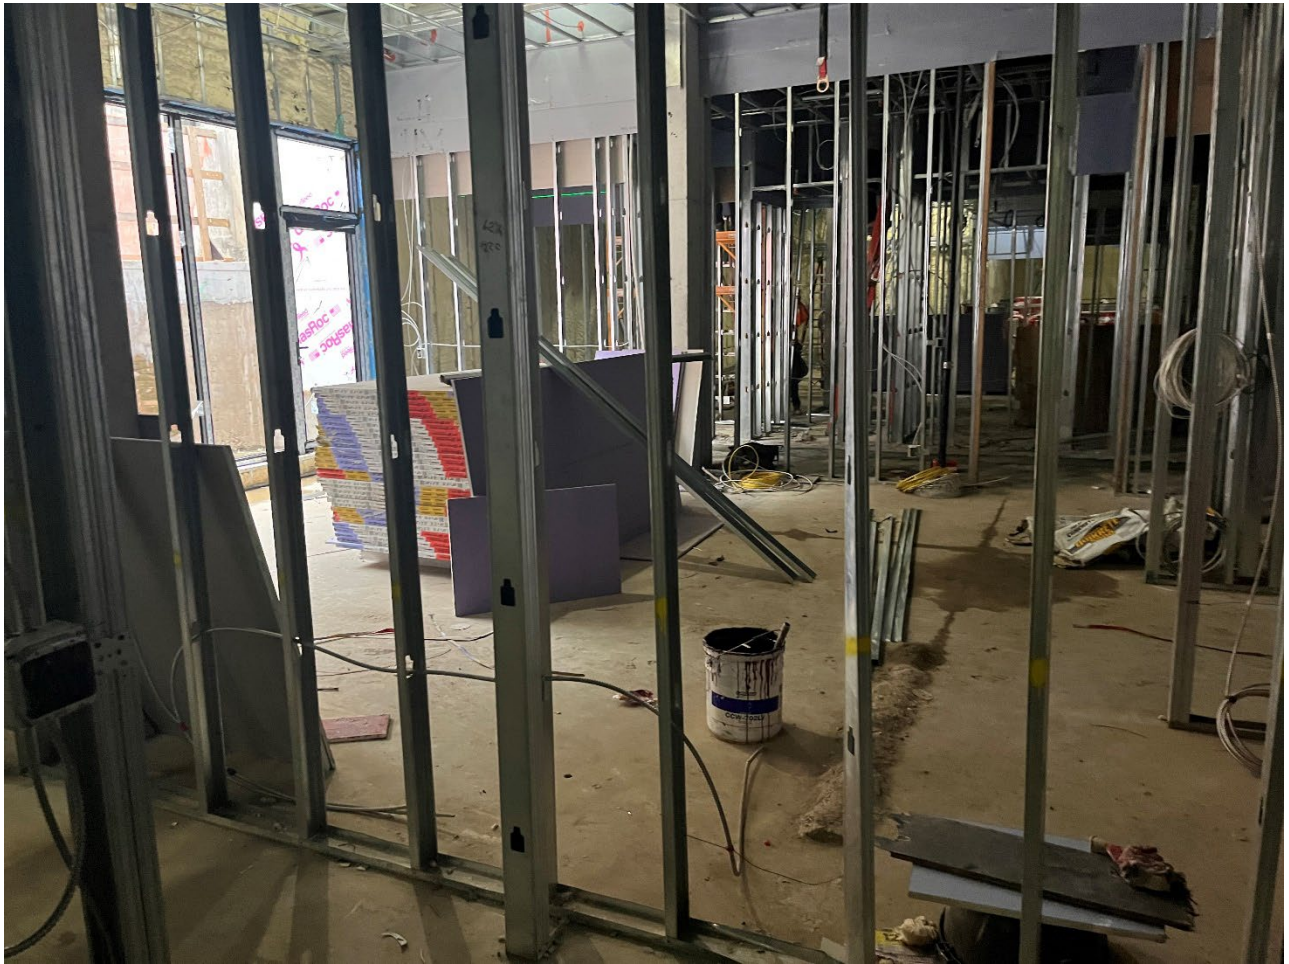
View of the Sauna Spa Room, which is the proposed location of sample IA-3.  
Facing south.

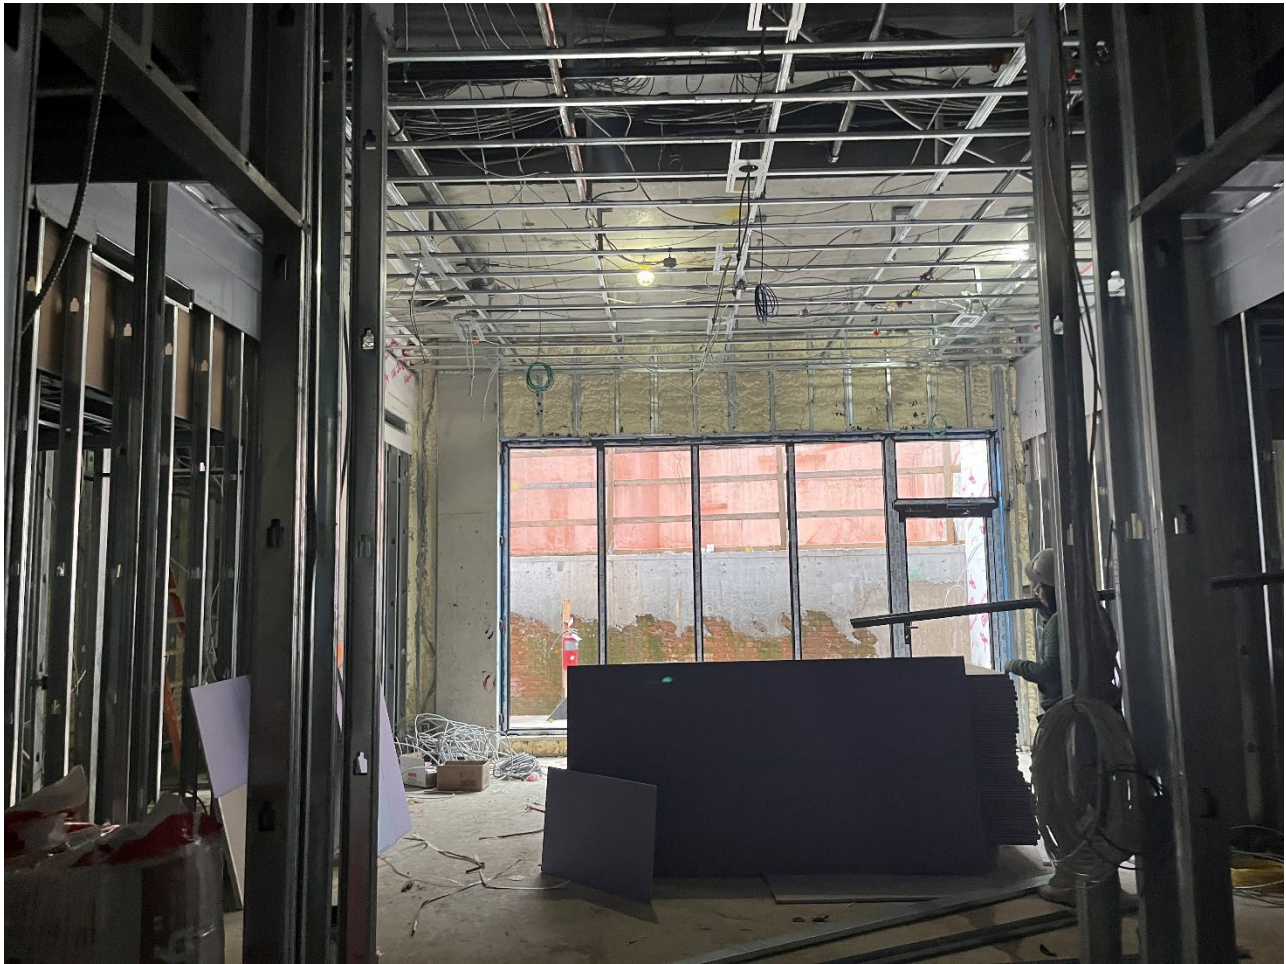
- Windows and a doorway in the eastern wall of the Sauna Spa room were not yet installed in their frames, leaving an open window to outdoor air that would directly interfere with indoor air samples IA-1 and IA-3. All windows and doors should be closed during collection of indoor air samples;

The open door and window frame on the eastern wall of the Sauna/Spa Room, facing east.

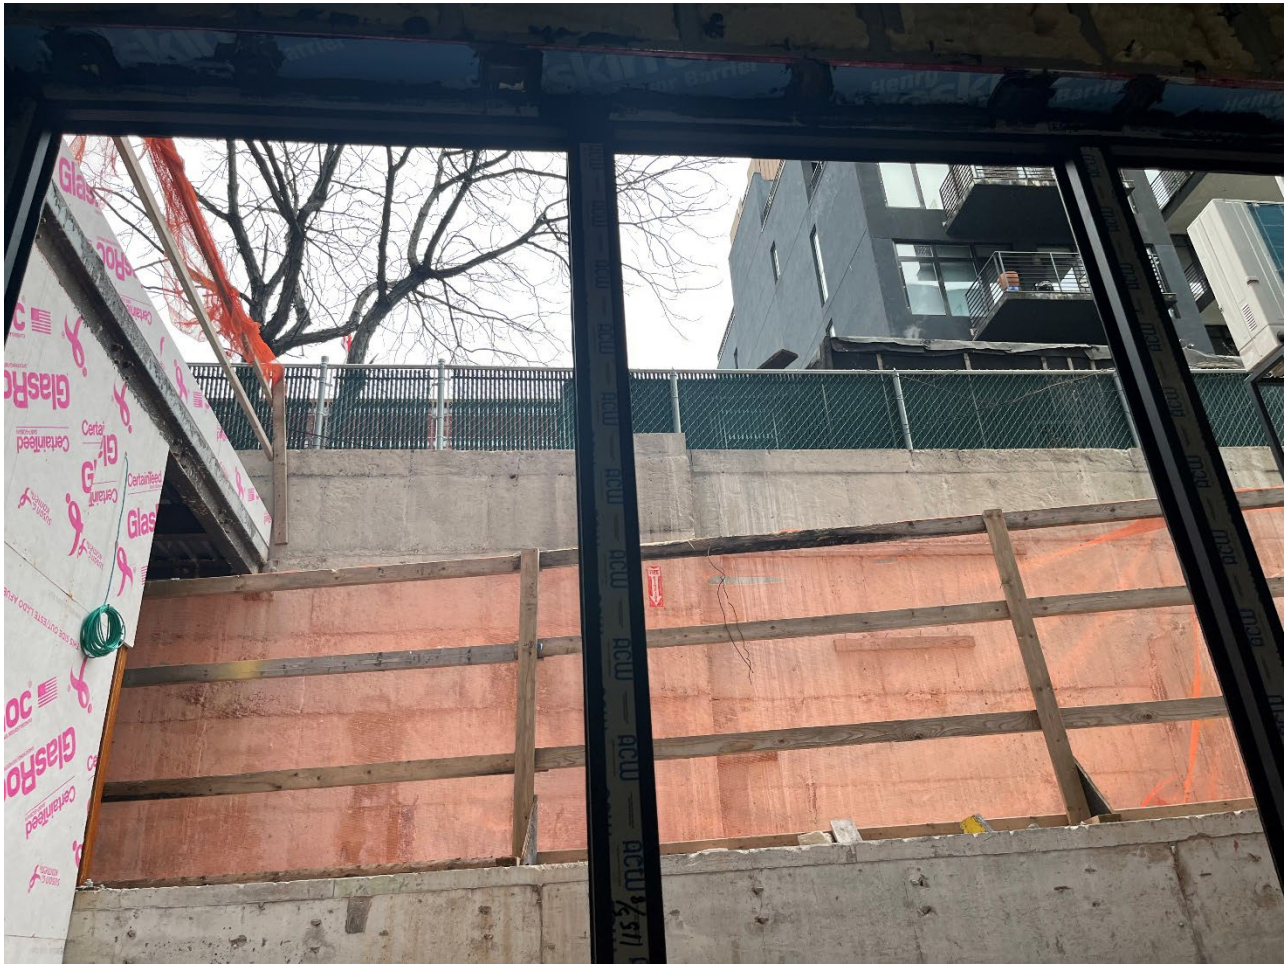
Looking outside the open window frame from on the eastern wall of the Sauna/Spa Room.

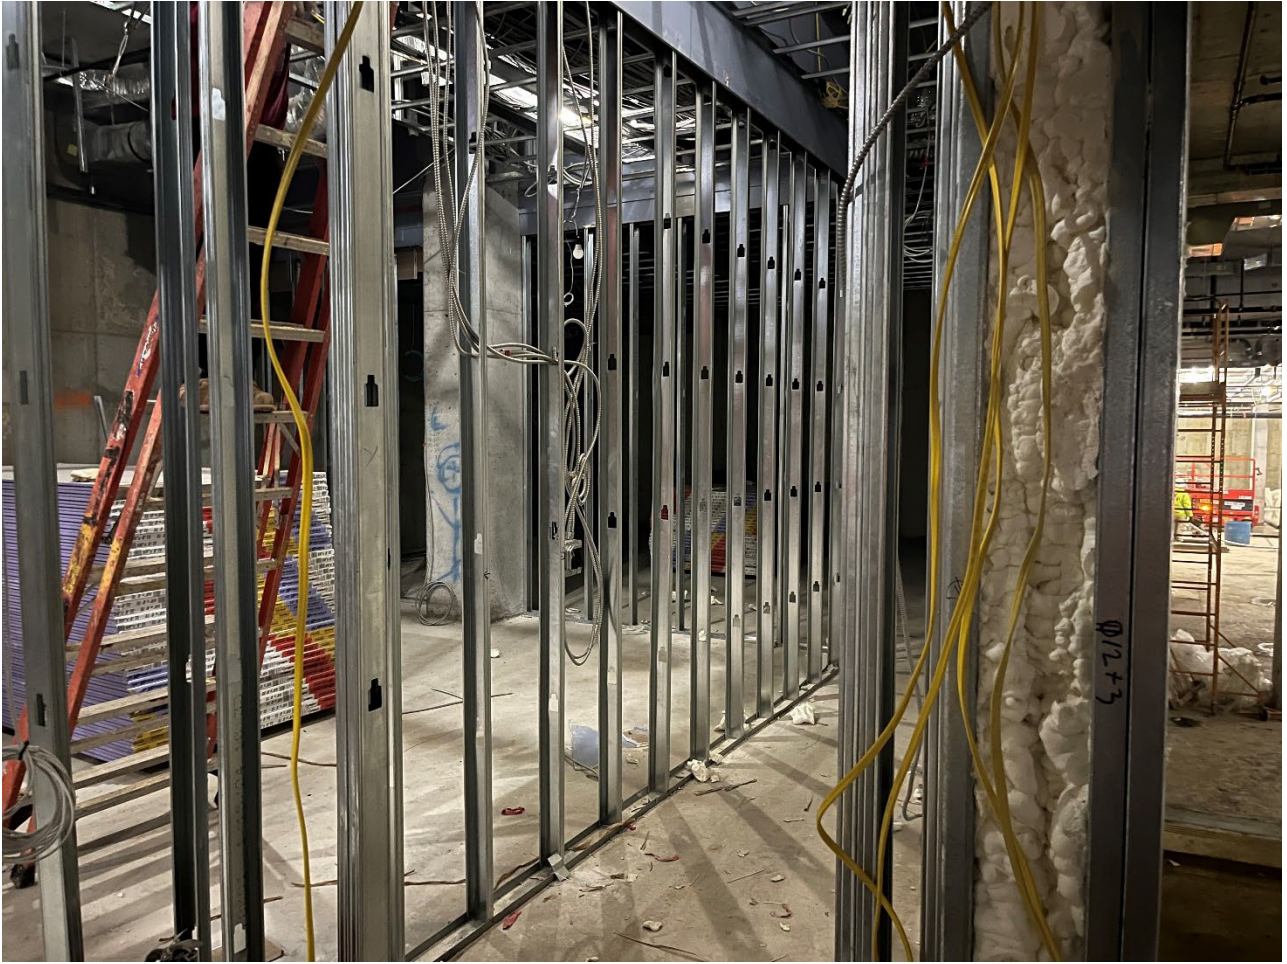
View of the Golf Sim Room and Screening Room from the corner of the hallway near the doorway to the Parking Garage, facing west.

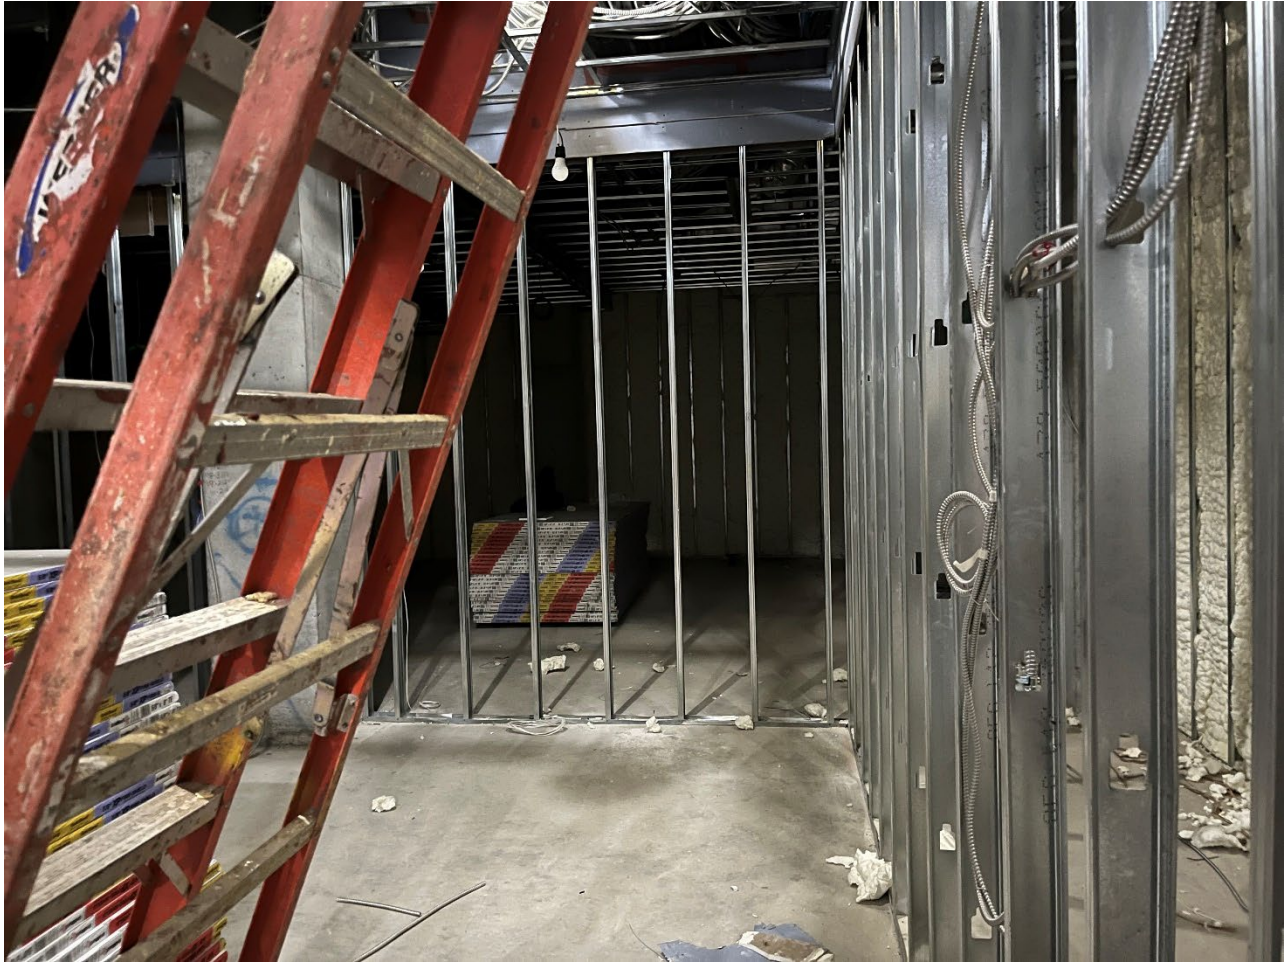
View of the Screening Room, which is the proposed location for samples IA-1 and SS-1, from the Golf Sim Room, facing west.

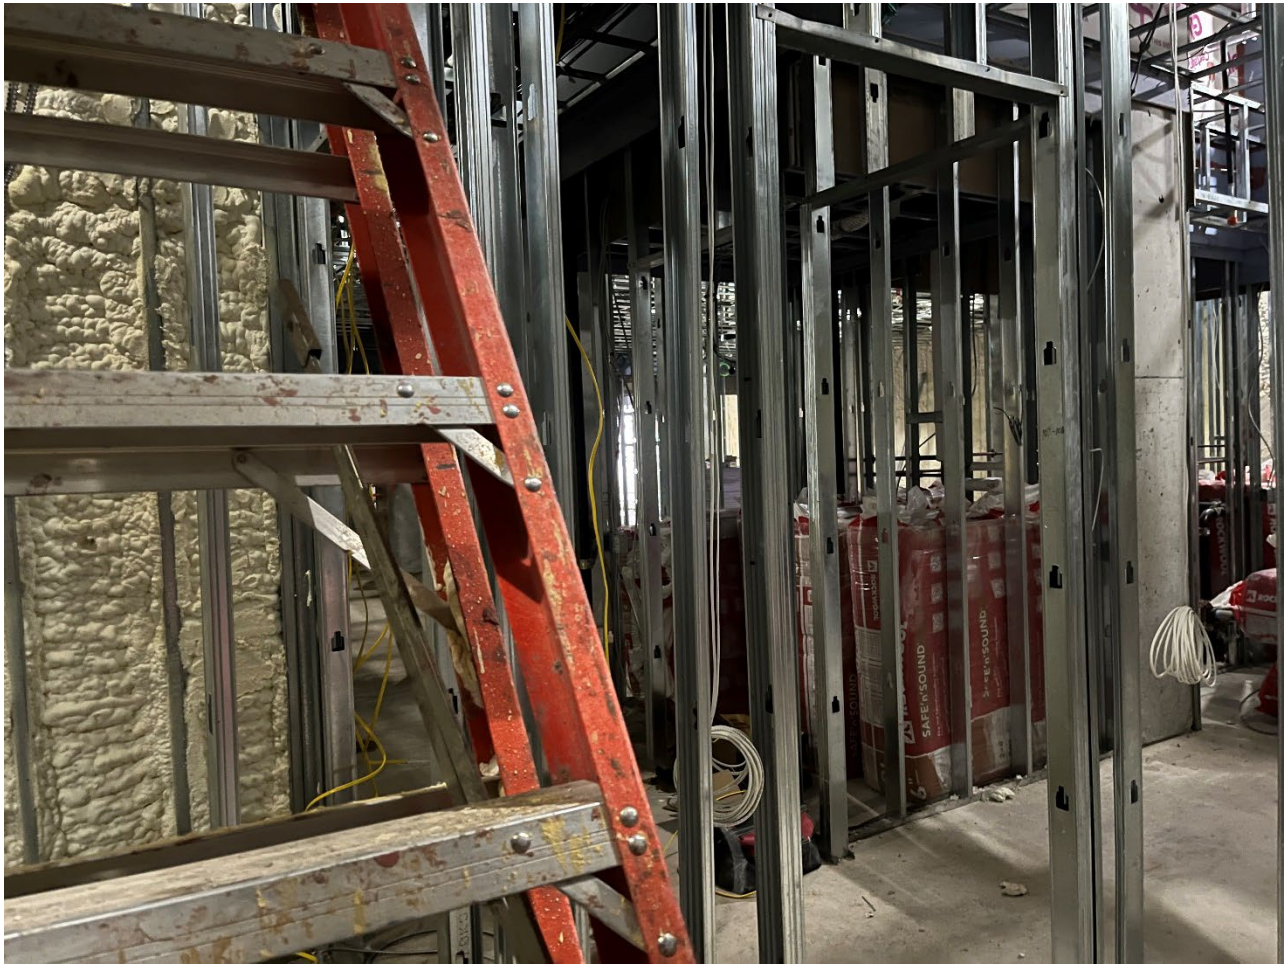
View from the Golf Sim Room, facing northeast toward the Sauna Room. The bright light in the center of this photograph is the open window frame in the Sauna Room. The orange ladder is the same one shown in the previous photograph.
