18 June 2024

**Re: Annual Maintenance and Monitoring Report – 2022 and 2023
Former Acme Steel/Metal Works
95 Lombardy Street/46 Anthony Street
Brooklyn, New York
NYSDEC Site No. 224131
Langan Project No.: 170157201**

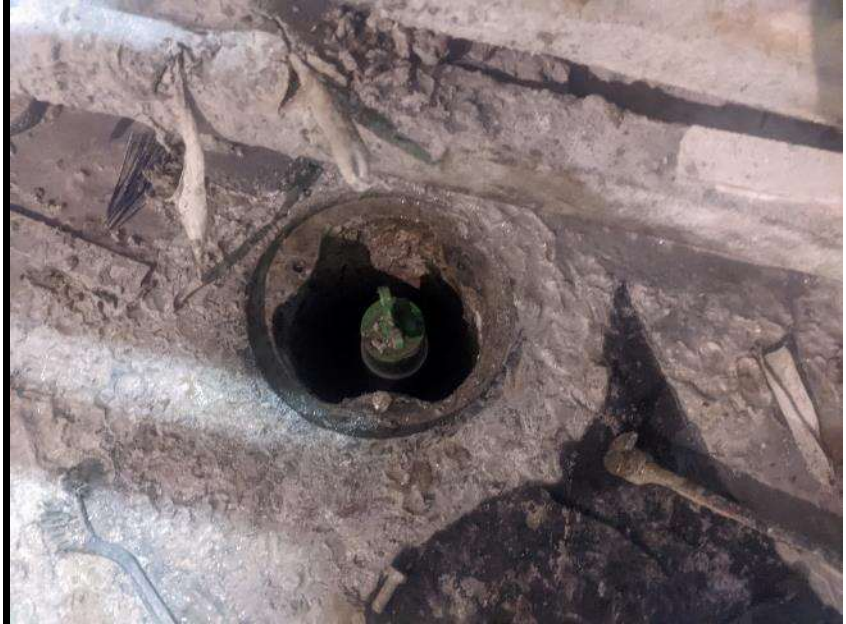
General view of monitoring well ACME-MW-4D at 60 Anthony after AWT performed maintenance/ housekeeping.

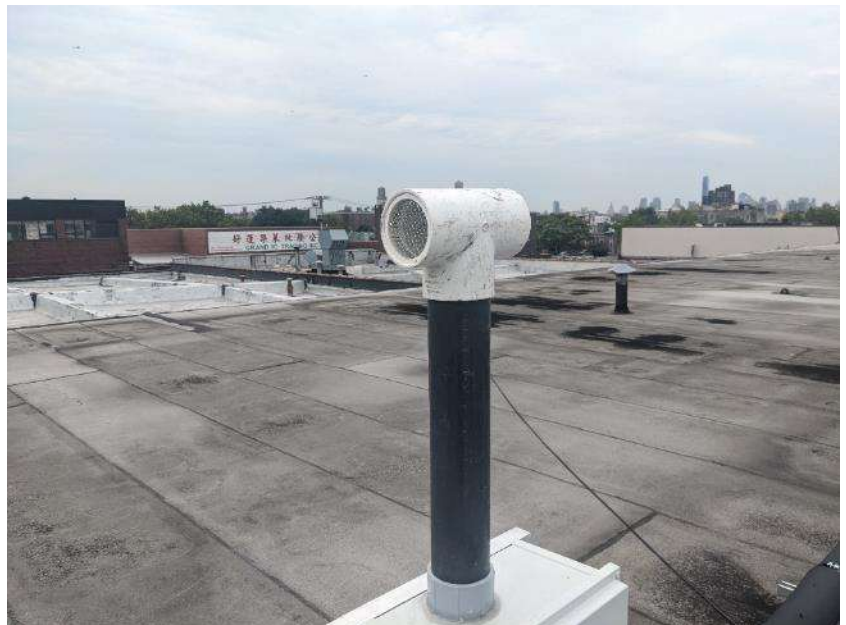
Photo 2:

General view of vent cap installed on blower at 60 Anthony Street (facing south).

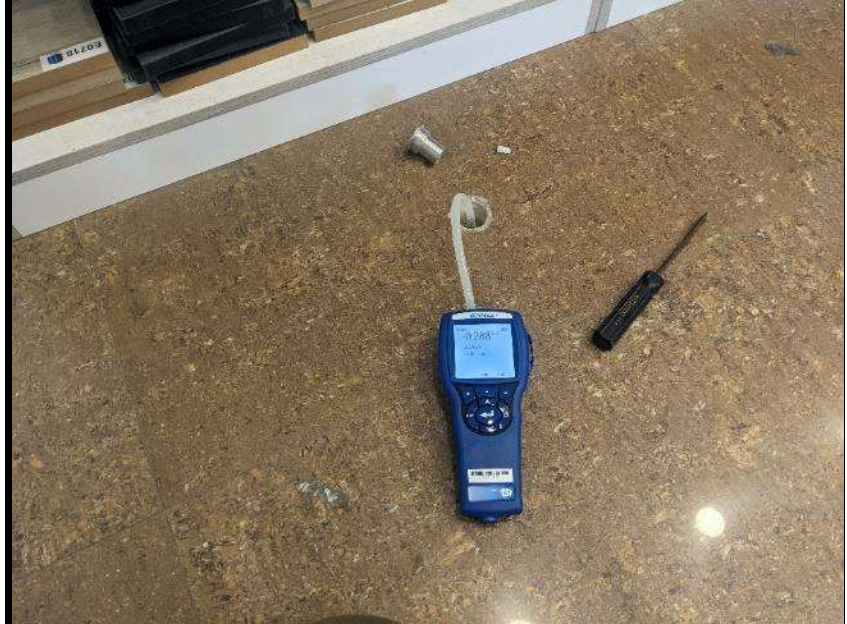
General view of pressure differential reading at ACME-SSV-02 at 95 Lombardy Street (facing east).

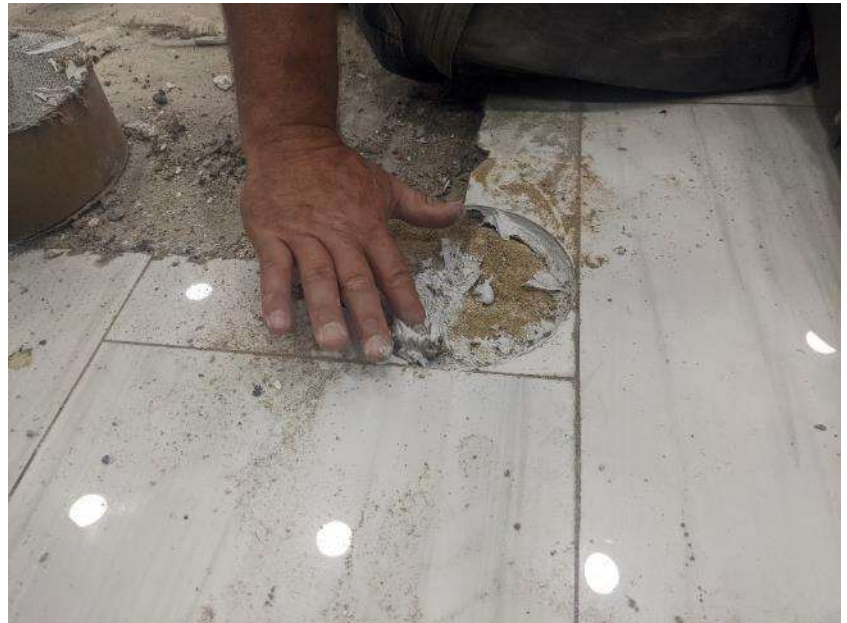
Photo 4:

General view of AWT using caulk to seal the joints near SSD pit ACME-DP-01 at 95 Lombardy (facing north).

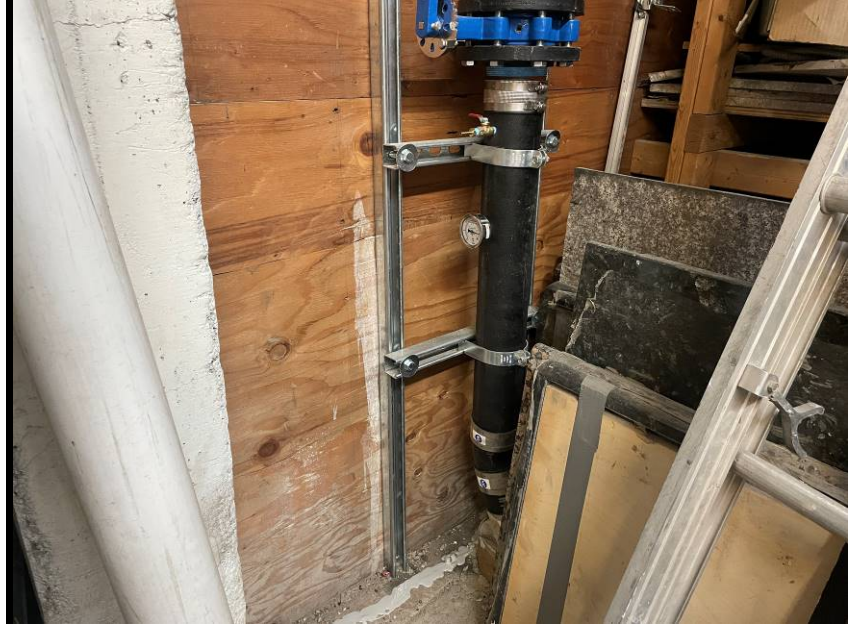
General view of riser pipe at ACME-DP-05 (facing north).

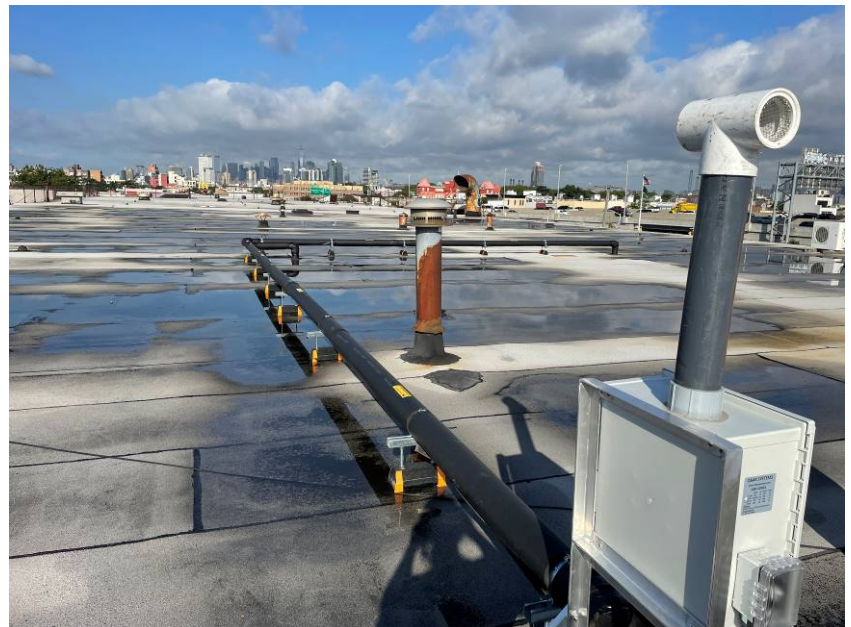
Photo 2:

General view of SSD system components on the roof at 60 Anthony Street (facing west).

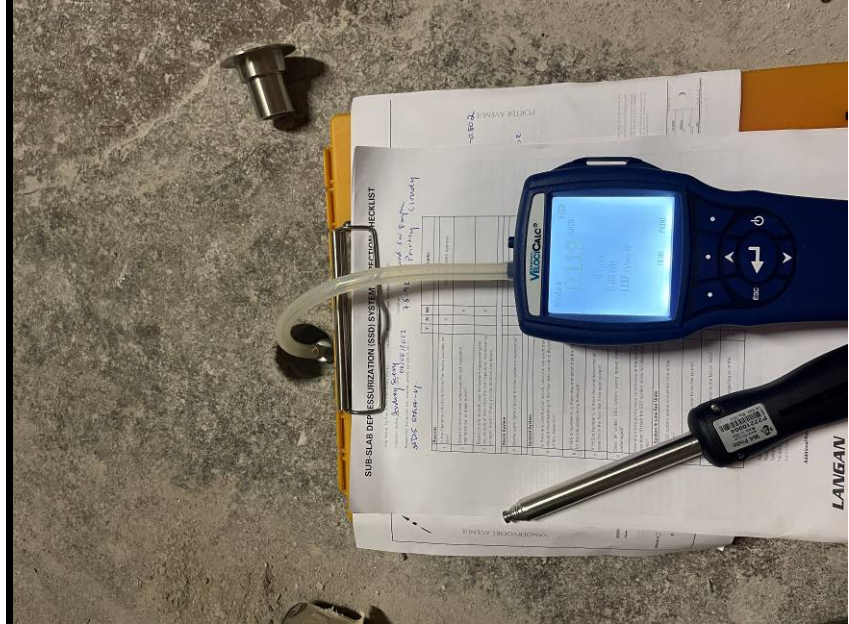
General view of vacuum reading at ACME-SSV-06.

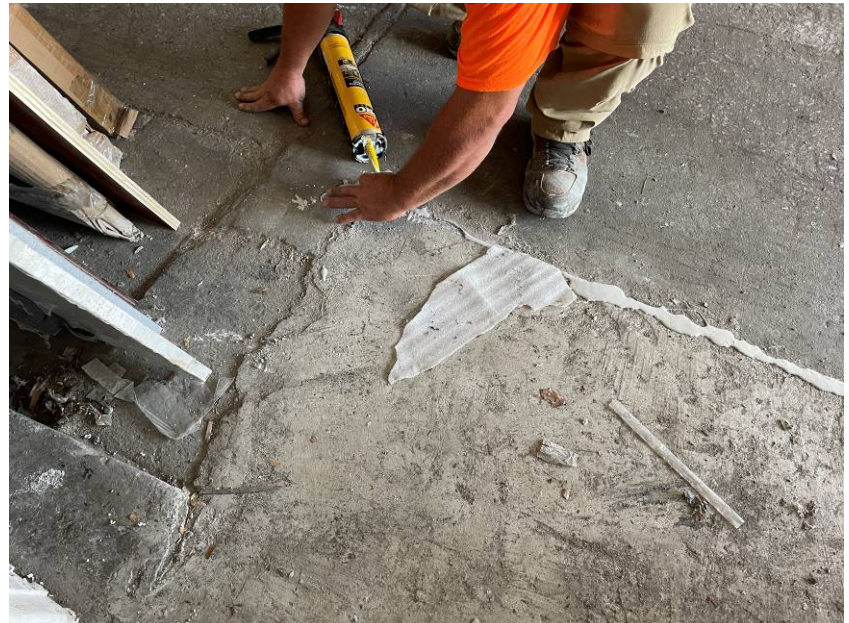
Photo 4:

General view of AWT using caulk to seal concrete joints near SSD pit ACME-DP-04.

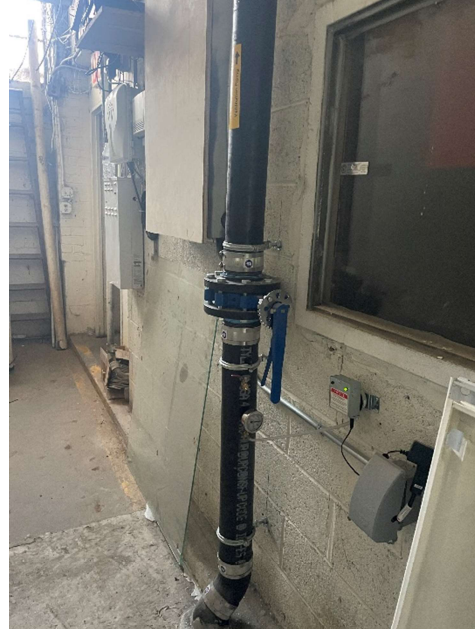
View of the ACME-DP-06 depressurization pit riser and SSD system alarm at 60 Anthony Street (facing north).

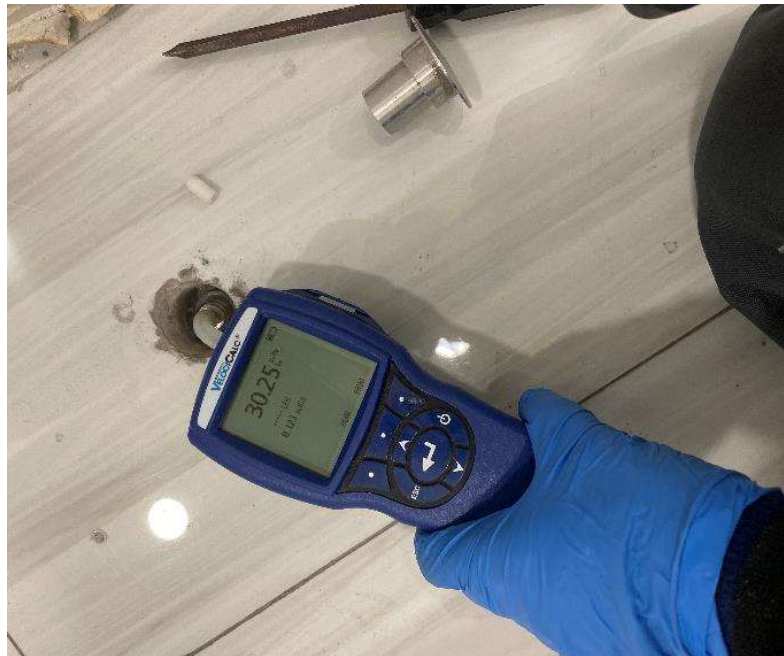
Photo 2:

View of pressure differential reading at ACME-SSV-03R at 95 Lombardy Street.

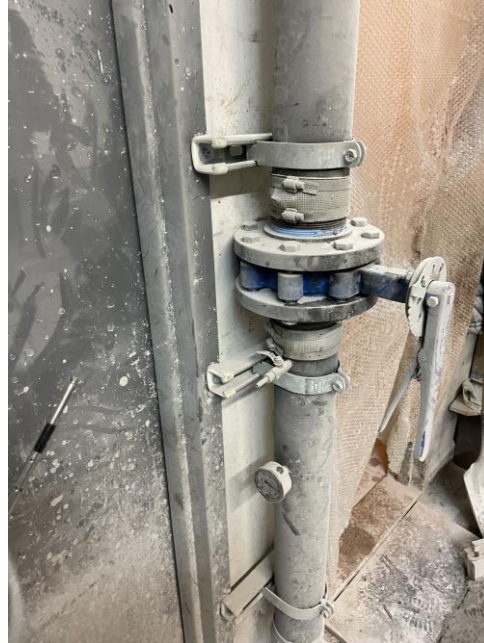
View of the ACME-DP-07 depressurization pit riser at 60 Anthony Street (facing northeast).

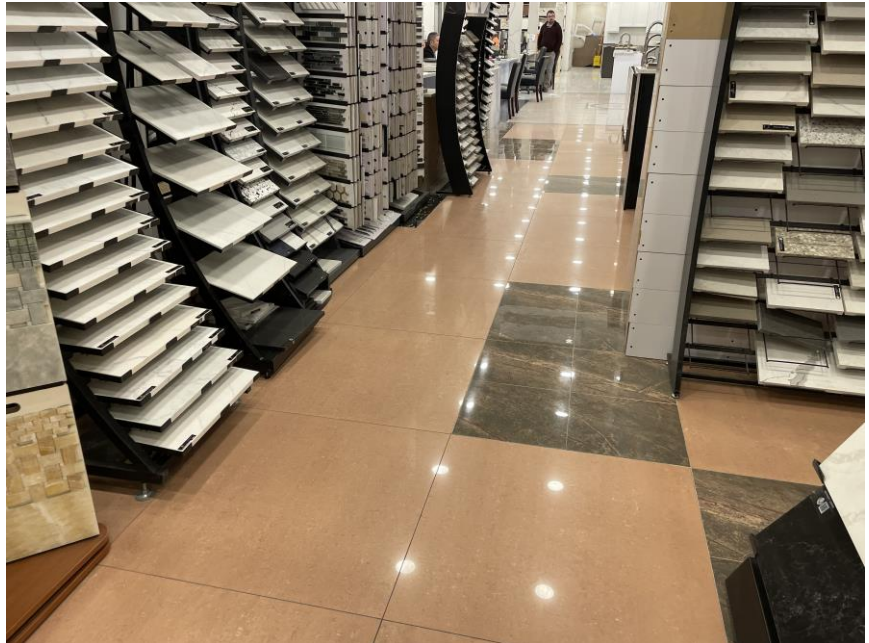
Photo 2:

View of site cover at 95 Lombardy Street (facing south)

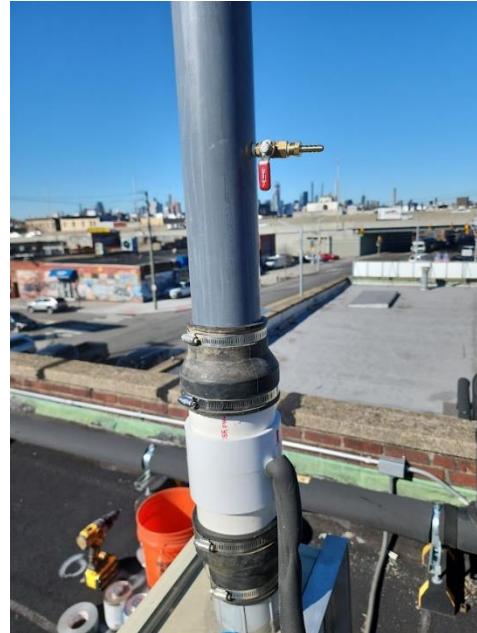
View of the sample port on the SSD discharge stack at 95 Lombardy Street (facing northwest).

No design alterations or modifications to the SSD systems are proposed except for the installation of a sample port on the blower discharge stack at 95 Lombardy Street, which was completed on 5 February 2024 per NYSDEC's request.

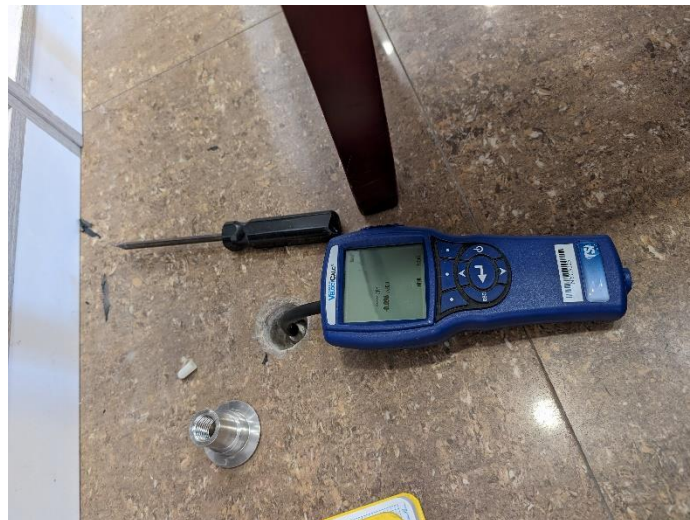
Photo 2:

View of pressure differential reading collection at SSV-02R at 95 Lombardy Street.

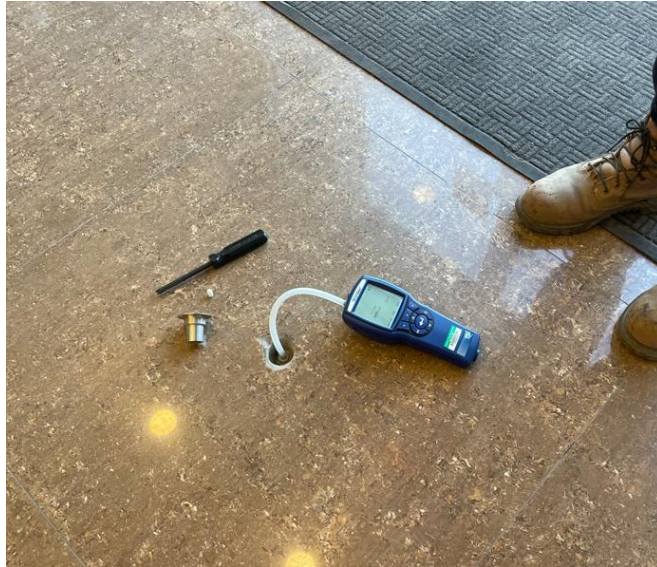
View of pressure differential reading collection at SSV-01R at 95 Lombardy Street.

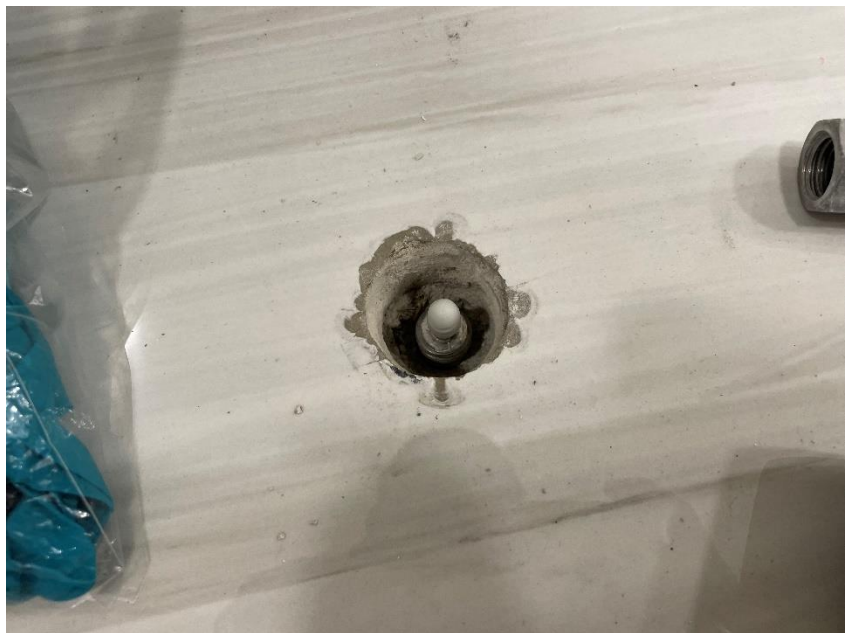
Photo 2:

View of the VMP SSV-03R after the sleeve was reinstalled at 95 Lombardy Street.

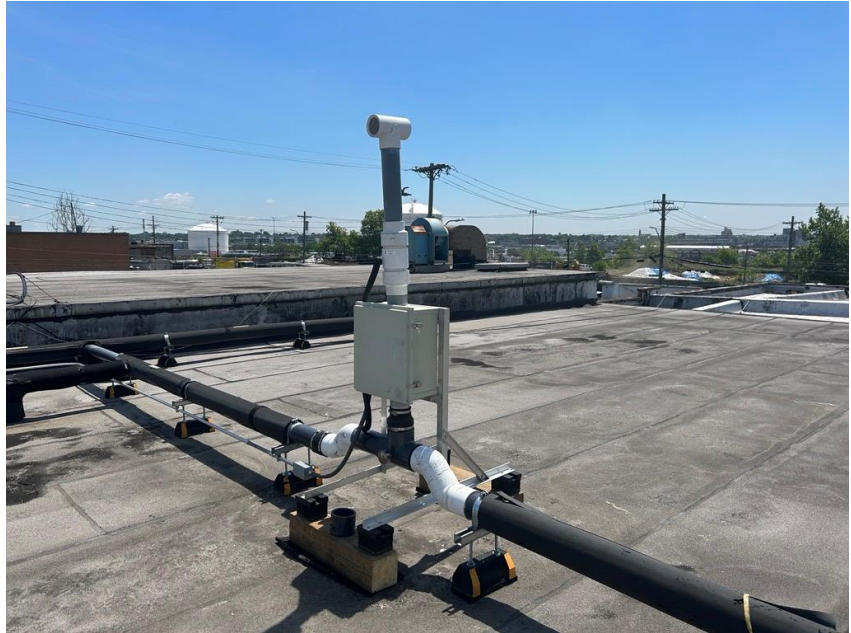
View of the 60 Anthony Street SSD system blower and roof-mounted SSD system piping (facing southeast).

Maintenance for the 60 Anthony Street SSD system was performed on 17 May 2024. AWT repaired the SSD system blower, adjusted the pitch of roof-mounted SSD system piping, and replaced damaged piping insulation. On 20 May 2024, Langan increased the operating speed of the blower and sealed the surficial cracks surrounding vacuum monitoring point SSV-05 with concrete patch as a precautionary measure. Langan then collected confirmatory vacuum readings, as presented in the table below:

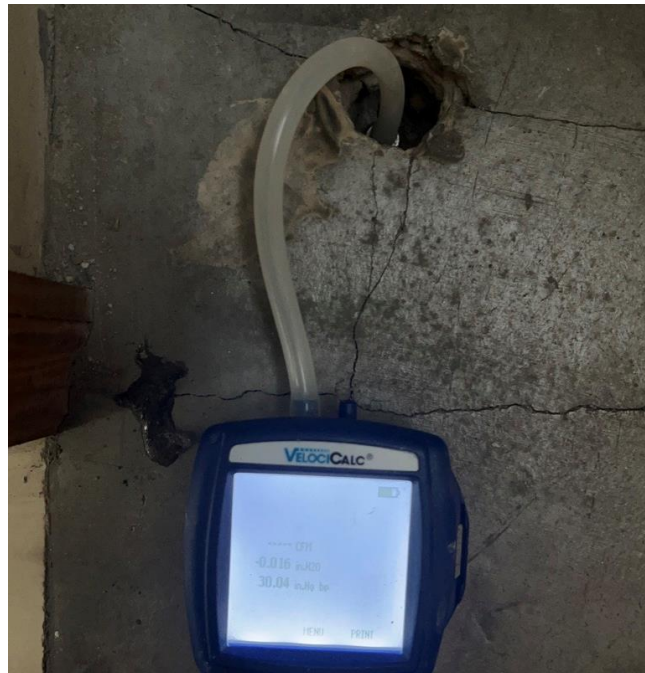
Photo 2:

View of Langan collecting a confirmatory differential pressure reading at vapor monitoring point ACME-SSV-05 at 60 Anthony Street (facing west).

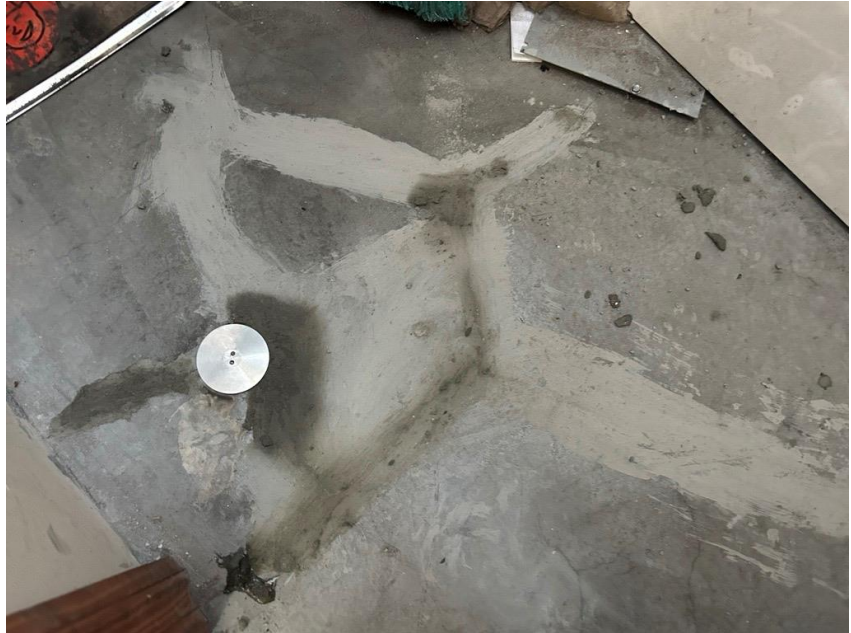
View of the final condition of the slab surrounding vapor monitoring point ACME-SSV-05 at 60 Anthony Street (facing northwest).
