November 4, 2024
REVISED: November 11, 2024

**Re: Interim Site Management Plan - Periodic Review Report
688 Court Street
Brooklyn, New York
NYSDEC Site No. 224145
Langan Project No. 170662501**

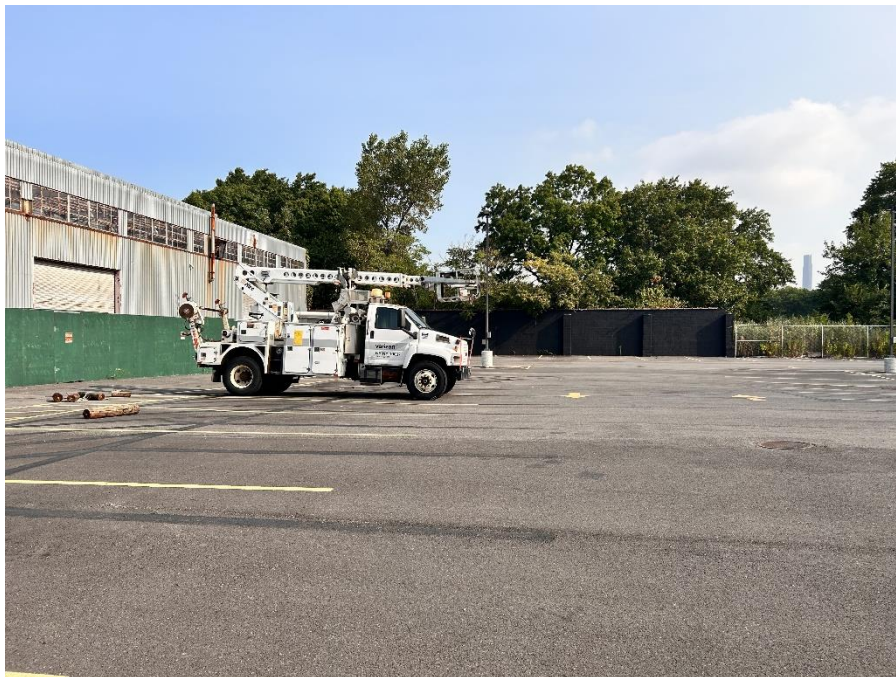
Photo 4: Northwestern part of site adjacent to 725 Clinton Street (facing northwest). Note remaining vehicle from previous tenant

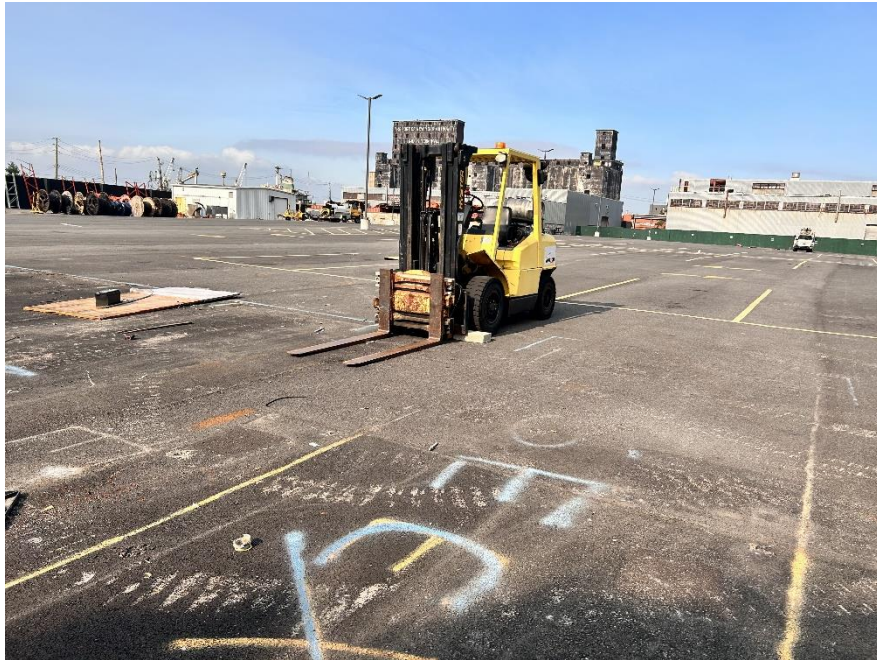
Photo 5: Remaining equipment from previous tenant in the eastern part of the site (facing southwest).

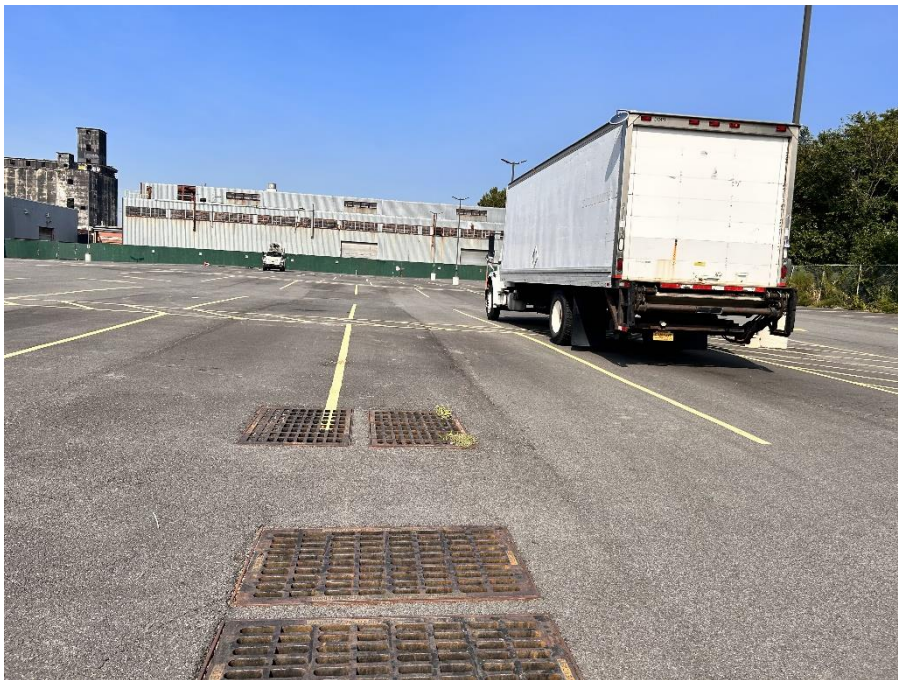
Photo 6: Storm drains and remaining vehicle from previous tenant vehicle in the central part of the site (facing west).

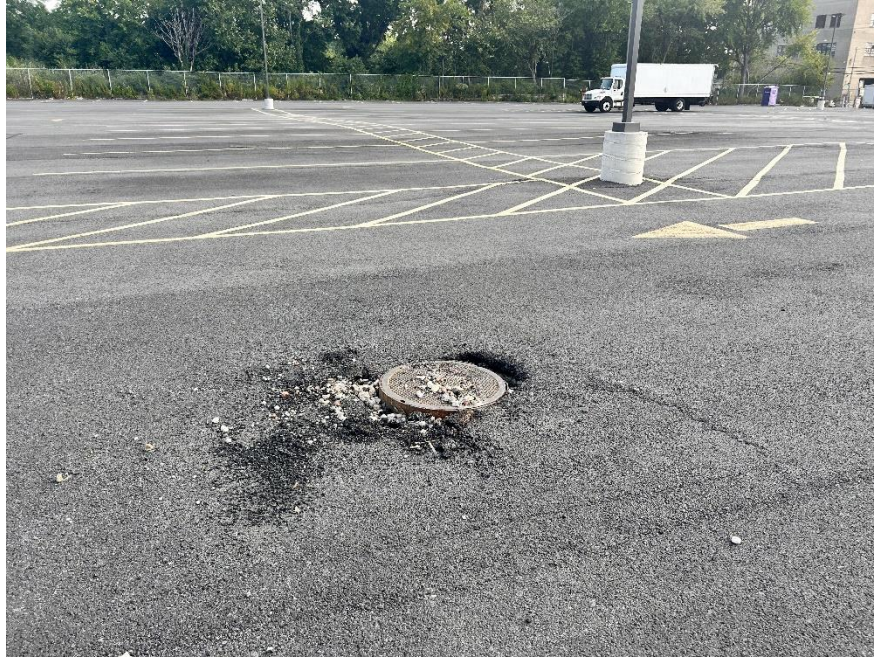
Injection, extraction, and monitoring wells covered by manhole covers were observed throughout the site. Asphalt surrounding one manhole cover (EW-20) in the central part of the site exhibited evidence of spalling at the contact with the cover; however, the underlying soil was not exposed. The remaining manhole covers, and surrounding asphalt-paved areas were observed to be intact and free from surficial cracks. Langan observed localized staining of the asphalt in the northern part of the site. Langan did not observe indications that the staining has penetrated the asphalt cover. Odors or other indications of a release were not observed.

- Spalling of surrounding asphalt was observed near the collar of a manhole cover for an extraction well (EW-20) on the central part of the site. Soil underlying the asphalt was not exposed.

Photo 7: Spalling asphalt around manhole cover in the central part of the site (facing northeast).

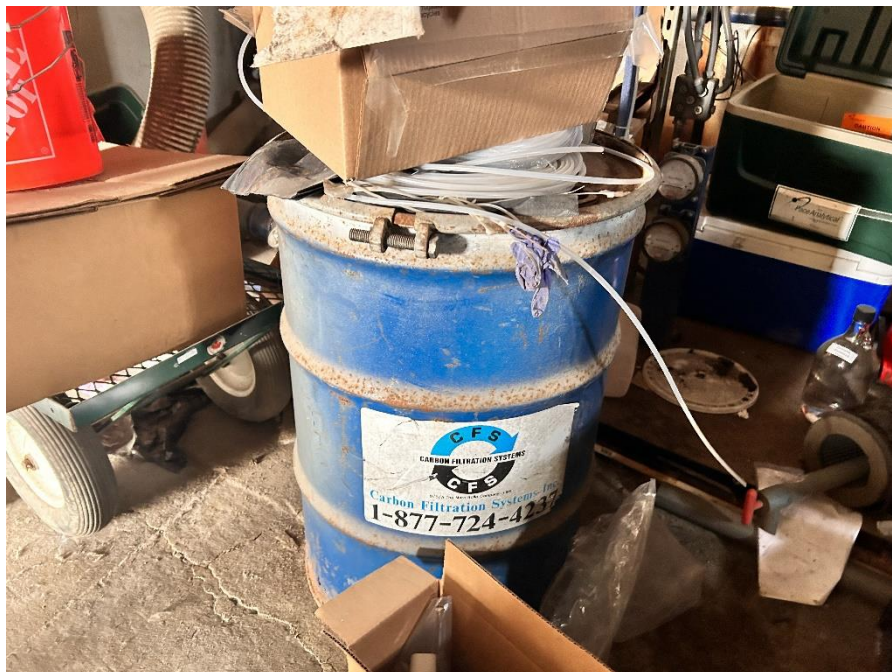
Photo 11: 55-gallon metal drum containing activated carbon in treatment building.

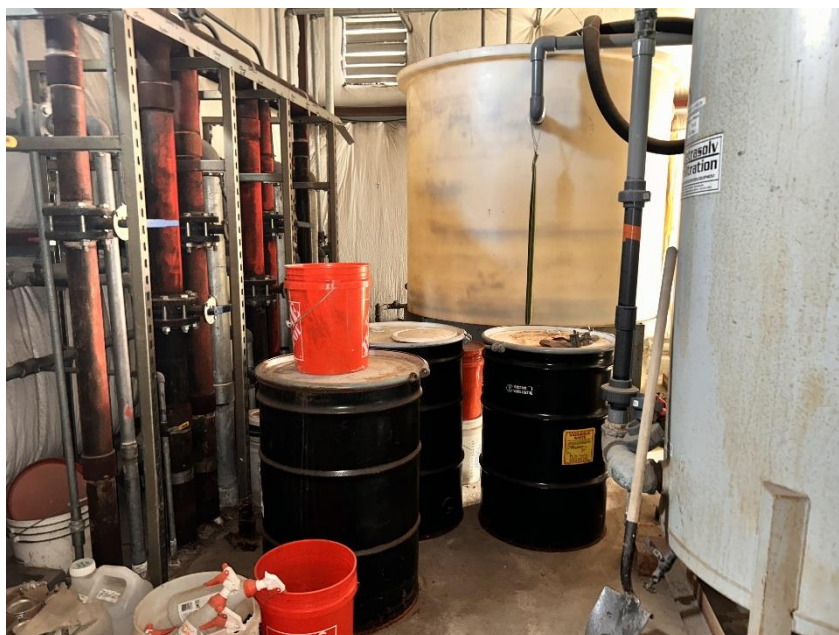
- One 1-gallon of d-Limonene® cleaning solvent
- One 1-gallon container of muriatic acid
- One 0.5-gallon carton of Alconox® powdered precision cleaner
- One 50-gallon high-density polyethylene (HDPE) drum of Redux® B-15 microbiocide
- One 15-ounce canister of Rust-oleum® Pro Enamel
- Two 15-ounce canisters of Krylon® inverted marking paint
- One 4-liter container of Hexanes ACS degreasing solvent
- One 55-gallon steel drum labeled as "Carbon Filtration Systems – Inc." with an illegible non-hazardous waste label
- One steel 55-gallon drum labeled "PCB water" on a hazardous waste label, one steel 55-gallon drum with a blank hazardous waste label, and one steel, unlabeled 55-gallon drum. The drums were also observed during the September 2022, March 2023, September

2023, and March 2024 inspections. Woodard & Curran, the environmental engineer for the RP, informed Langan in September 2022 that one of the drums labeled as hazardous waste is empty and the other contains investigation-derived waste generated during previous gauging events. The drums were reportedly pre-labeled as hazardous as a precautionary measure and have not been confirmed to contain hazardous waste.

Photo 12: Two 55-gallon drums labeled "PCB water" and one 55-gallon drum with a blank hazardous waste label inside the treatment building (facing east).

- We recommend off-site disposal of the two 55-gallon drums of investigation-derived waste, one unlabeled 55-gallon drum, and one 55-gallon drum with a non-hazardous waste label in the treatment building, in accordance with applicable local, state, and federal laws and regulations. Until removal can be accommodated, we recommend securing the building with a lock to restrict tenant access to drums.

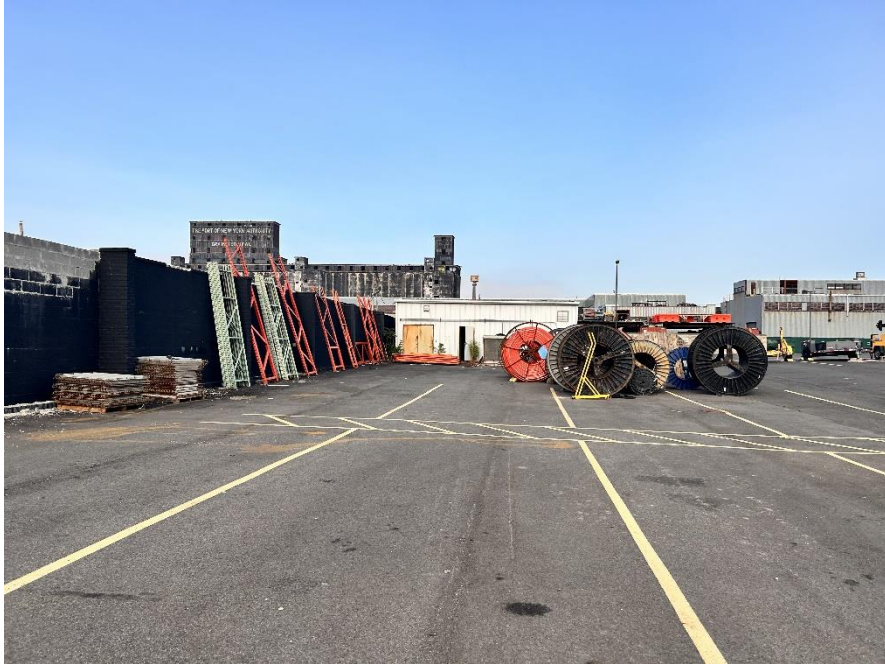
Photo 13: Remaining telecommunications equipment from previous tenant near the southern site boundary (facing north).

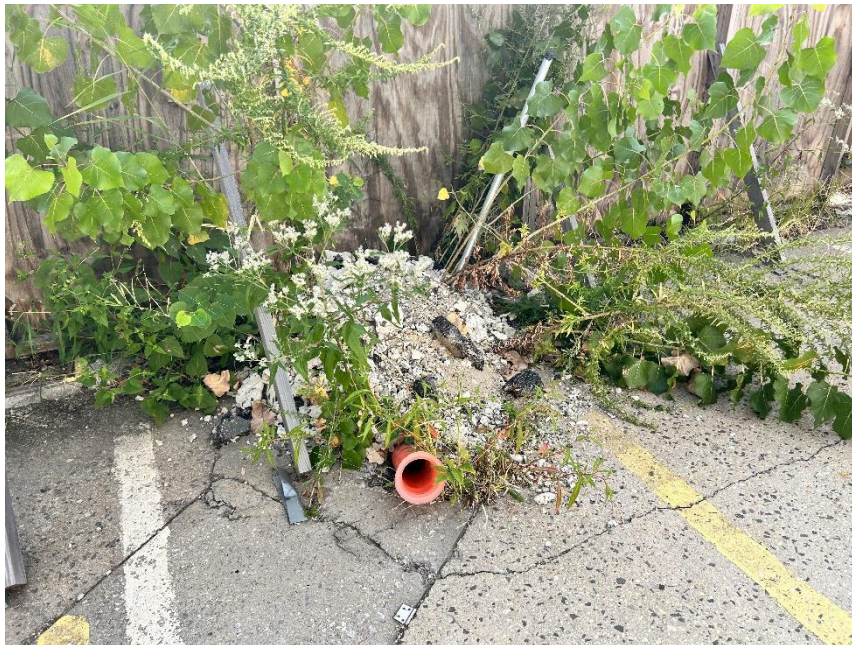
- One of the ECs at the site, the site-wide composite cover system, contains an approximately 3-foot by 3-foot crack and three approximately 1-foot by 2-foot cracks through which soil and vegetation are visible. The areas of exposed soil are within an area on the northwestern part of the site that is secured by construction fencing in preparation for demolition of the 725 Clinton Street building and expansion of the parking lot. The secured area is only accessible to authorized personnel.

Photo 15: Area of exposed soil in the concrete pavement within the secured construction area adjoining 725 Clinton Street building (facing east).

- We recommend that the area of the aforementioned exposed soil remain secured behind fencing within the 725 Clinton Street construction area and remain inaccessible to unauthorized visitors, with only trained personnel operating in accordance with the 2016 ISMP and 2022 Excavation Work Plan having access to the exposed area. We understand the exposed area will be covered with pavement during expansion of the tenant parking lot in November 2024.

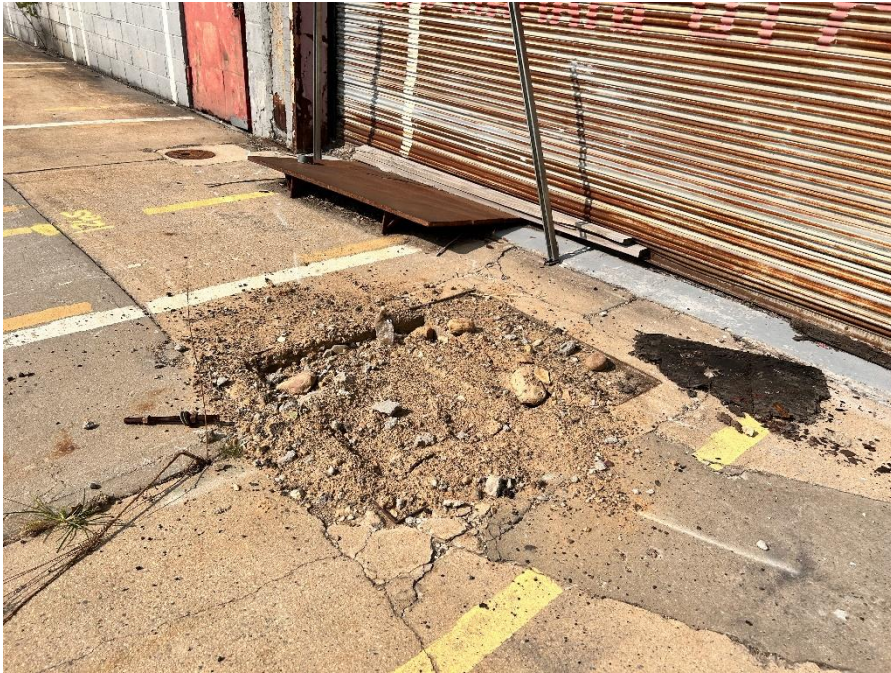
Photo 16: Exposed soil in concrete pavement in the central part of the secured construction area adjoining 725 Clinton Street building (facing southwest).

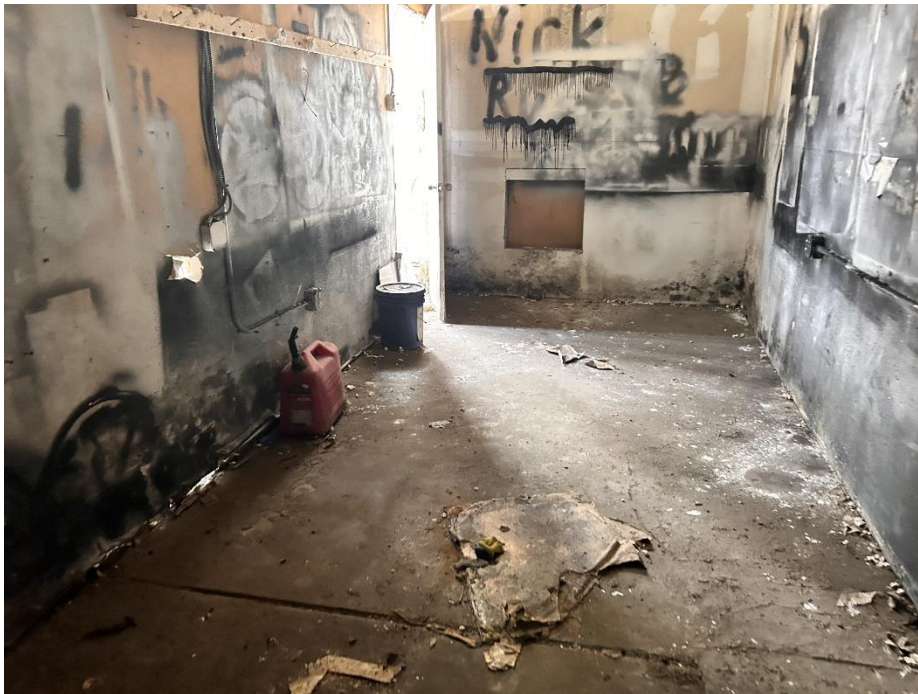
Photo 19: Five-gallon gasoline canisters and five-gallon bucket of gear oil inside 725 Clinton Street (facing east).
