SMP Photolog – Vault Sampling

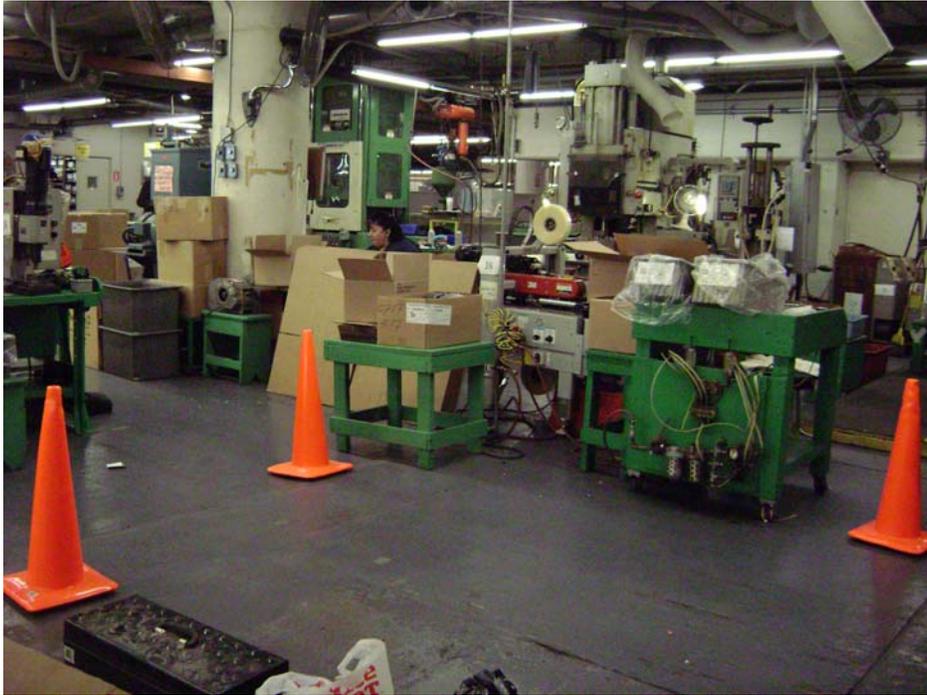
Photo #5: Vault #2 located between SG04 and SG11. Orange cones are outlining the perimeter of the vault.

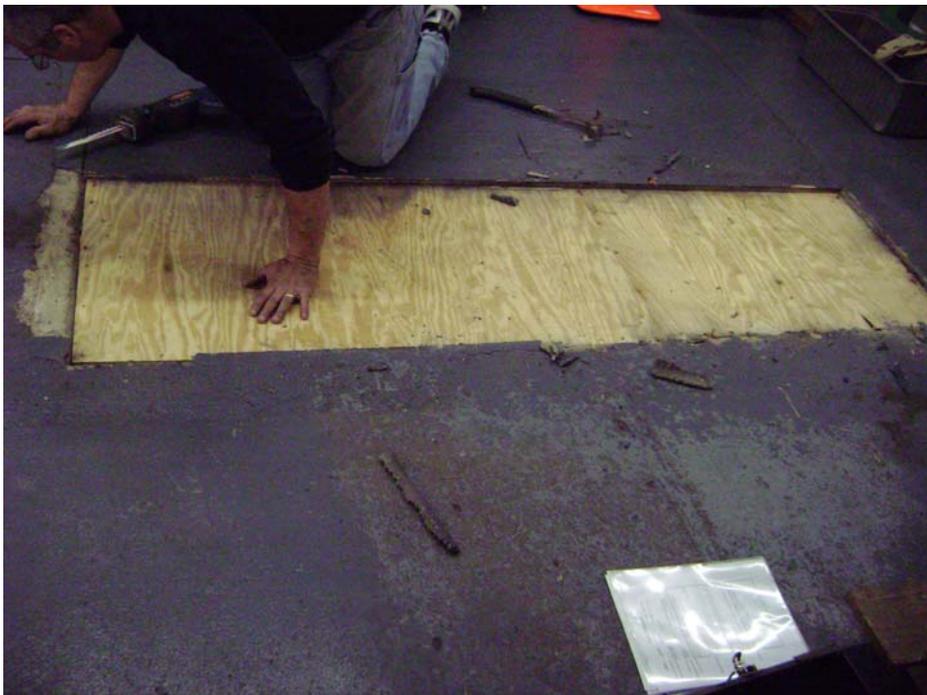
Photo #6: Removing wood plank layers from Vault #2.

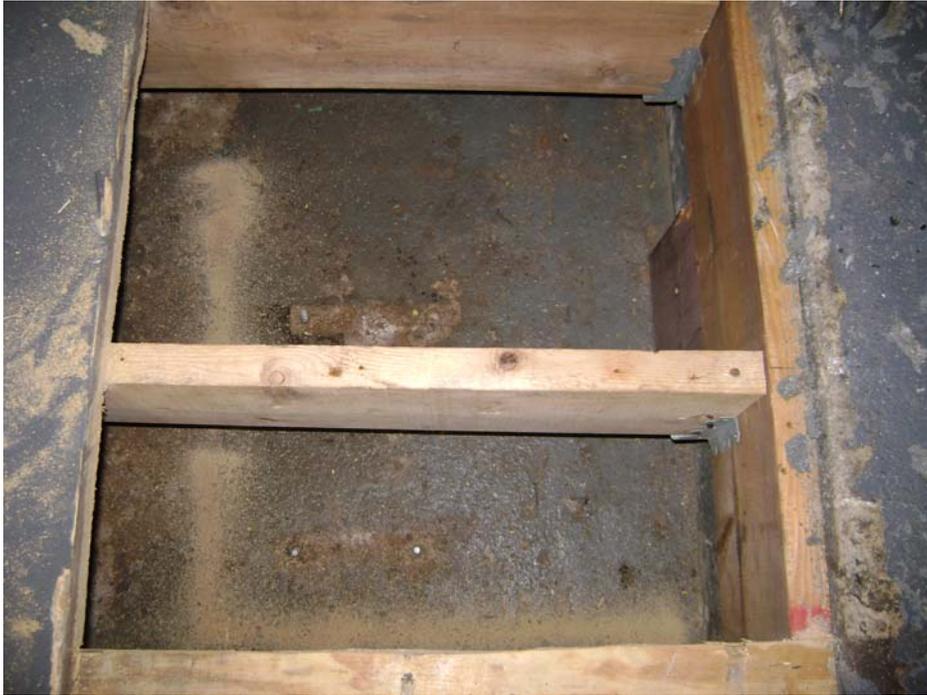
Photo #7: Removed an approximate 2 by 2 foot piece of plank from Vault #2.

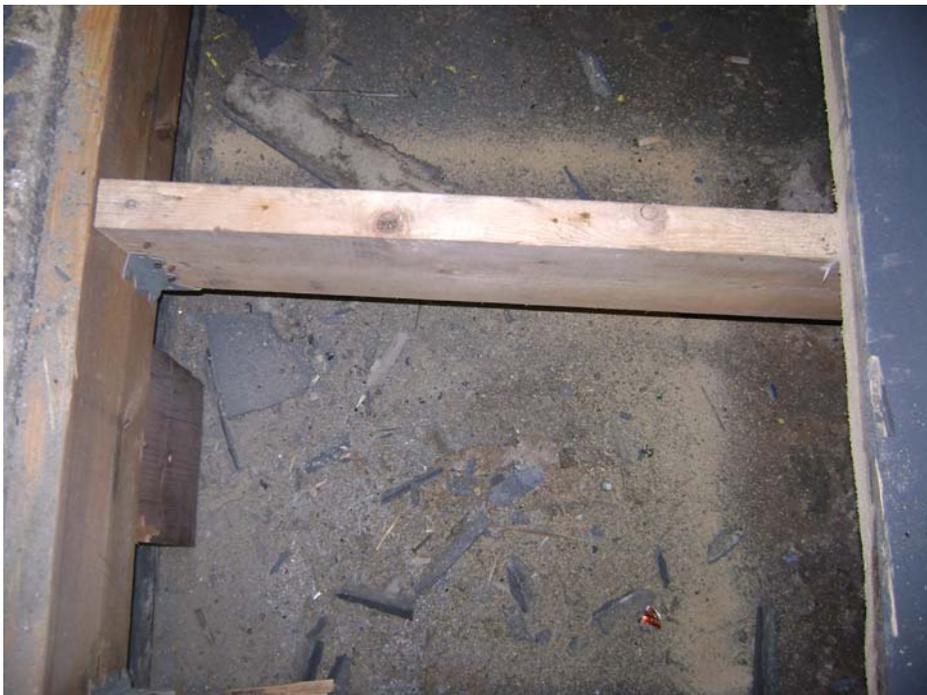
Photo #8: No sample was collected. Bottom of Vault #2 consisted of concrete, dust, and pieces of wood.

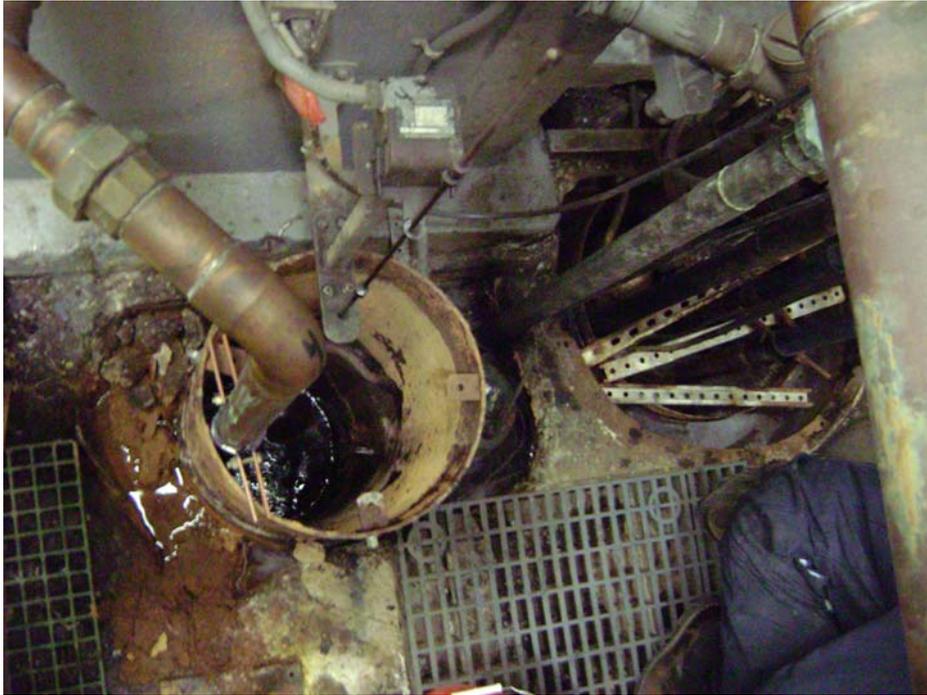
Photo #9: Aerial view of Sump #2 (left) and Sump #1 (right).

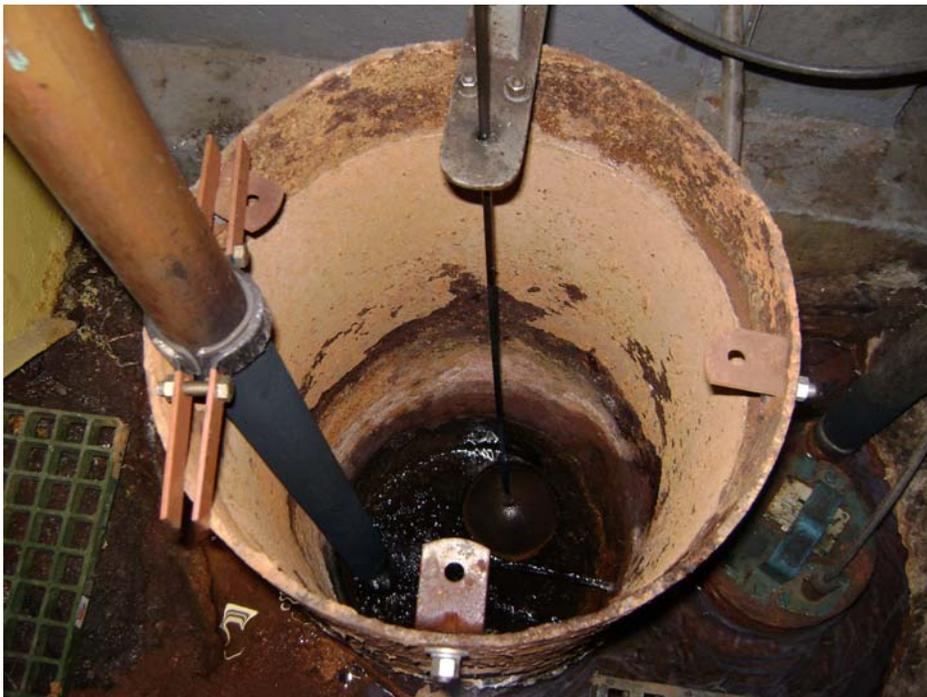
Photo #10: Sump #2, collected water sample via bailer.

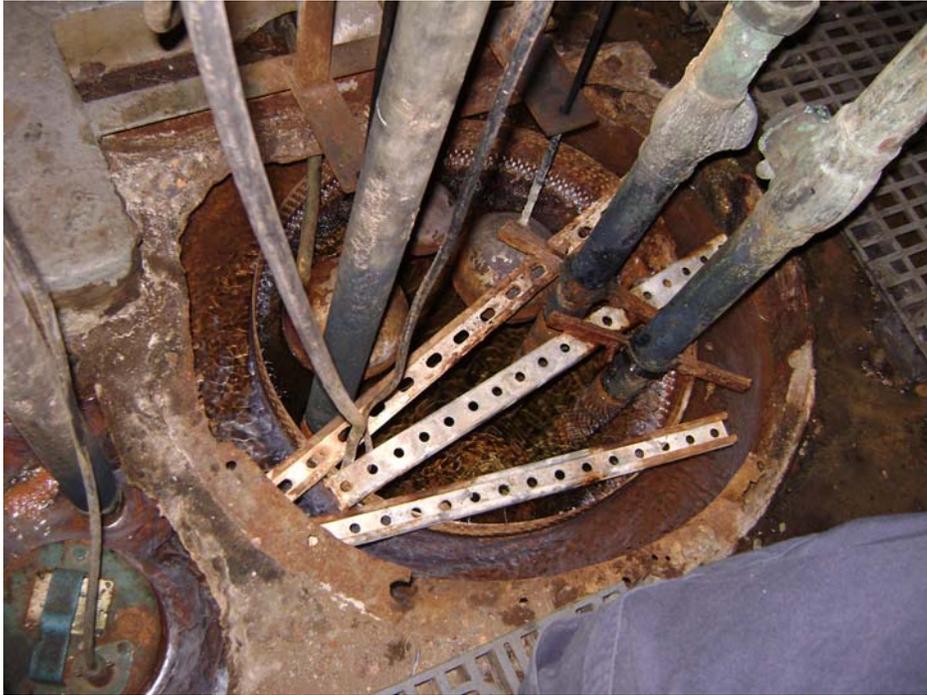
Photo #11: Sump #1, collected water sample via bailer.

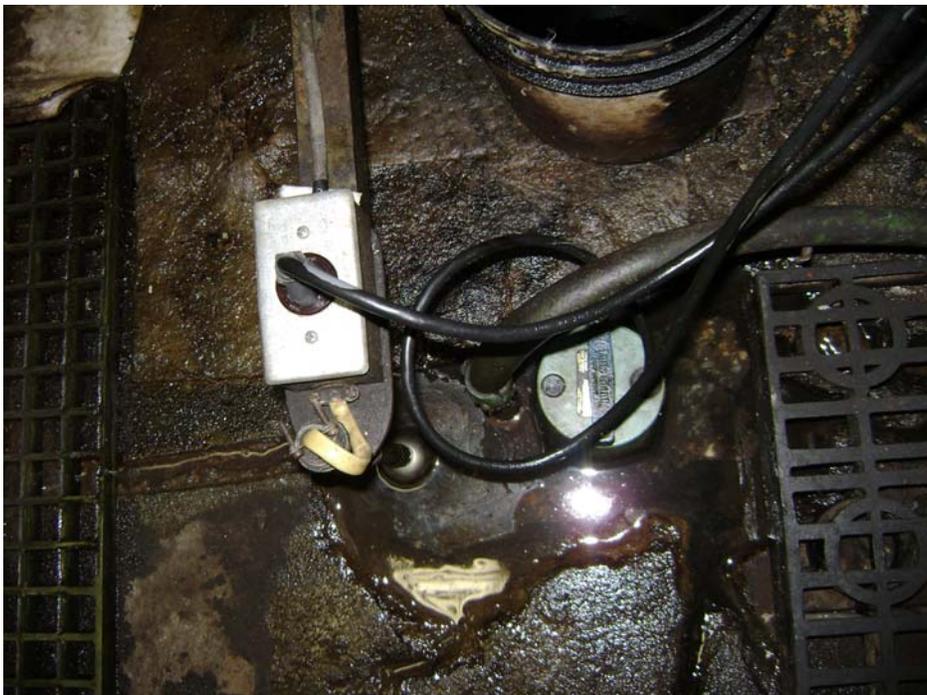
Photo #12: Sump #3, collected water sample via grab with glass jar. Approximately 3 inches of water, visible sheen.

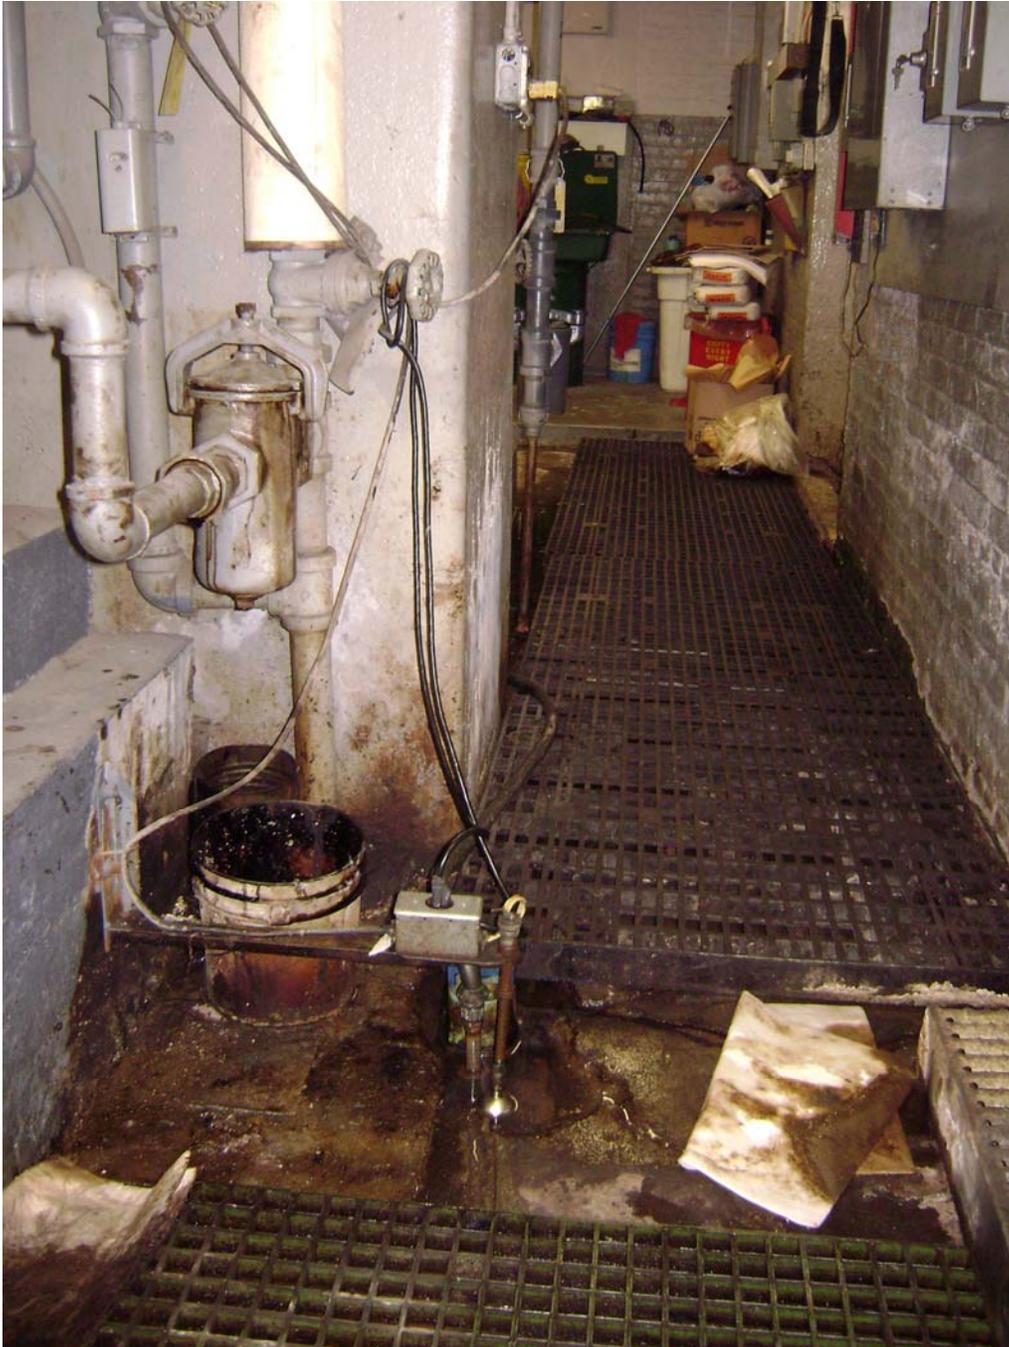
Photo #13: Along the western wall of the sub-basement. Sump #3 is located here (underneath electrical outlet).

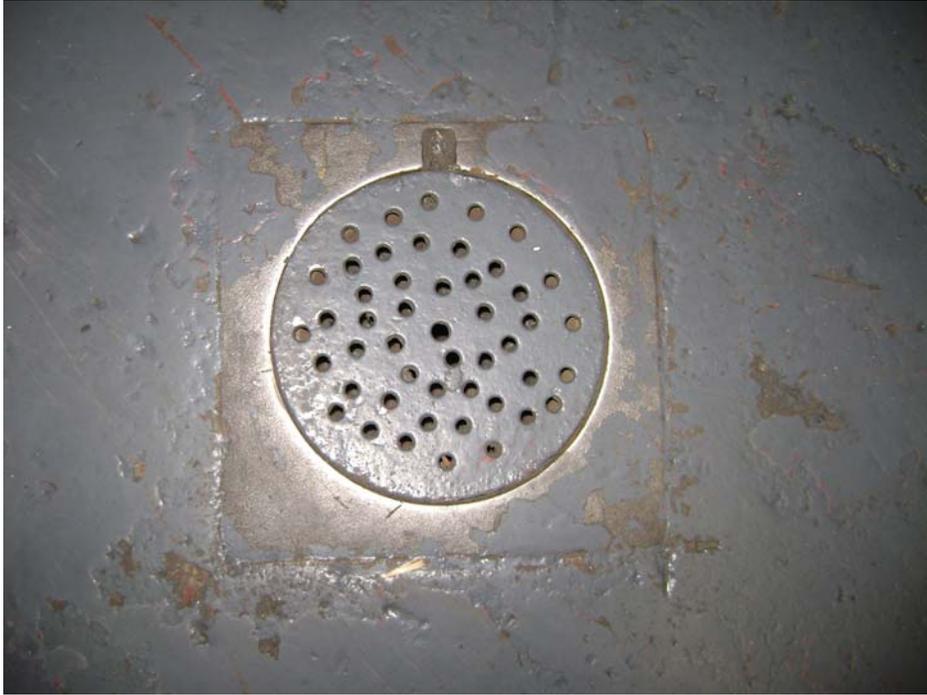
Photo #14: Floor Drain adjacent to SB07 subslab location.

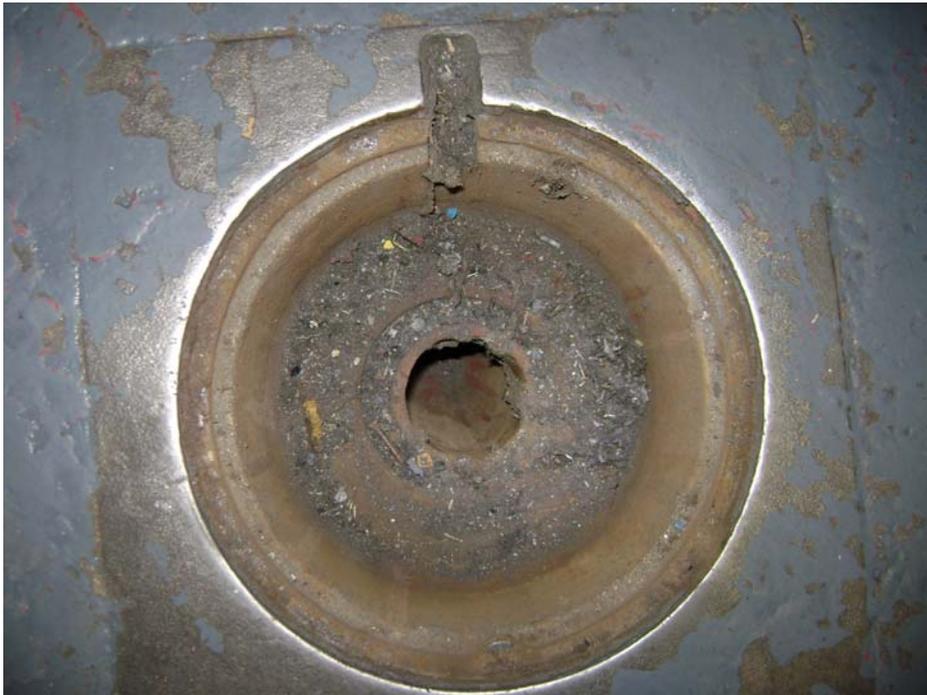
Photo #15: Inside Floor Drain – no sample collected (all dust).

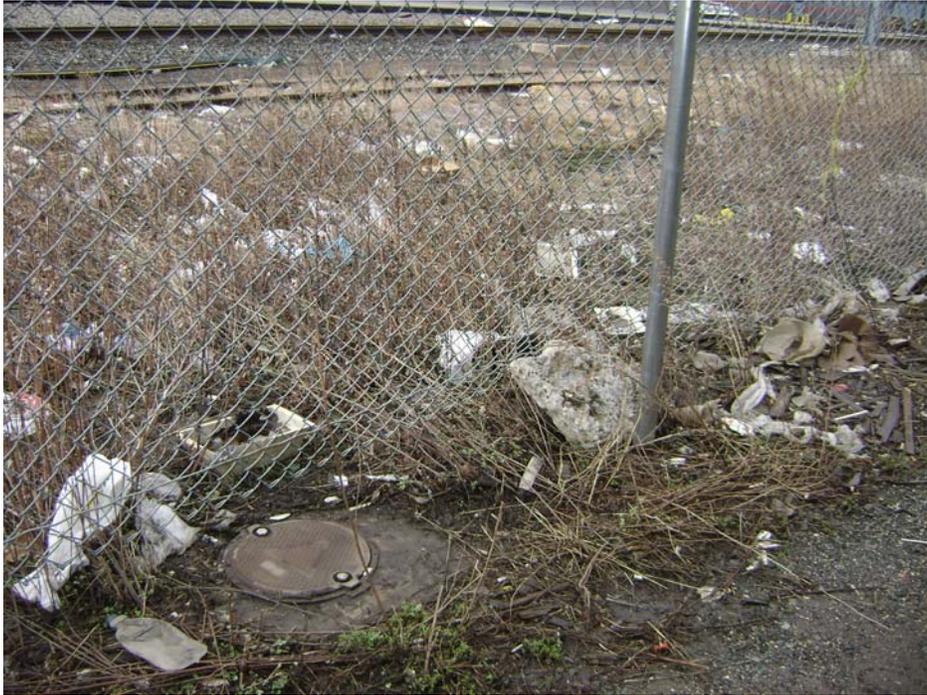
Photo #46: Cut ties connecting fence to pole and placed rock between fence and pole to create a better working area around MW12.

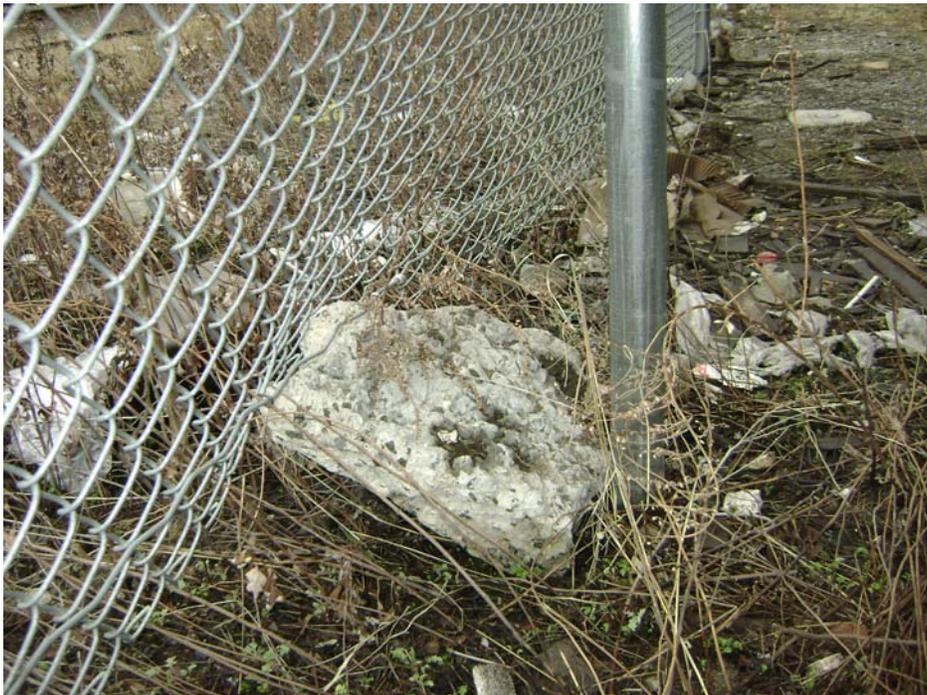
Photo #47: Closer picture of rock extending fence.

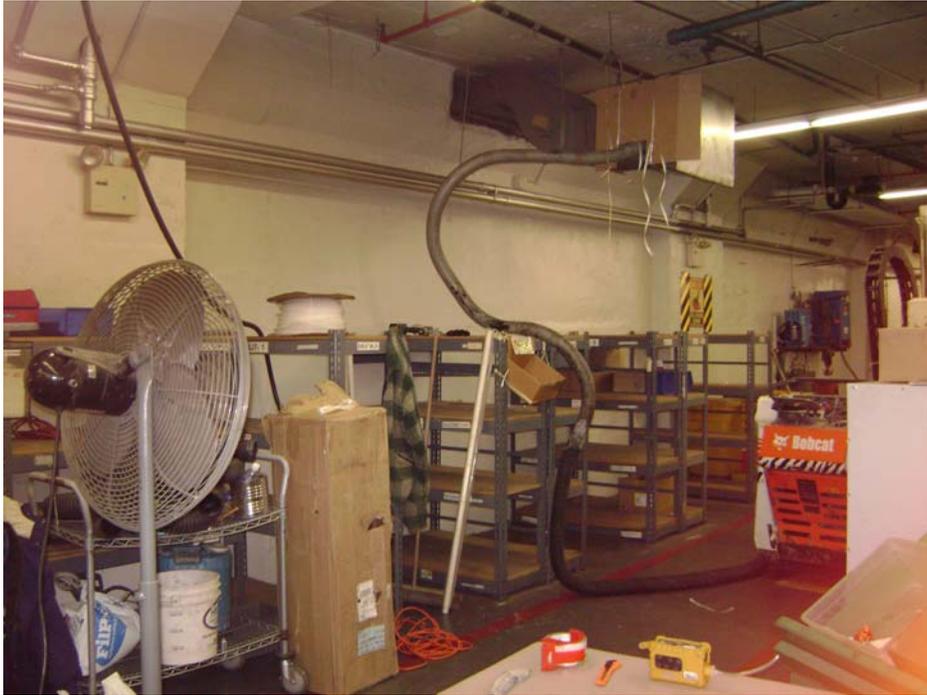
Photo #50: Venting fumes of Geoprobe rig while drilling inside.

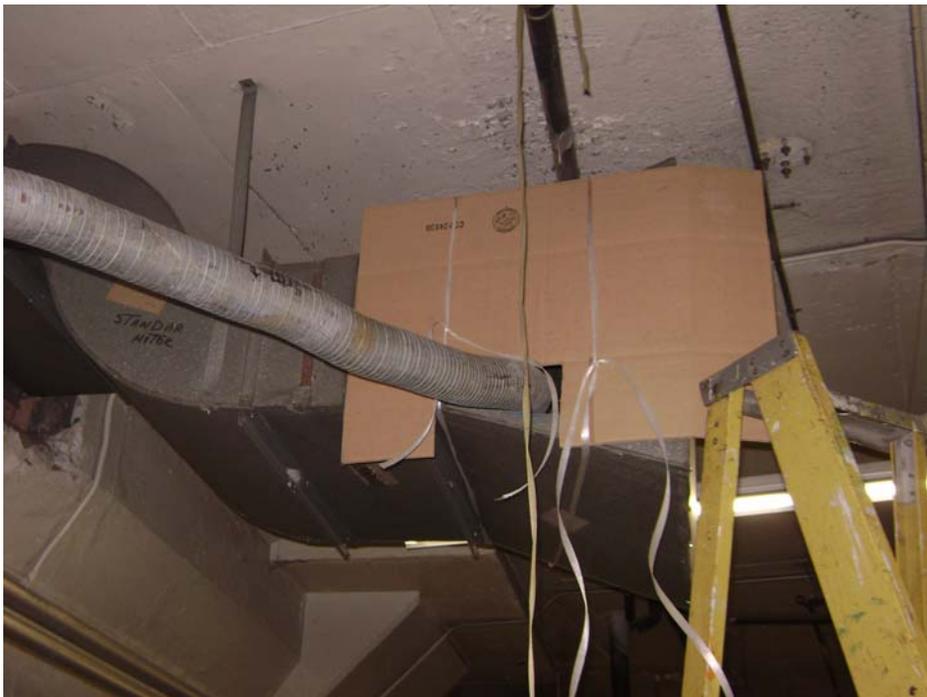
Photo #51: Sealing ventilation.

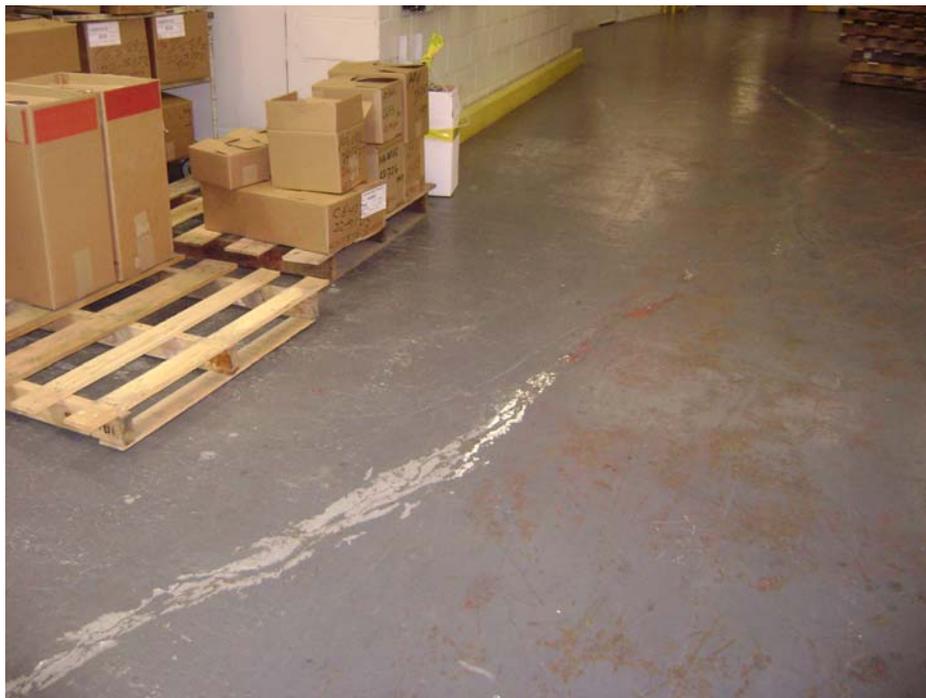
Photo #91: Thin crack in subslab within the faded painted area.

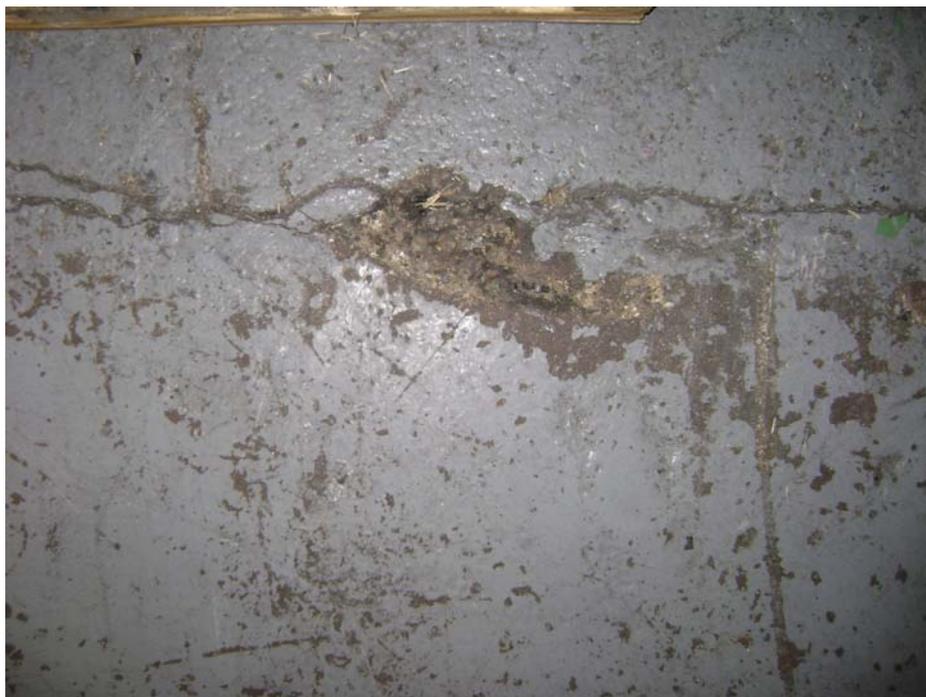
Photo #92: Cracks in Subslab.
