Subject: Sub-slab Depressurization System Remedial Action Report
Standard Motor Products, Inc. Site
Long Island City, New York
Class 2 Site No. 2-41-016

**FINAL
SUB-SLAB DEPRESSURIZATION SYSTEM REMEDIAL
ACTION REPORT
STANDARD MOTOR PRODUCTS, INC. SITE
(Site No. 2-41-016)
Long Island City, Queens, New York**

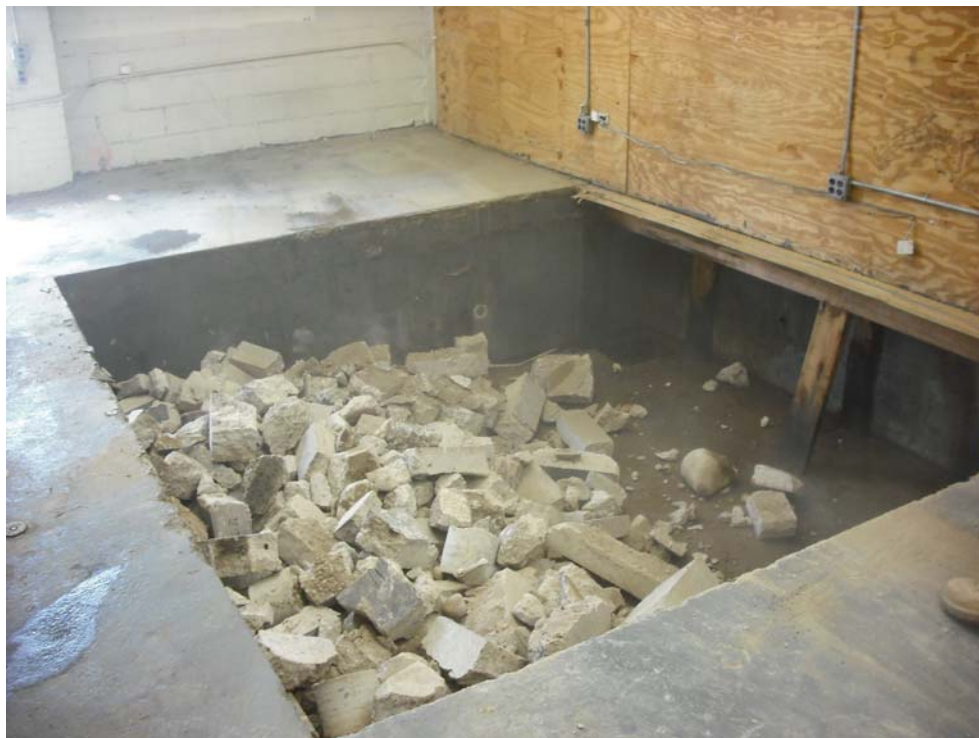
Photo 6: Concrete cuttings placed into equipment vault prior to pouring of new concrete

Trenches for the extraction well sumps were backfilled with the excavated soil and approximately four cubic yards of concrete were used to restore the concrete back to pre-remediation conditions and to fill in a basement vault as shown in Appendix D. Concrete cuttings were used to help fill in existing equipment recesses/vaults in the basement and the remainder was filled with fresh concrete. All equipment not associated with the SSDS was demobilized and the Site was restored to pre-construction conditions.

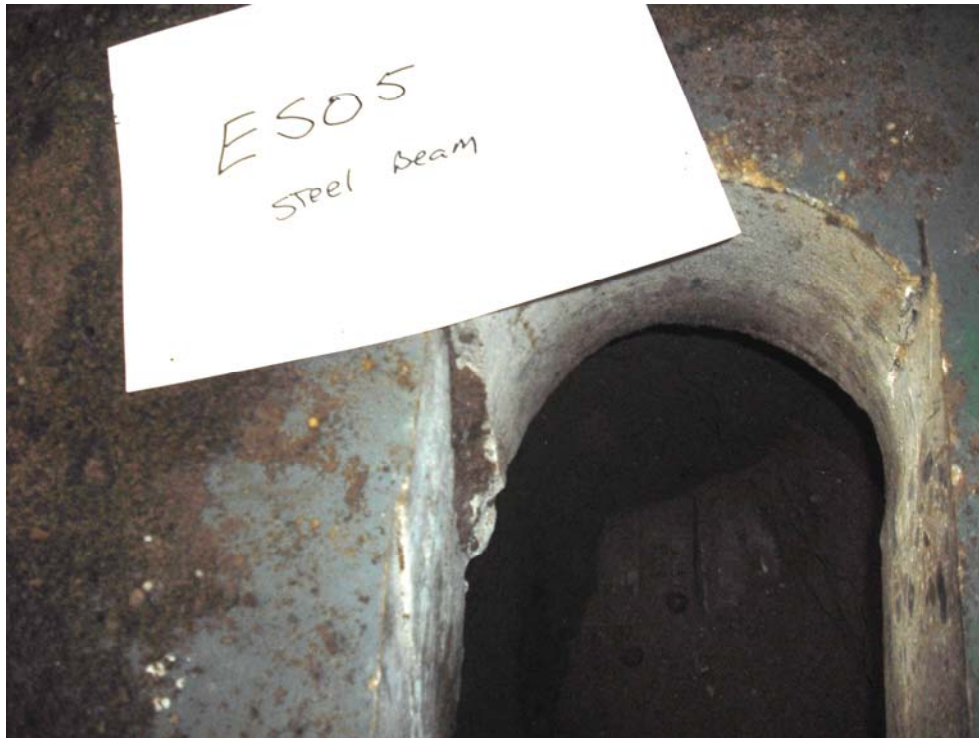
- The location of ES-05 was moved approximately 2 feet south due to site conditions. A steel beam was encountered beneath the concrete. A photograph of the steel beam encountered is shown in Appendix D.

Photo 7: Steel beam encountered at ES-05 prior to changing location

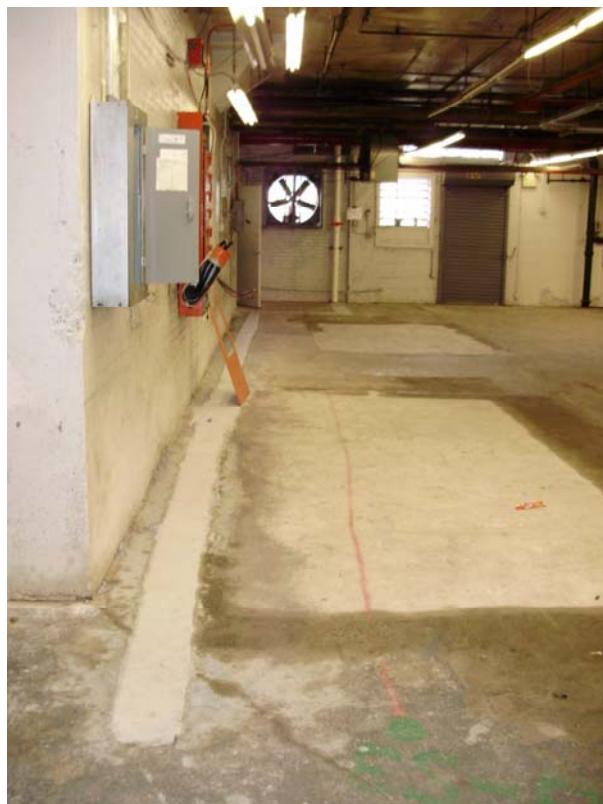
- Minor adjustments were made to the trenching layout due to unanticipated site conditions encountered during construction. Based on field conditions, the routing of the piping was needed to avoid various obstructions. The final piping locations are shown in the “As-Built” drawings in Appendix C.

- The location of ES-07 moved approximately 2 feet east due to site conditions. A sub-slab wall from a recessed equipment vault was encountered. A photograph of the trench pathway is provided in Appendix D.

Photo 8: Trenching direction was altered near far wall due to site conditions
