**FINAL
SUMMARY REPORT**

**ROCKAWAY PARK FORMER MANUFACTURED GAS PLANT SITE
BULKHEAD AREA
INTERIM REMEDIAL MEASURE (IRM)**

**KEYSPAN CORPORATION
1 METROTECH CENTER
BROOKLYN, NEW YORK**

**TETRA TECH FW, INC.
1000 THE AMERICAN ROAD
MORRIS PLAINS, NEW JERSEY**

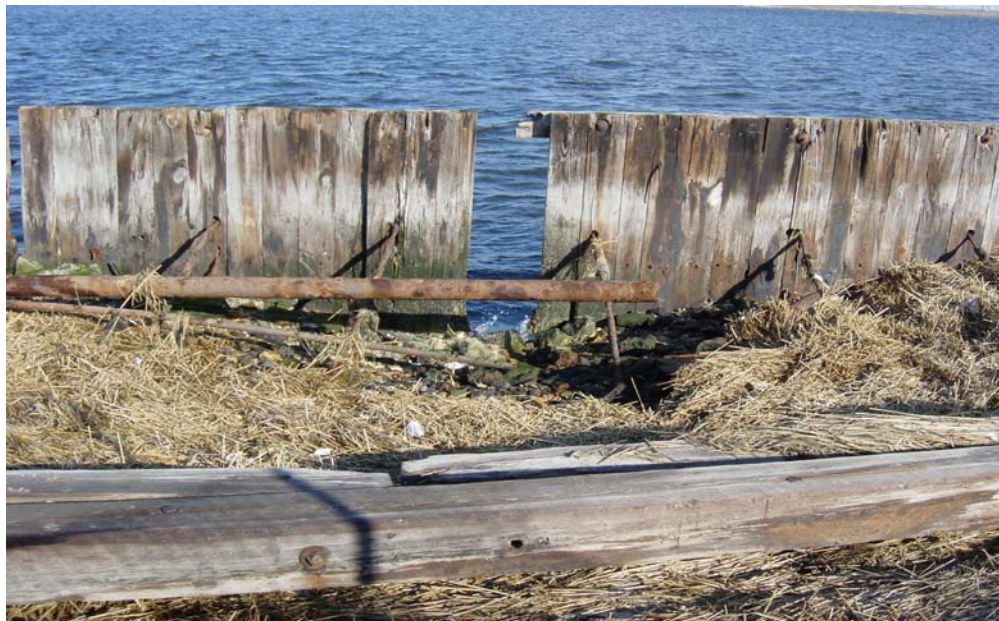
This IRM took place in the western portion of the bulkhead area directly across the road from the current plant property (reference **Figure 2** for a plan view of the site). The bulkhead, at the time, was comprised of reinforced timbers and wood beams and was severely deteriorated in most sections as a result of long exposure to weather and tides. The tie-back rods associated with the bulkhead wall were corroded, and holes in the walls allowed miscellaneous floating debris to collect within the confines of the bulkhead. Subsequent to the IRM, the City of New York undertook a rehabilitation of the bulkhead structure.

Damage to the Bulkhead has resulted in debris washing on the beach during high tide.

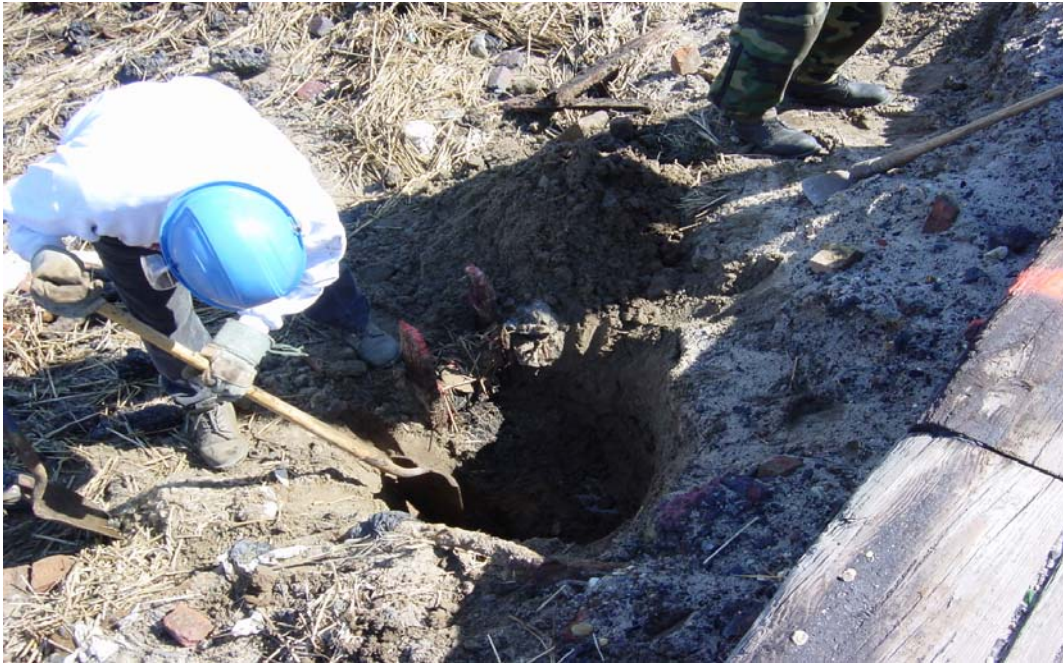
Coastal Environmental manually excavated the soil to reach the pipes located beneath the ground surface.

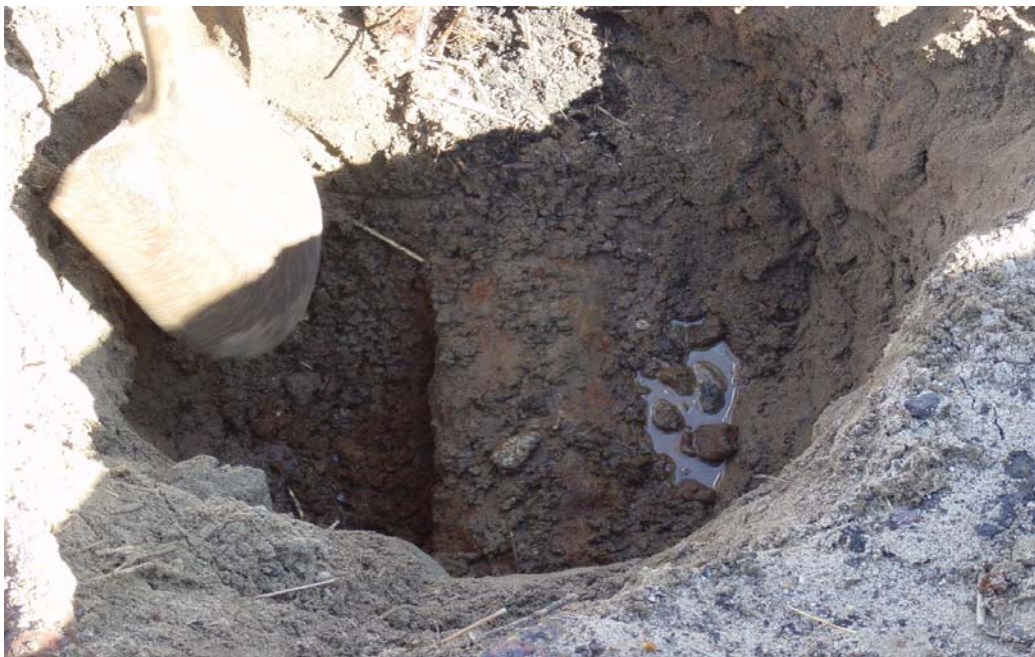
One of the pipes that was uncovered during excavation.

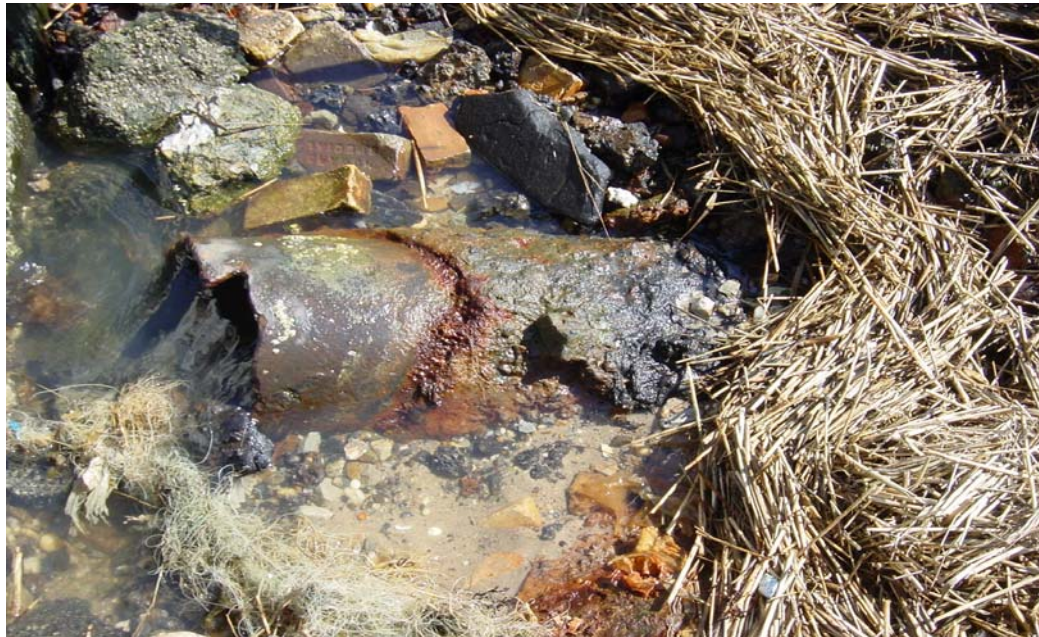
The 12-inch diameter pipe, uncovered during the previous excavation, was relocated by Coastal Environmental. A 3-foot x 3-foot section around the pipe, at approximately 3 feet bgs, was exposed and examined. The soil immediately around the pipe exhibited dark brown to black staining and contained a slight fuel/petroleum odor. This soil was excavated, placed into a 5-gallon bucket, and transferred into a 55-gallon drum. A square opening was cut in the top of the pipe with a gas-powered circular saw and the interior was inspected by representatives of TtFW and the NYSDEC. Seawater and sludge were visually identified in the pipe and approximately 10 gallons of sludge was removed and placed into a 55-gallon drum. The pipe was subsequently plugged with a Portland Cement mix. The material generated from these field activities were relocated to the former Rockaway MGP site staging area.

The 12-inch diameter pipe. A section of soil measuring approximately 3 feet X 3 feet was excavated by hand. The pipe was inspected and sealed with Portland Cement to prevent future exposure pathways.

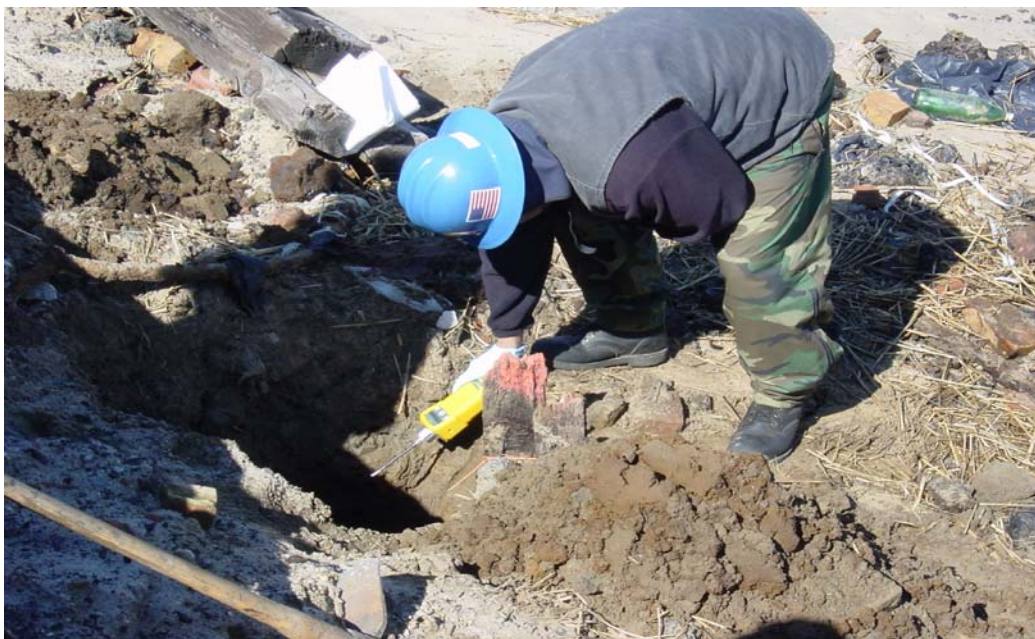
Soil from the excavation was screened with a PID. This was one of the methods used to determine if the soil required disposal.

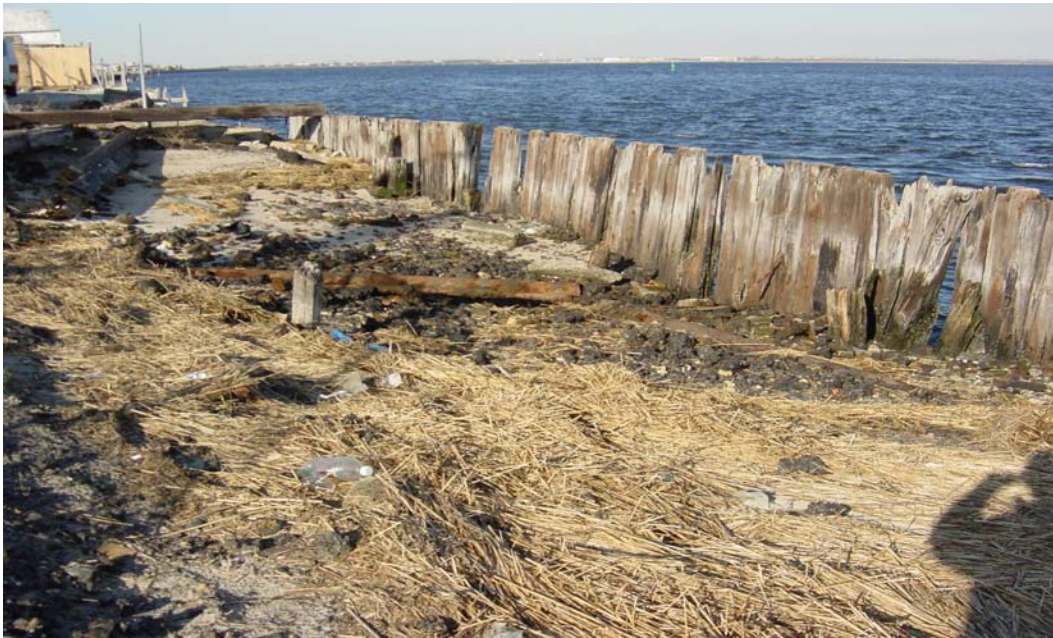
The Bulkhead IRM Area was restored with soil from the surrounding area.
