Construction Completion Report

127-13 Merrick Boulevard

NYSDEC Site Number: 241128

November 2015

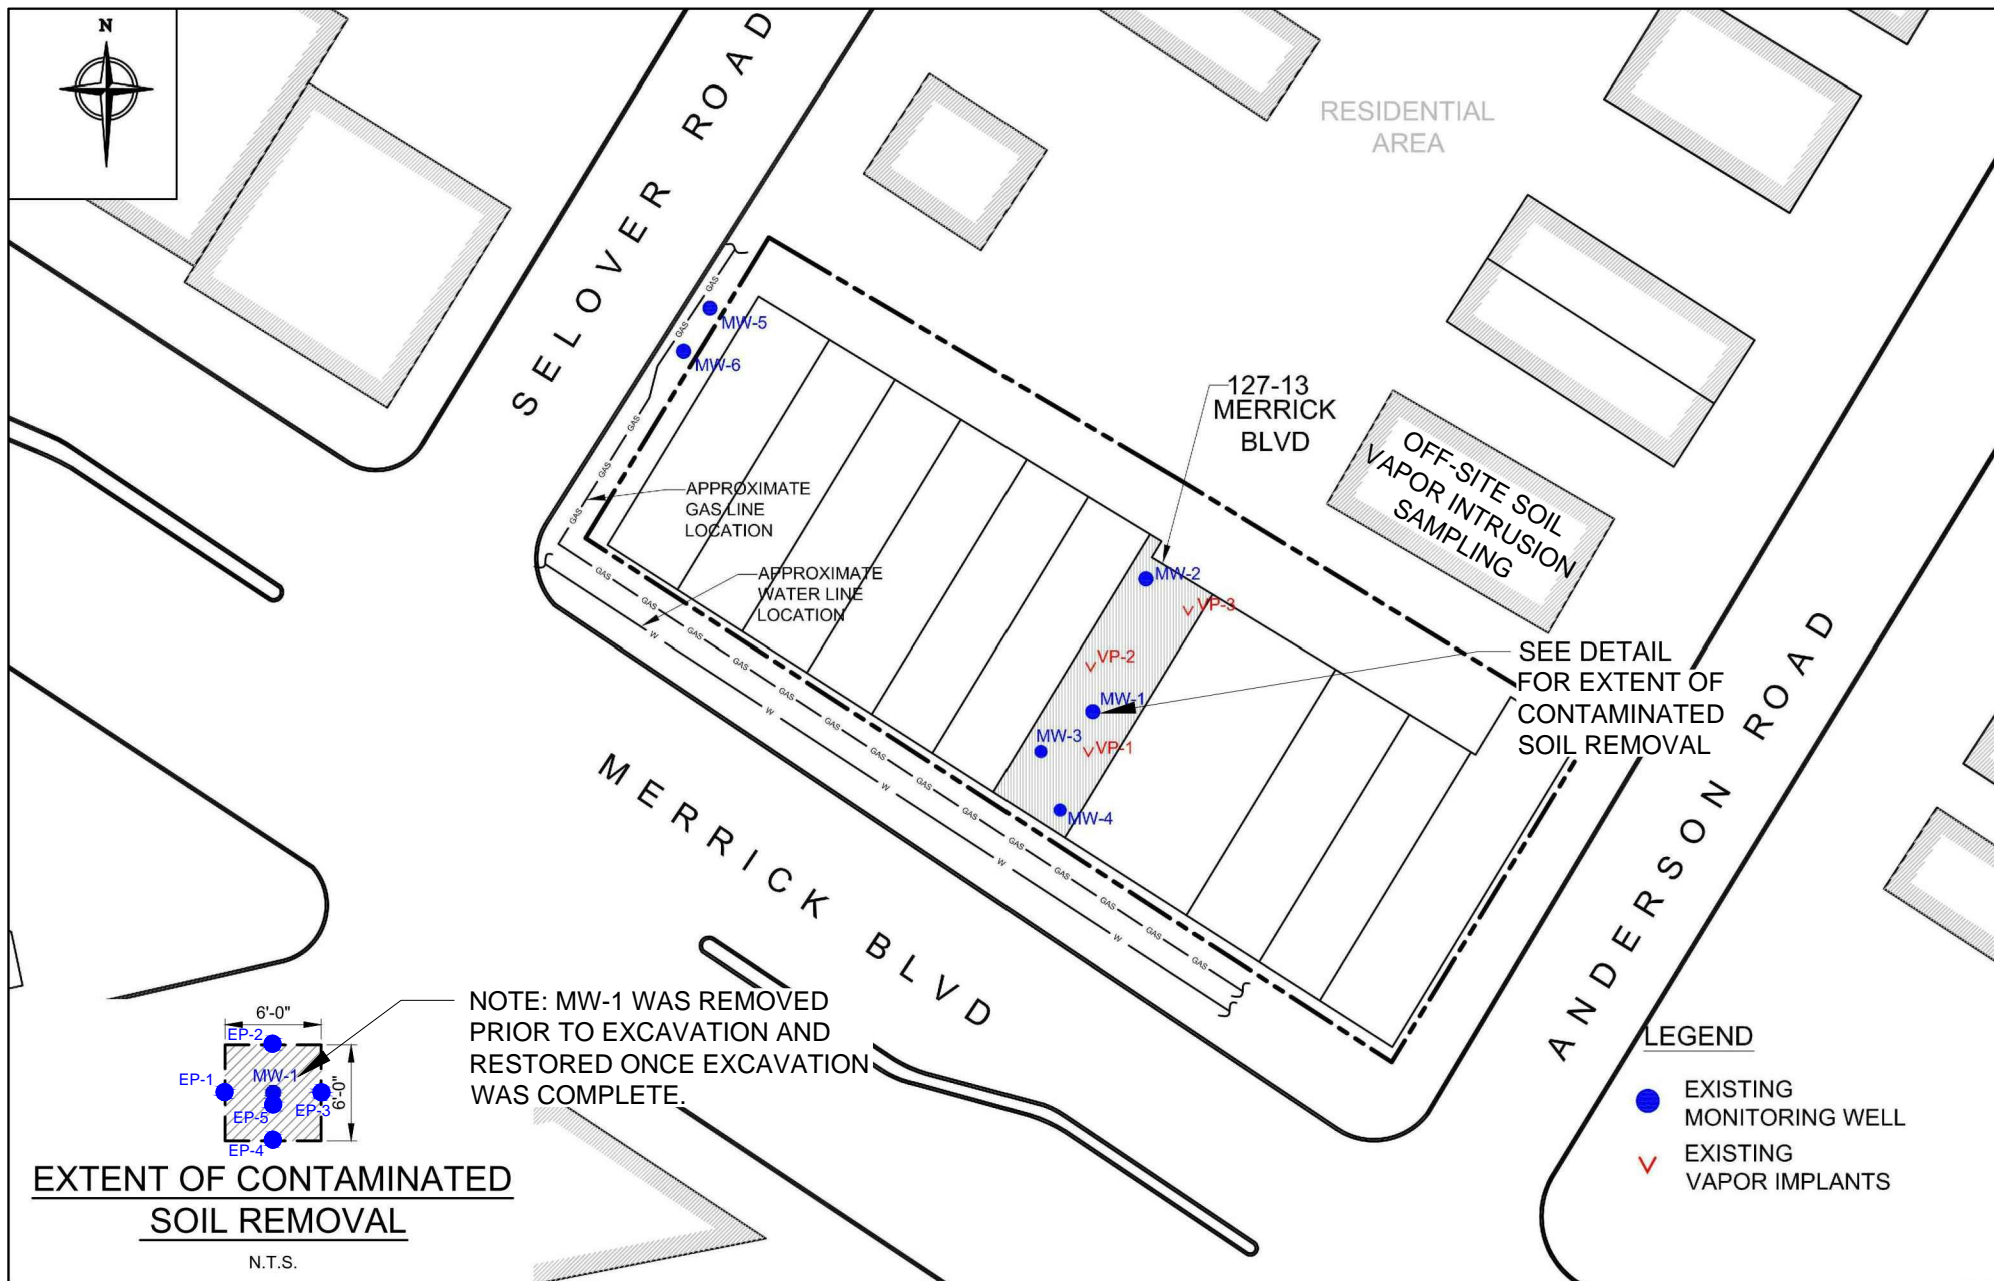
AREA OF REMEDIATION

The contaminated floor drain was roughly in the center of the 127-13 basement. To remove the contaminated soil around the drain, Brookside Environmental of Copiague, New York excavated and removed a volume of soil 6 feet by 6 feet by 6 feet deep on April 3, 2013. This volume was based on the site characterization data and was adjusted to a 5 foot depth due to groundwater intrusion and collapsing of the excavation walls.

The ceiling of the basement was lined with polyethylene sheeting to prevent the migration of potential vapors into the store above. The concrete slab around the floor drain was broken up and removed for disposal. Excavation with the vactor removed contaminated soil in and around the floor drain. When the soil was removed, the vactor hosing was disconnected and the load was shipped to the disposal facility. As the excavation was deepened, groundwater was encountered at approximately 4.5 feet below grade. Soil straddling the water table was removed to the extent possible by the vactor as well as any water that accumulated in the excavation.

Excavation continued horizontally and vertically to below the water table until contaminated soil was removed. Confirmatory endpoint soil samples were collected. Methods of collection followed the Quality Assurance Plan attached to the approved Site Characterization Work Plan. Five endpoint samples were collected under the oversight of NYSDEC; four on the sidewalls at an approximate three foot depth and one at the bottom of the excavation, approximately five feet below grade and below the water table.

When sufficient soil and water were removed, gravel (Appendix L) was backfilled in the excavation. The excavation was brought up to grade.
