TYLL ENGINEERING & CONSULTING PC

Re: Annual Certification and Corrective Actions Plan  
NYSDEC Site Number: 241128  
127-13 Merrick Blvd., Jamaica, NY

## Annual Site-wide Inspection Form

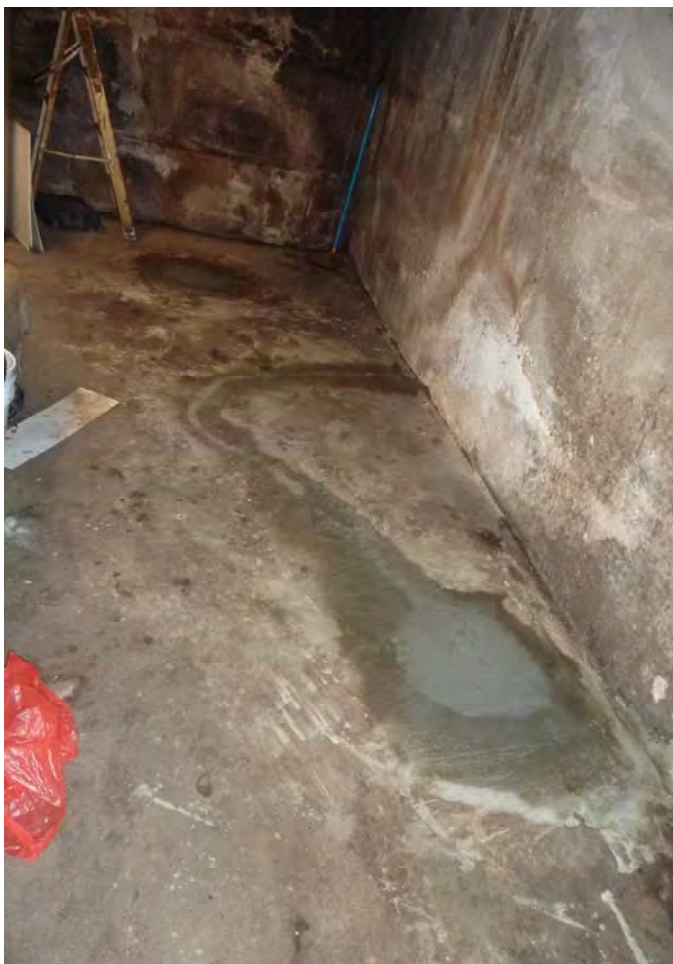
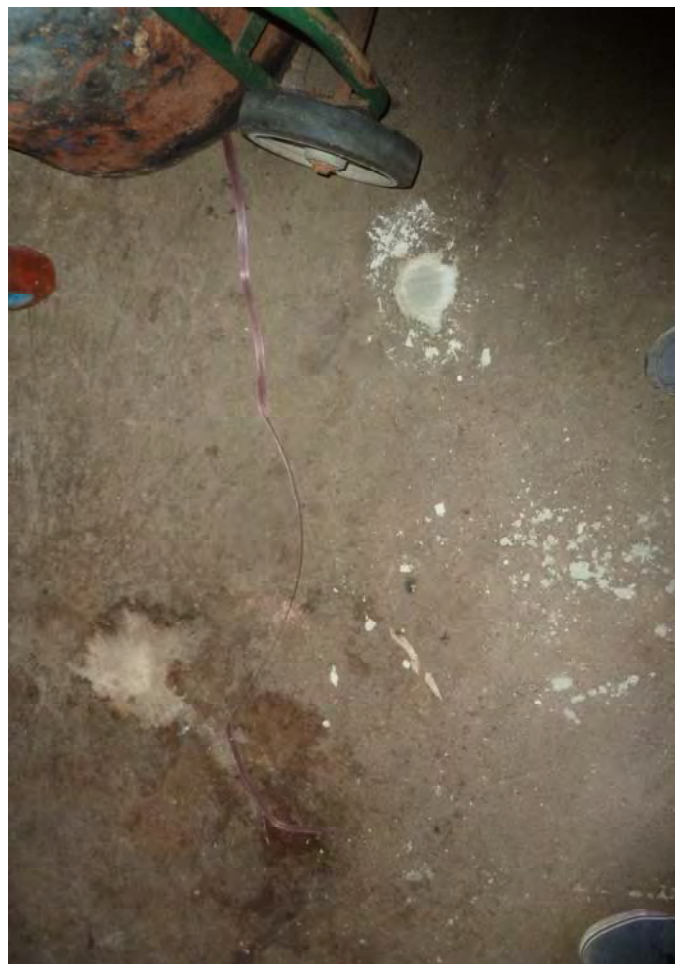
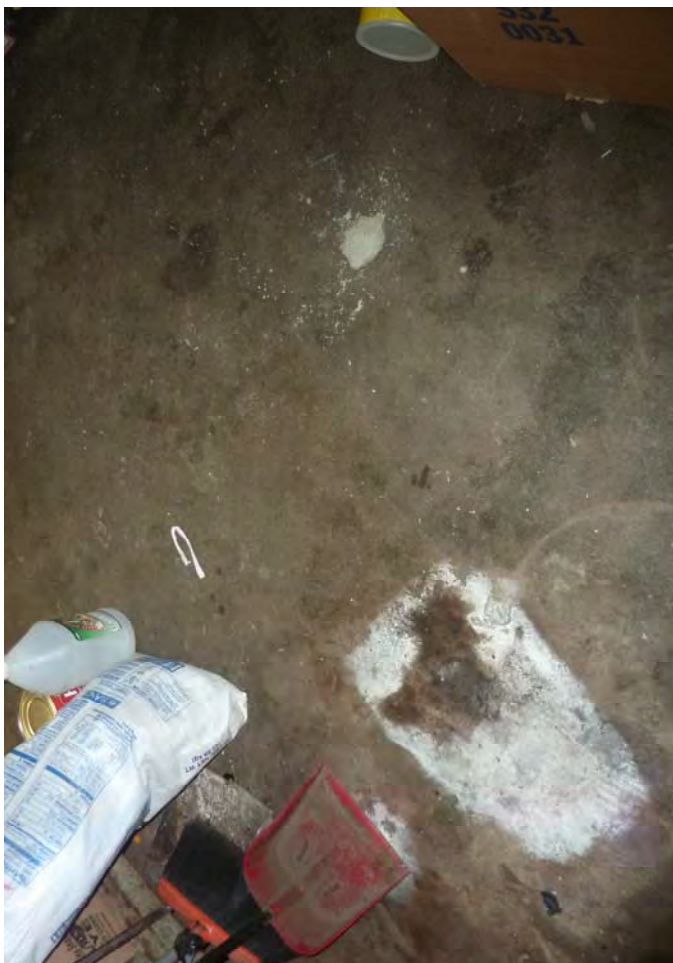
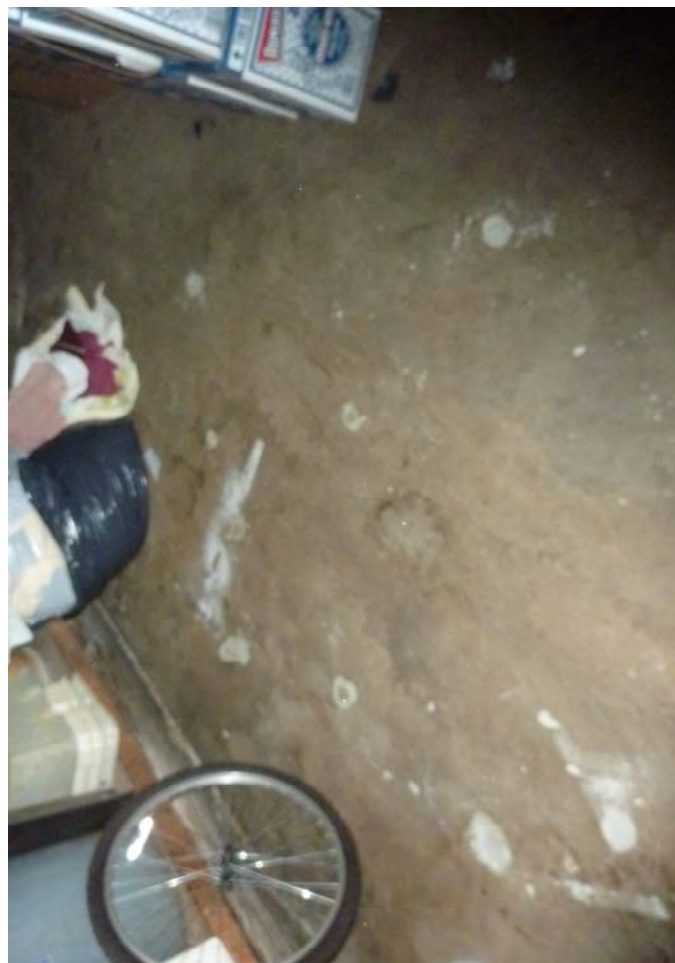
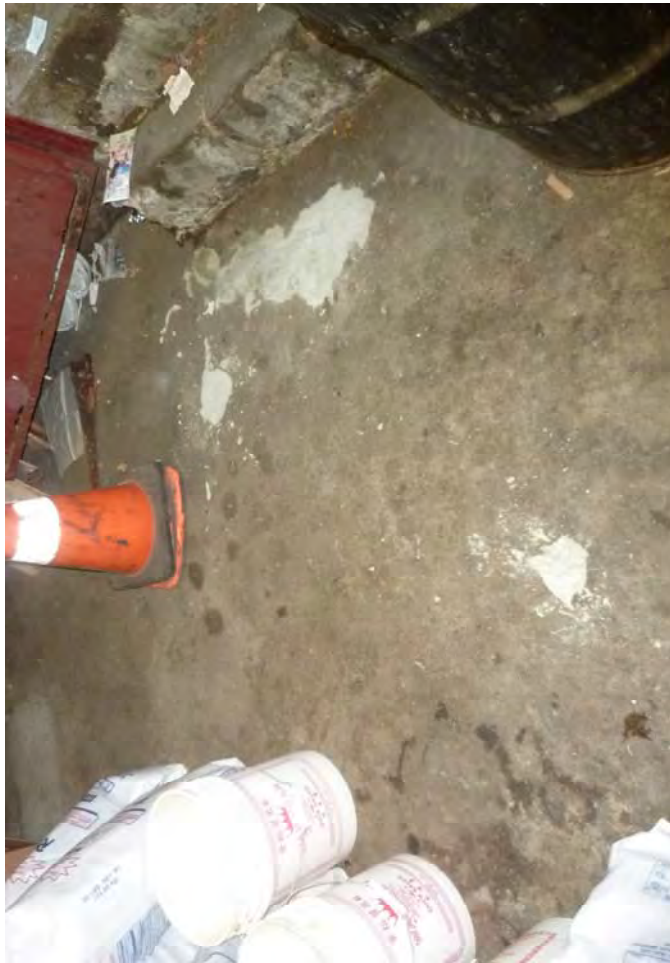
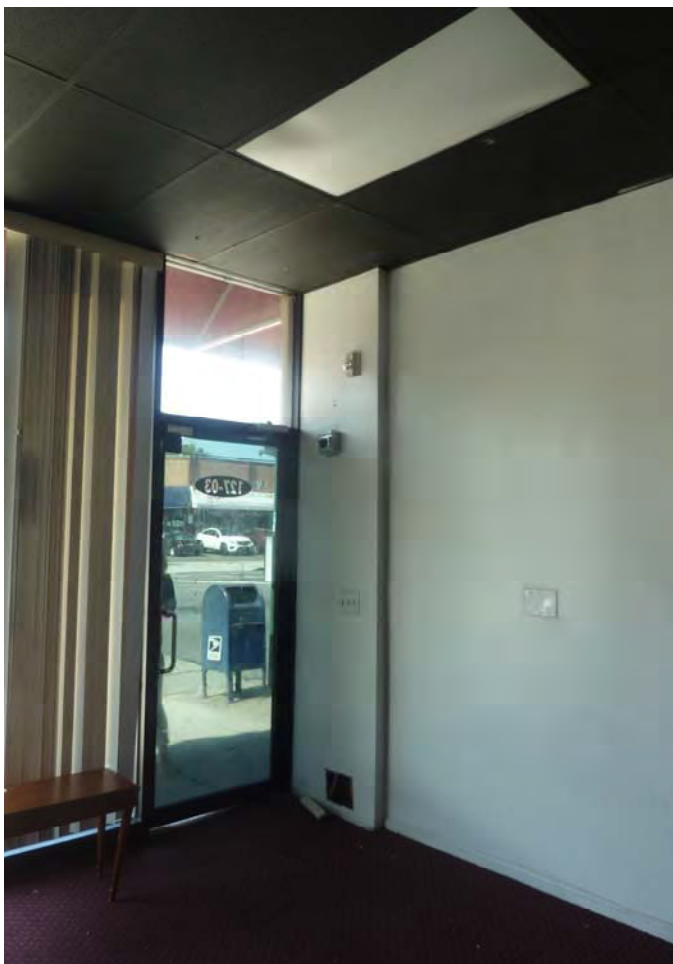
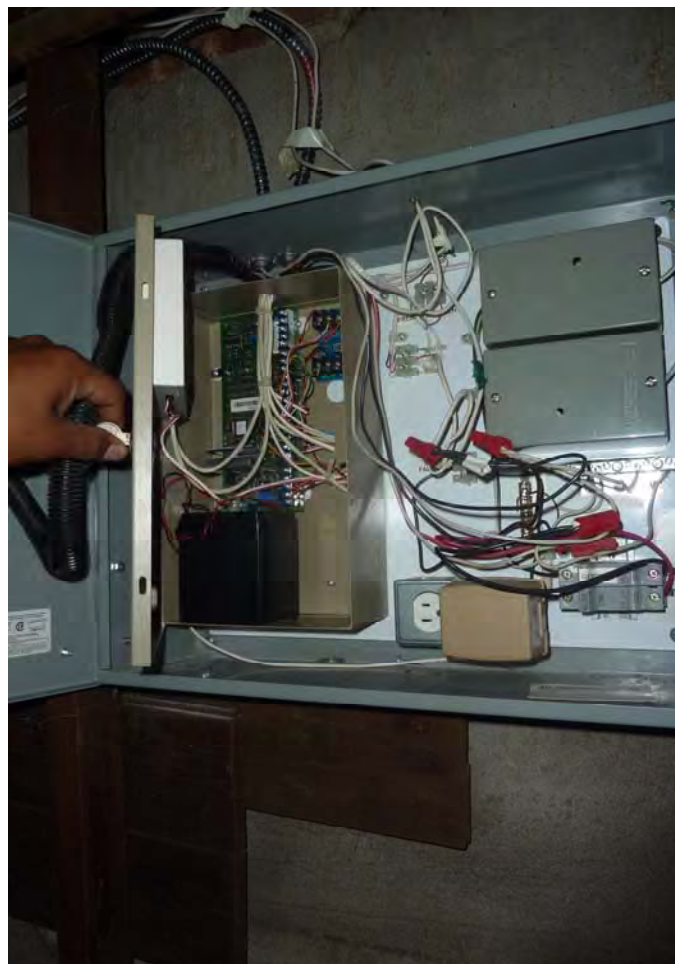
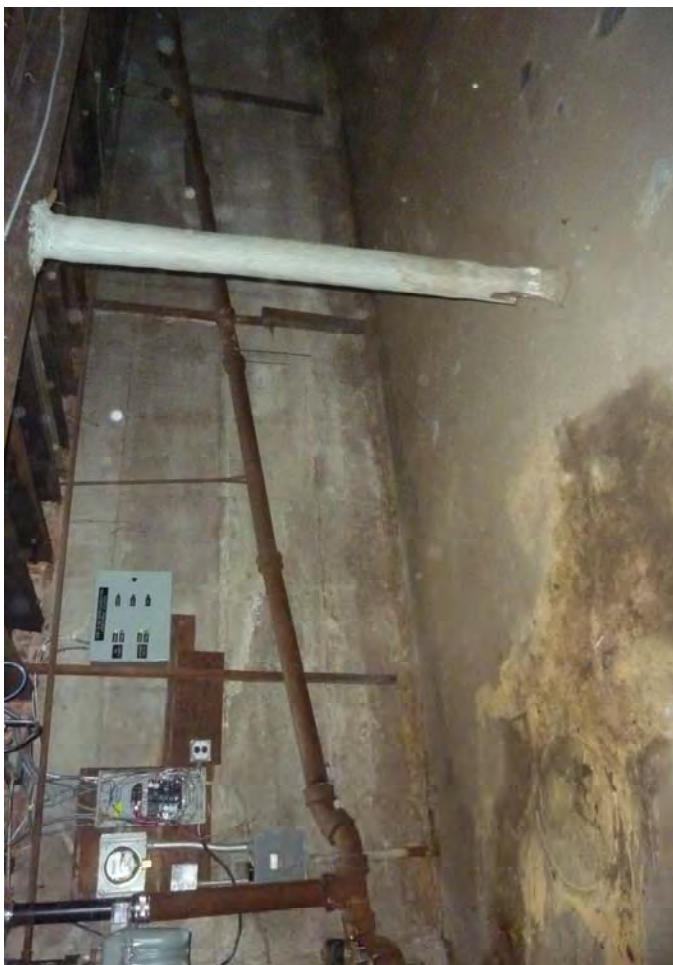
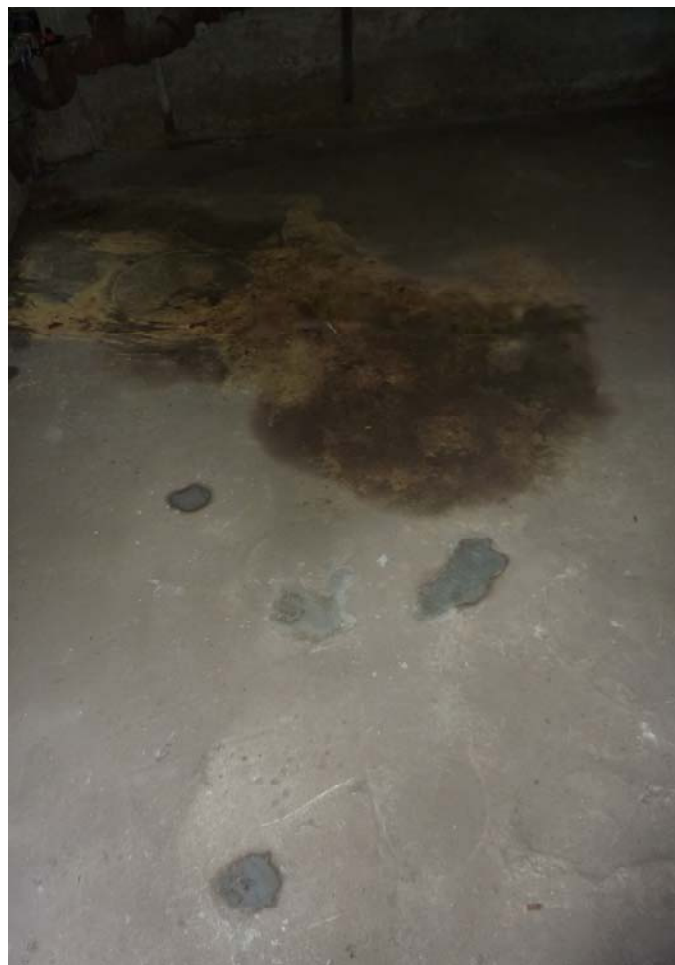
**ATTACHMENT 1  
PHOTOGRAPHS  
OF COMPLETED  
CONCRETE WORK**

On July 18 & 19, 2016, the Owners contracted with Jose K. Rogel Padilla Construction to repair the holes discovered in the eight (8) basement units for 127-1, 3, 5, 7, 9, 13, 15 and 17. Photographs of these concrete repairs can be found in Attachment 1. The remaining 3 units (127-19, 21, and 23) have finished basement and no deficiencies were observed at the time of the inspection.

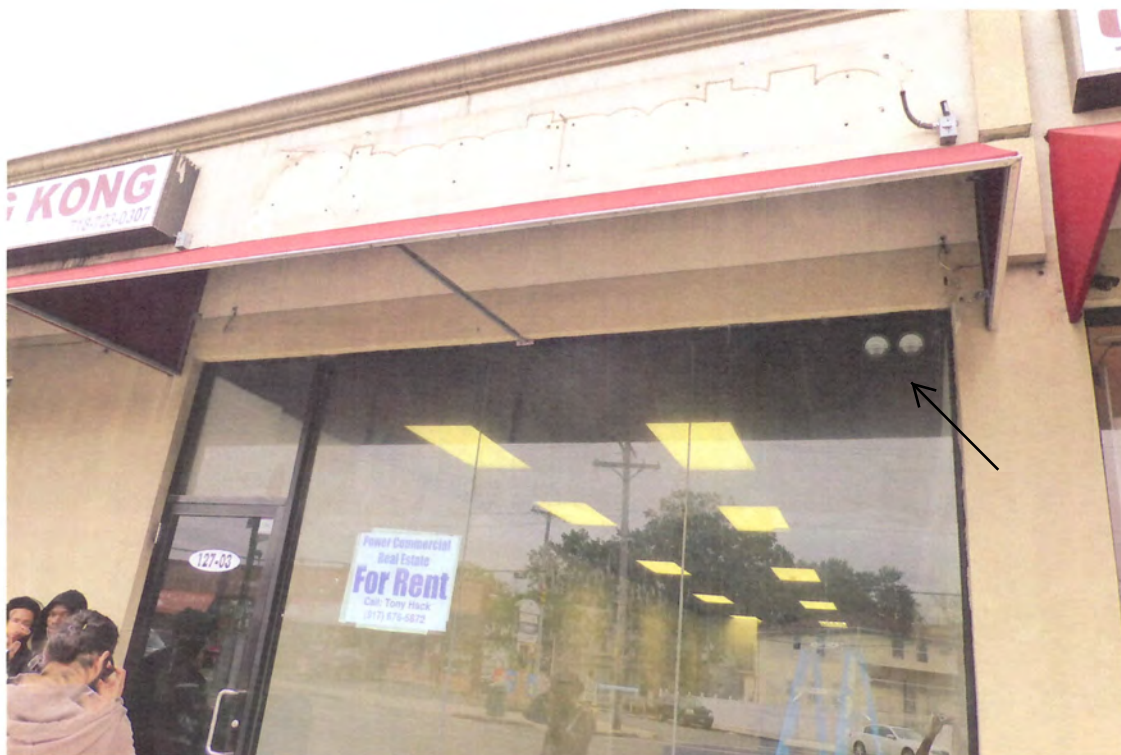
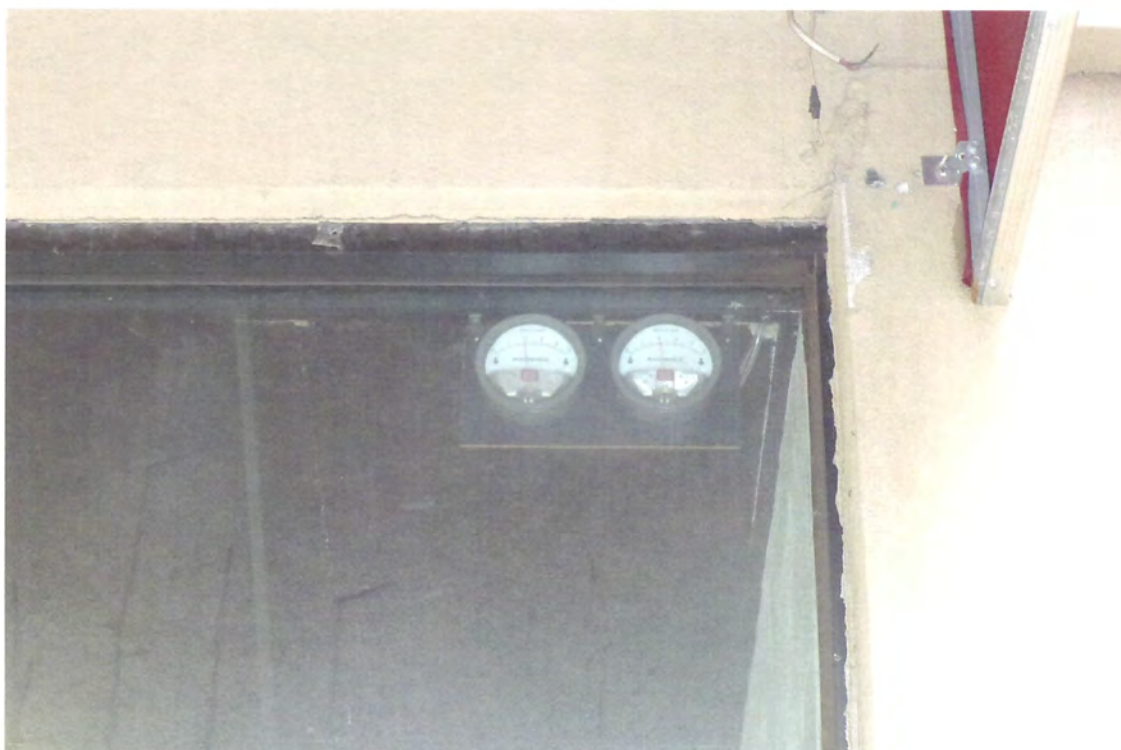
**PHOTOGRAPHS  
OF MAGNAHELIC GAUGES  
INSTALLED ON SEPTEMBER 29, 2016**

Through further investigation on July 19, 2016 it was determined that the light and siren were in fact installed on the ground level within Unit 127-03 just above where the control panel is located in the cellar. The light and siren are installed adjacent and above the front door of the store, visible to occupants of the store and from the street. We will not be relocating the existing warning light to Little Caesars (Unit 127-07) as previously discussed. The addition of two magnehelic gauges visible from the street was completed on September 29, 2016. Photographs of this installation can be found in Attachment 2.

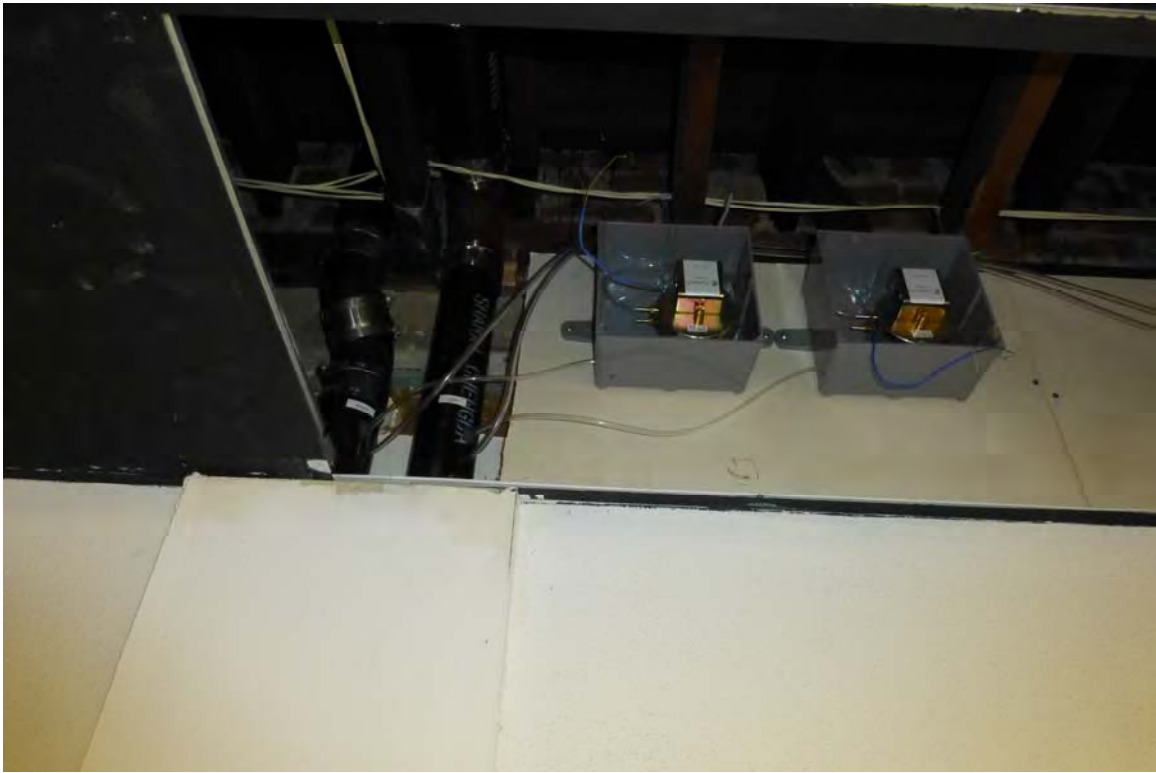
**PHOTOGRAPHS  
OF PRESSURE SWITCHES  
INSTALLED ON SEPTEMBER 29, 2016**

During a recent service call with the company who installed the SSDS control panel, All-time Detection, Inc., it was determined that the two pressure switches in the original design were not installed during the initial installation of the SSDS. As a result, two new pressure switches were installed within the dropped ceiling of the ground level of Unit 127-03 and connected to the control panel in the cellar. The system was tested at the end of the repairs and was properly operating. Photographs of this installation can be found in Attachment 3.
