TYLL ENGINEERING & CONSULTING PC

Re: Annual Certification and Corrective Actions Report
Certification Period: 5/19/16 to 9/29/16
NYSDEC Site Number: 241128
127-13 Merrick Blvd., Jamaica, NY

Repair of Deficiencies of the Concrete Slab

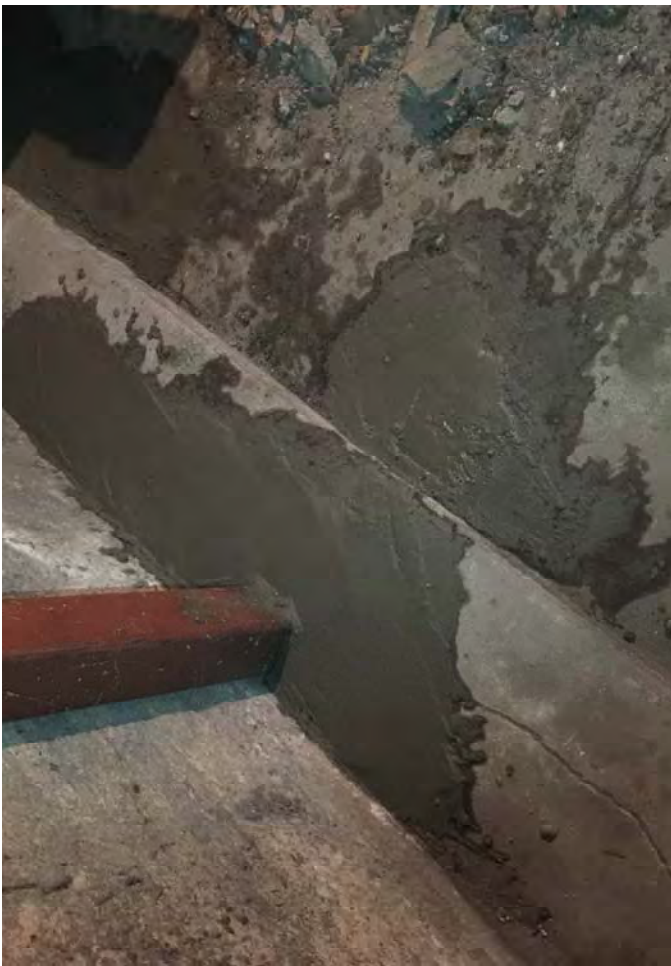
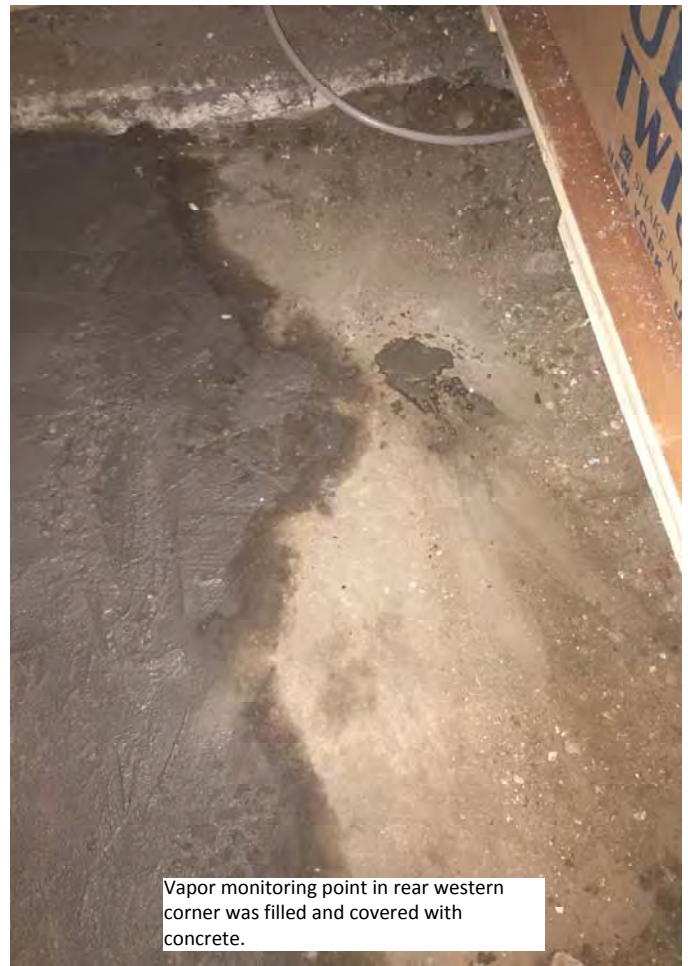
Vapor monitoring point in rear western corner was filled and covered with concrete.

Groundwater monitoring well in center of basement corner was filled and covered with concrete.

During the repair of the concrete slabs in the multiple basements, two monitoring points were discovered in the basement of unit 127-13. One point was a vapor monitoring point (VP-3) in the northeastern corner of the basement and the other was a <1" diameter PVC monitoring well in the center of the basement. Both points were filled with cement/grout to grade as specified in Section 2.1 Grouting In-Place within the NYSDEC document "CP-43: Groundwater Monitoring Well Decommissioning Policy". Photographs of the closed points can be found in the photos for 127-13 Unit in Attachment 1.
