### **Periodic Review Report**

**February 2025 to February 2026**

**32-01 57<sup>th</sup> Street Site**

**NYSDEC Site # 241197**

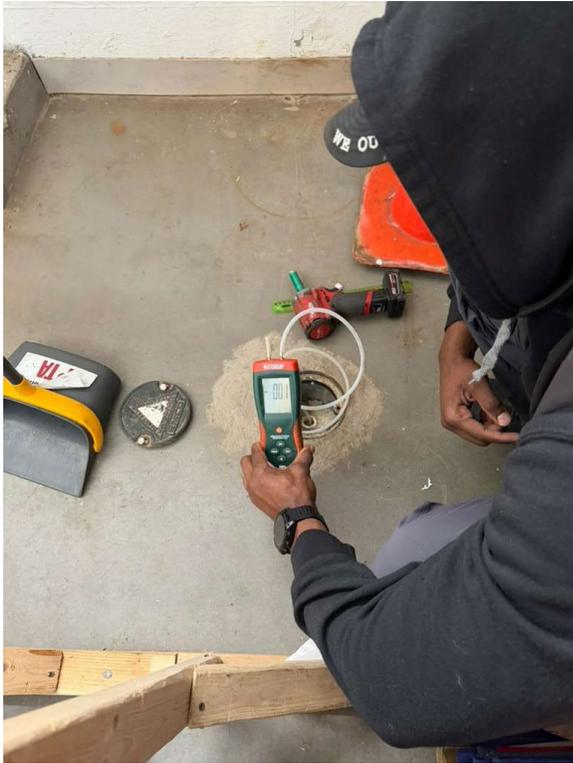
As noted above, the negative pressure (vacuum) at the Magnehelic gauges was recorded between -1 WC at SSDS-4 and -2 WC at SSDS-3. The measured vacuum at the sub-slab vacuum monitoring points Probes #1 to Probe #5 ranged between 0.01 WC at Probes #1, Probe #2 and Probe #5, and -0.52 WC at Probe #4. No organic

Vacuum measurement at  
Probe #1

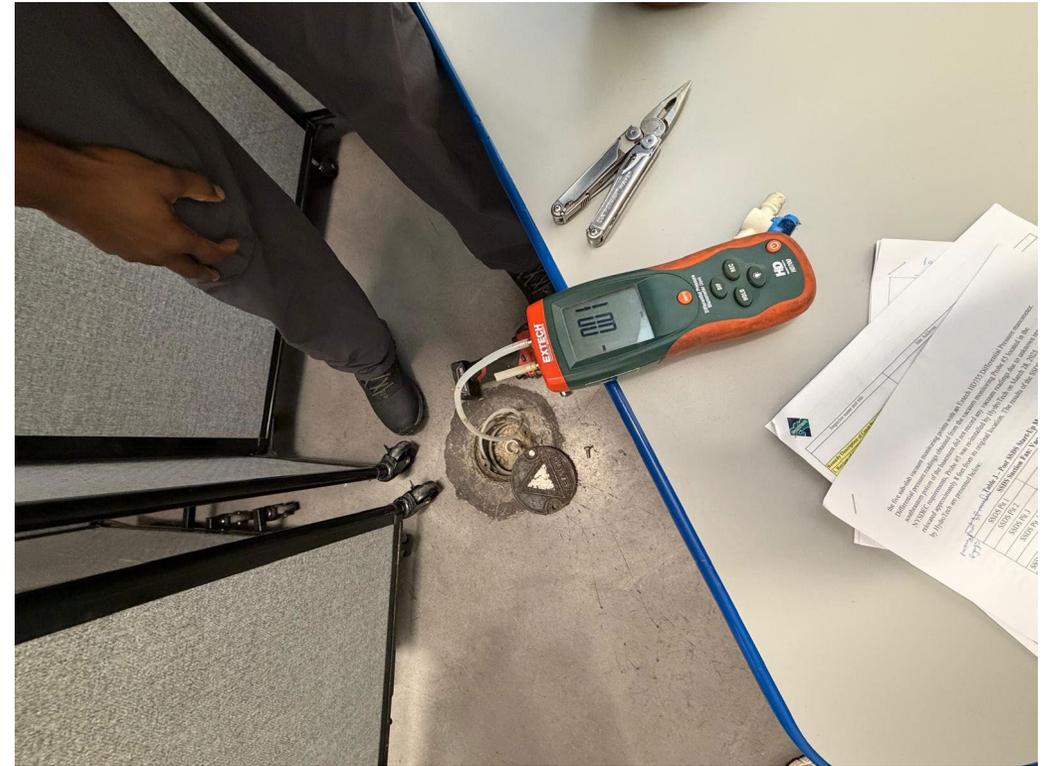
Vacuum measurement at Probe #2

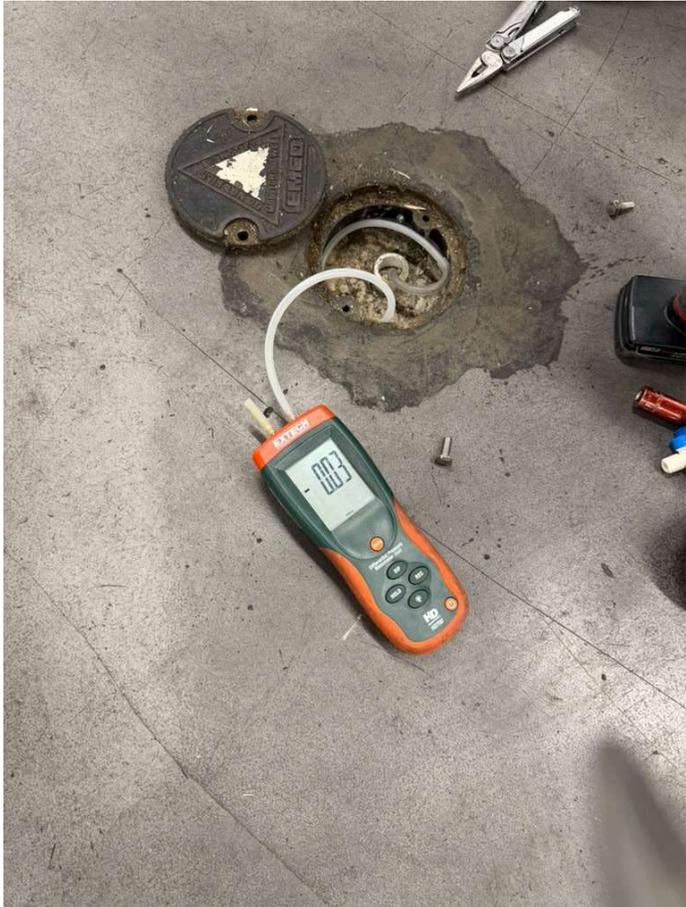
Vacuum measurement at  
Probe #3

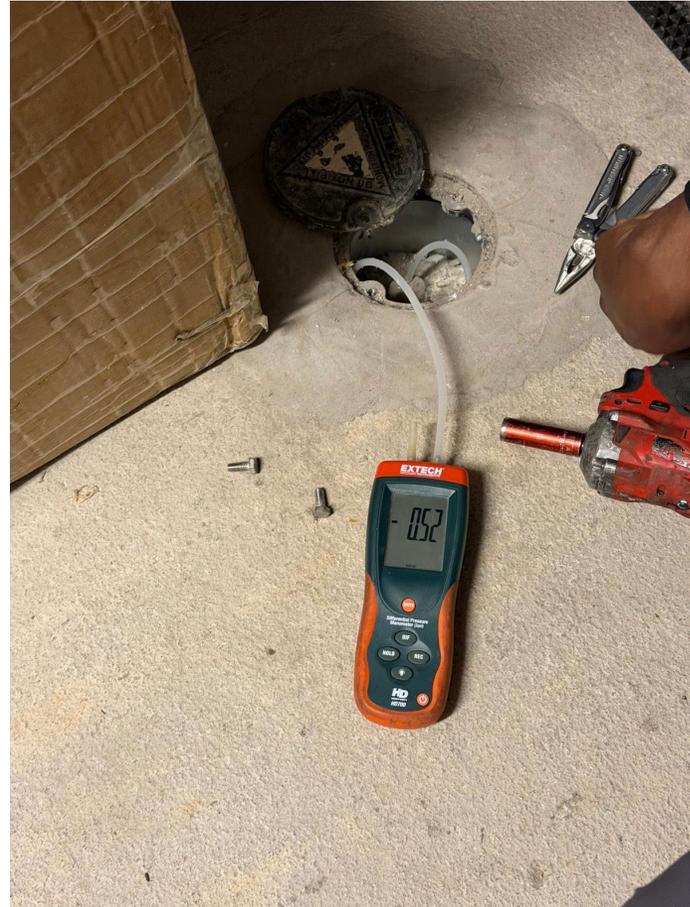
Vacuum measurement at  
Probe #4

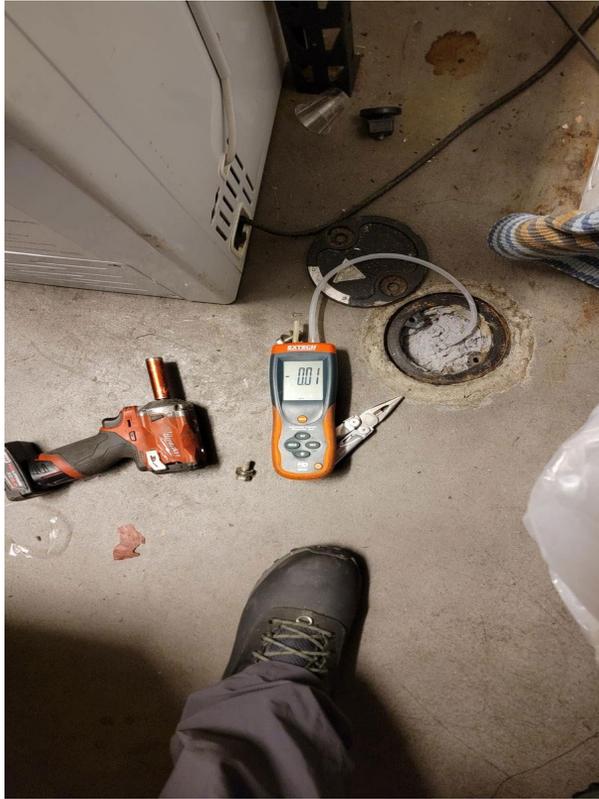
Vacuum measurement at  
Probe #5

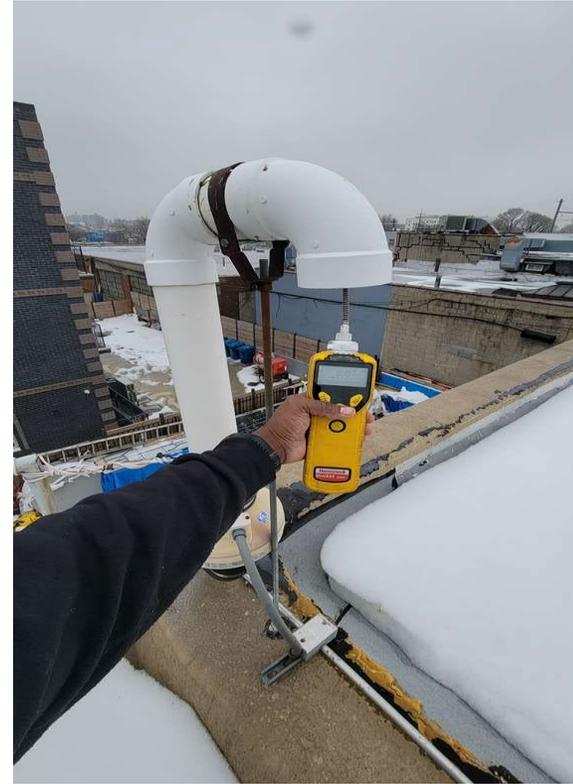
The SVE system inspection and monitoring during this reporting period indicate the system components including the suction fan, the individual Magnehelic gauges and alarm are functioning properly in accordance with the SVE system OM&M in the SMP. The negative pressure dial at the SVE Magnehelic gauge indicated a vacuum of -4 WC. Also, no organic vapors (<0.1 ppm) were measured with the PID the SVE exhaust. The monitoring of the SVE system during this period also reflects a comparable performance noted during the previous February 2025 monitoring event.

Organic vapor measurement at  
SVE effluent

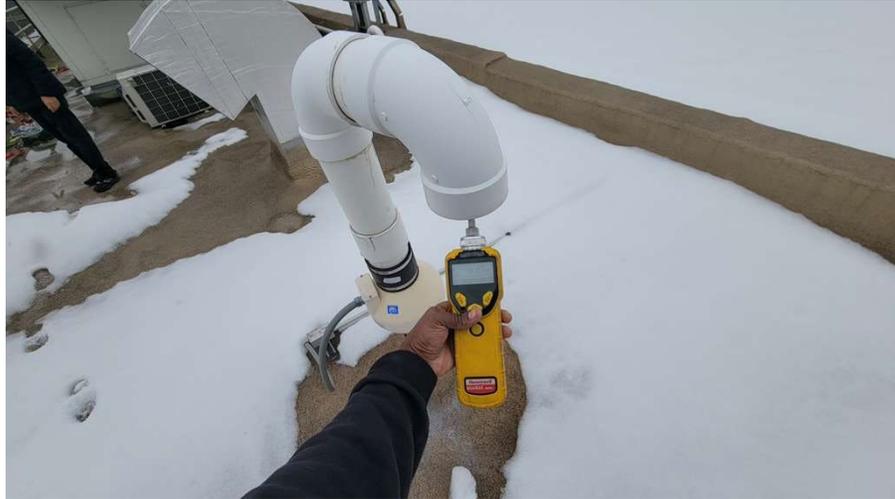
vapors (<0.1 ppm) were measured with the PID the two exhausts from SSDS Pit 1 to SSDS Pit 3 and SSDS-4. Overall, the recent SSDS monitoring data reflects a comparable performance noted during the previous February 2025 SSDS monitoring event.

Organic vapor measurement at the effluent from SSDS Pit 1 to SSDS Pit 3

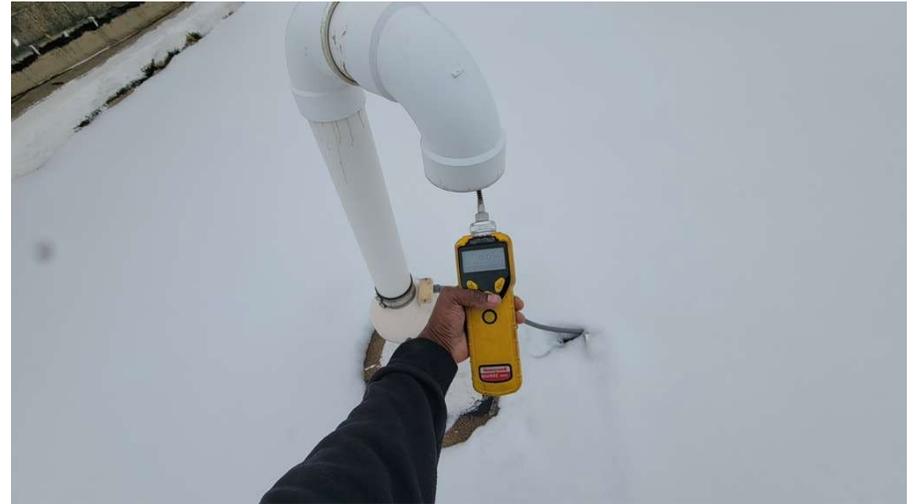
Organic vapor measurement at the effluent from SSDS Pit 4

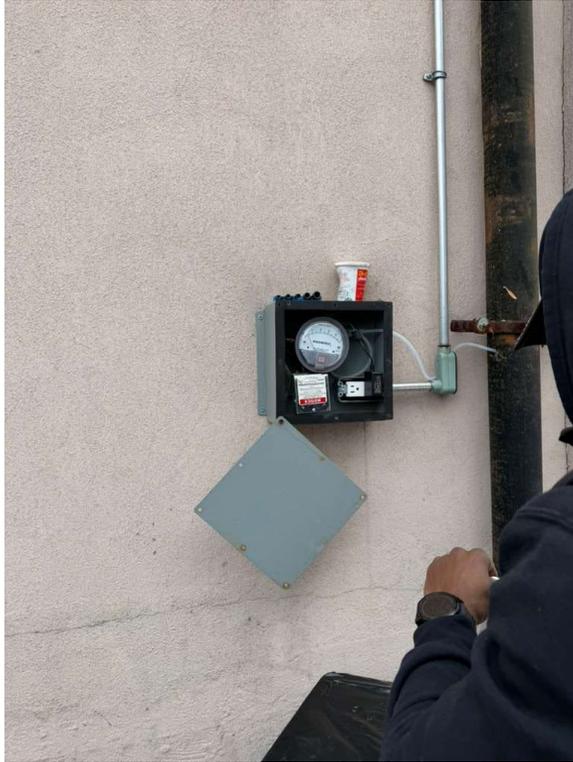
Dwyer magnehelic gauge and alarm at SVE system

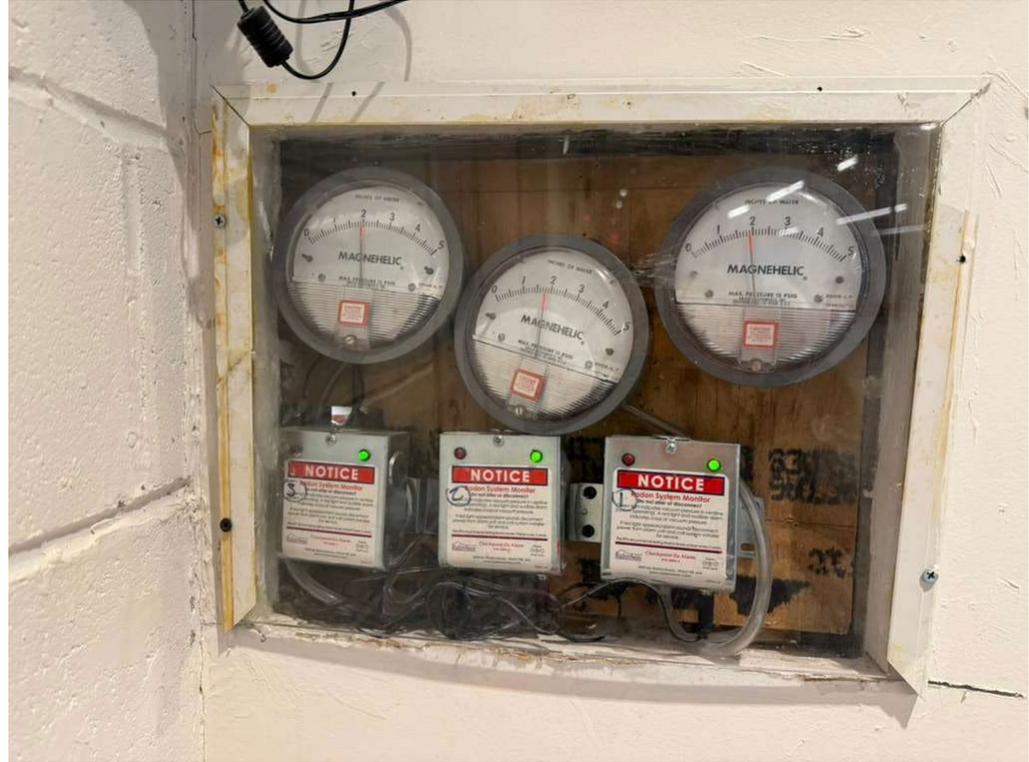
Dwyer magnehelic gauges and alarms at SSDS Pit 1 to Pit 3

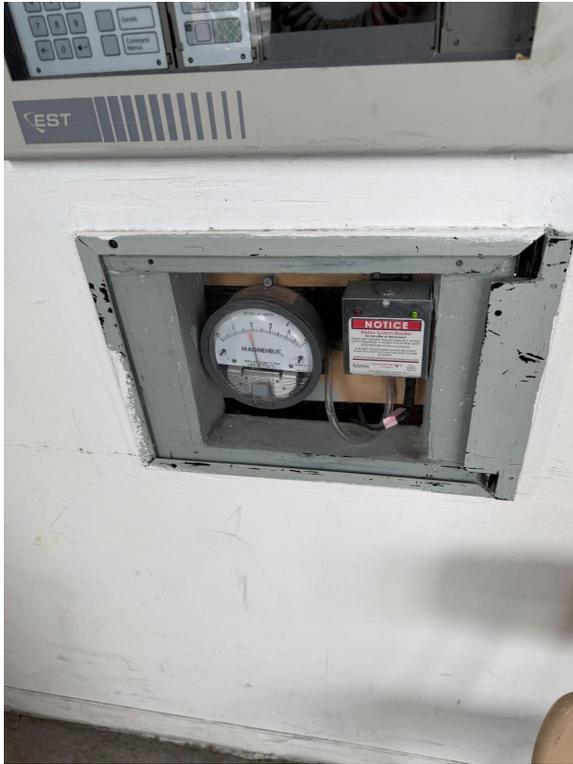
Dwyer magnehelic gauge  
and alarm at SSDS Pit 4

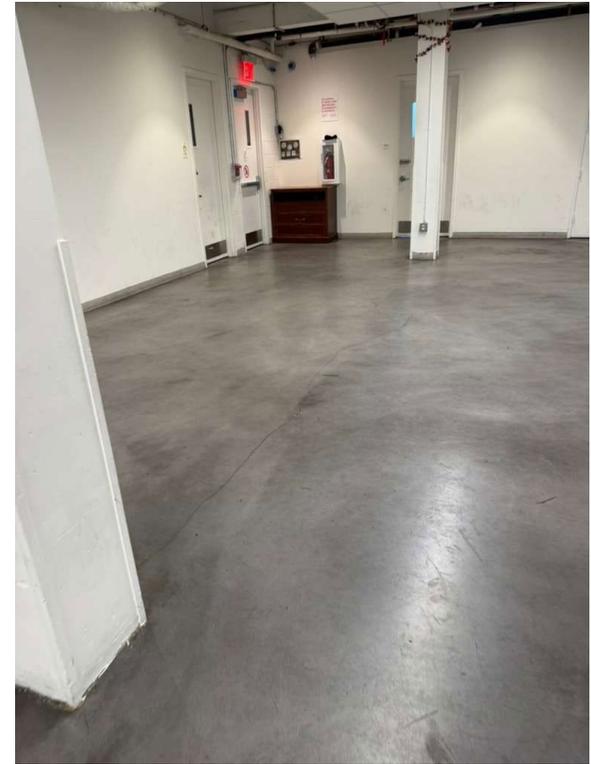
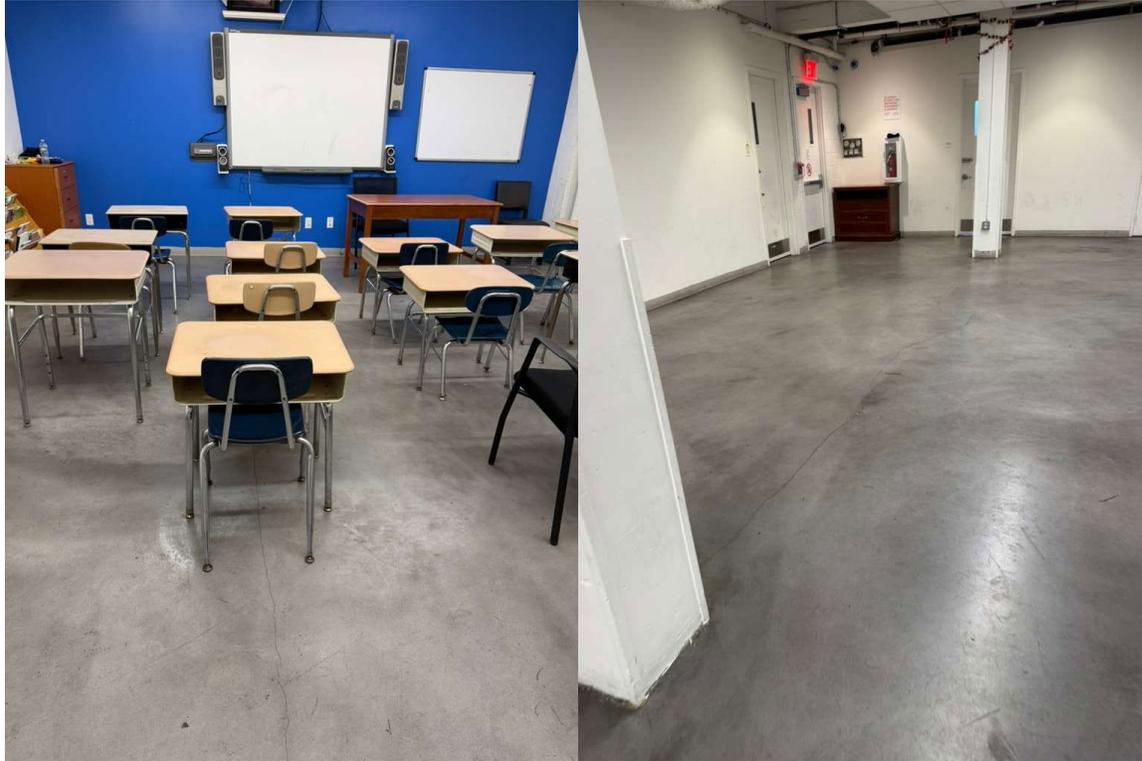
Findings of the inspection observations indicated the cover system was not altered and it continues to show evidence of the same surficial cracks observed in the building slab and around slab joints as during the February 2025 inspection. These cracks range in thickness from 1 to 2 millimeters.

The cover system at the Site shows evidence of surficial cracks in the slab that should not short-circuit the negative pressure under the slab by the SSDS as evidenced by the satisfactory vacuum communication measured at the sub-slab vacuum monitoring points. Monitoring at the five vacuum monitoring points (Probe #1 to probe #5) achieved the minimum vacuum of -0.01 WC required for this Site. This sub-slab vacuum is induced by the operation of the two SSDS suction fans at the SSDS Pit 1 to SSDS Pit 3, and SSDS Pit 4.

View of fine cracks in the  
basement slab

View of fine cracks in the basement slab

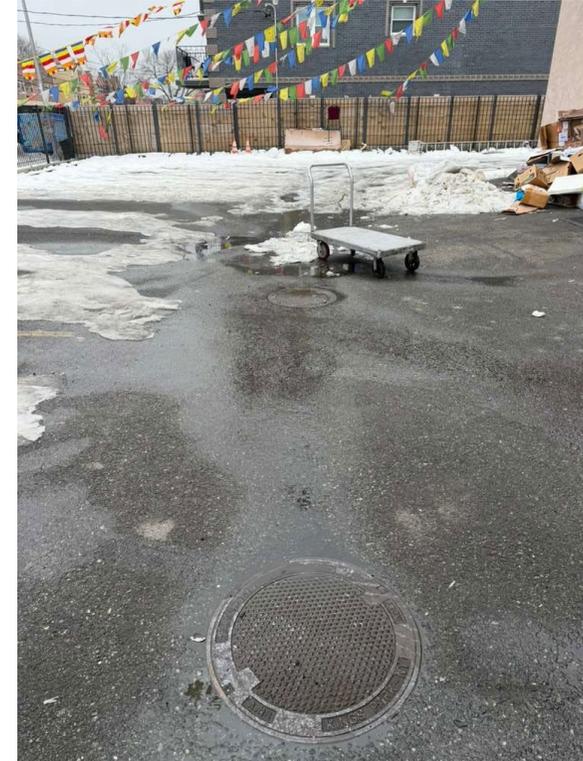
View of manholes of retention tank system beneath the open parking area
