FORMER DURASPEC ELECTROPLATING FACILITY  
QUEENS COUNTY  
JAMAICA, NEW YORK

## 2024-2025 PERIODIC REVIEW REPORT

Reporting Period December 12, 2023 to December 12, 2024

NYSDEC Site Number: 241204

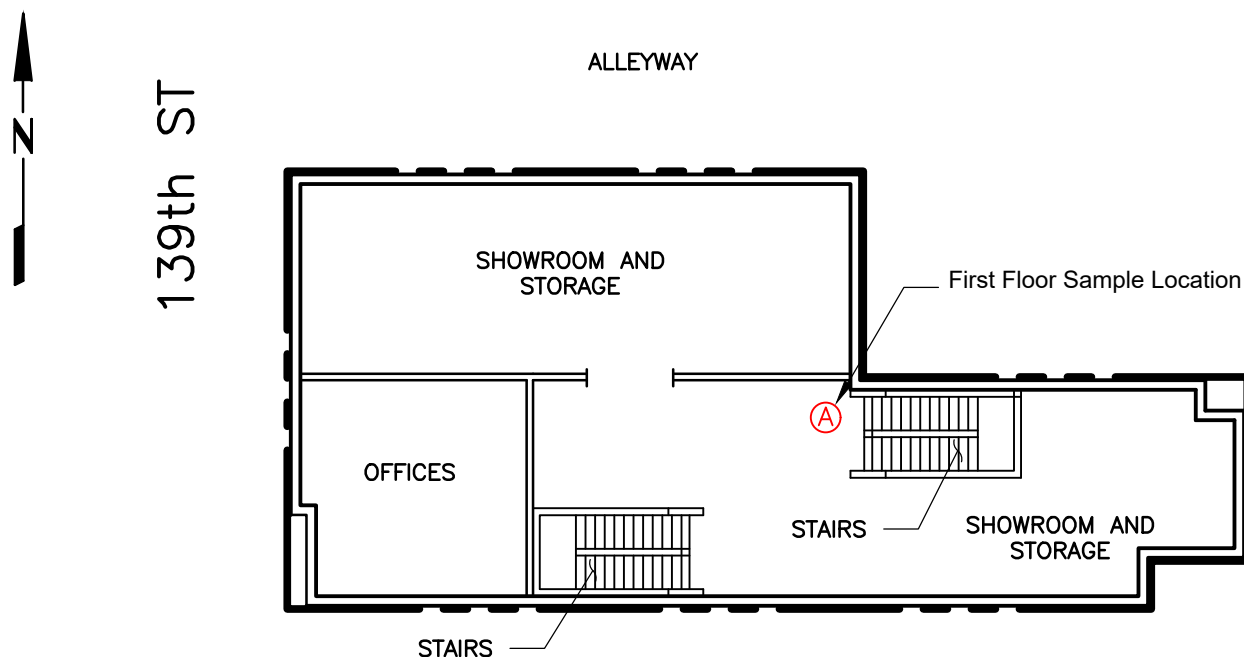
Indoor Air Sampling Location  
First Floor  
Figure 3A

Since the SSDS was placed into operation, there have been no exceedances of the NYSDOH indoor air guidelines for PCE or TCE. In November 2024 TCE was not detected in either of the indoor air samples. PCE and TCE were not detected at reporting levels of 0.037 ug/m<sup>3</sup>. Carbon tetrachloride, a substance not related to the operations at Duraspec and not detected in the previous soil vapor samples, was detected between 0.081 ug/m<sup>3</sup> and 0.083 ug/m<sup>3</sup> during the most recent sampling round. Other VOC detections were recorded at relatively low levels. The data collected from the November 2024 sampling round is included on Table 1. A presentation of the historical detections measured since 2019 are included on Table 2.

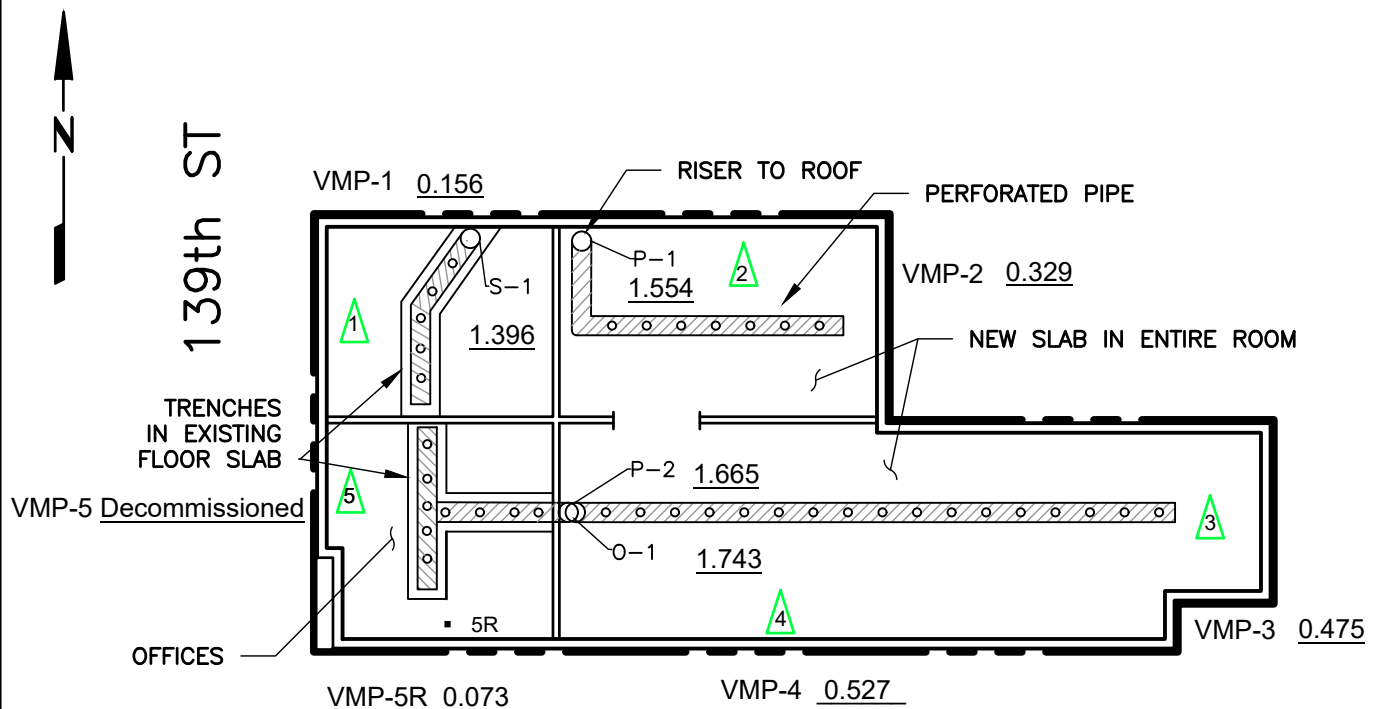
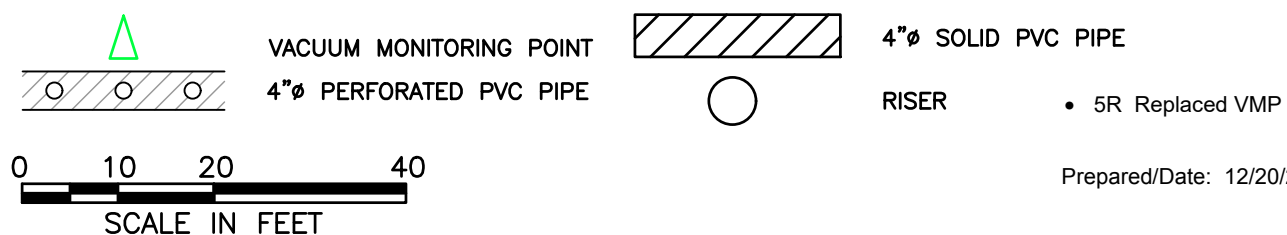
SSD System And Vacuum  
Monitoring Points  
Figure 4

All of the SSDS fans and piping were inspected during the November 2024 sampling event and everything was observed to be in good working order. The measured vacuum in the four SSD riser pipes ranged from 1.396 to 1.743 inches of water. A map summarizing our observations and measurements is included as Figure 4.

Five vacuum monitoring points (VMPs) were installed for use during the pilot and start up tests of the SSDS. Identified as VMPs 1 through 5R, the five points were located and measured on November 8, 2024. (The original VMP-5 is located in a carpeted office and was decommissioned on November 16, 2023. A new VMP, identified as VMP-5R, was installed in the floor of a closet located in the hallway outside of the office.) The measured vacuum in the five VMPs ranged from 0.073 to 0.527 inches of water. This information is also summarized on a map which is included as Figure 4.

- Prior to the 2025 sampling event, the tenants should be notified in advance in order to make sure the vacuum monitoring ports on the riser vents and the VMPs are accessible.

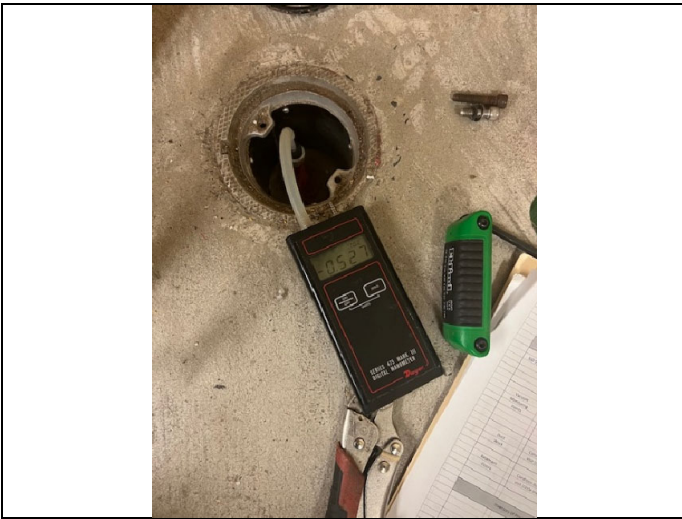
1. Measuring Pressure in vacuum point VMP-4

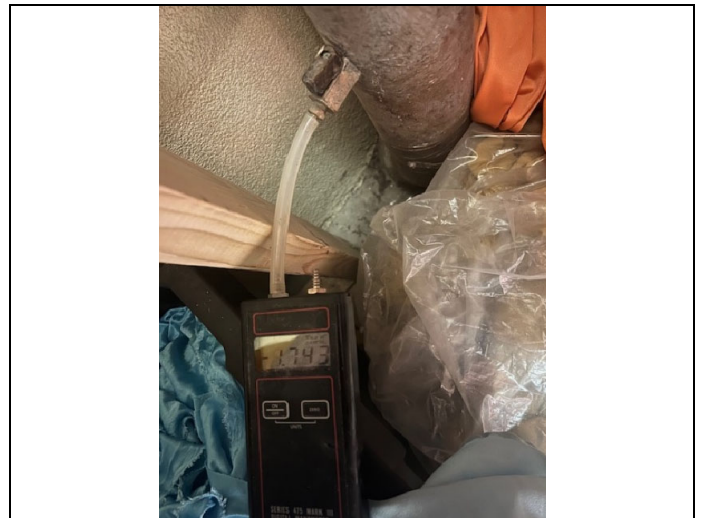
4. Measuring Pressure in fan O-1

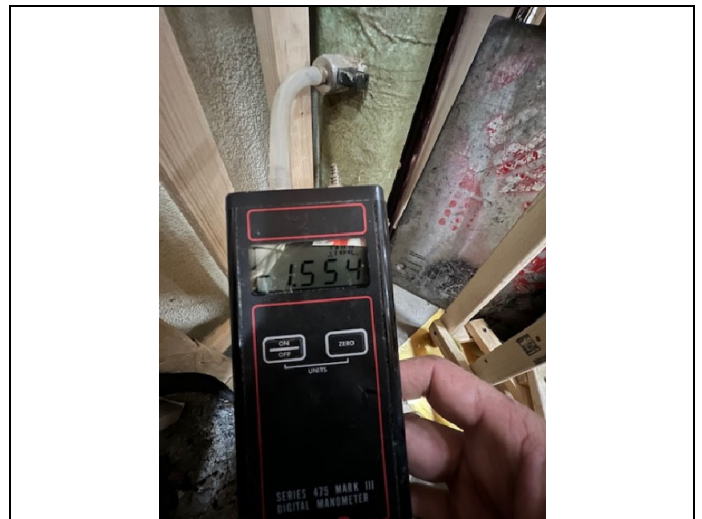
6. Measuring Pressure in fan P-1

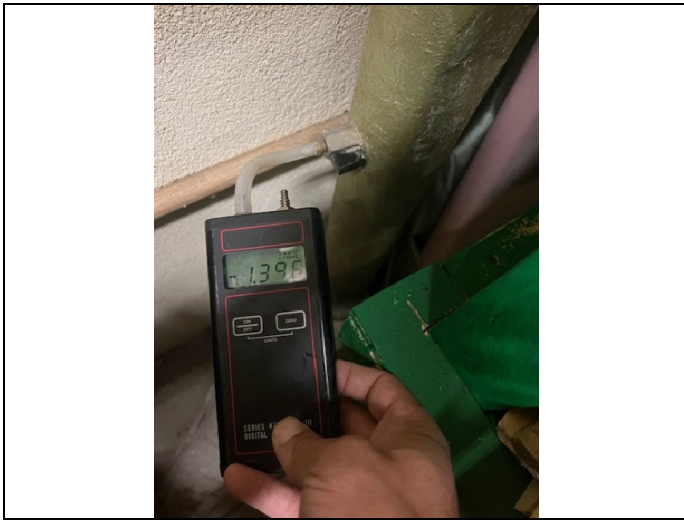
7. Measuring Pressure in fan P-1

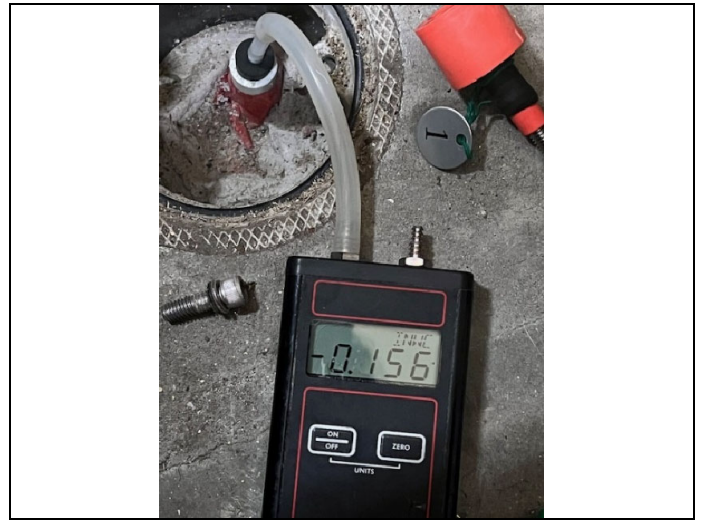
8. Measuring Pressure in vacuum point VMP-1

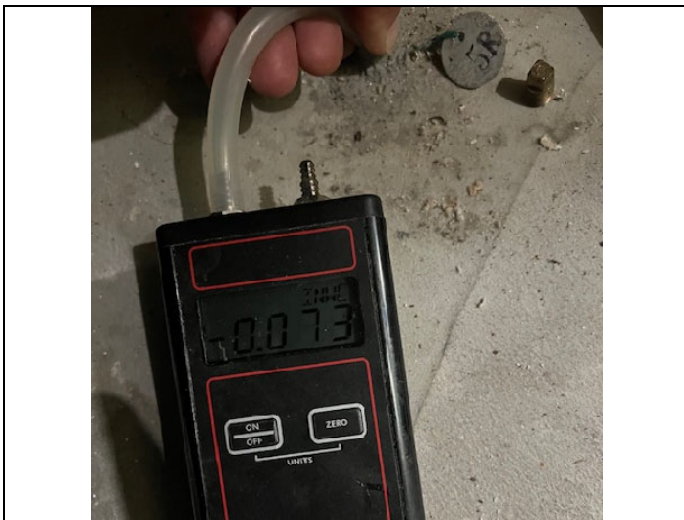
9. Measuring Pressure in vacuum point VMP-5

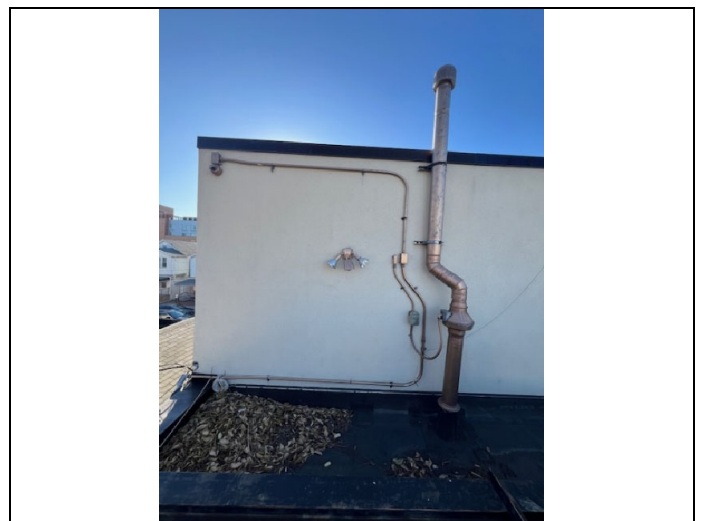
12. SSDS Fan on the Roof
