# PERIODIC REVIEW REPORT MARCH 2020 – MARCH 2023

**SCHATZ FEDERAL BEARINGS  
CITY OF POUGHKEEPSIE, NEW YORK 12602**

**NYSDEC Site No. 314003**

JULY 2023

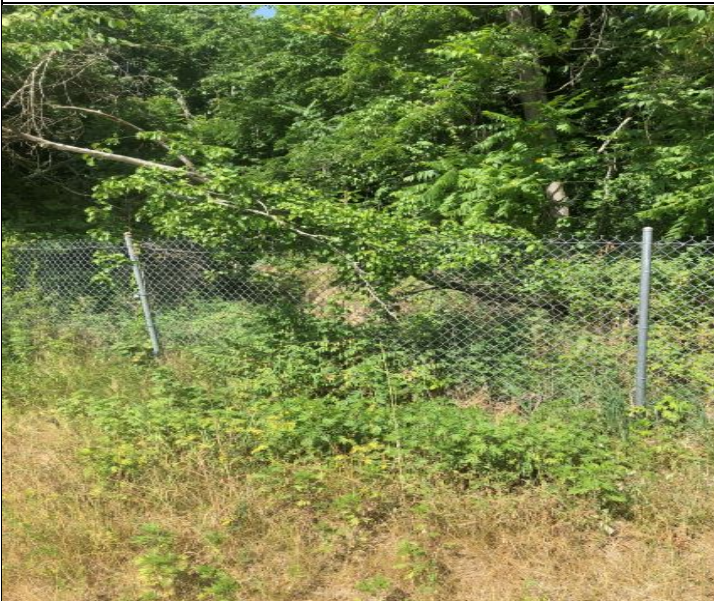
The drainage swales, channels and culverts appear to be in good condition, however vegetation in the drainage channels is currently tall and could possibly impede the flow of water. The swales and channels are stable with no noticeable areas of active erosion. Site access roads around the perimeter of the Site are in good condition, with no signs of erosion along the road. The perimeter fence is in good condition and the gates are secure, except for a fallen tree that has slightly damaged the fence.

**Photo 3:** Tree that has fallen on the perimeter fence on the southern portion of the landfill.

- Remove vegetation within the drainage channels to limit the possibility of Site flooding and erosion of the landfill cap.
- Repair damage to the Site perimeter fence near monitoring well S-8.

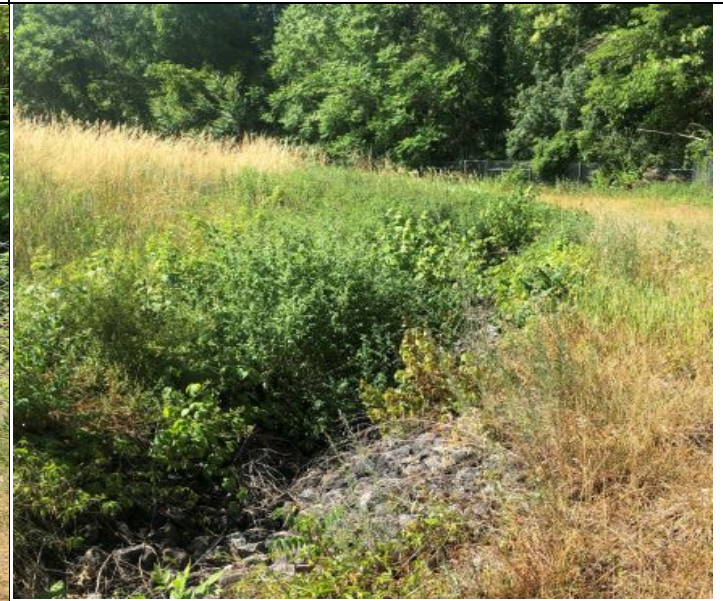
**Photo 4:** Thick vegetation located in the drainage areas near the southern portion of the landfill

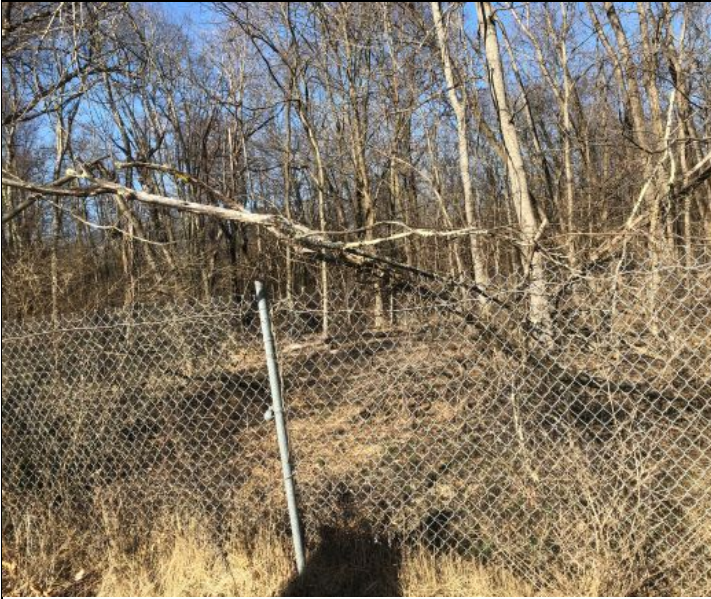
**Photo 5:** Area of where the tree had landed on the fence that was removed by the team during the inspection. Located by the northwest corner of the Site.

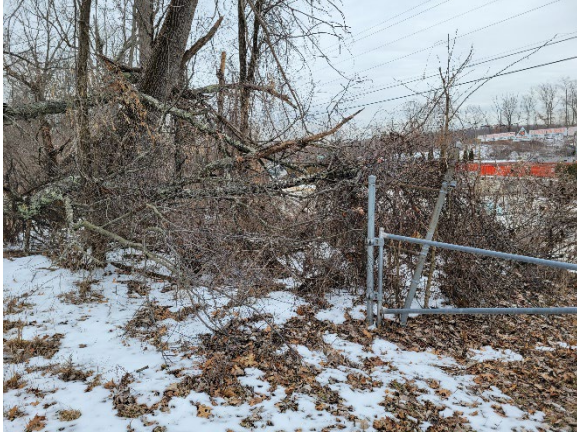
**Photo 1** – Fence damage and downed trees near gate along Van Wagner Road.

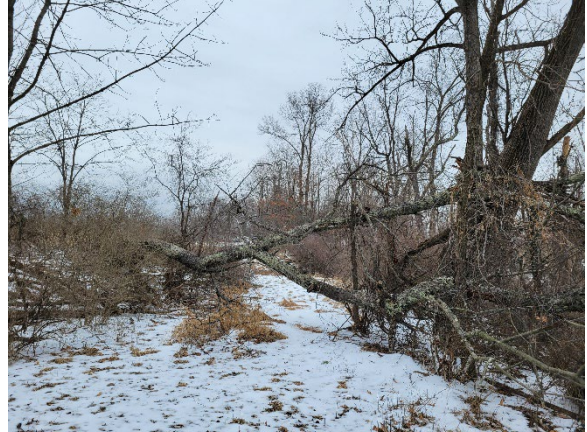
**Photo 2** – Downed trees near gate along Van Wagner Road.

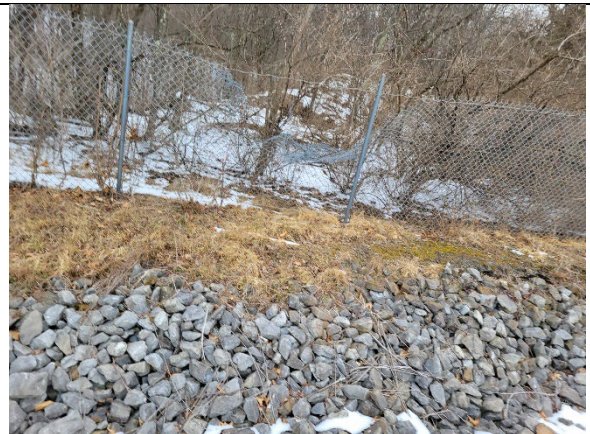
**Photo 6** – Looking north at damage to the fence along the northern boundary of the landfill.

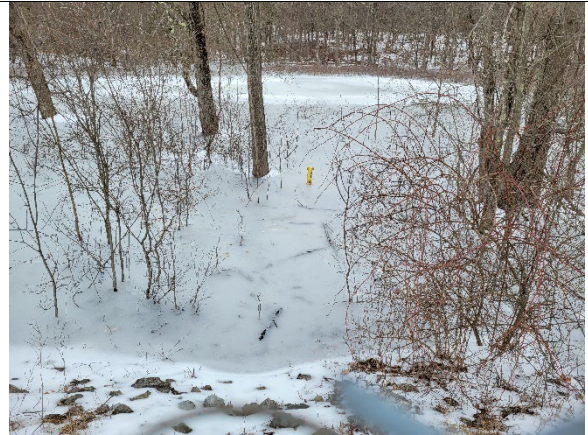
**Photo 8** – Looking north at S-8 located in a flooded and frozen drainage area northwest of the landfill.

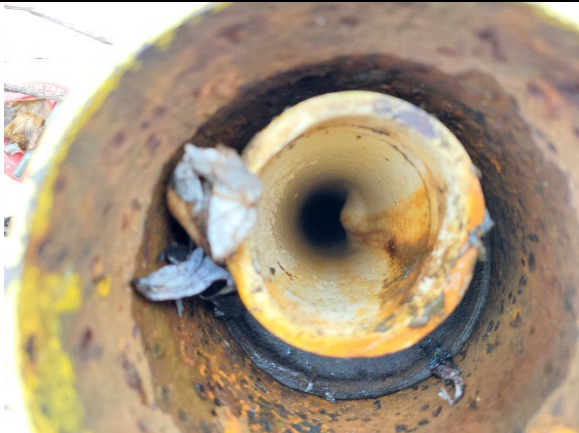
**Photo 8** – Well casing damage observed in S-7.

- Repair/replace the well casing lids for monitoring wells B-5, S-4, and S-7 and cut the PVC riser in monitoring well B-1 so that a riser cap can fit and the well cap can be locked.

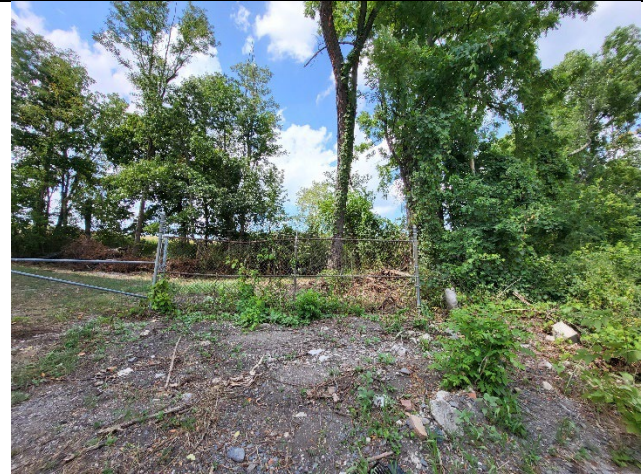
**Photo 2** – Downed trees near gate along Van Wagner Road.

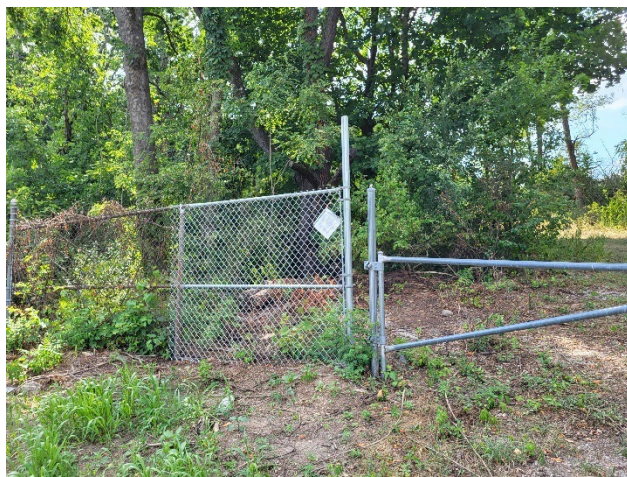
**Photo 3** – View of the new fence section added in by PES, with the tree cut down and cleared.

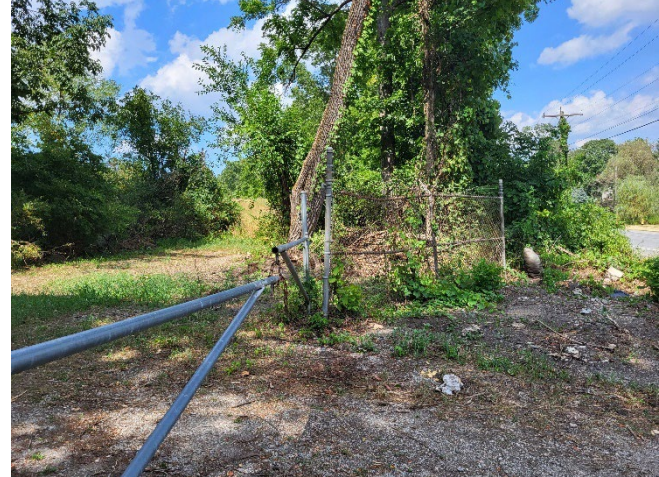
**Photo 4** – View of the other side of the entry fence, tree was cut down and cleared from the area.

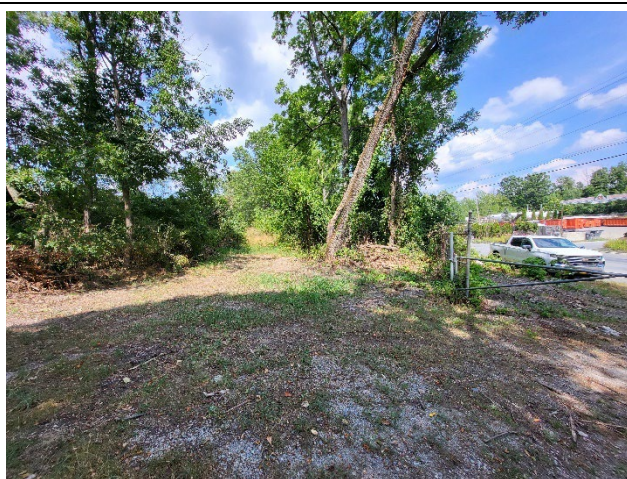
**Photo 5** – Dirt road which has been cleared of all obstructions by PES.

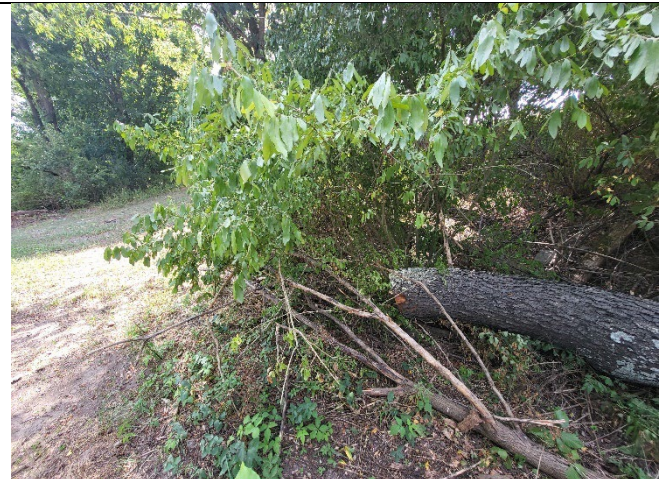
**Photo 6** – Photograph of a cut down tree, which has been moved away from the access roads.

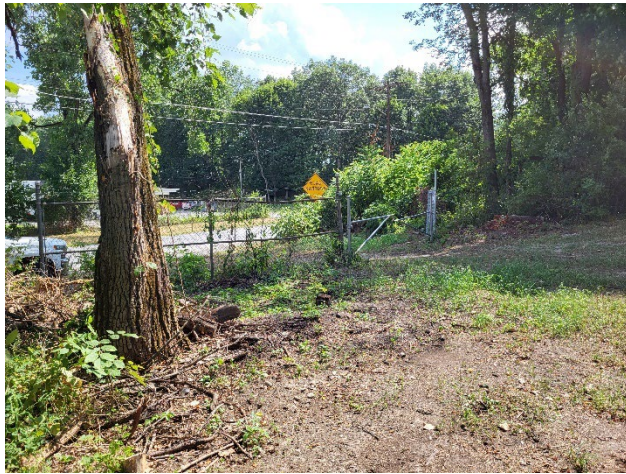
**Photo 7** – Looking toward Van Wagner Road at the cleared trees near the entry gate.

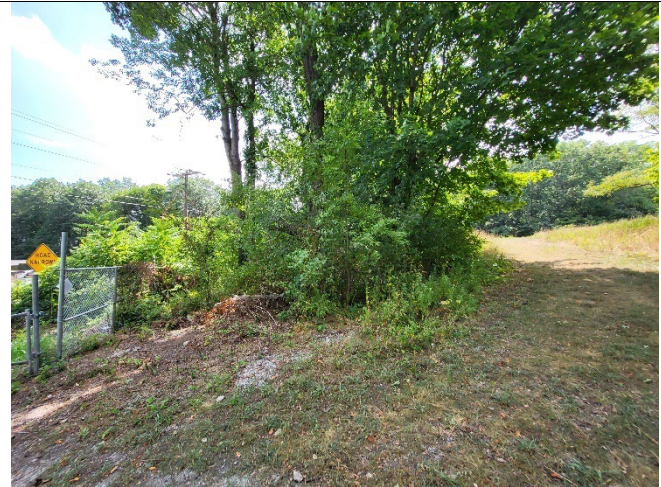
**Photo 8** – View of the access road near the former fallen tree area, which has been cleared,
