REPORT FOR  
INSTALLATION OF ON-SITE MONITORING WELLS  
TEXACO'S INACTIVE DISPOSAL SITE  
BEACON, NEW YORK

Texaco, Inc.  
Beacon, New York

June 18, 1986  
Project File No. 2755

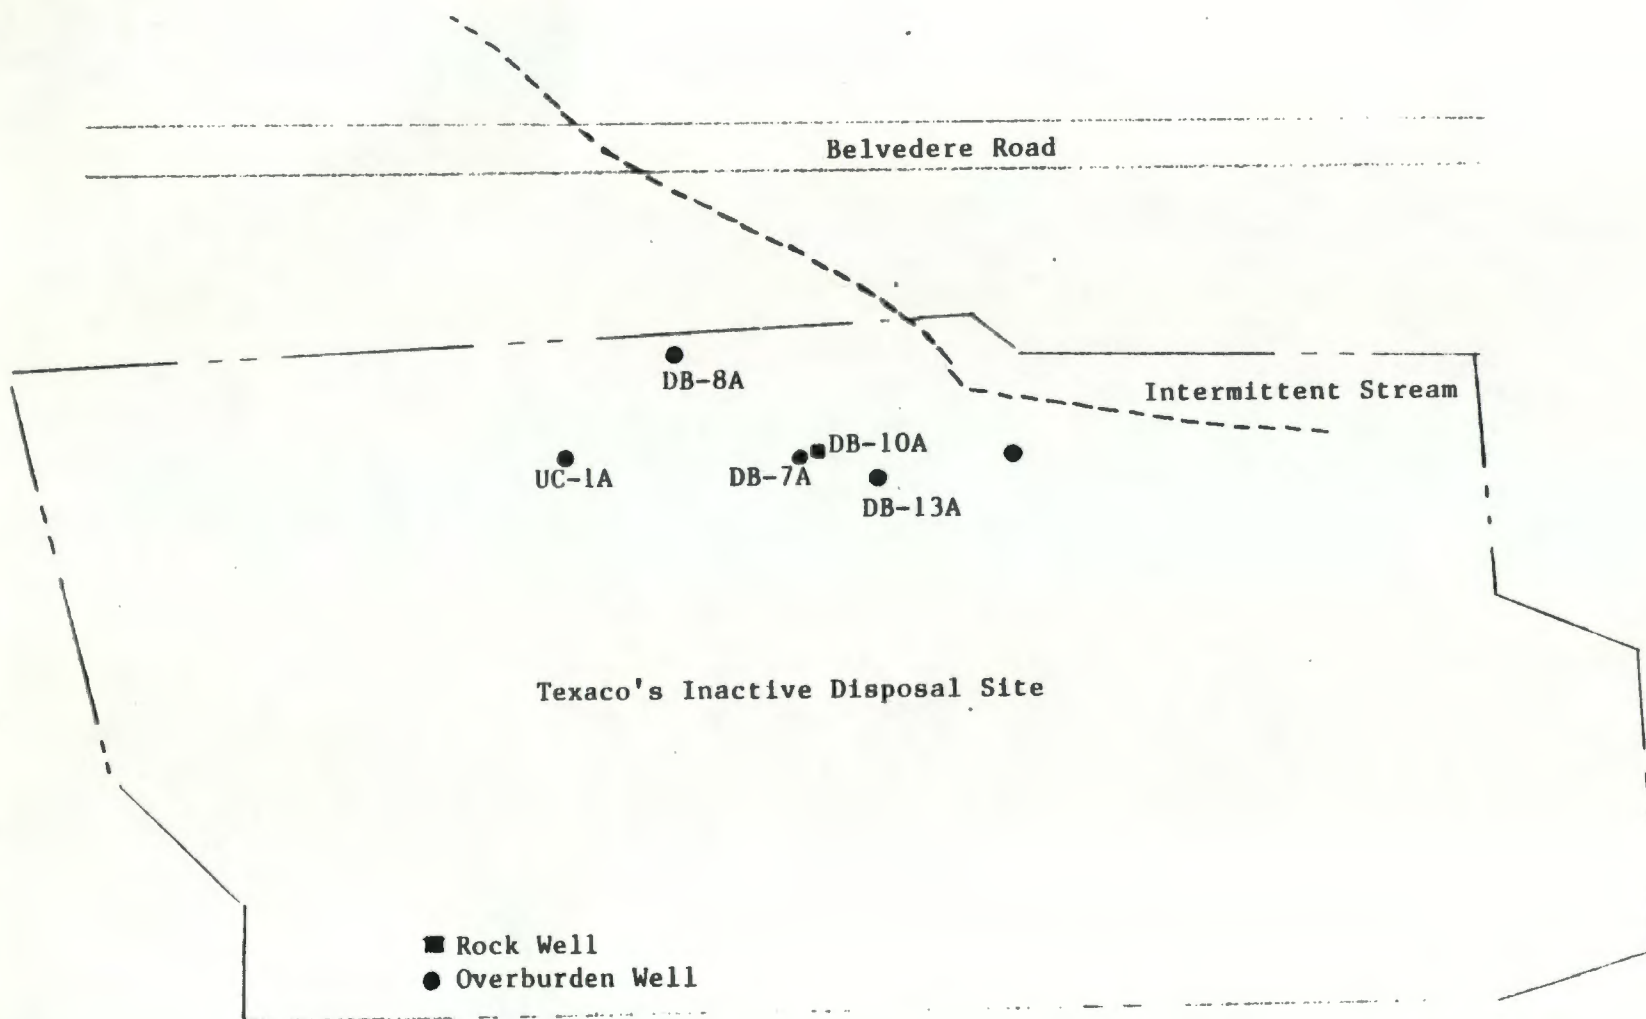
Fig. 2.1

Prior to the start of work, representatives of OHM met with Texaco's representatives to verify well locations relative to the locations of the damaged wells. Figure 2.1 shows the monitoring well locations.

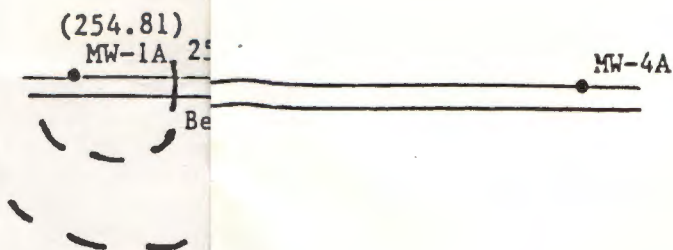
Groundwater levels were measured at selected on-site wells and off-site wells completed in the overburden on February 28. The observed groundwater elevations are listed in Table 1. Interpreted groundwater elevation contours, the locations of wells at which water level measurements were measured, and the locations of the wells slated for replacement are shown in Figure 1.

Comparison of the interpreted directions of groundwater flow indicated in Figure 1 with those in the December 7, 1984 report to Texaco (Project No. 1767) indicate that the changes in topography which have resulted from excavation operations have not significantly affected the groundwater flow regime at the site.
