**RCRA Comprehensive Ground Water Monitoring Evaluation  
(CME) Inspection  
Texaco Research Center  
EPA ID No. NYD091894899  
NYSDEC Site No. 3-14-004  
Town of Fishkill, Dutchess County  
October 2023**

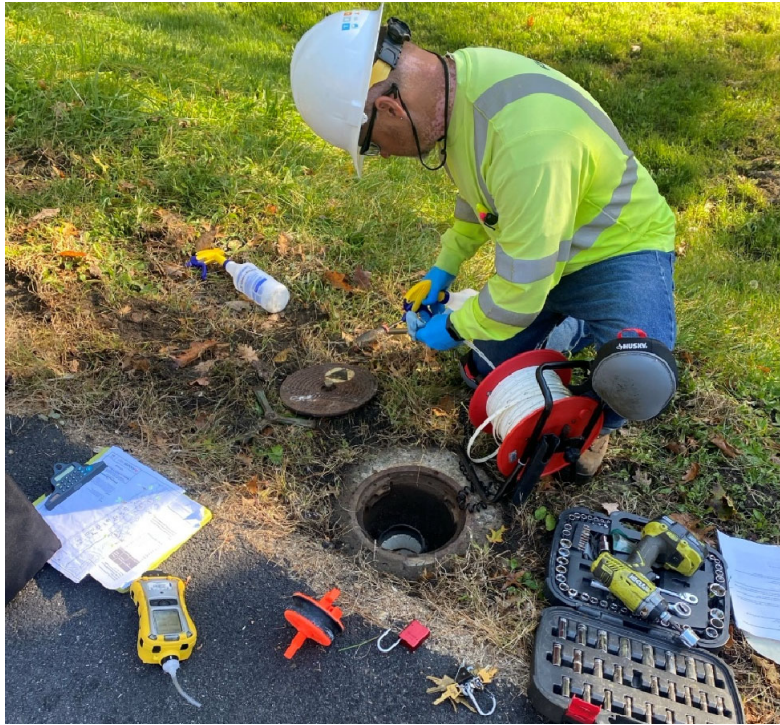
1. Decontamination of interface meter at OS-2.

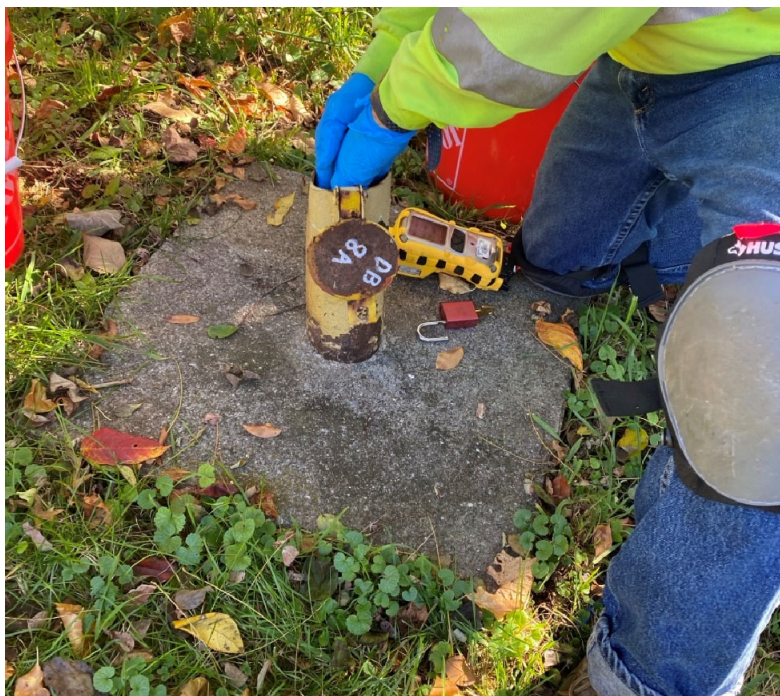
2. Accessing DB-8A for sounding of well.

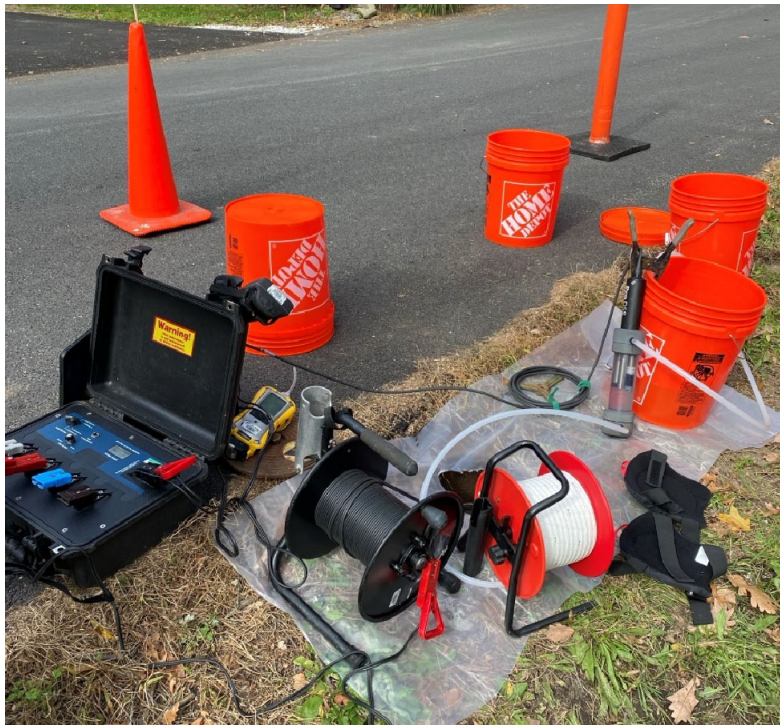
3. Groundwater sampling setup at OS-2.

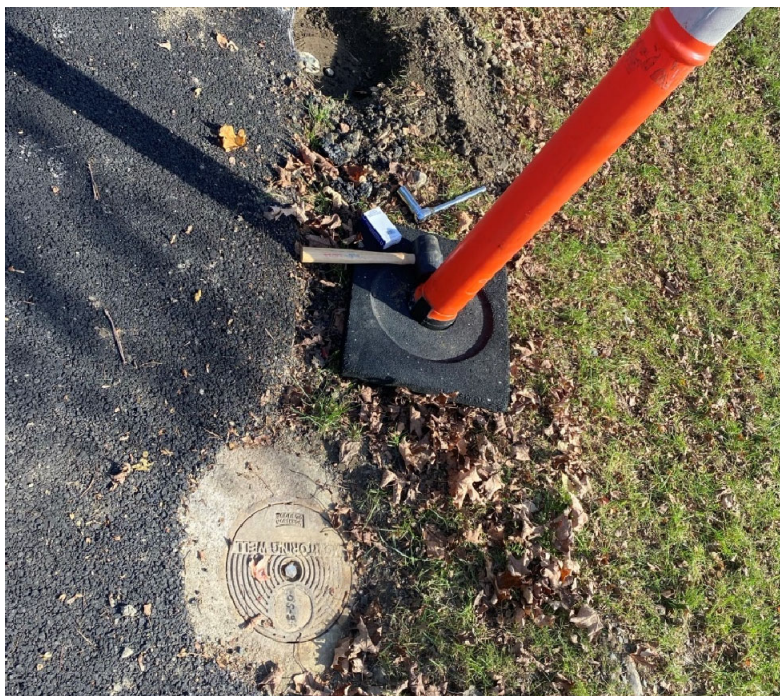
4. OS-3/OR-3. Recent paving buried OR-3. Located with metal detector and exposed.
