GLOBALFOUNDRIES B322 Renovation Project Closure Certification for SWMUs in Building 322, Hopewell Junction, NY Permit Module II of IBM's 6NYCRR Part 373 Hazardous Waste Management Permit

This Certification Letter has been prepared by Arcadis of New York, Inc. (Arcadis) to document the closure of solid waste management units (SWMUs) as part of the partial demolition project for Building 322 at the GLOBALFOUNDRIES US2 LLC Fab 10 Facility, Hopewell Junction, New York. The SWMU closure work was performed pursuant to the *Plan for Closure of SWMUs in Building 322, Hopewell Junction, NY* prepared by Arcadis (April 20, 2018) and approved by New York State Department of Environmental Conservation (NYSDEC) on May 9, 2018.

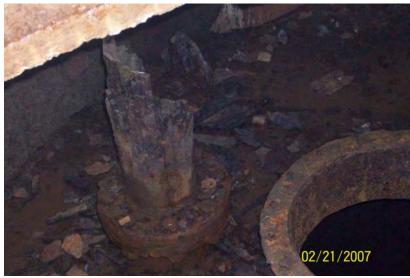
Top of Tank 208

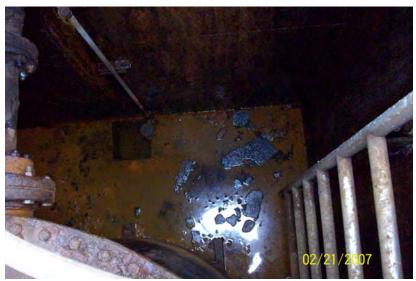
Interior of Tank 208 after the tank was decontaminated.

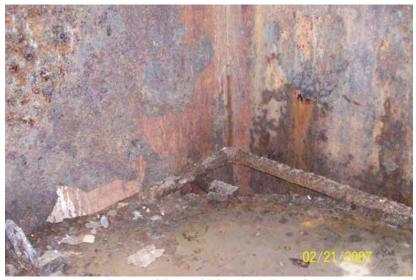
Water noted pooling within the containment dike of Tank 208.

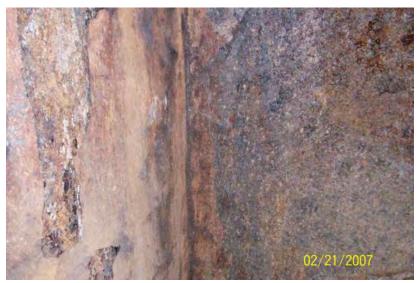
Rusted and corroded conditions within noted the stainless steel containment dike of Tank 208.

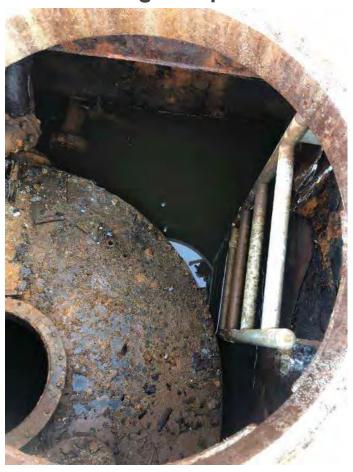
Water In Vault Prior To Being Pumped Out

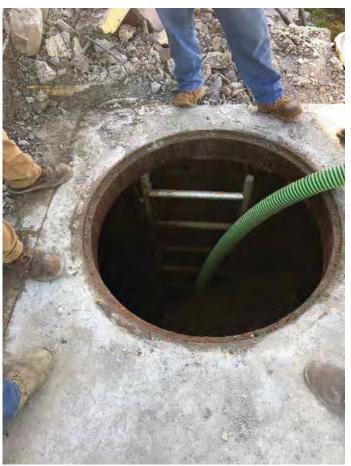
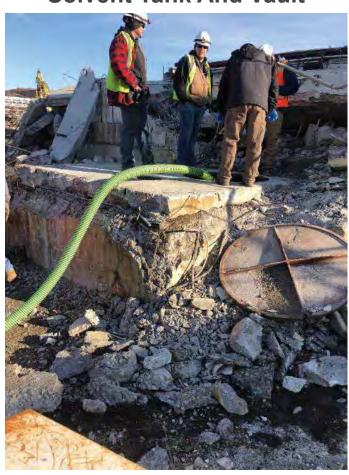
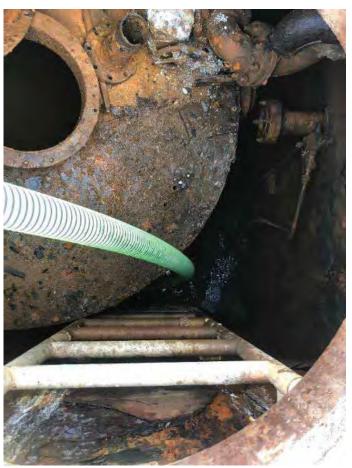
Pumping Water Out Of Solvent Tank And Vault

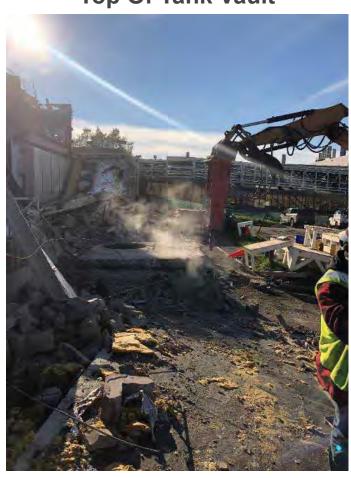
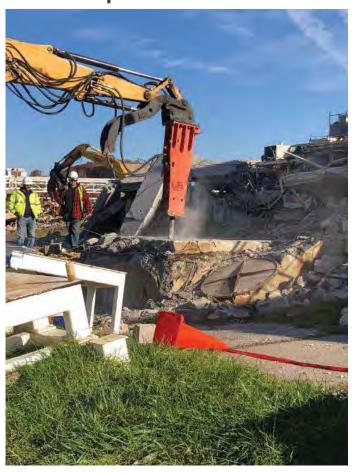
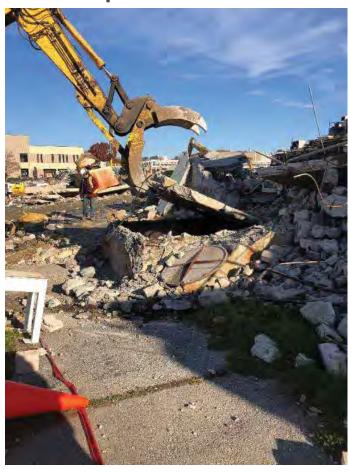
Removal To Top Of Tank Vault

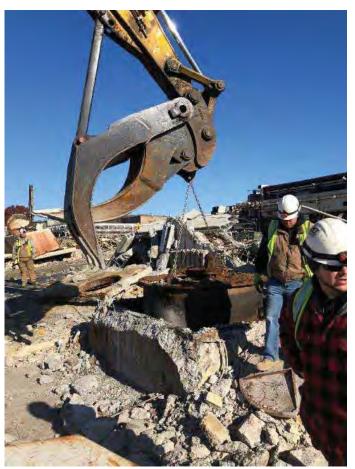
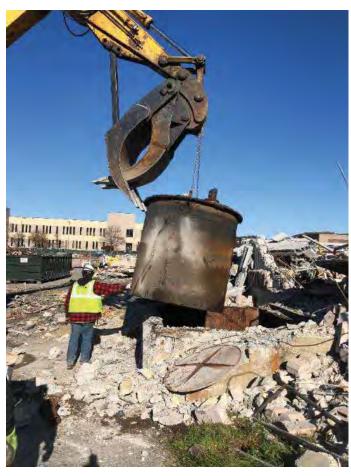
Removal Of Previously Closed Out Solvent Tank

- The decontamination of SWMU Tank 208 was provided in the attached Tank 208 Closure Report prepared and signed in 2010 by a professional engineer not affiliated with Arcadis. Arcadis reviewed the Tank 208 Closure Report and included it as documentation of Tank 208 closure. Arcadis only observed the removal of Tank 208 during the same day demolition of the concrete vault cover in 2018. 2018. Underground floor drain piping between the solvent room and Tank 208 had been previously sealed at the floor drains and remains in place. Therefore, Arcadis' certification of Tank 208 removal is limited to the tank only.

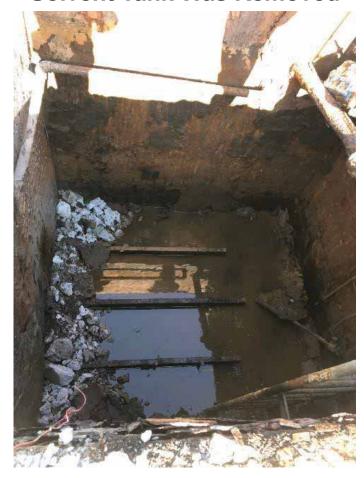
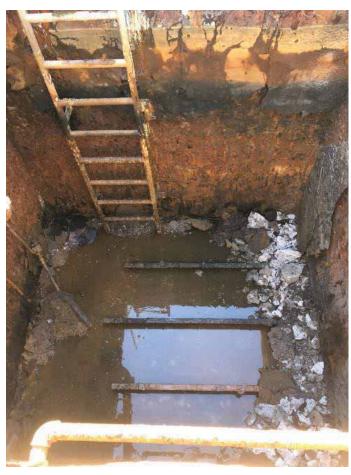
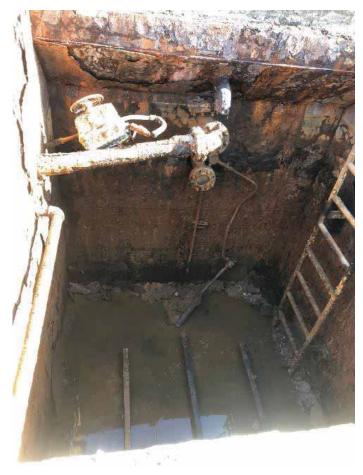
Inside Vault After Solvent Tank Was Removed

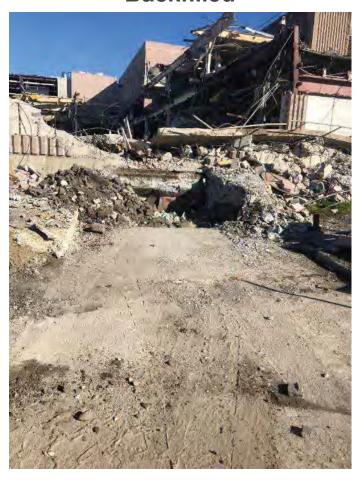
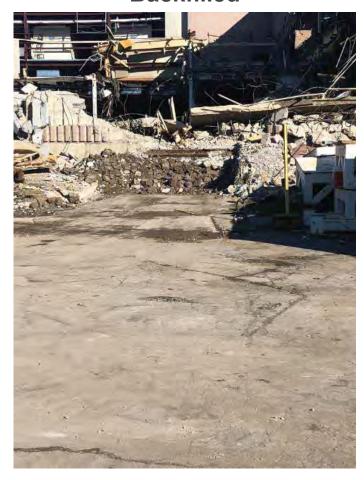
Vault Backfilled

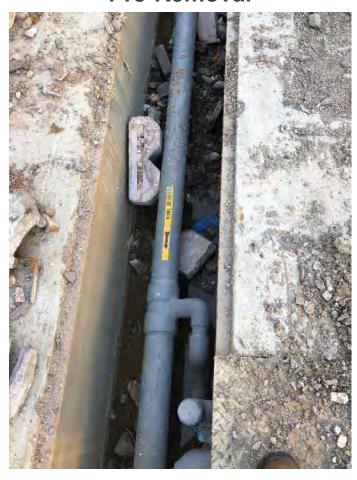
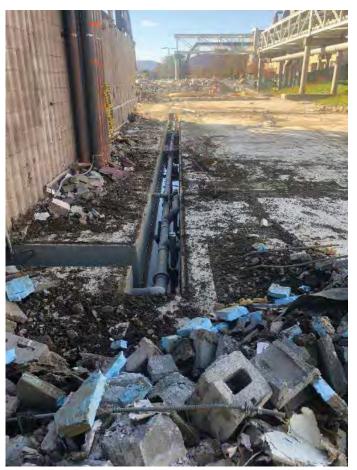
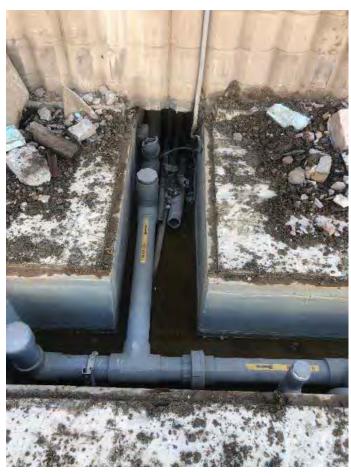
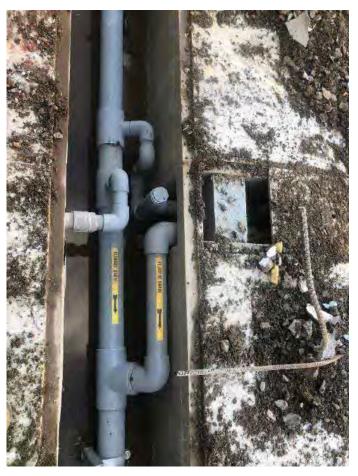
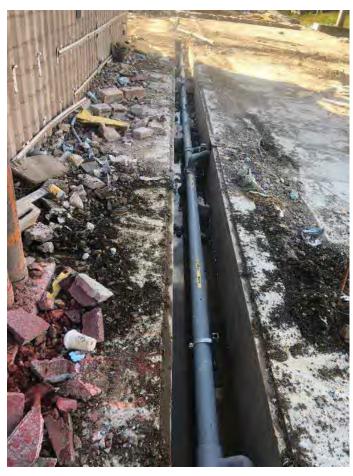
Fluoride Pipe Pre-Removal

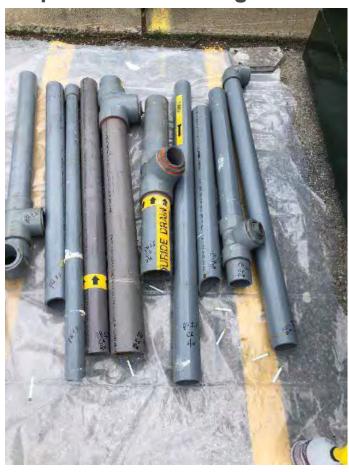
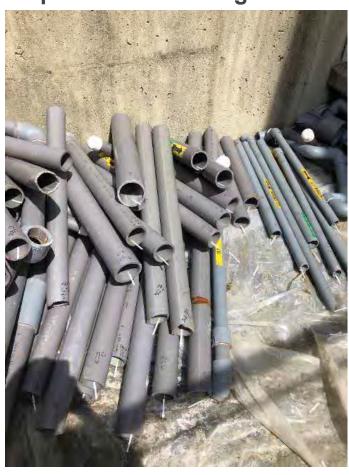
Each rinsed section of fluoride/heavy metal pipe was inspected to confirm decontamination to the clean debris surface criterion defined in the Closure Plan. Because the source of fluoride in the former semi-conductor processes was hydrofluoric acid (a corrosive fluid), representative pipe ends were also field tested for pH with Hydrion® pH test strips to confirm that the interior pipe surface was within a neutral range of pH 5 to 8. Based on absence of visible residue (clean debris surface criterion) and neutral pH verification, the decontaminated piping was released for disposal as non-hazardous waste (See Third Party Observation and Testing).

Fluoride Pipe Sampled And Inspected After Being Cleaned

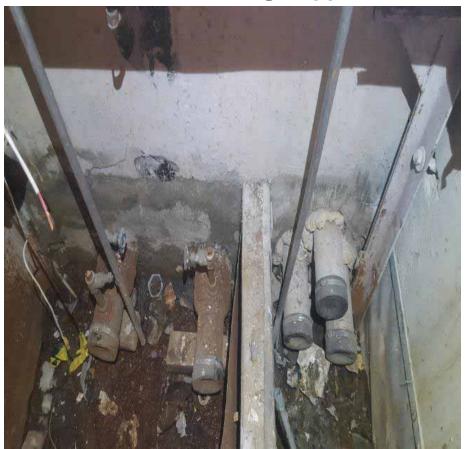
- The SWMU transfer piping mains exited B322 through the east side foundation to underground
 waste transfer piping. The mains at the foundation wall were accessible beneath gantry doors in the
 east side hallway floor. Because the underground piping was not part of the project, the SWMU
 piping mains were cut and capped inside B322 at the foundation walls.

Fluoride Pipe Going Out Of Building Capped

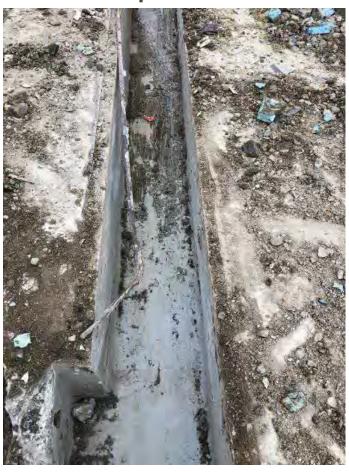
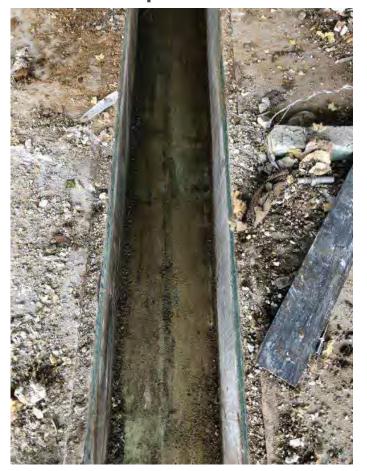
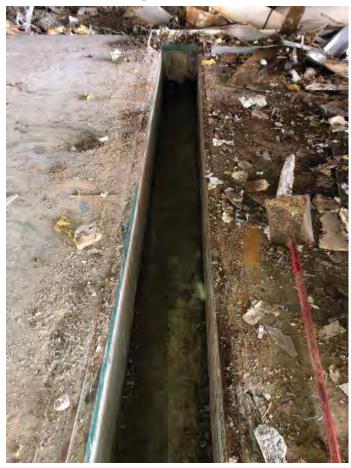
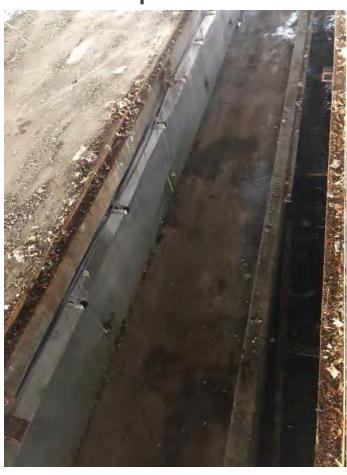
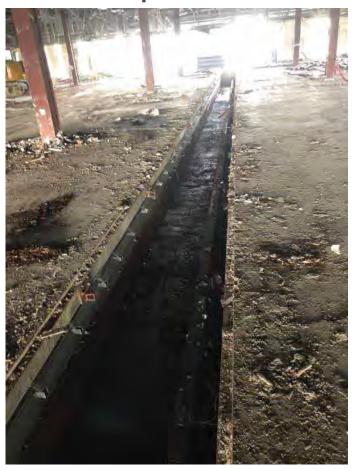
Cleaned Trench After Fluoride Pipe Was Removed

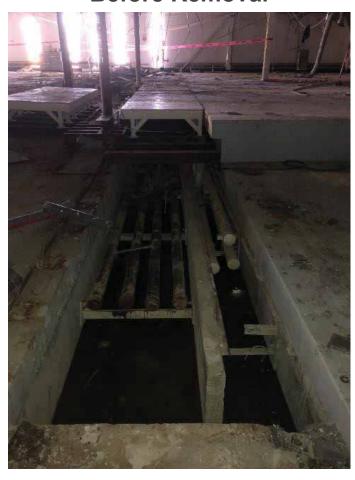
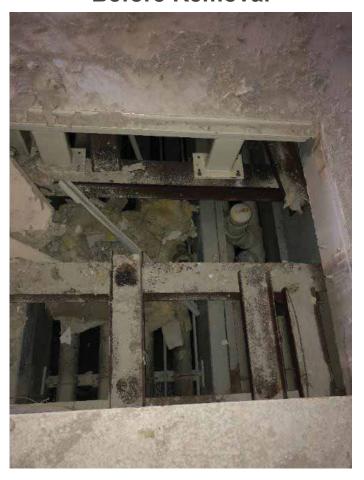
Industrial Waste Pipe Before Removal

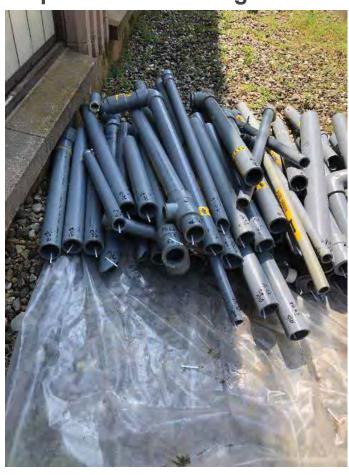
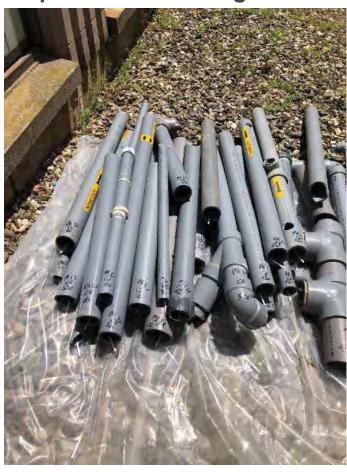
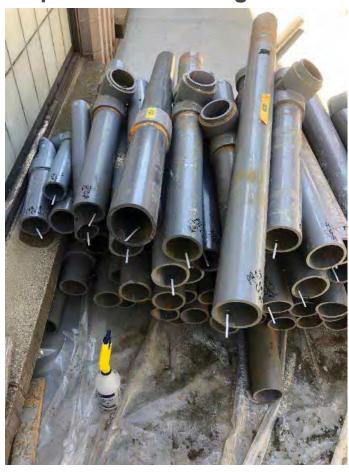
variety of acids other than fluoride-containing acids, verification of decontamination was the same as described above for the fluoride drains sections. Based on absence of visible residue (clean debris surface criterion) and neutral pH verification, the decontaminated piping was released for disposal as non-hazardous waste (See Third Party Observation and Testing).

Industrial Waste Pipe Sampled And Inspected After Being Cleaned

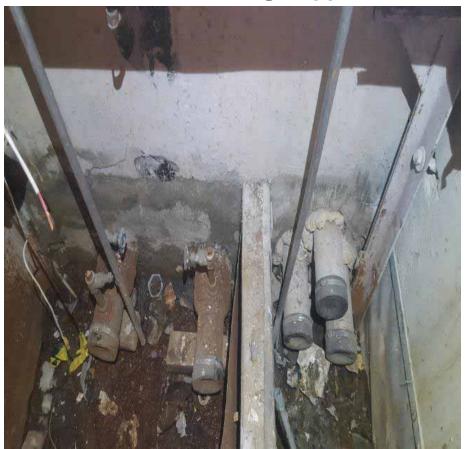
Industrial Waste Pipe Going Out Of Building Capped

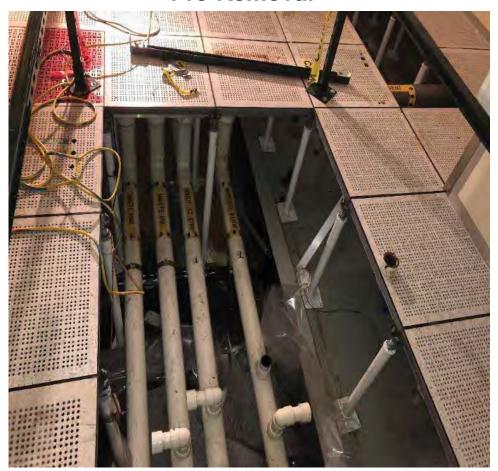
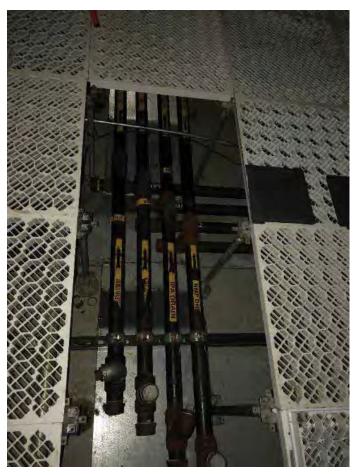
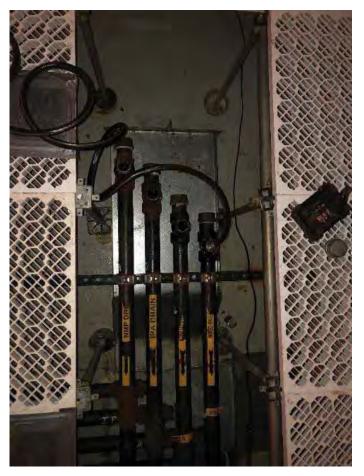
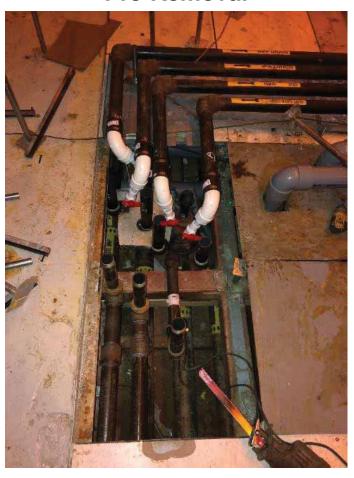
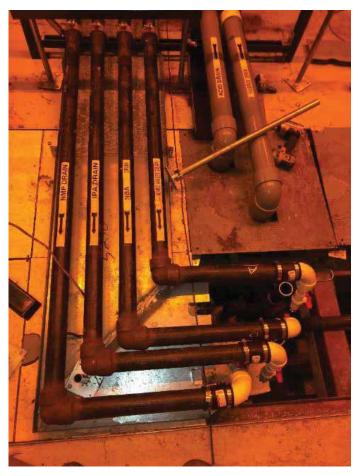
All solvent waste drains were constructed of carbon steel pipe, with welded seams. Threaded fittings were limited to connection points for process equipment, all of which were sealed with threaded steel caps. Test cuts in the solvent drain system exhibited very little visible residue in the AZ strip, IPA and NMP drains when viewed in cross section. However, the mixed solvent drain contained significant dry residue. GLOBALFOUNDRIES considered the option to decontaminate the solvent drains but elected to dispose of all solvent waste piping removed during the project as a hazardous waste. Arcadis' observation of solvent pipe removal confirmed that this system was removed and segregated into lined hazardous waste rolloffs to be shipped offsite for disposal (See Third Party Observation and Testing).

Solvent Pipe Pre-Removal

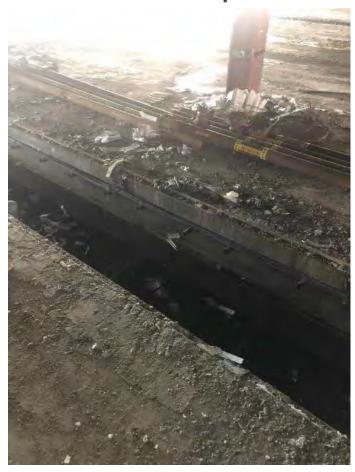
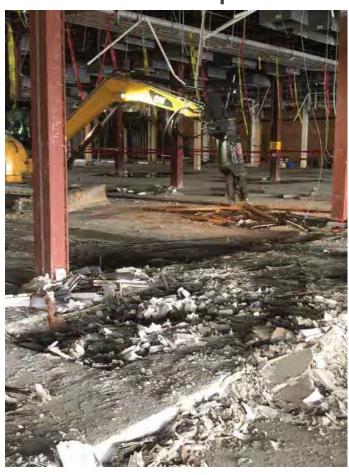
Removal Of Solvent Pipe

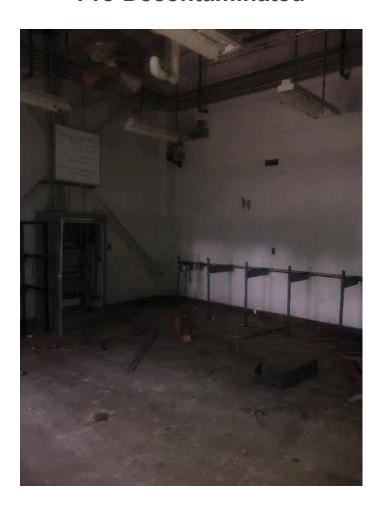
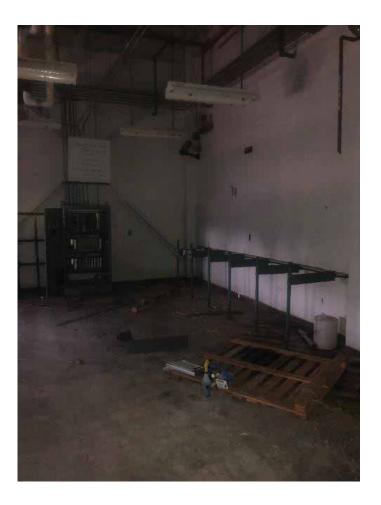
- The waste container loading/unloading area (enclosed dock), was inspected and cleaned to a debrisfree surface condition. The surface was tested with pH test strips to verify that it met the neutral criteria for the project (pH range of 5-8).

Pre-Decontaminated

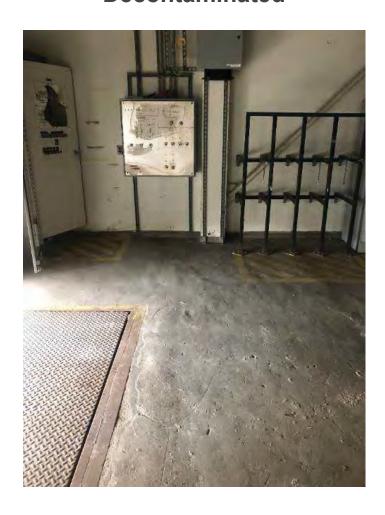
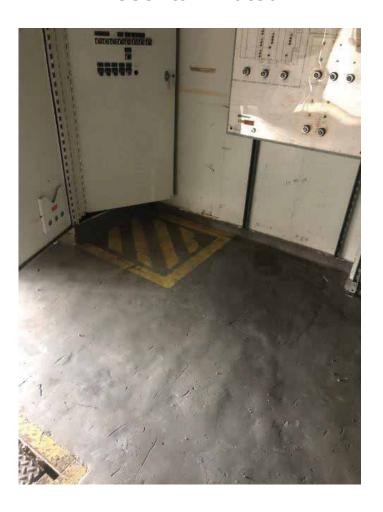
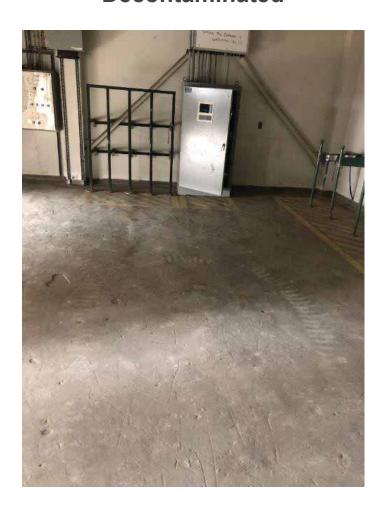
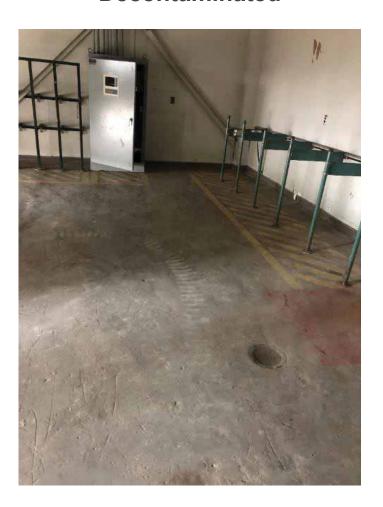
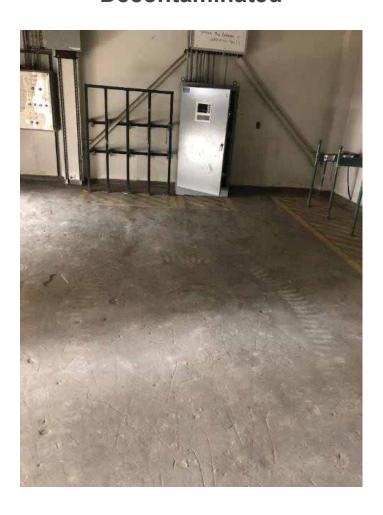
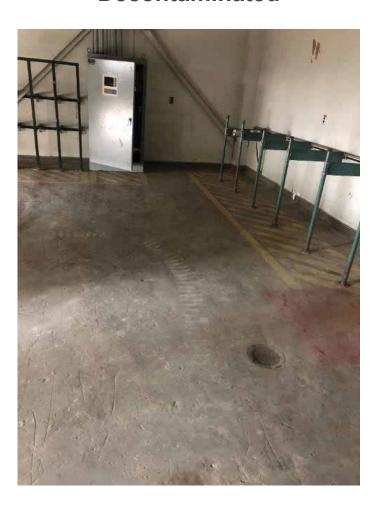
Decontaminated
