# DAILY OBSERVATION REPORT

Report: July 14, 2025

New York State  
Department of Environmental Conservation  
Division of Environmental Remediation  
Remedial Bureau C

Site: Spill No. 2500910  
135 Main Street, Poughkeepsie,  
Dutchess County

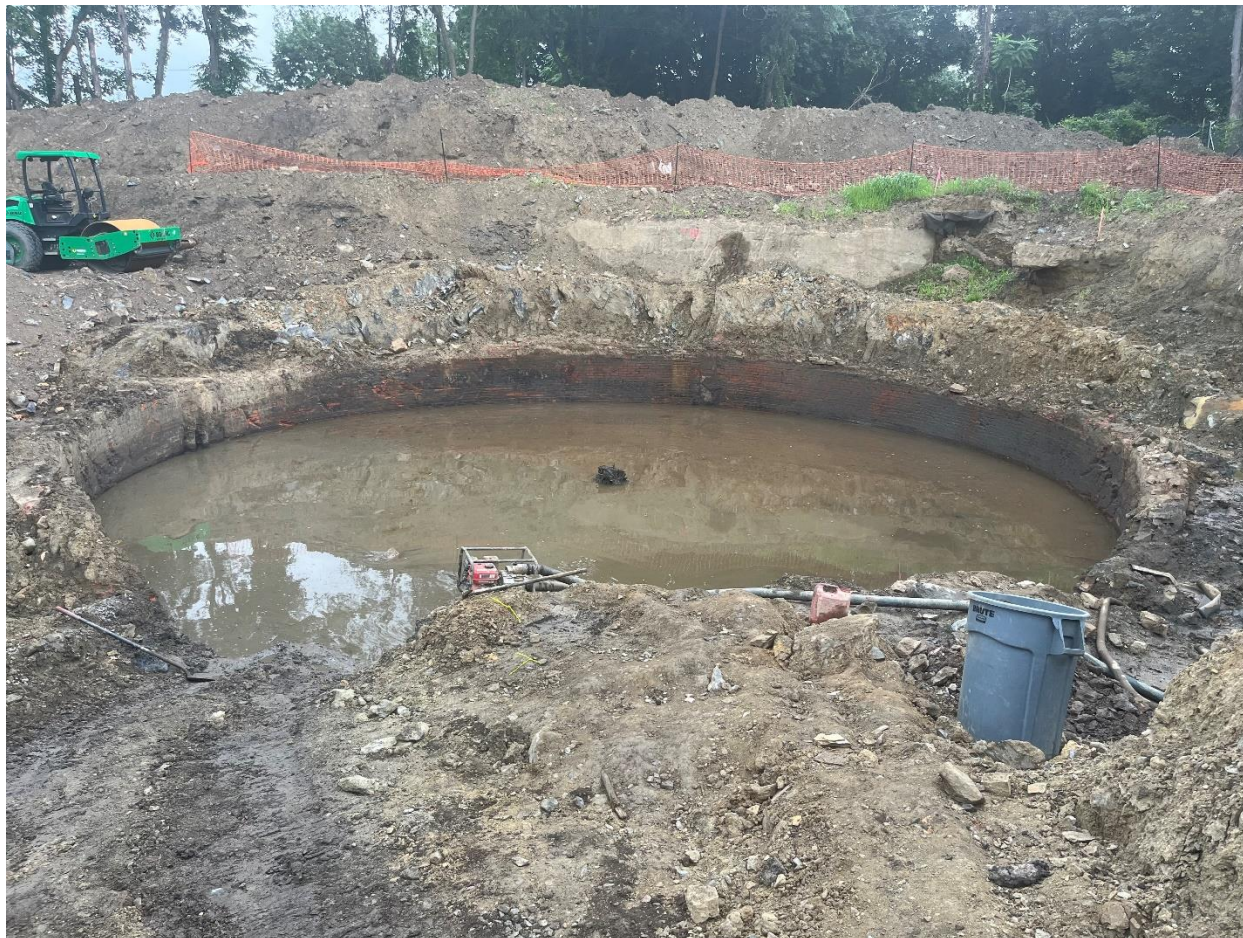
View of the holder in the morning before water was removed.

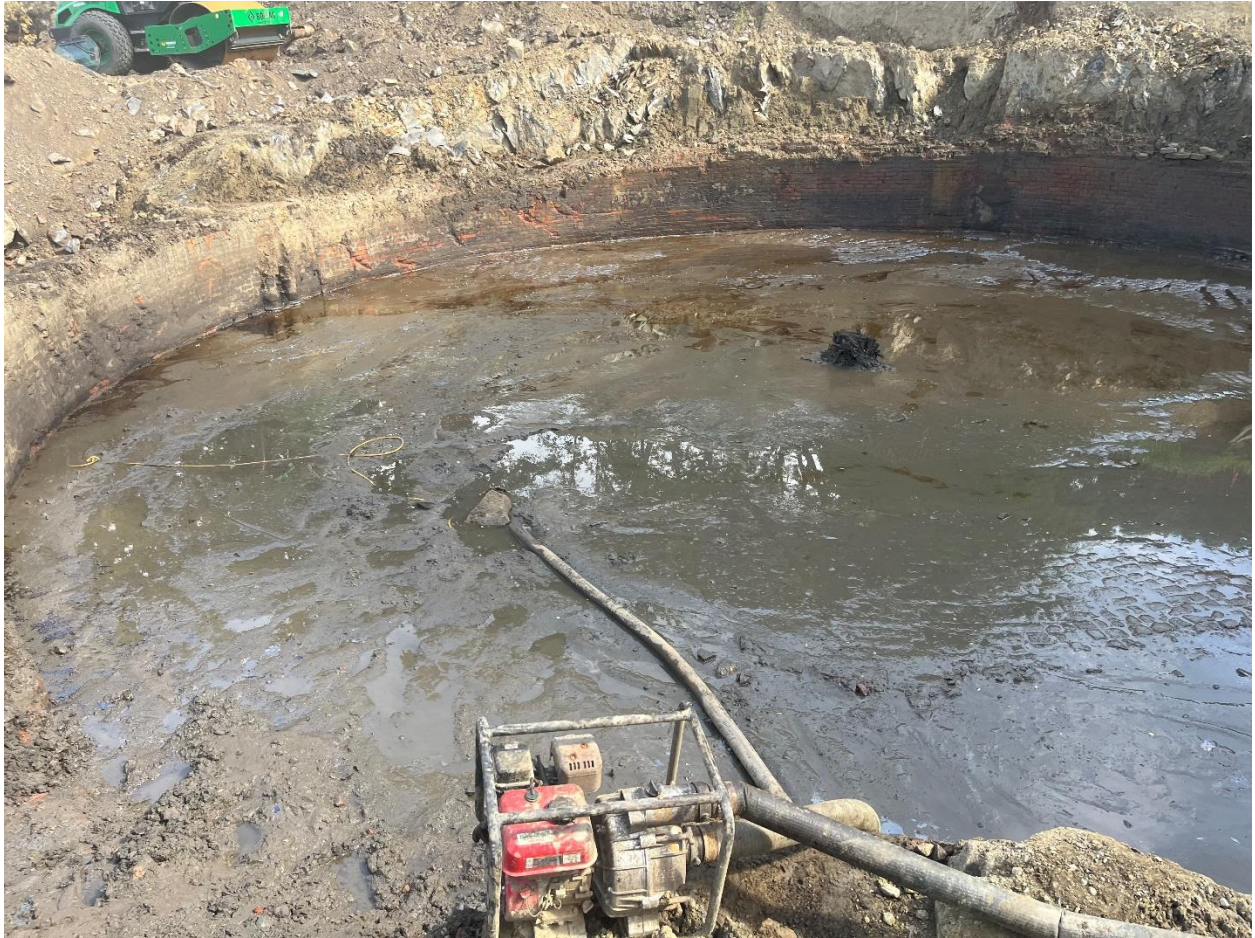
- C2G used a vacuum truck to pump water and silt with containing large dark blebs from the former MGP holder foundation. Water was observed moving upward into the gas holder foundation through the brick floor.
- Dibartolo Landscaping, Inc. and Paths began and completed demolition the former gas holder foundation brick sidewalls. Soil that appeared to be stained and coated with MGP coal tar was observed along the entire perimeter outside from where the foundation wall was. The brick from the demolished wall was placed along the soil stockpiled for disposal. The coated soil that was outside the holder foundation wall produced strong mothball-like odors; C2G mitigated these odors by spraying Biosolve on the soil after excavation work was ended for the day.

The holder bottom after water was removed.

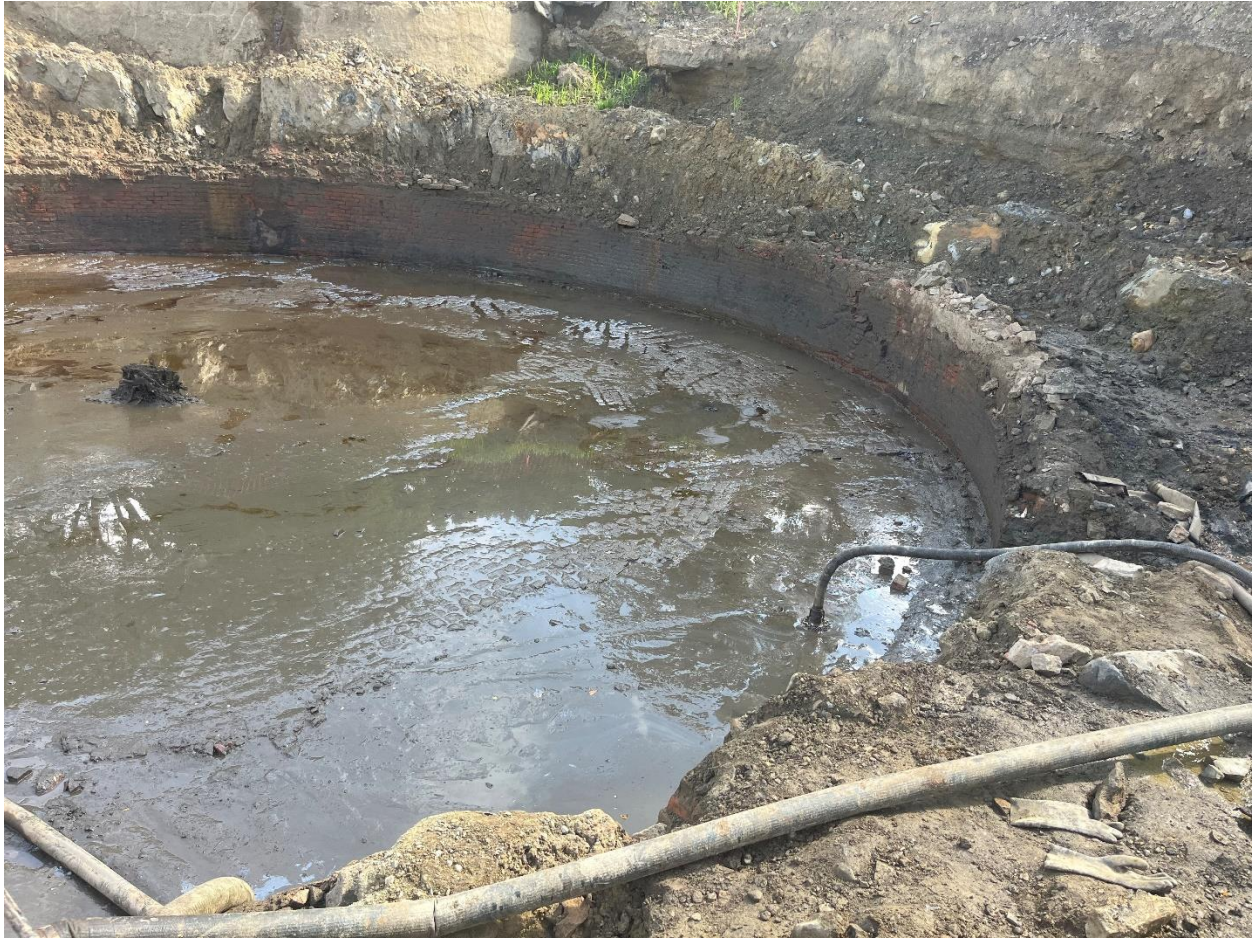
The holder bottom after water was removed.

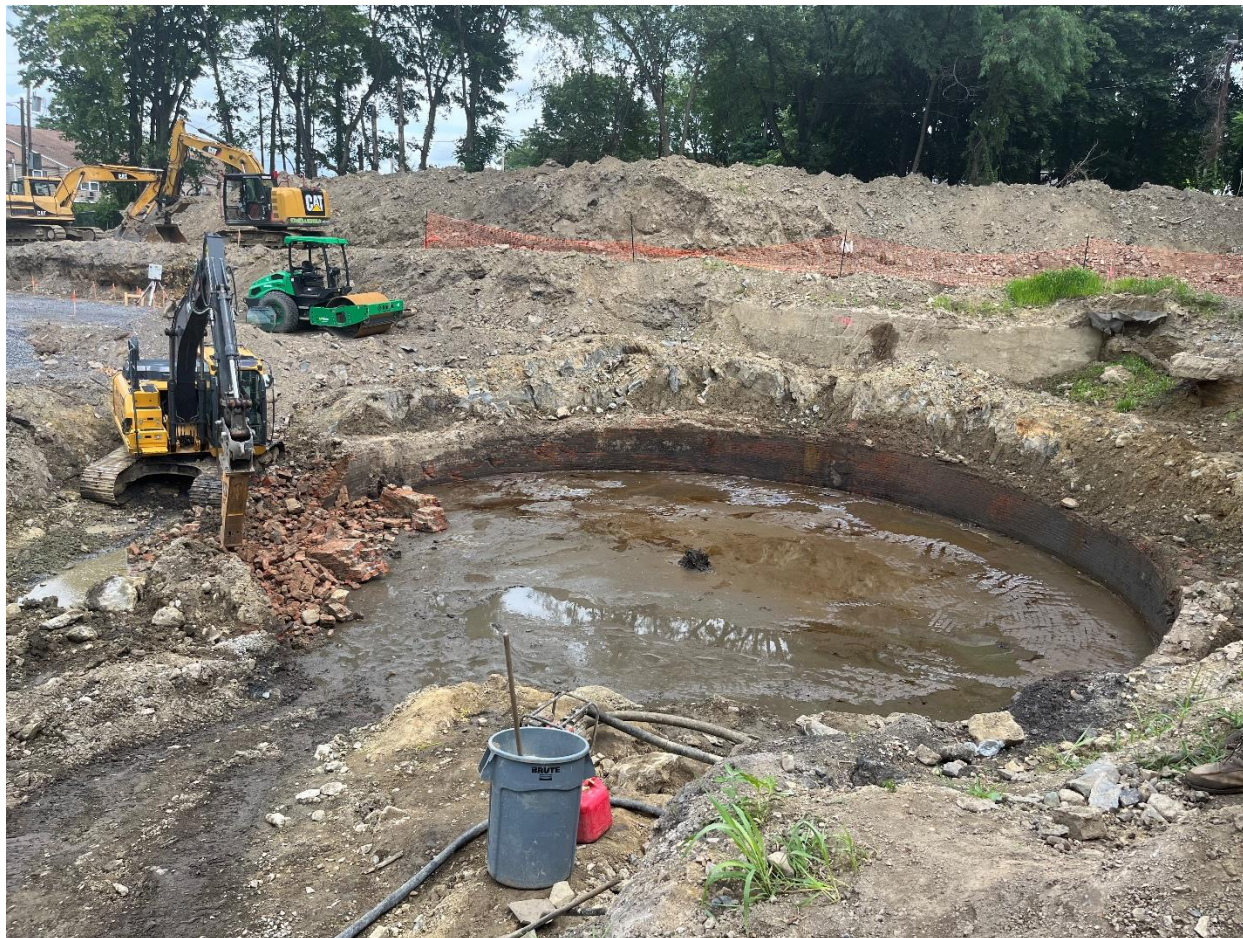
Beginning demolition of the holder's foundation wall.

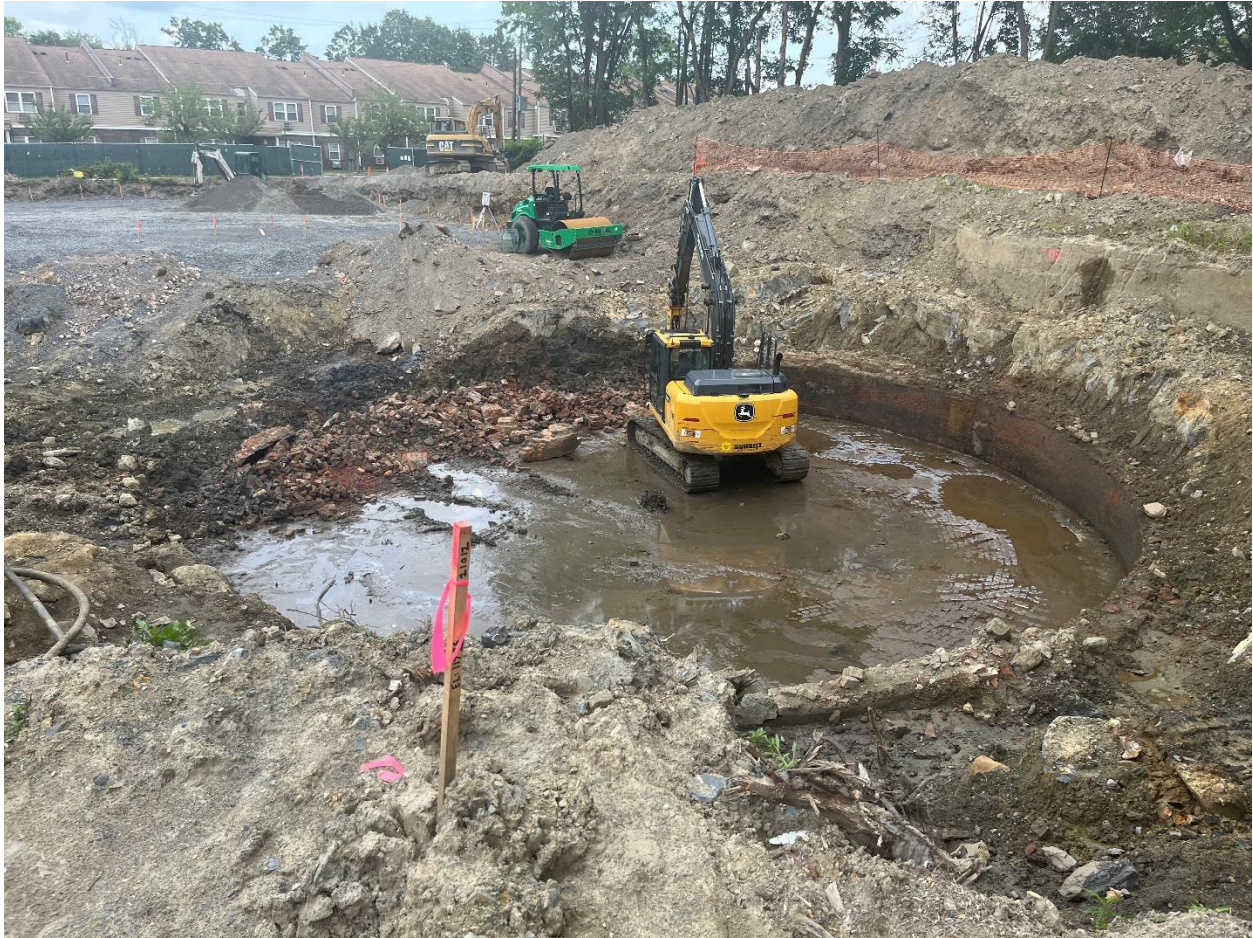
Demolition of the foundation wall.

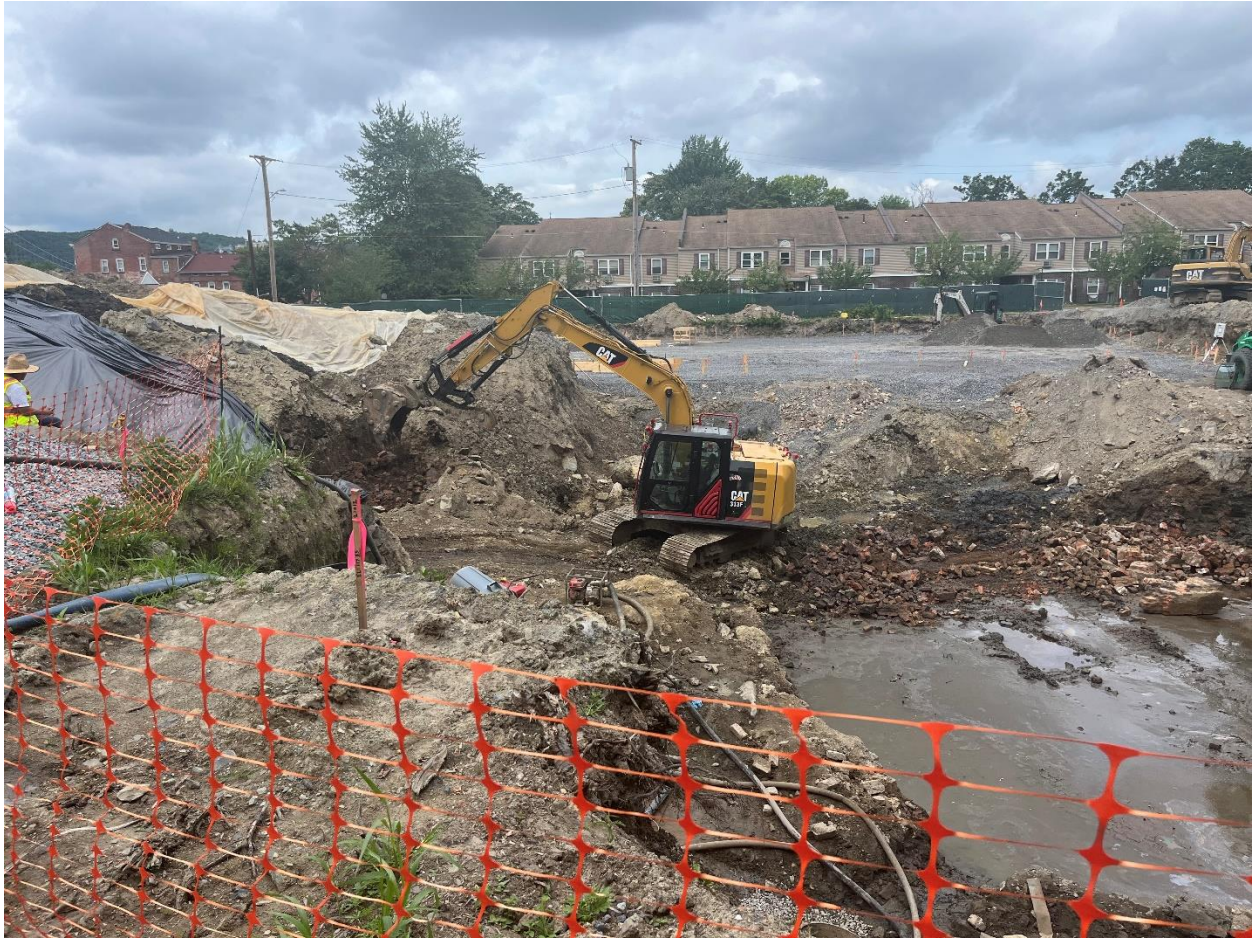
Stockpiling brick from the holder foundation.

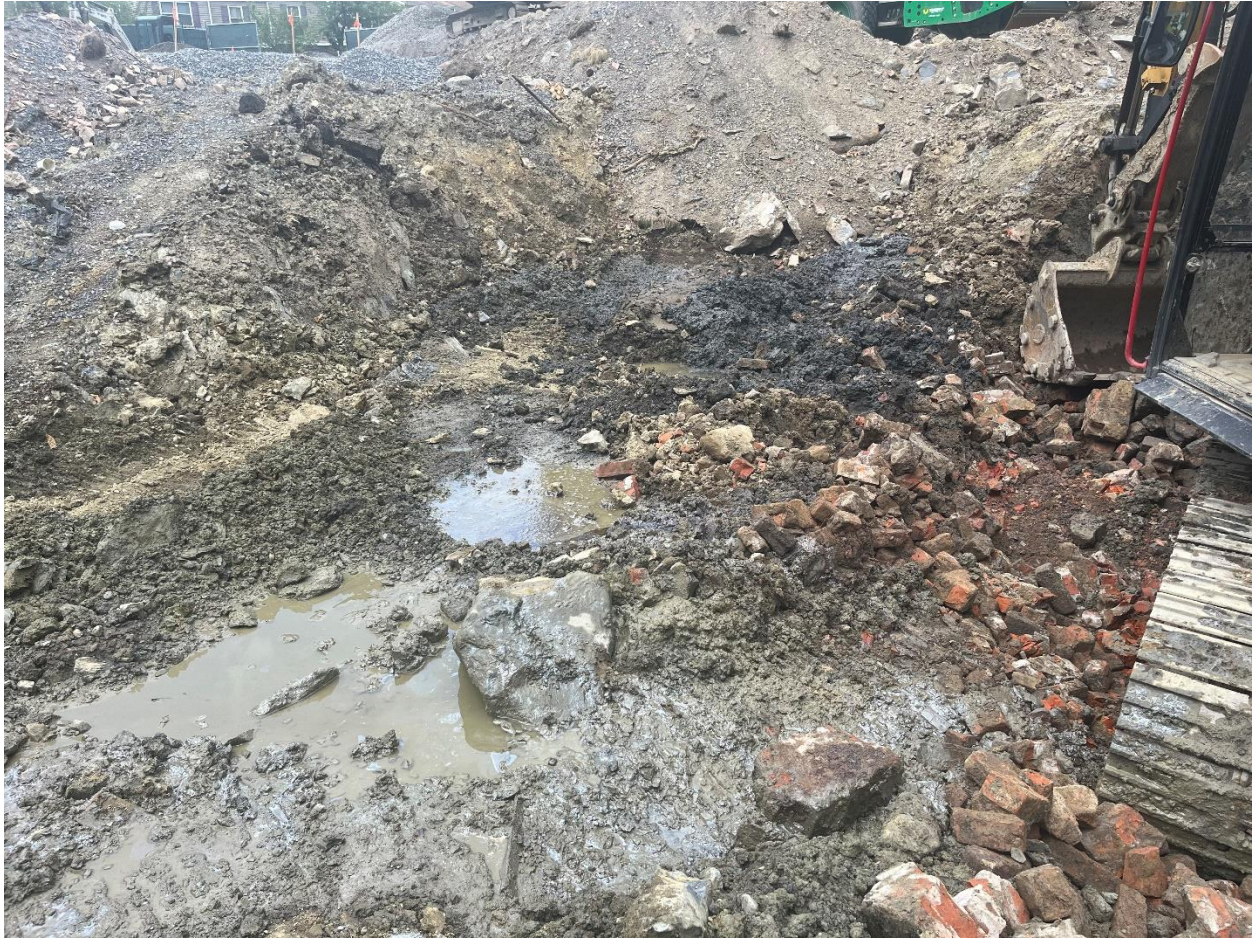
NAPL or tar coated soil at the exterior of the former holder foundation sidewall. Located at the portion shown to be demolished in the photographs above.

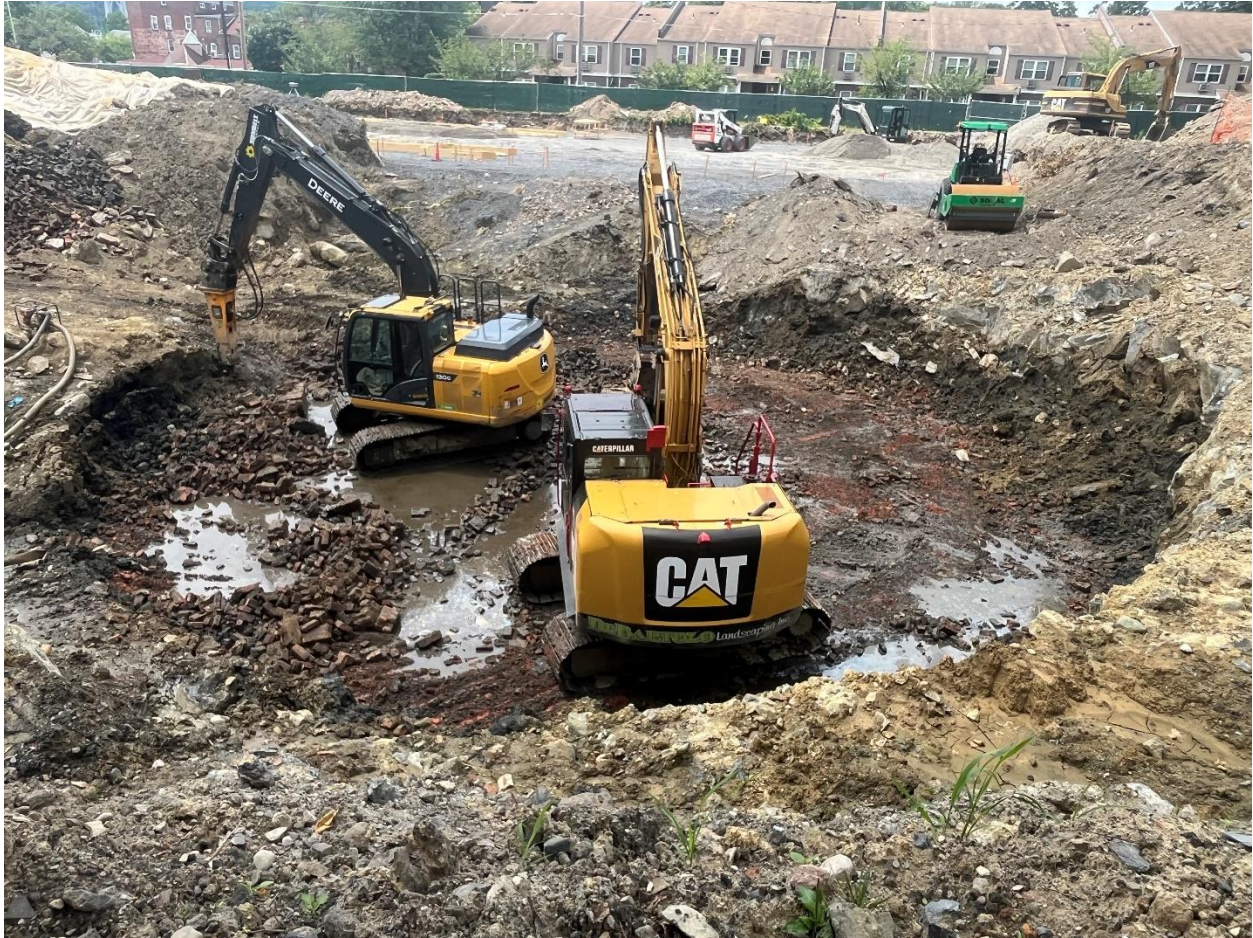
The foundation wall completely demolished.

- The former gasholder's brick floor is planned to be demolished on 7/15/2025.
- After the former gas holder's floor is demolished Path's construction plans to excavate an additional two feet of soil laterally along the entire perimeter from where the foundation walls were. Path's will expand the excavation laterally and vertically to "chase" and remove all soil visibly coated or saturated with tar or NAPL until soils are clean or bedrock is encountered.
- After excavation is completed soil documentation samples for chemical analysis will be collected from every 30 linear foot of sidewall and 900 square foot of excavation bottom. These samples will not be collected from bedrock

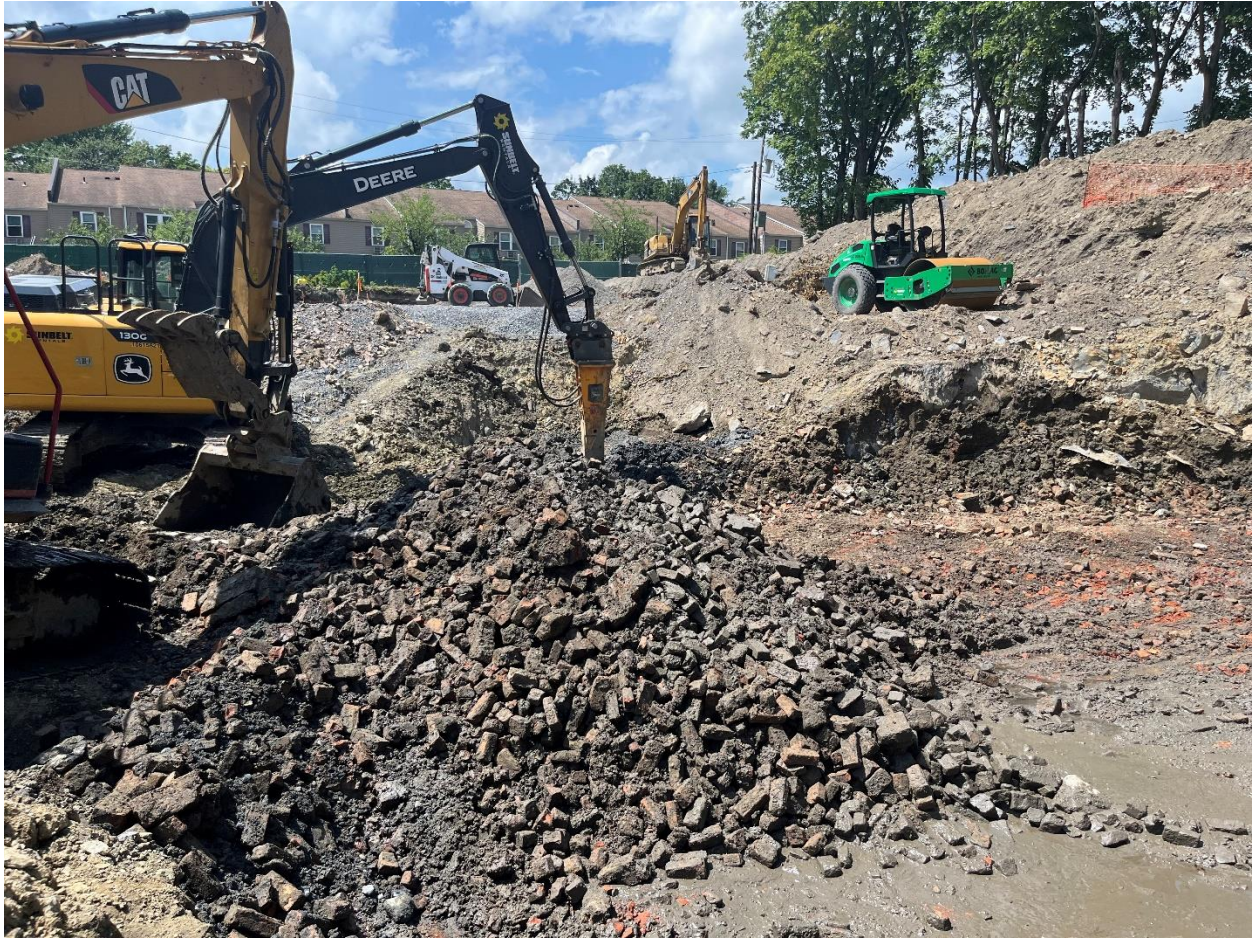
The excavation sidewall, photographs below continue clockwise.

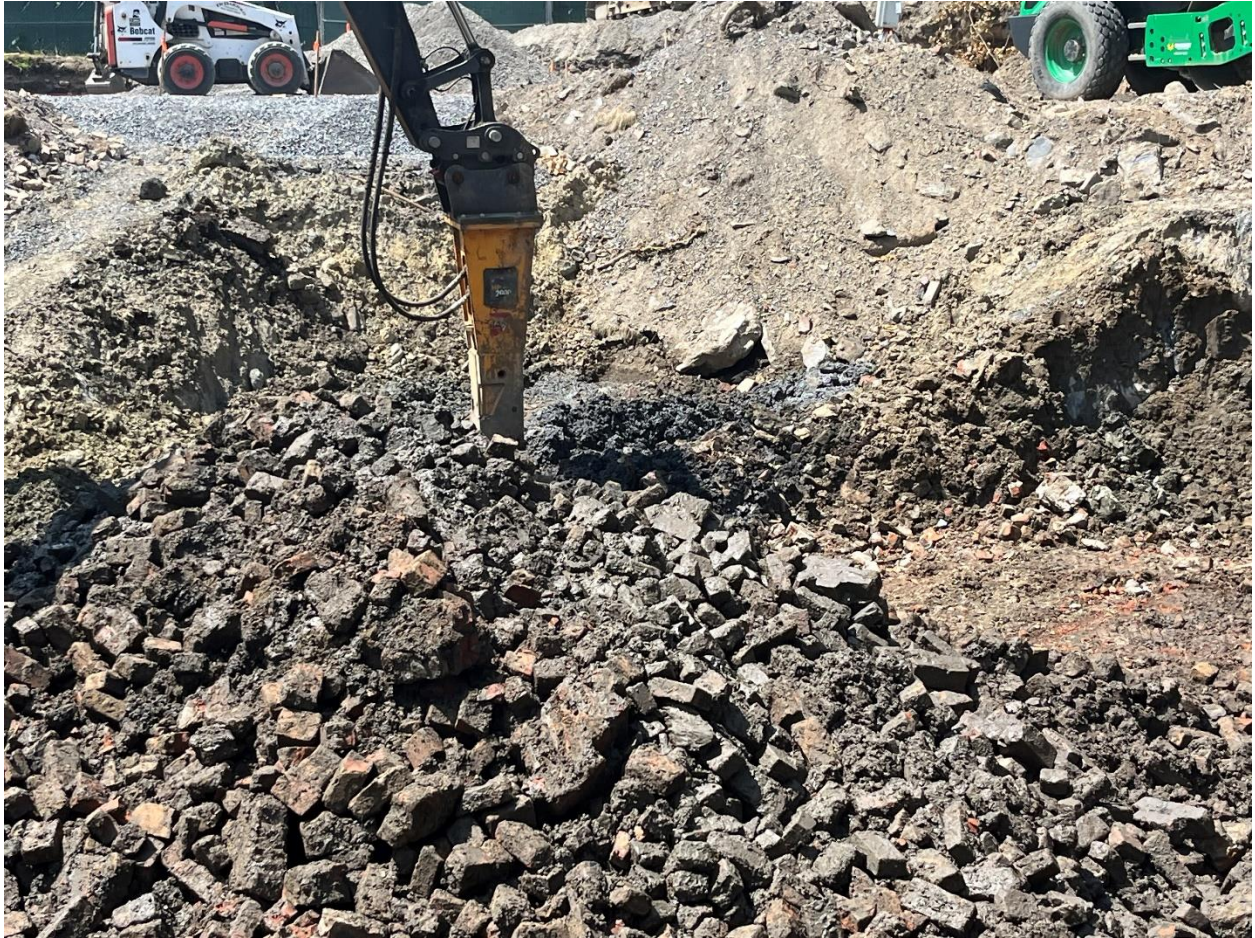
(same location as the photo above showing grossly contaminated soil)

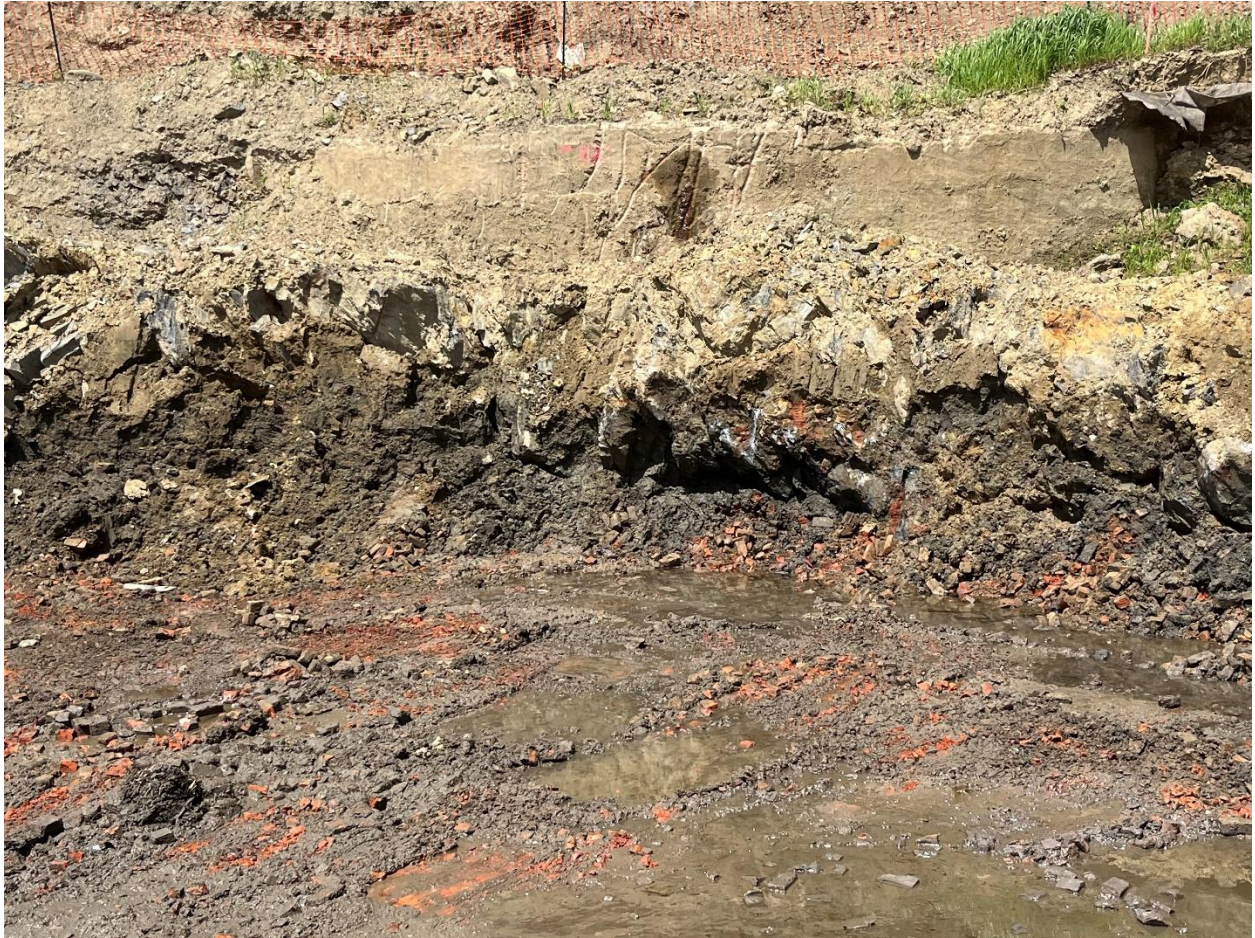
(potential bedrock at sidewall here)

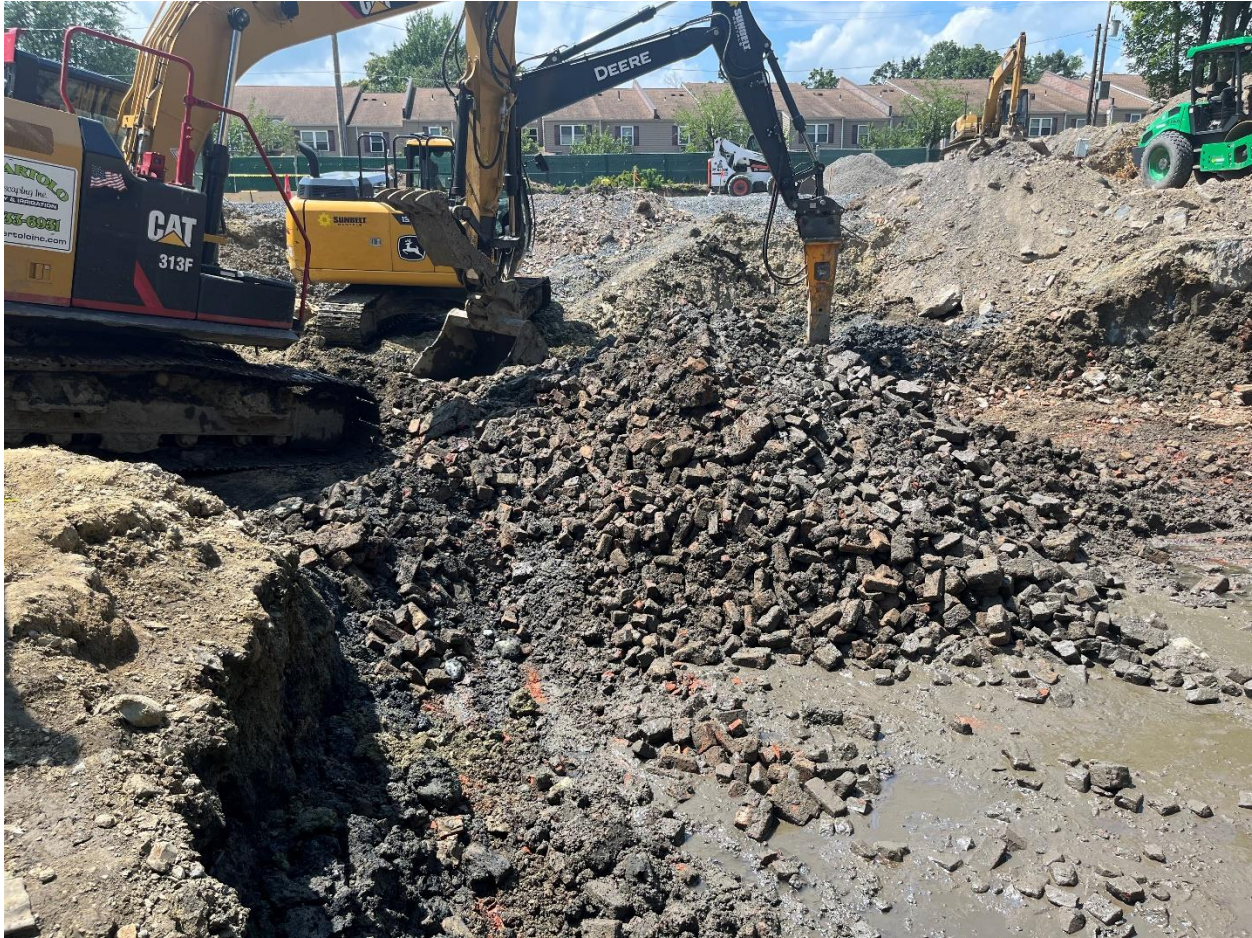
(Back at original location.)
