NYSDEC Contractor PM: Paths Construction NYSDEC PM: Sarah Saucier Remedial Bureau C Construction Manager: Jesus (Leo) Montoya **Division of Environmental Remediation** Project Engineers: Paths construction Site: Bayeaux St Remedial Contractor: C2G Josh Dendell Phase: Spill Site No.: Spill# 2500910 Air Monitoring: Hillman Dominic Health & Safety: Paths Construction Weather Conditions **General Description Mostly sunny Mostly sunny** pm am **Temperature** 80 80 pm am Wind Direction south am south pm **HEALTH & SAFETY:** (*If any box(s) below are checked "Yes", list the deviation under the "Items for Concern" section of this report). *Yes () No (X) NA () Were there any changes to the Health & Safety Plan? Were there any exceedances at the perimeter *Yes () No (X) Air: NA () action level reported on this date? Were there any Noise /Vibration exceedances Noise: *Yes () No (x) NA Vibration: *Yes () reported on this date? No (x)NA Were there any breaches to the tent structure or silt fence reported/observed on this date? *Yes () No () (X) Were there any dust/odor issues reported or observed on this date? *Yes () No (X) NA () **WASTE HAULING:** (*If any box(s) below are checked "Yes", list

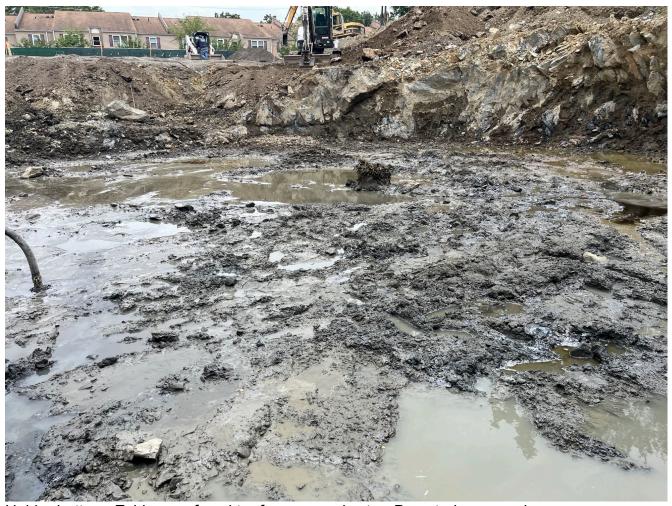
C2G removing base of holder structure and contaminated soil. Dewatering of holder area ongoing. Dewatering pumped to vac truck and trucked offsite. Blebs and stringers of NAPL evident in water during dewatering. Ebullitions of coal tar from bedrock is occurring.

Holder bottom. Evidence of coal tar from groundwater. Dewatering occurring.

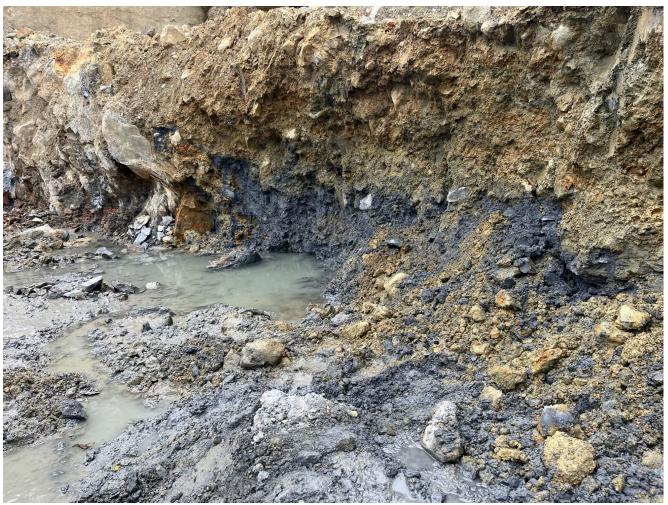
The side walls of excavation: east and south wall has dark blue stain approximately 1-2 ft in thickness just above excavation bottom. North wall is bed rock and further excavation of north holder foundation is planned. West wall is excavated to bedrock and clean soil was backfilled to grade. End point samples are planned for east and south wall. DEC requested east and south wall end point samples.

East wall of excavation. One to two foot thick layer of blue stained soil evident just above base of excavation.

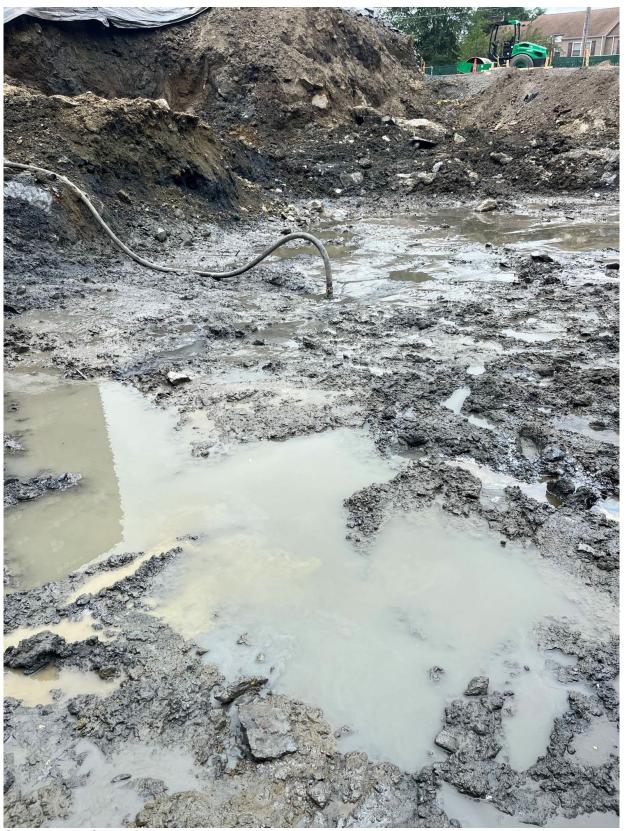
South wall of excavation. End point samples will be taken. Blue staining évident at base of excavation.

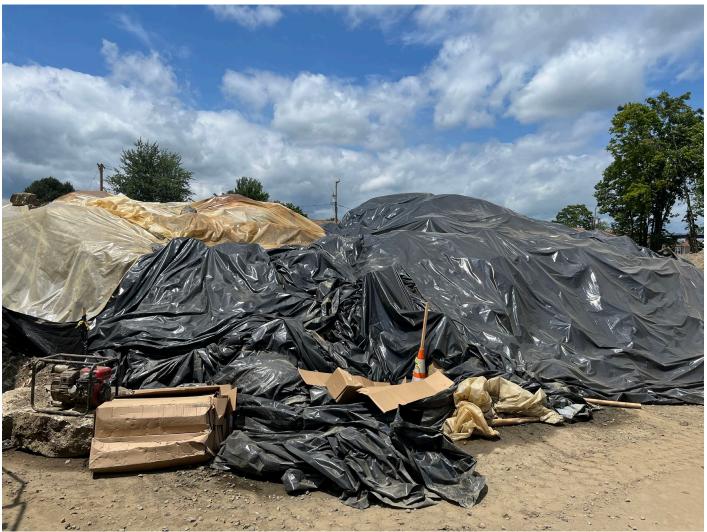
Soil pile mostly covered, small area had plastic cover blown off. Requested recovering. Paths immediately covered pile.

Covered stockpile of soil to be disposed.
