# NEW YORK STATE DEPARTMENT OF ENVIRONMENTAL CONSERVATION

## INSPECTION REPORT

**Site Name:** Former Schatz Federal Bearing  
**Location:** 60-70 Fairview Ave.  
Poughkeepsie, Dutchess County, NY

<b>Date</b>	March 6, 2018
<b>Time</b>	9:30 am – 1:30 pm
<b>Weather</b>	No wind Sunshine
<b>Temperature</b>	33-48°F
<b>Wind Direction</b>	Variable

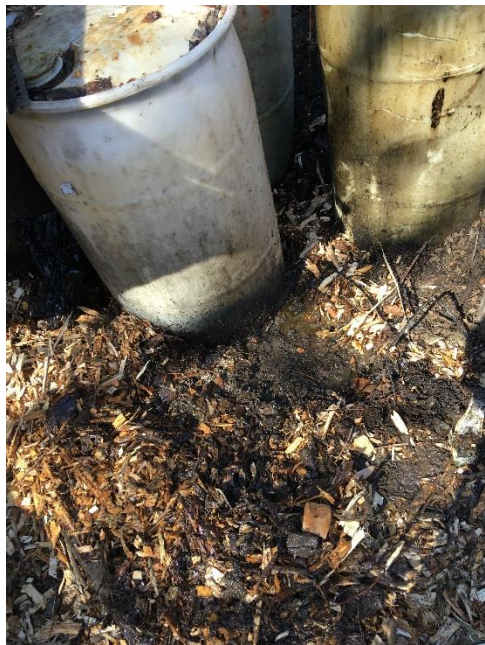
**Figure 1:** Location of Soil Sample S-1. Top layer of wood chips was removed and the sample was collected from the top layer of soil. Fluid within the soil appeared viscous.

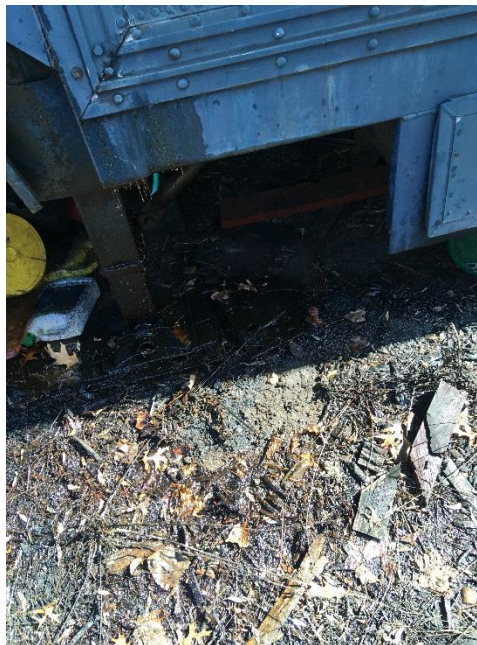
**Figure 2:** Location of Soil Sample S-2. Product appeared to be dripping from trailer. Product on ground surface was white gelatinous substance.

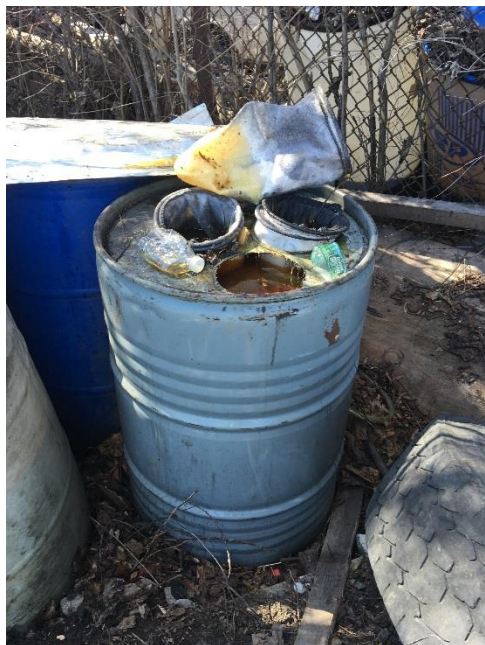
**Figure 3:** Location of Aqueous Sample D-1. Drum filled with some type of hydraulic oil.

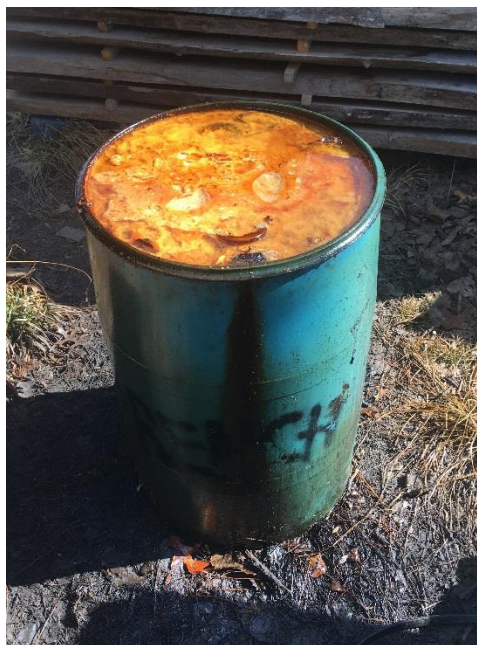
**Figure 4:** Location of Aqueous Sample D-2. Drum had pungent odor, much like a paint thinner. Cap on drum was not secured. Product that had overflowed and could be seen surrounding drum.

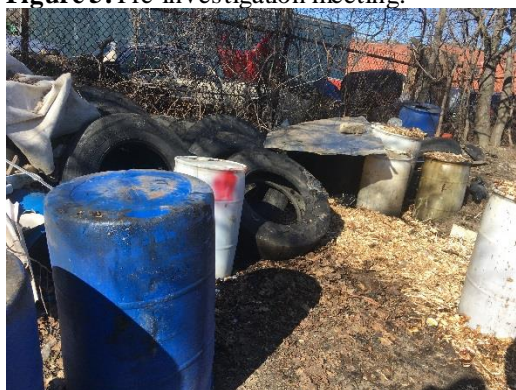
**Figure 7:** Oil saturated woodchips on ground and filled drums in background.

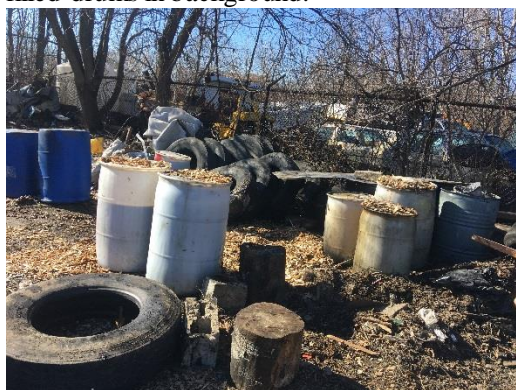
**Figure 9:** Filled drums, tires, and debris.

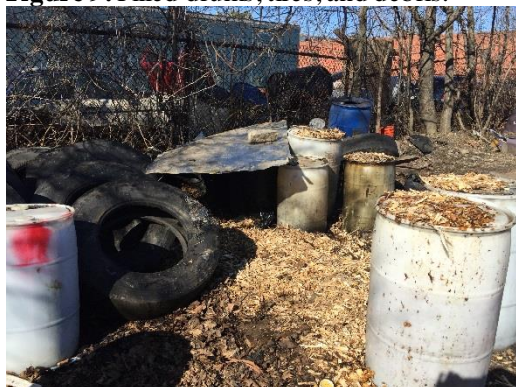
**Figure 11:** View of filled drums.

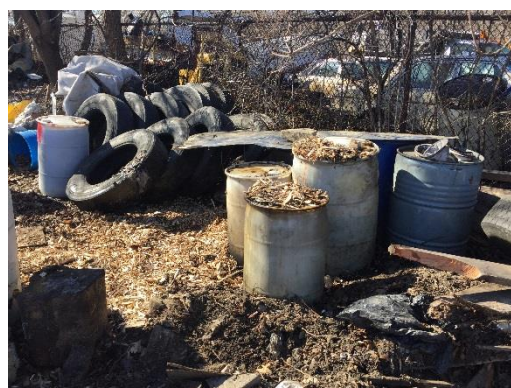
**Figure 6:** Location of Soil Sample S-1; filled drums.

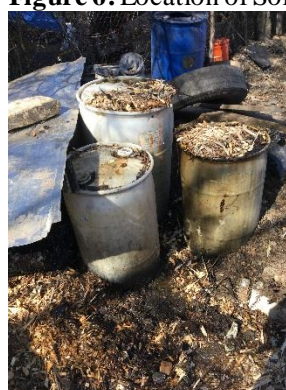
**Figure 8:** Filled drums.

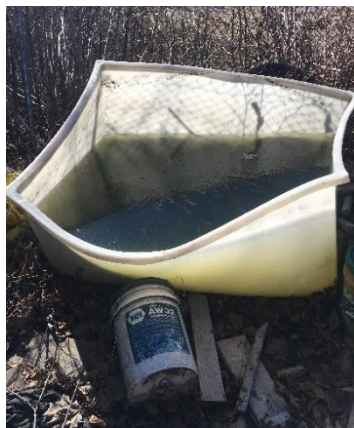
**Figure 13:** Container filled with fluid.

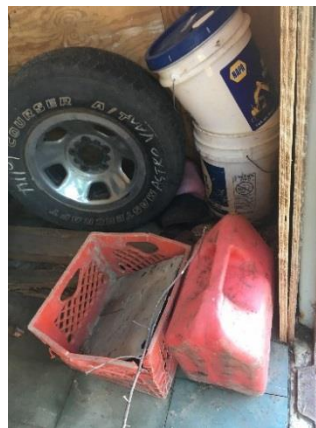
**Figure 14:** Tipped over gas can.

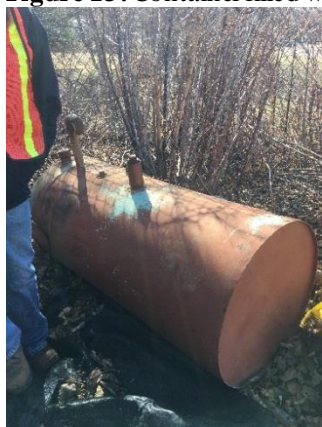
**Figure 15:** Oil tank possibly contained product.

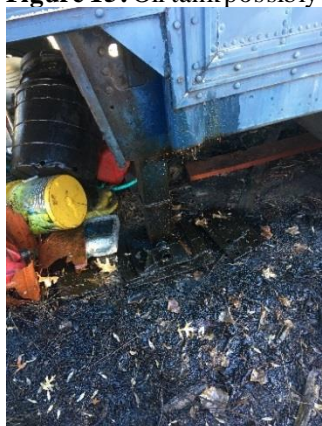
**Figure 17:** Location of Soil Sample S-2.

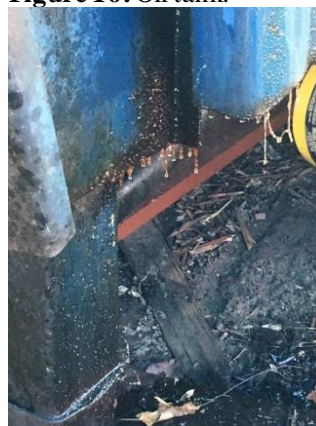
**Figure 18:** Fluid dripping from trailer.

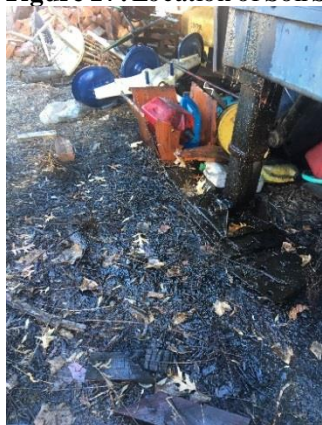
**Figure 19:** Product on ground surface.

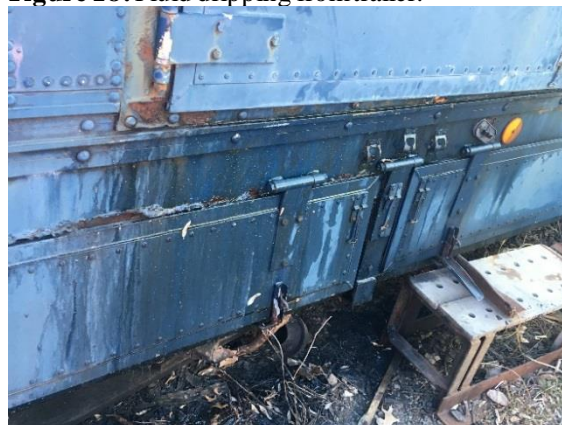
**Figure 20:** Additional area of trailer displaying fluid loss.

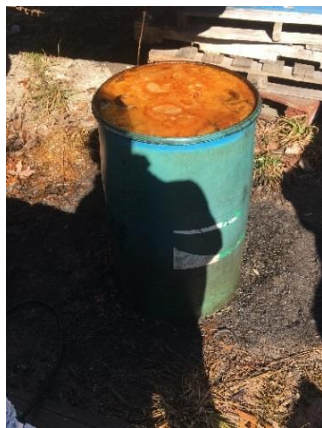
**Figure 21:** Location of Aqueous Sample D-2; filled drum.

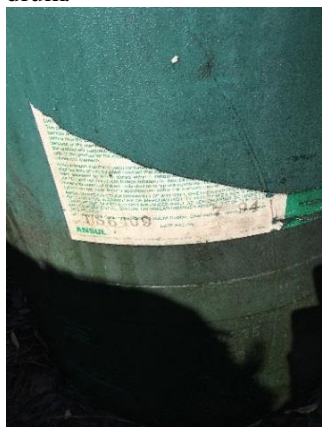
**Figure 23:** Full drum labeled: ANSUL SILV-EX Foam Concentrate, date 7/94.

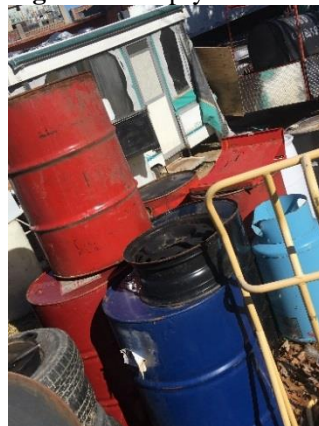
**Figure 28:** Empty drums, various labels.

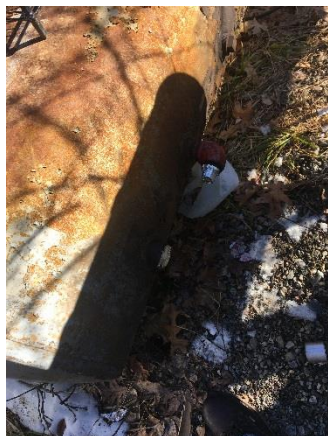
**Figure 29:** Fuel tank containing product, elevated PID reading.

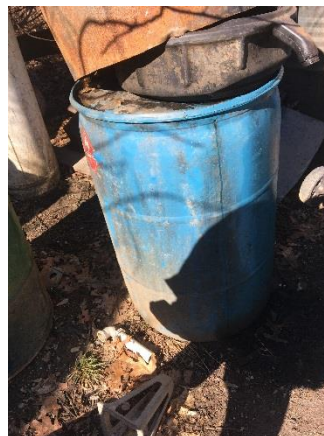
**Figure 30:** Filled drum, staining on ground.

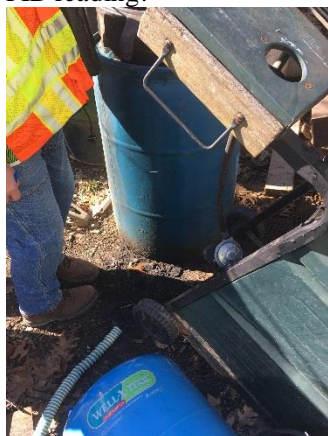
**Figure 31:** Filled drum, staining on ground.

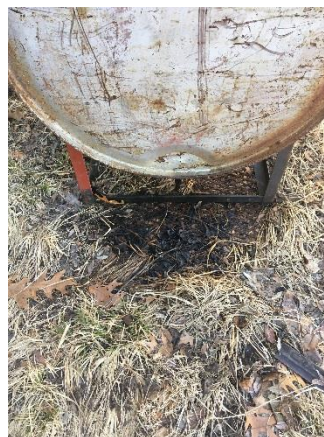
**Figure 32:** Staining observed on ground.

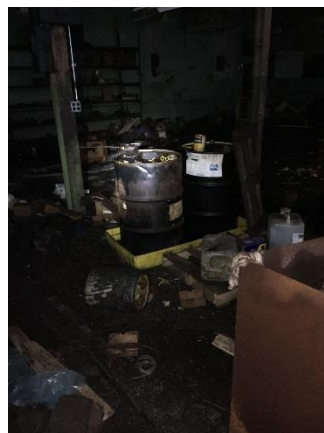
**Figure 36:** Two drums containing fluid.

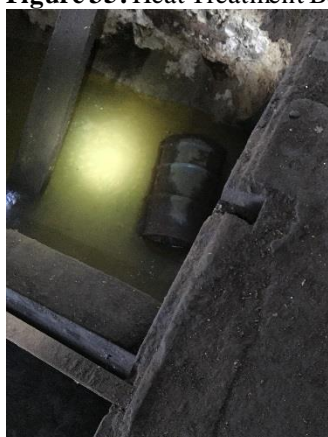
**Figure 37:** Drum in quenching pit (3 total).

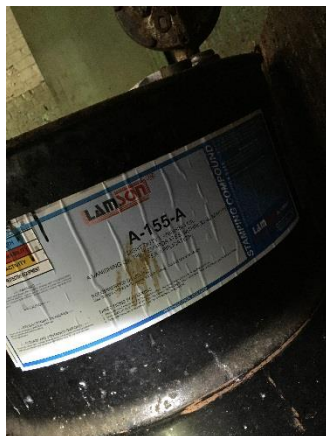
**Figure 41:** Drum labeled light vanishing oil; contained some product.

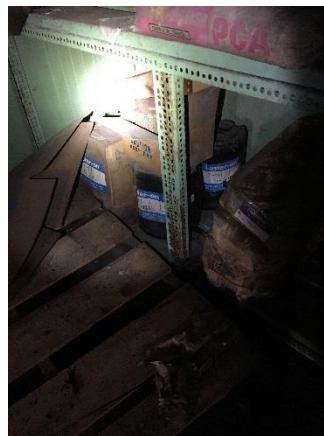
**Figure 42:** Full containers label Luster-on Z-30 and Z-31W

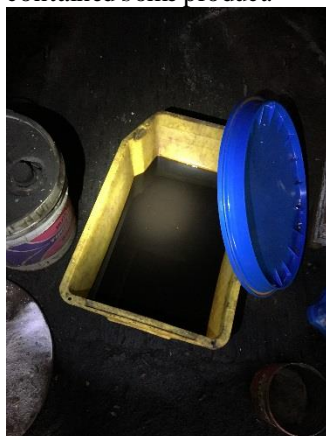
**Figure 43:** Bucket filled with black fluid.

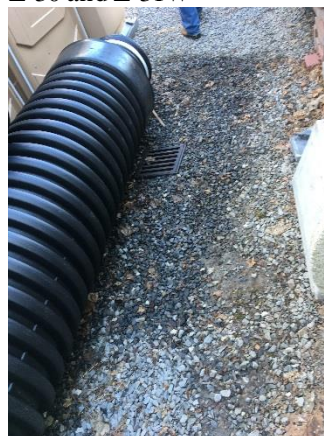
**Figure 44:** Staining around drain.
