**Re: Former Fargo Manufacturing Company
Annual Certification Report
130 Salt Point Turnpike
Poughkeepsie, New York
NYS DEC Site Number 3-14-082**

**INSTITUTIONAL/ENGINEERING CONTROL
INSPECTION FORM**

**Former Fargo Manufacturing Facility
NYSDEC Site Number 3-14-082**

**Former Fargo Manufacturing Company
130 Salt Point Turnpike; Poughkeepsie, New York
February 1, 2019**

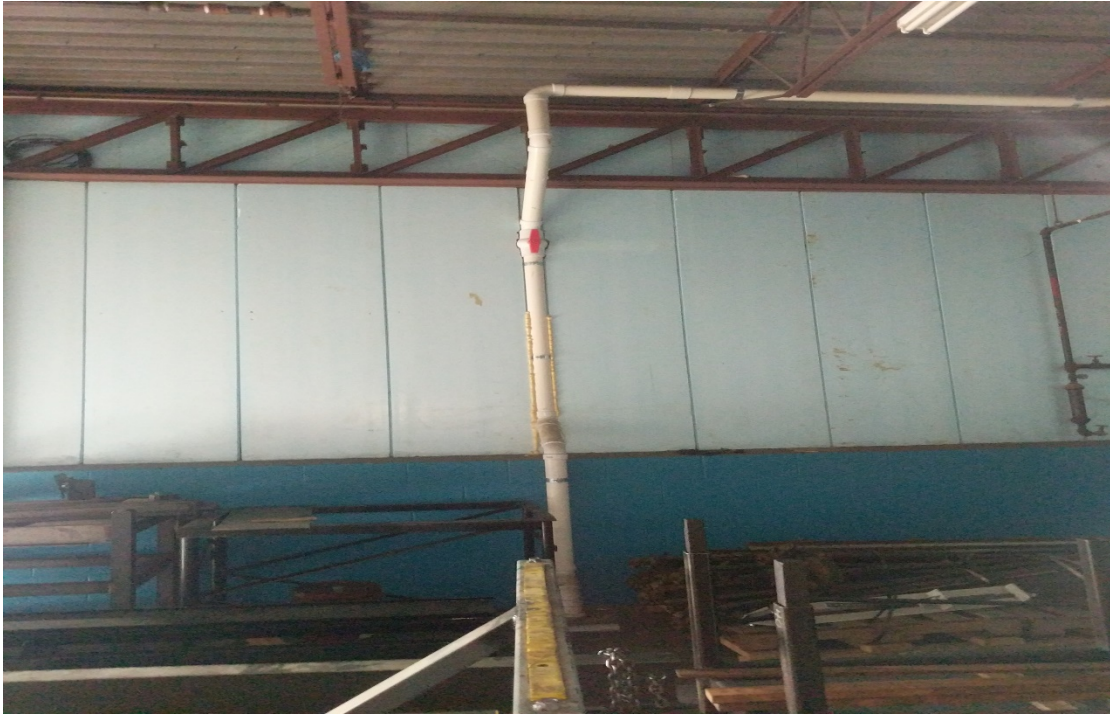
The concrete flooring above the mitigation areas was in good condition and there were no observed changes to the above grade sections of the SSDS. The 4-inch PVC riser pipes coming from the subgrade system were intact and gaps in the caulk were not observed at these joints. Pipe valves for both piping legs were observed in the open position in all cases.

Photo 1: *Interior PVC riser showing typical open valve 2/1/19*

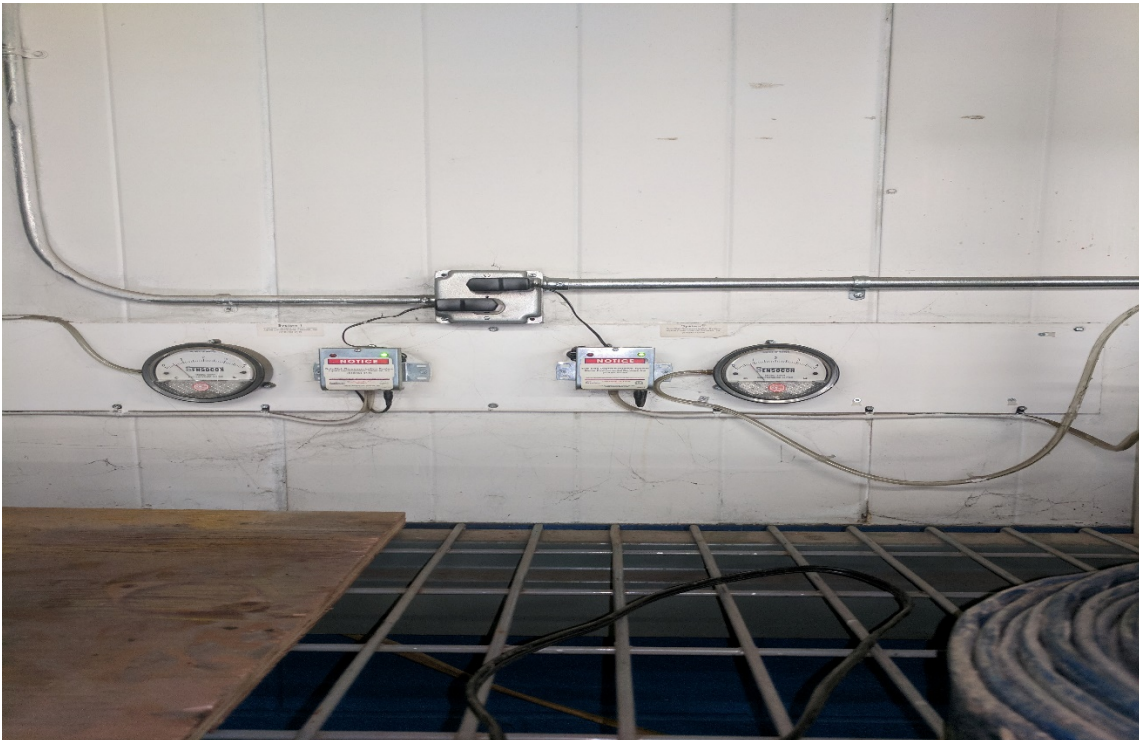
Mr. Brian McCarthy of EnSafe Inc. inspected the Site and the above grade parts of the sub-slab depressurization system (SSDS) on February 1, 2019. The SSDS was functioning properly during the inspection. The two legs of the SSDS registered a vacuum of 1.5 and 1.7 inches of water. According to the Site owner, one pitot tube was changed on the blower control unit the week of January 25, 2019. The SSDS has operated continuously since the previous inspection one year earlier. Two RadonAway GP501 fans, 13 ball valves, overhead PVC piping and a total of 13 subslab air extraction points makeup the two separate legs of the SSDS.

Photo 2: *Interior system pressure gauges during operation 2/1/19*

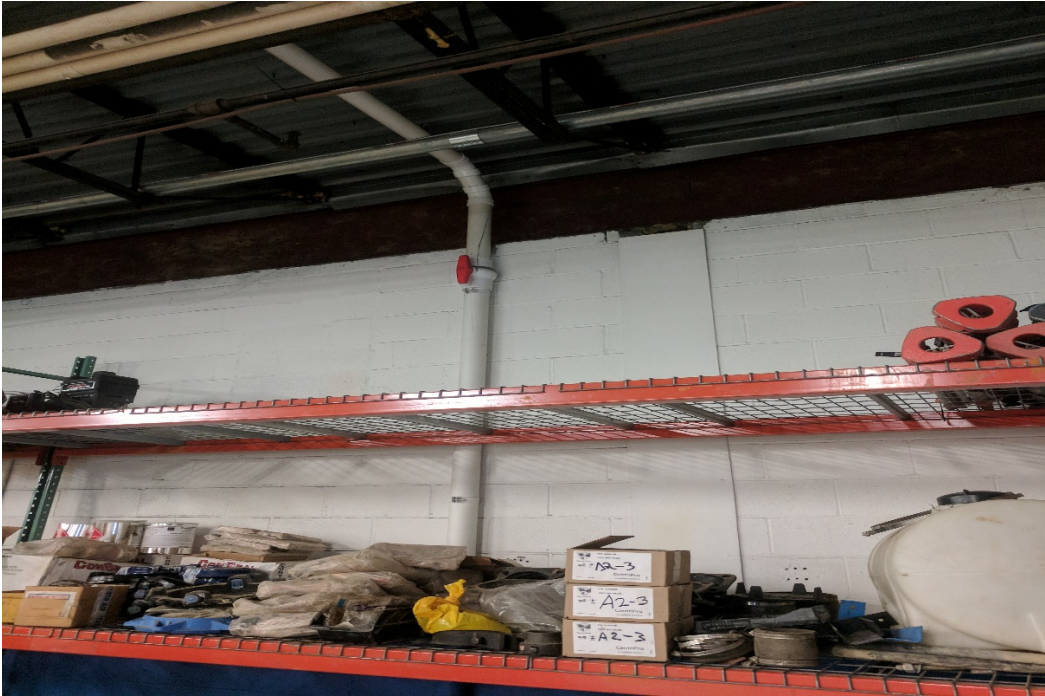
Photo 3: Interior riser open valve 2/1/19

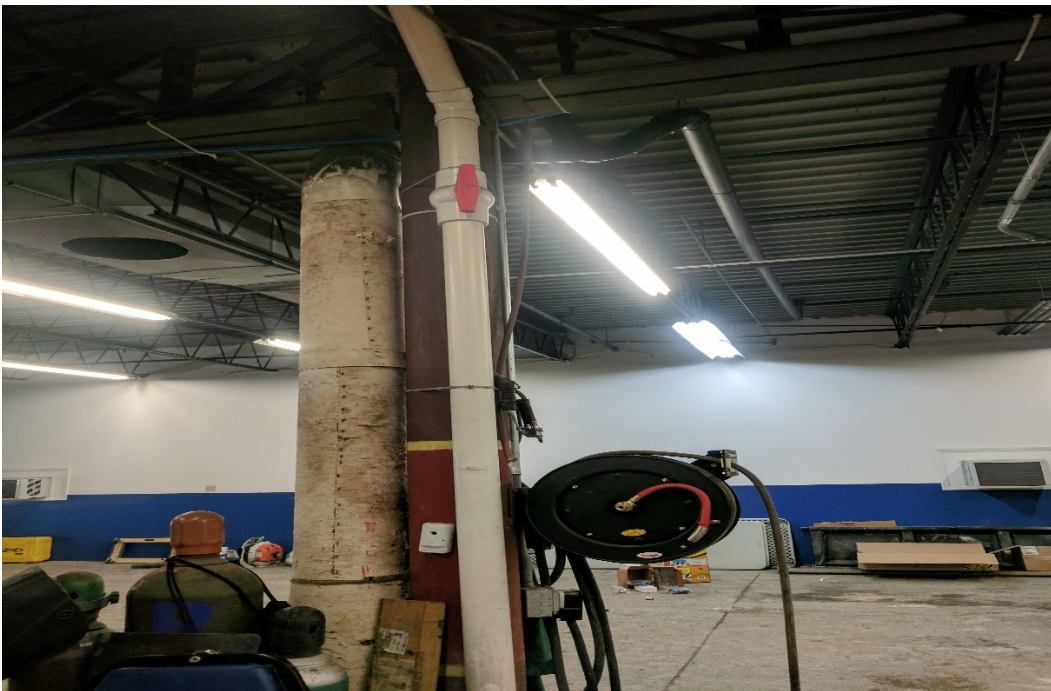
Photo 4: Interior riser open valve 2/1/19

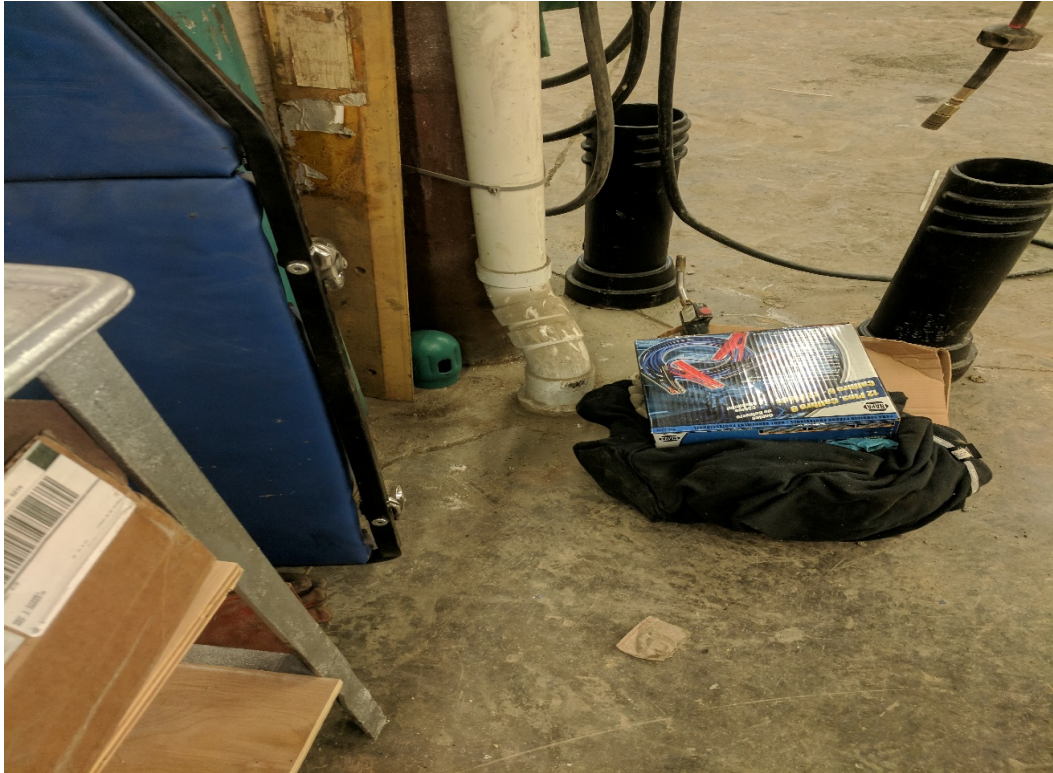
Photo 5: Interior riser joint at concrete floor 2/1/19

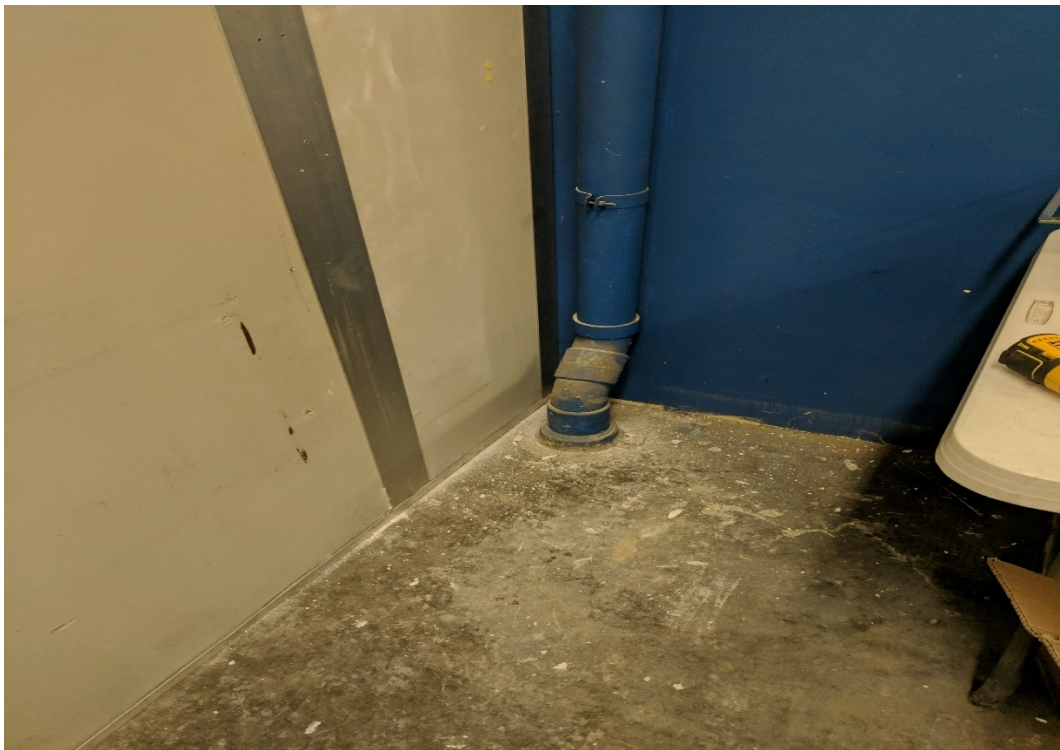
Photo 6: Interior riser joint at concrete floor 2/1/19

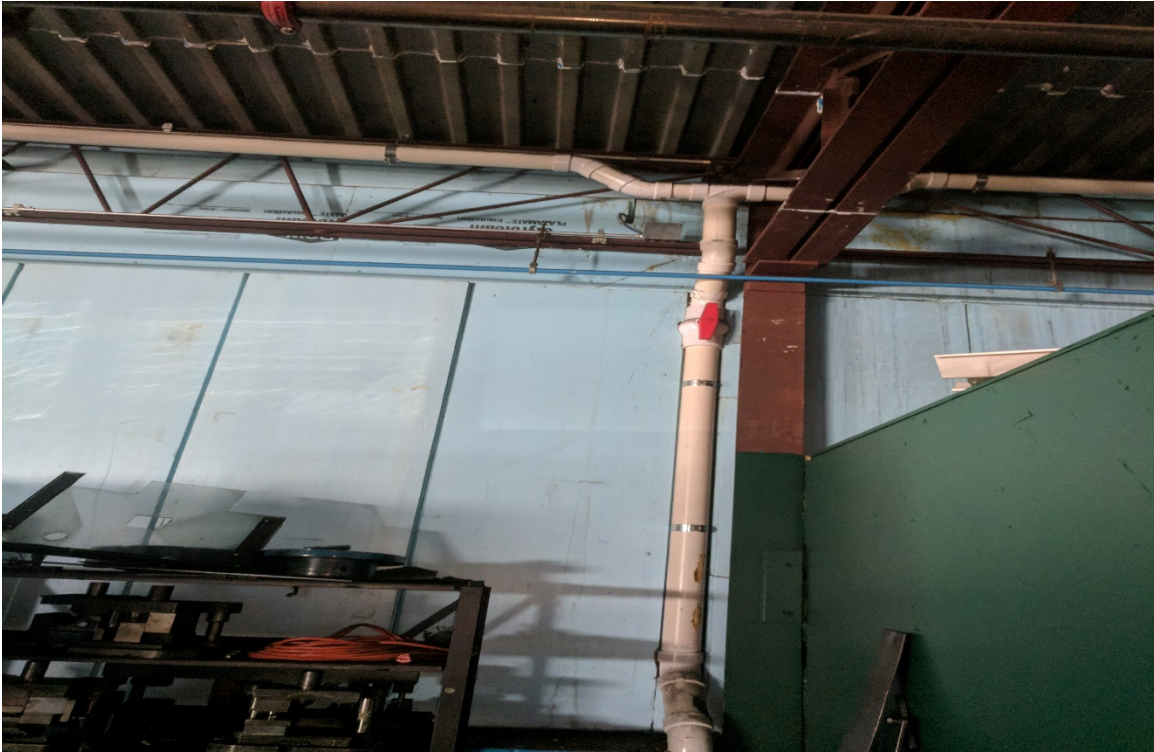
Photo 7: Interior riser and junction at pipe typical 2/1/19

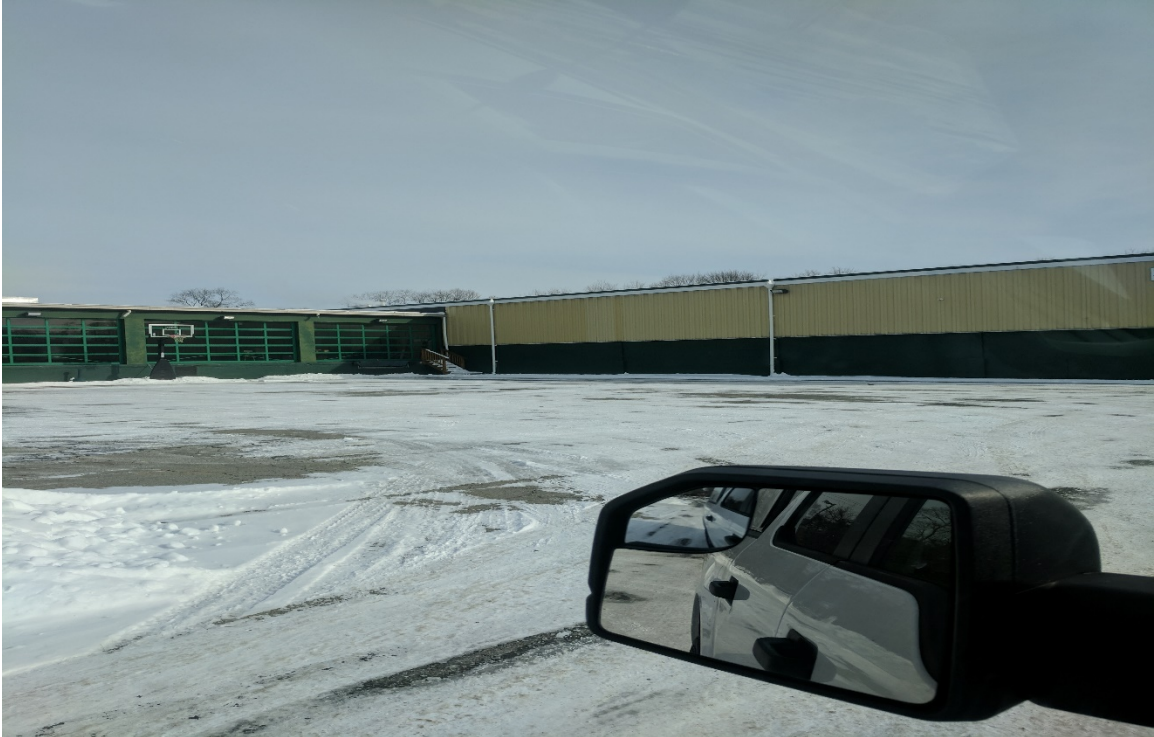
Photo 8: Exterior southwest side of building 2/1/19

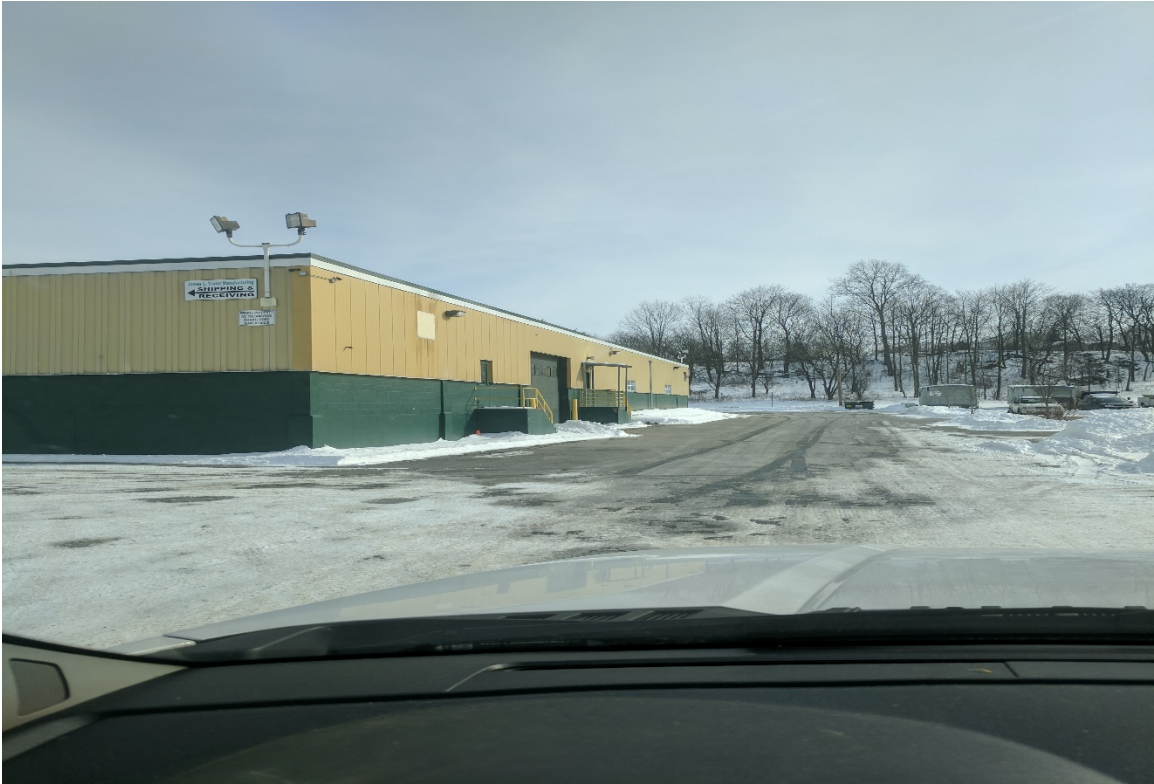
Photo 9: *Exterior south side of building 2/1/19*

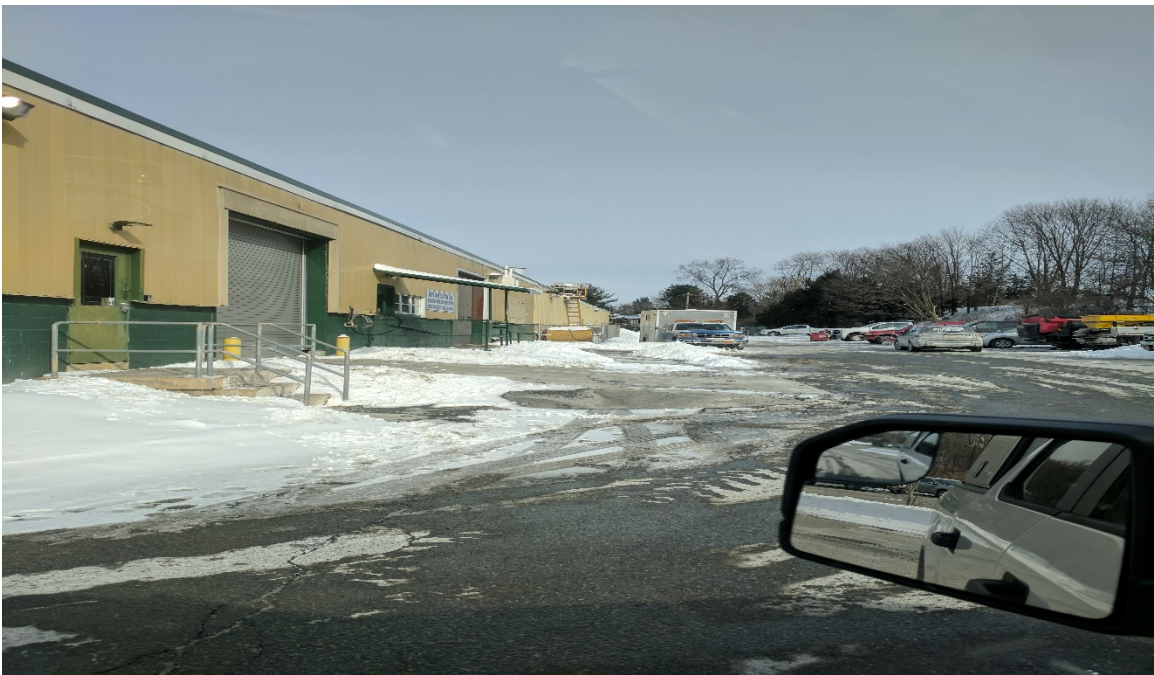
Photo 10: *Exterior east side of building 2/1/19*

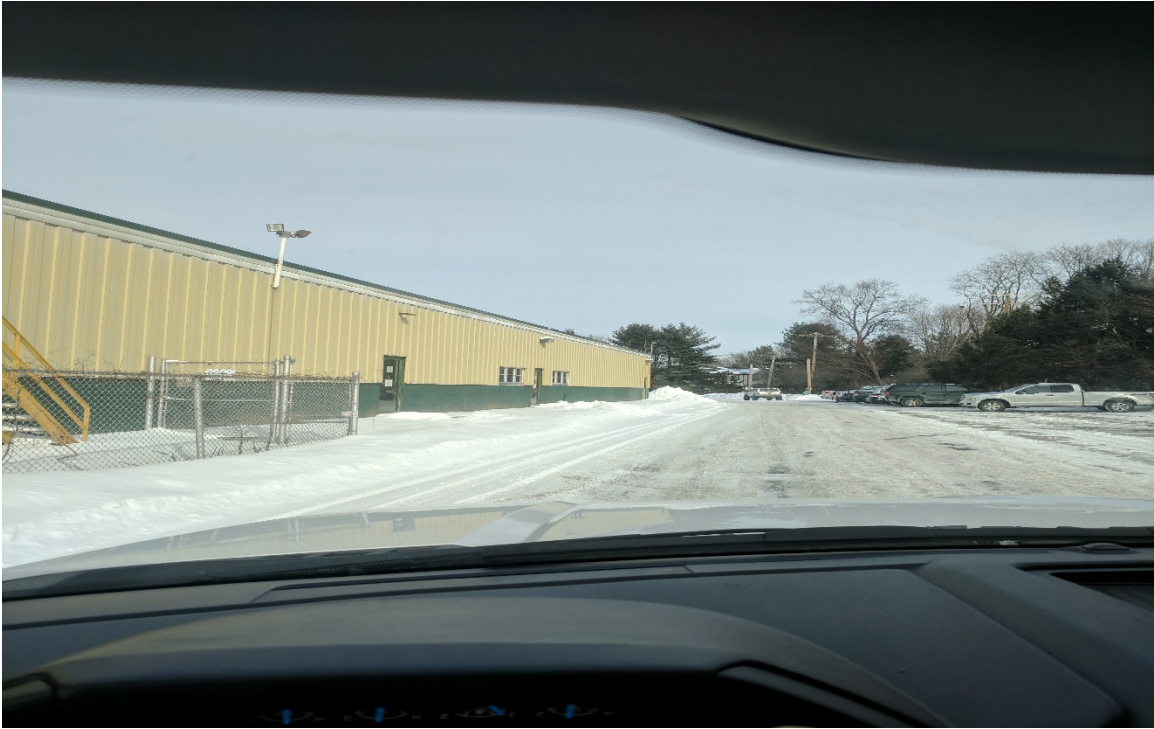
Photo 11: *Exterior east side of building 2/1/19*

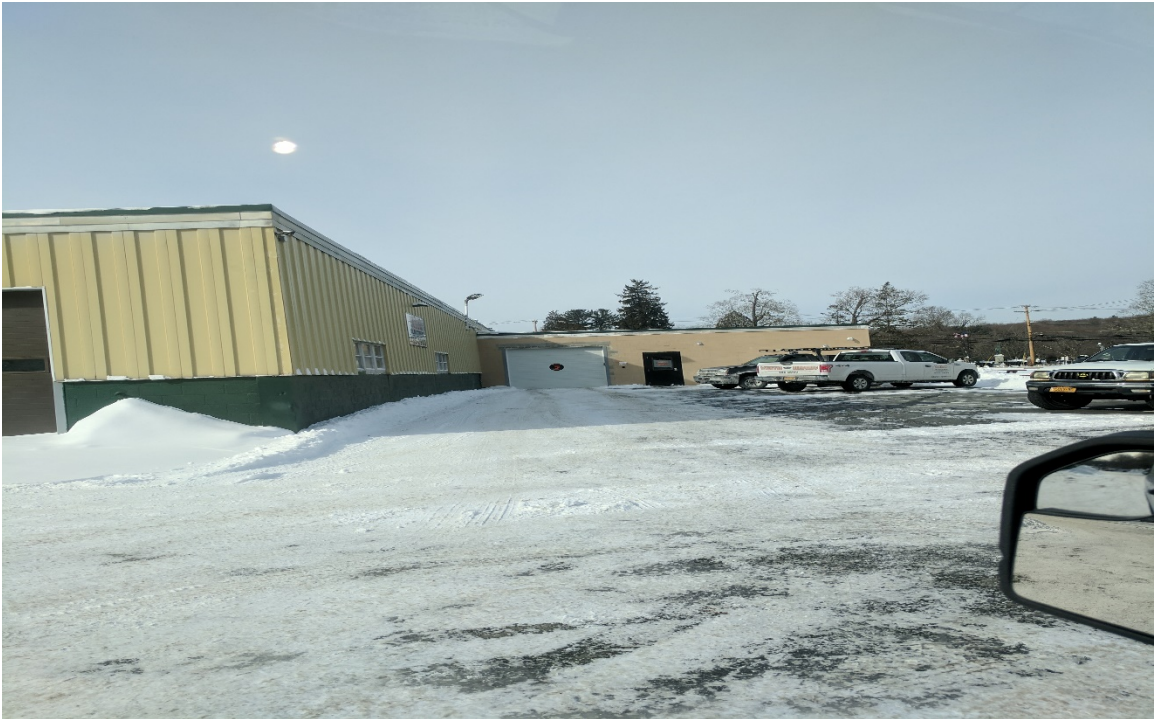
Photo 12: *Exterior east side of building 2/1/19*

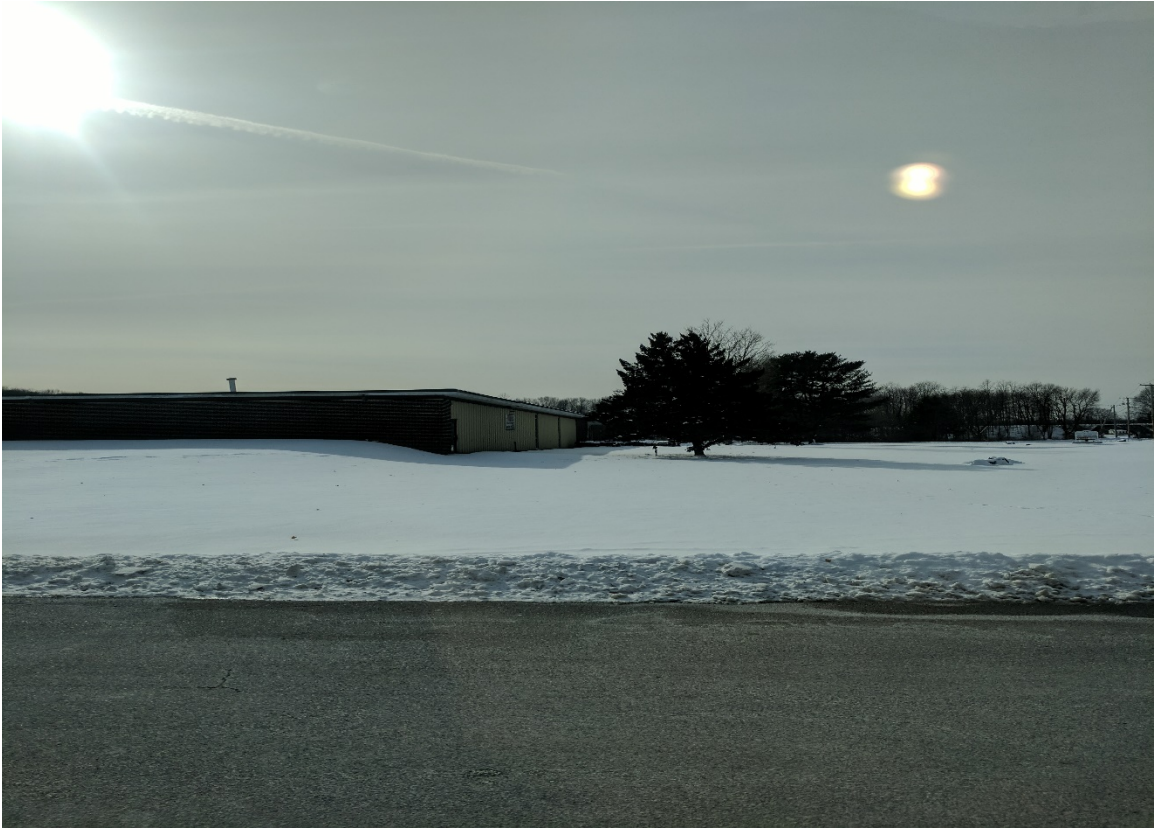
Photo 13: *Exterior north and west side of building 2/1/19*
