Re: Quarterly Progress Report – 1st Quarter 2020
Harriman Inactive Waste Disposal Site #336006

Former Nepera Plant - Harriman, NY: Quarterly Well Inspection Report

**RIVERBANK INSPECTION FORM
WEST BRANCH OF THE RAMAPO RIVER
MAYBROOK AND HARRIMAN TRUST
HARRIMAN, NEW YORK**

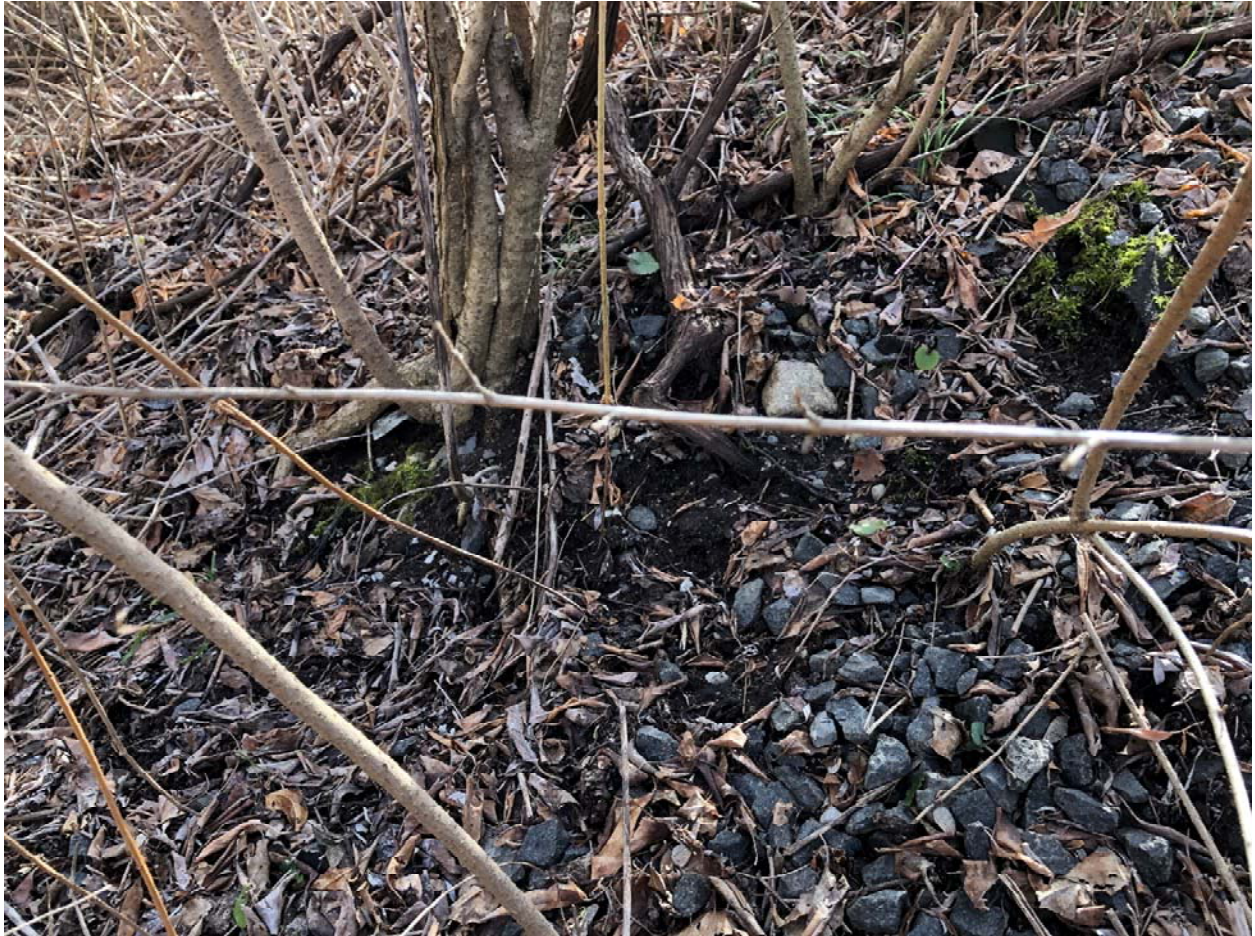
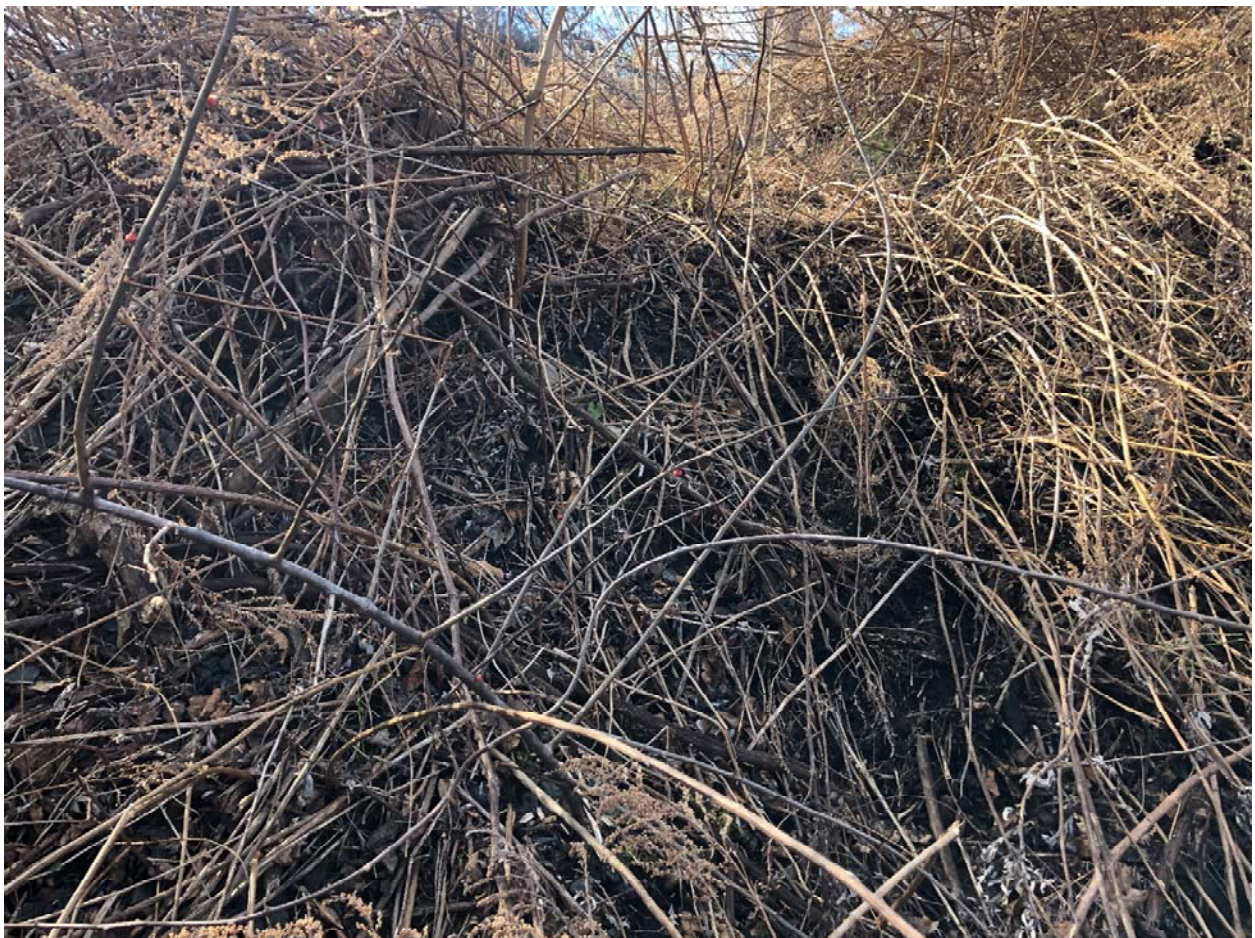
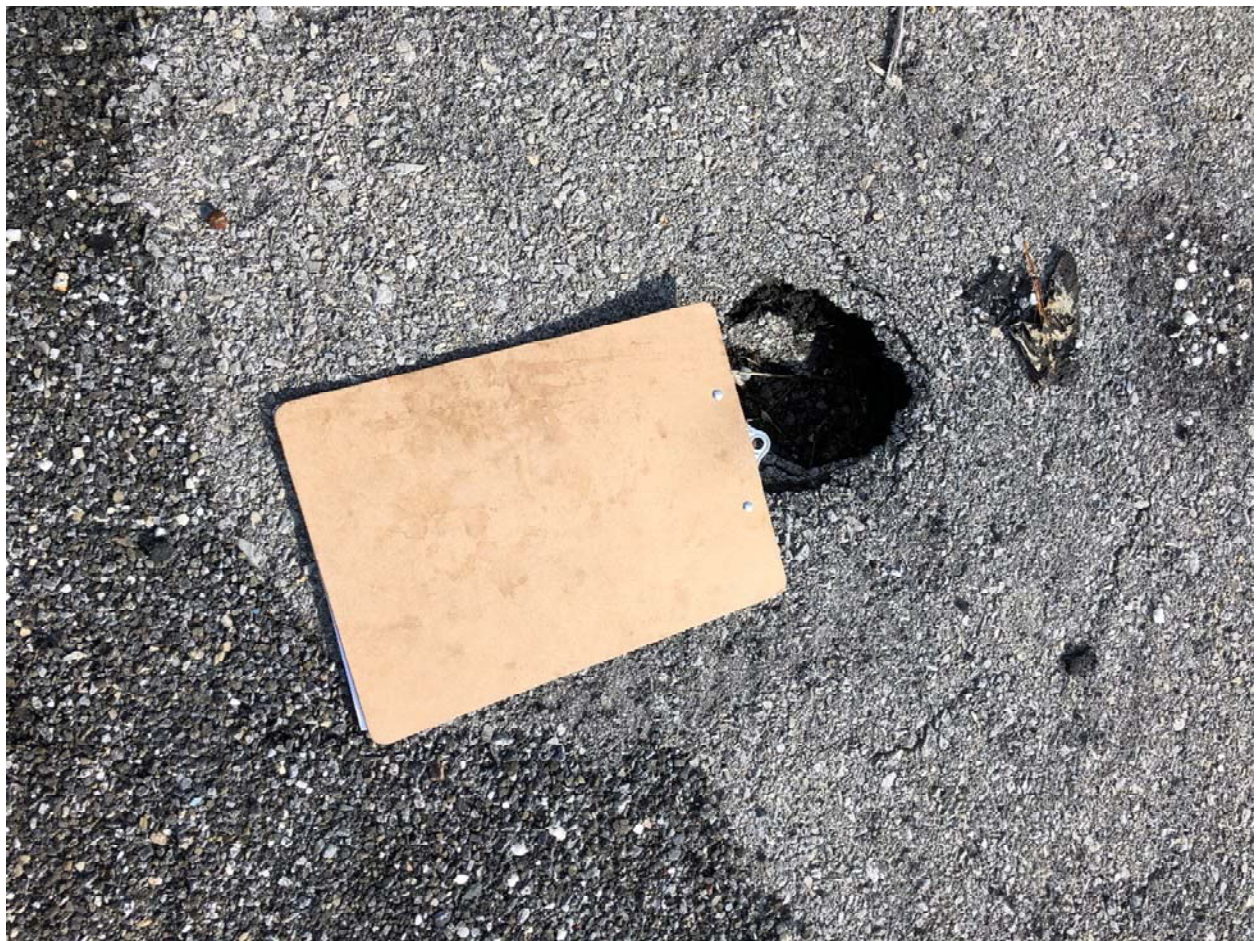
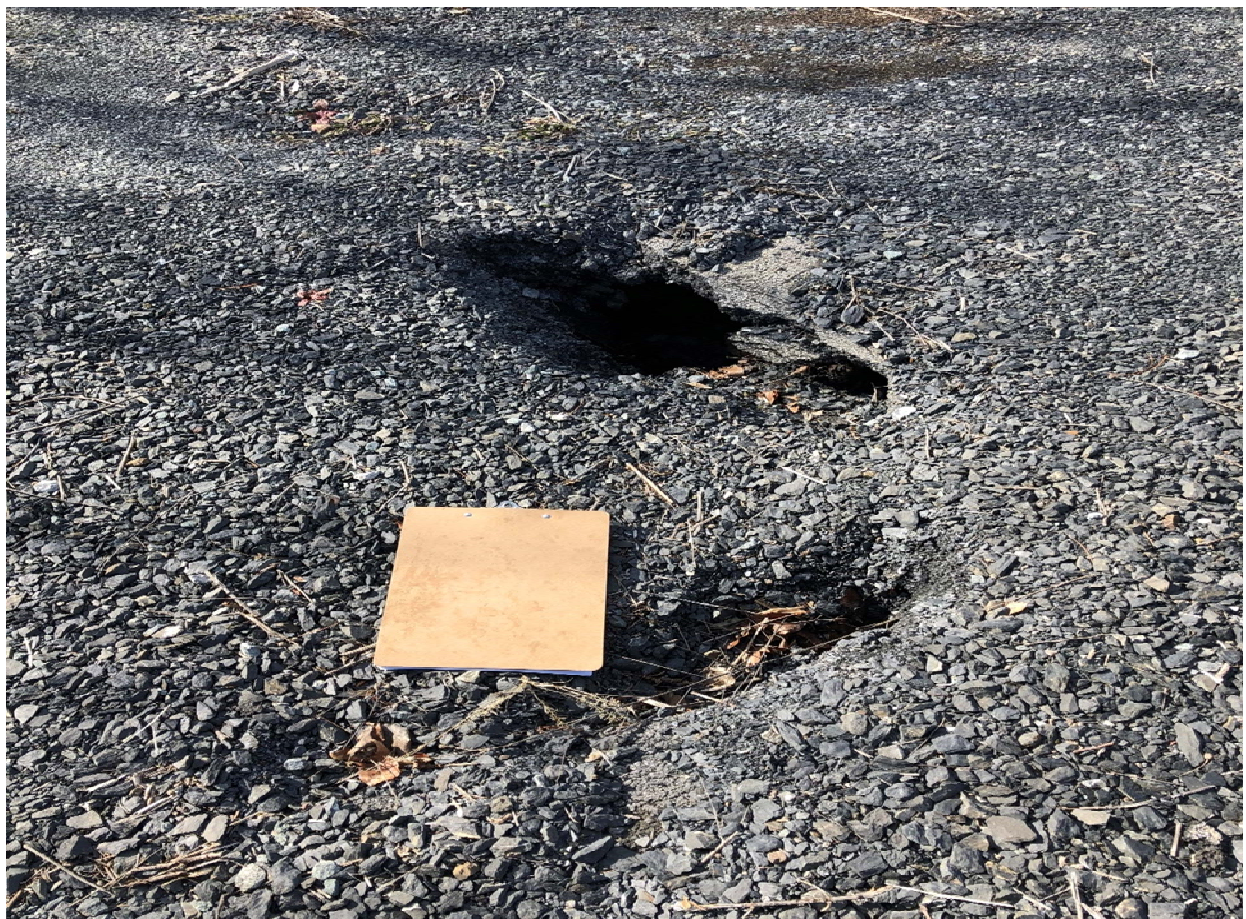
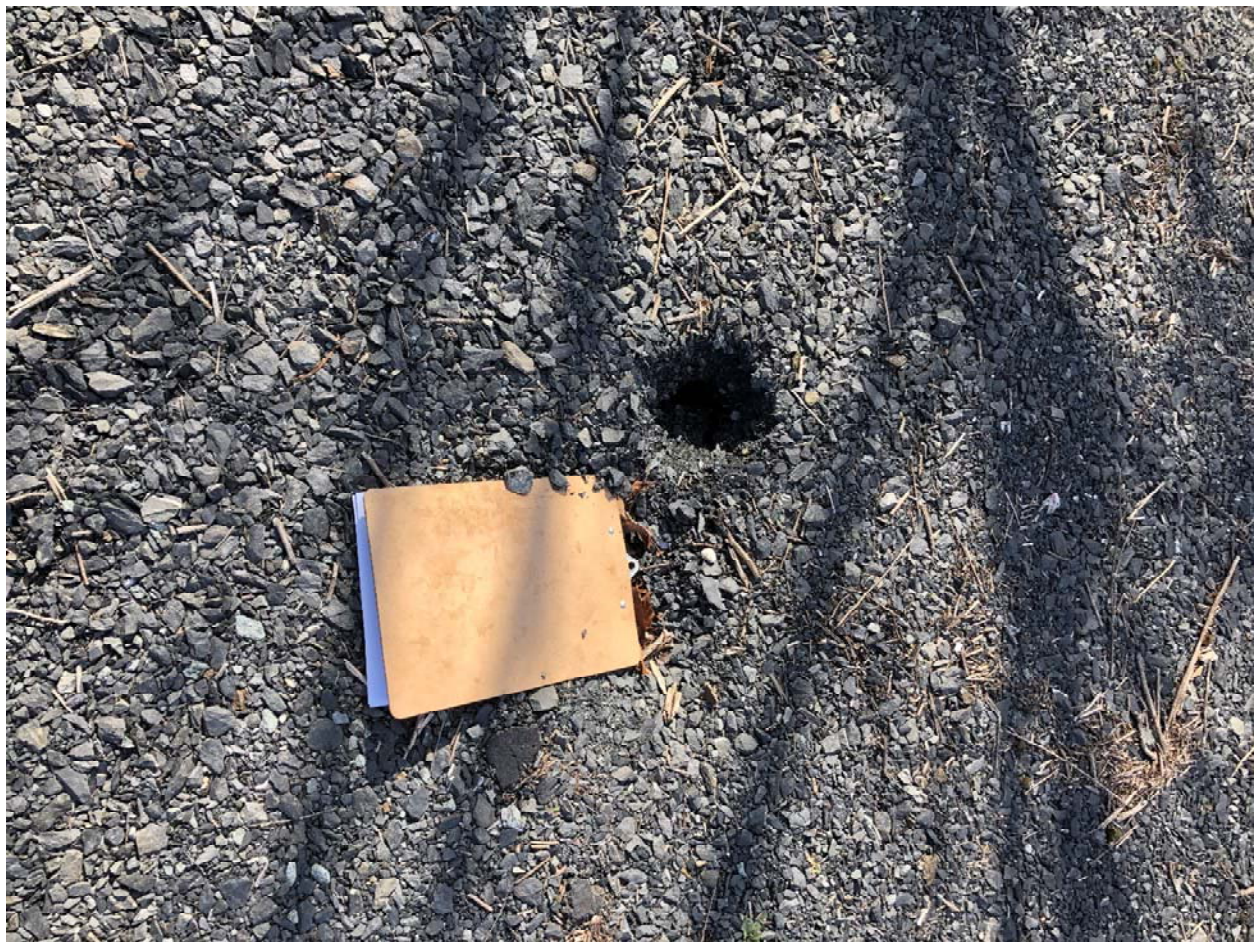
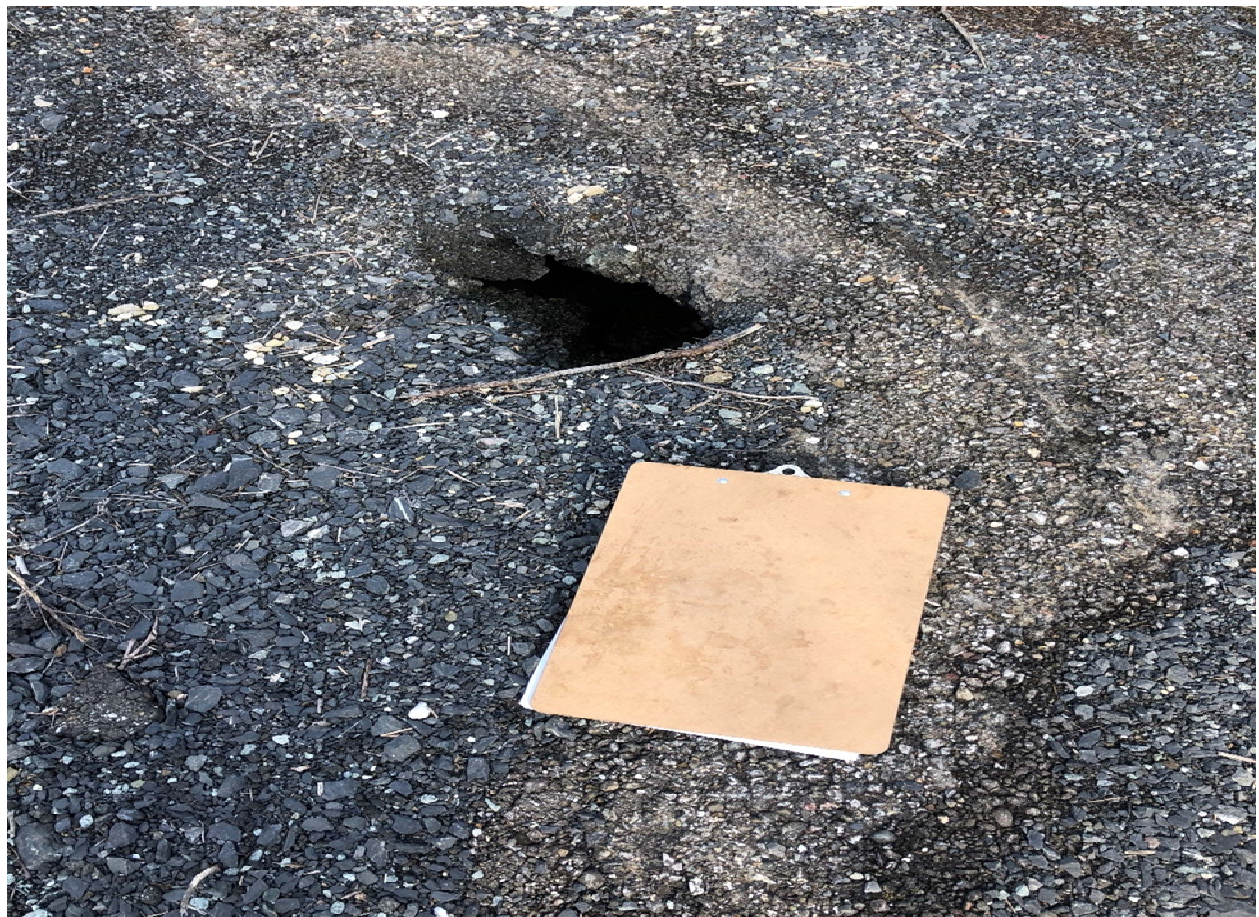
Representative Stream Bank Photos – February 19, 2020

- The interim cover along the West Branch of the Ramapo River was evaluated as a part of a site inspections performed on February 19, 2020. The interim cover remains in good condition. The cover vegetation is stable, well vegetated, and there are no signs of erosion. Representative photos are attached.

A. General condition of cover material	<u>Good</u>	Riverbank cover in good condition, no signs of erosion, no white material showing. (pictures included).
B. Settlement of covered area	<u>Adequate</u>	Small potholes (14) observed in parking lot area, although pavement cover generally remains intact. Photos attached.
C. General condition of silt fence	<u>N/A</u>	Silt fence has been removed from stream bank per NYSDEC approval on January 12, 2016.

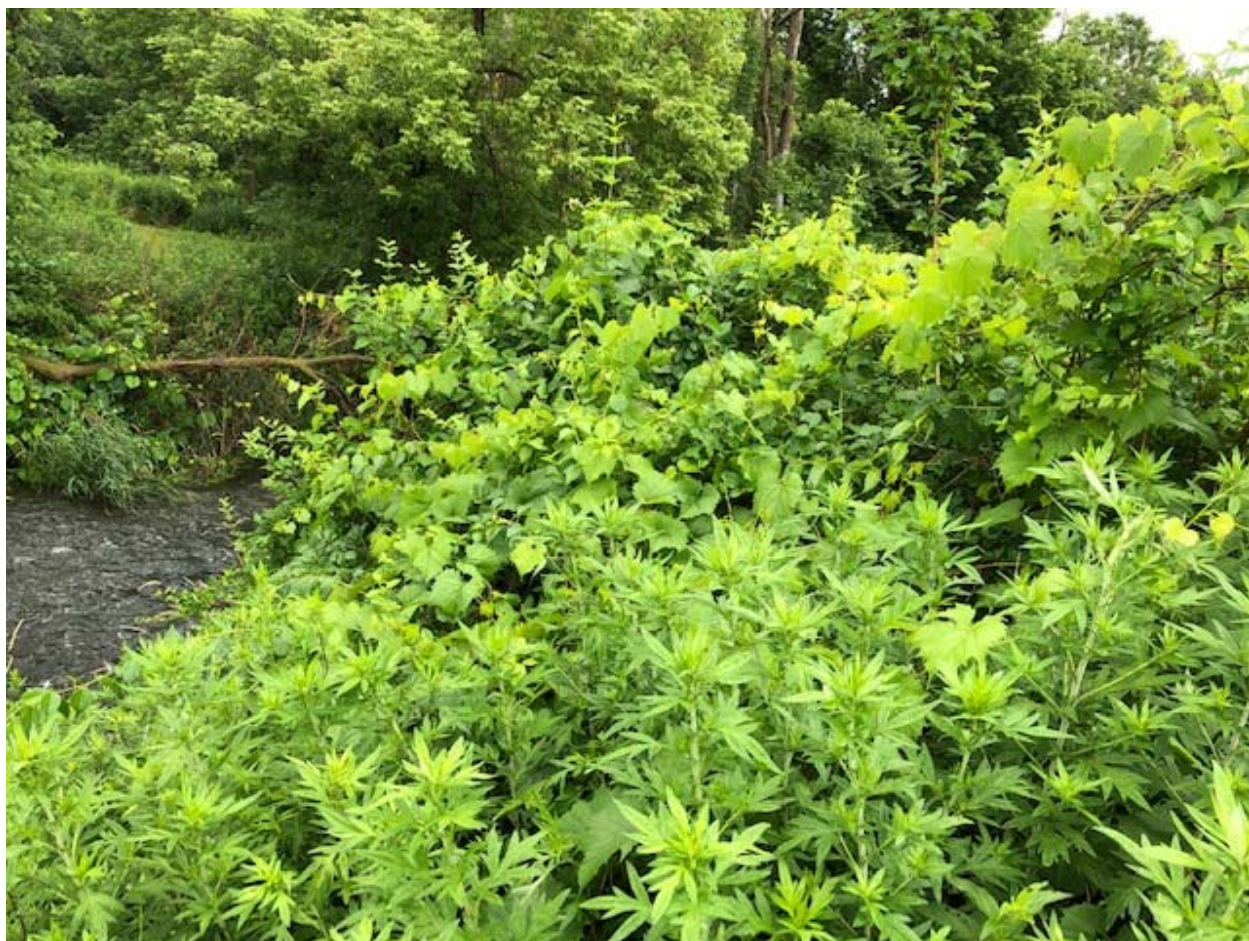
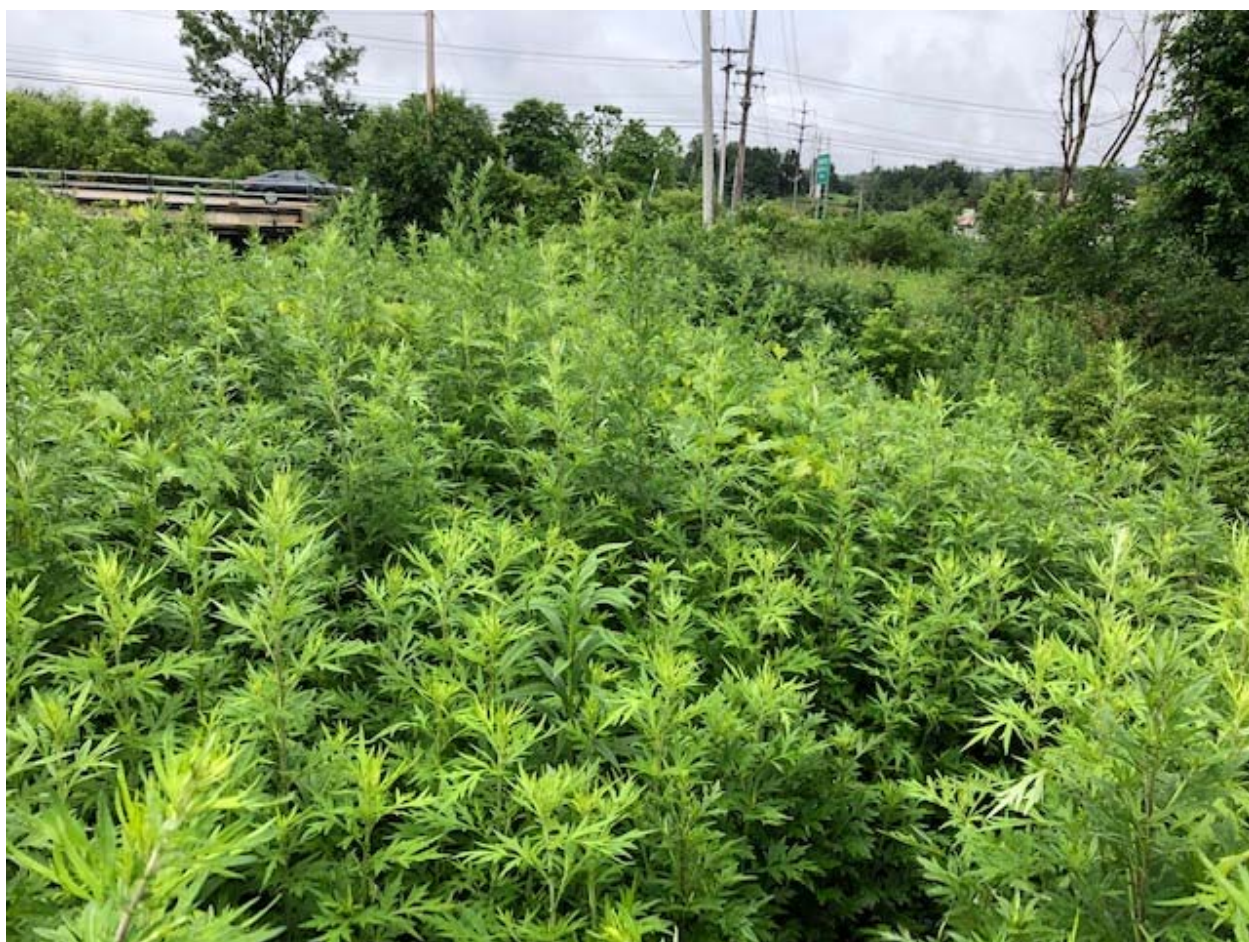
Representative Stream Bank Photos – June 30, 2020

- The interim cover along the West Branch of the Ramapo River was evaluated as a part of a site inspections performed on June 30, 2020. The interim cover remains in good condition. The cover vegetation is stable, well vegetated, and there are no signs of erosion. Representative photos are attached.

STATUS	COMMENTS
IRM COVER AND SILT FENCE			
A. General condition of cover material	<u>Good</u>		Riverbank cover in good condition, no signs of erosion, no white material showing. High vegetation on riverbank. (pictures included).
B. Settlement of covered area	<u>Adequate</u>		Potholes present in parking lot area, although pavement cover generally remains intact. (pictures included). 3 total potholes.
C. General condition of silt fence	<u>N/A</u>		Silt fence has been removed from stream bank per NYSDEC approval on January 12, 2016.

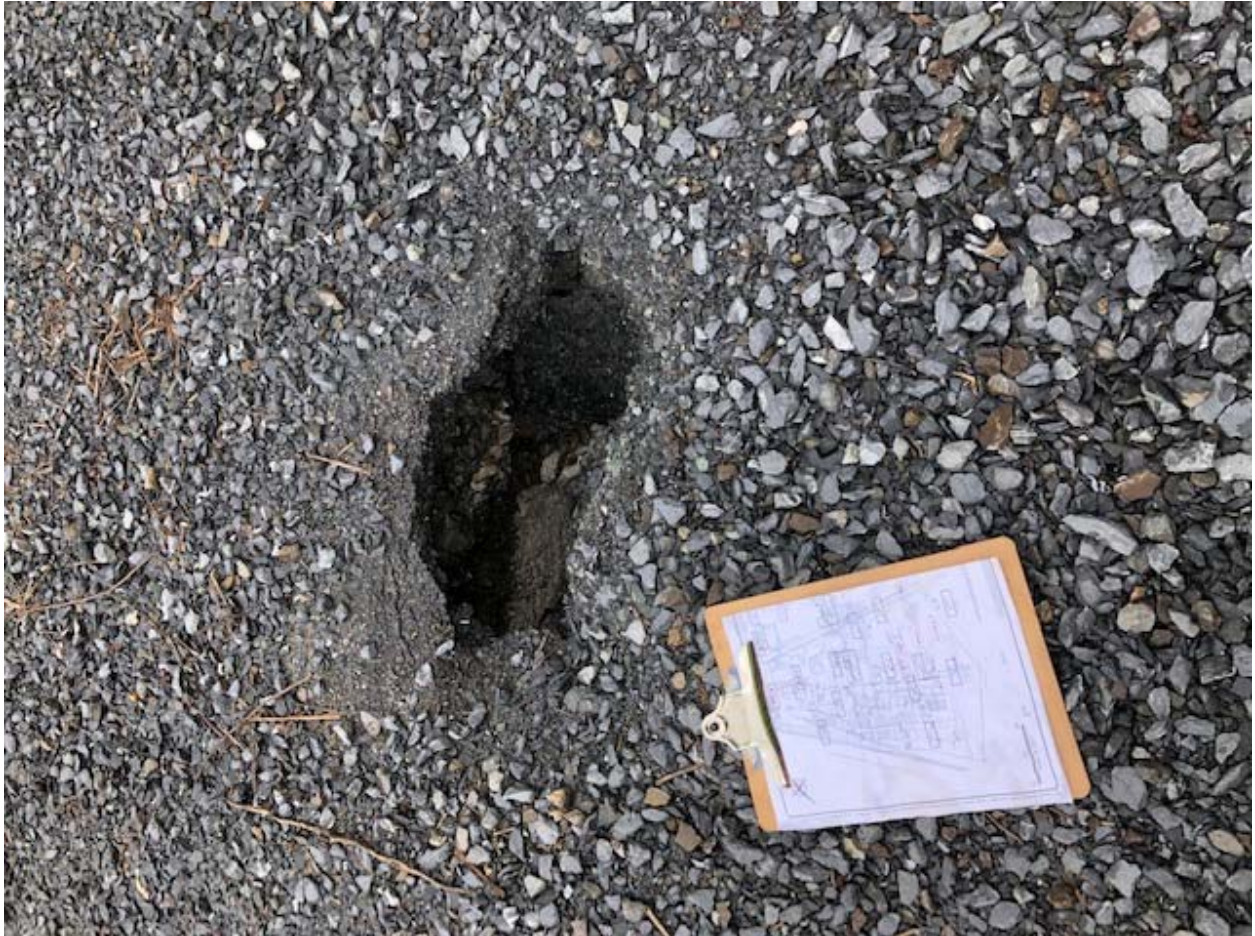
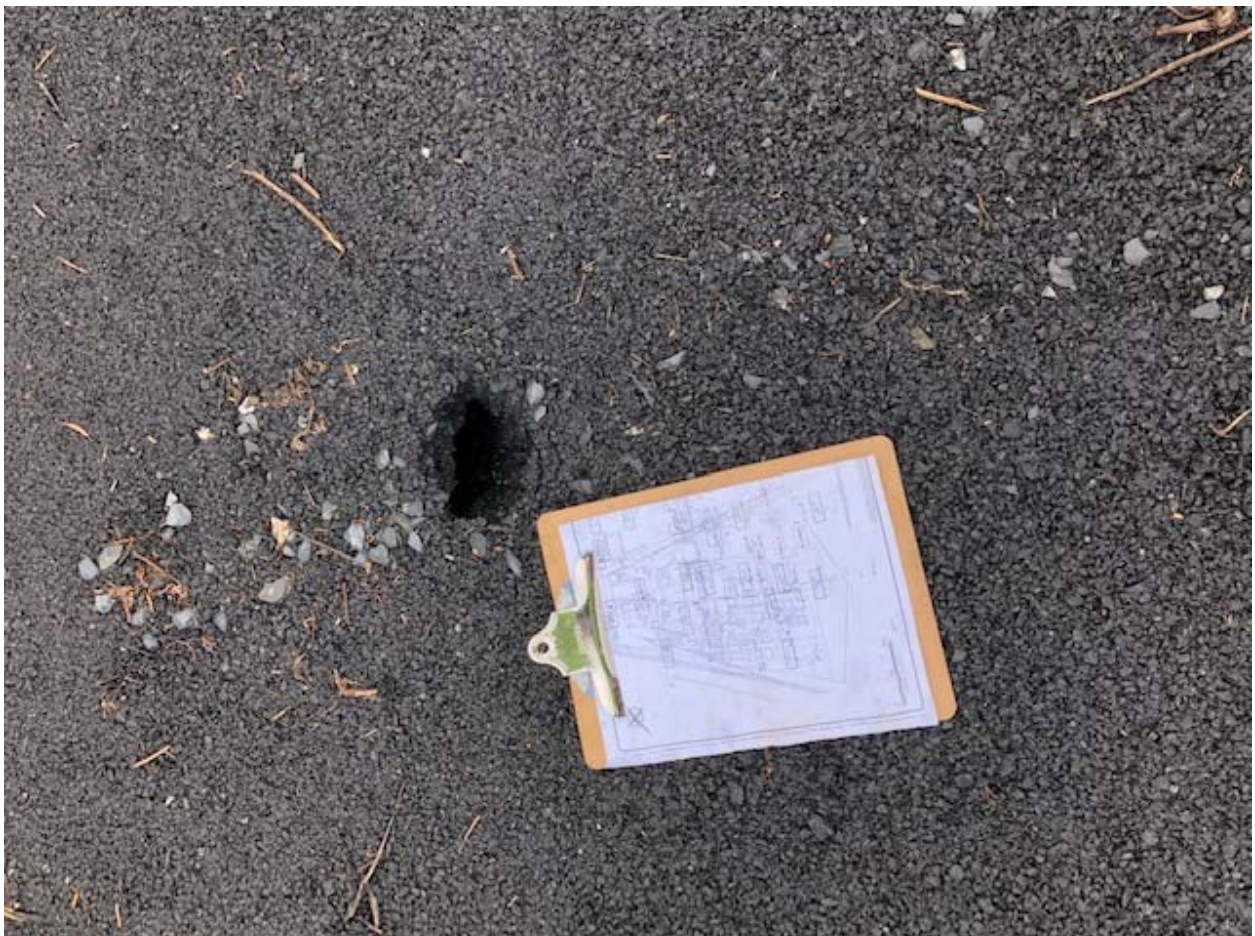
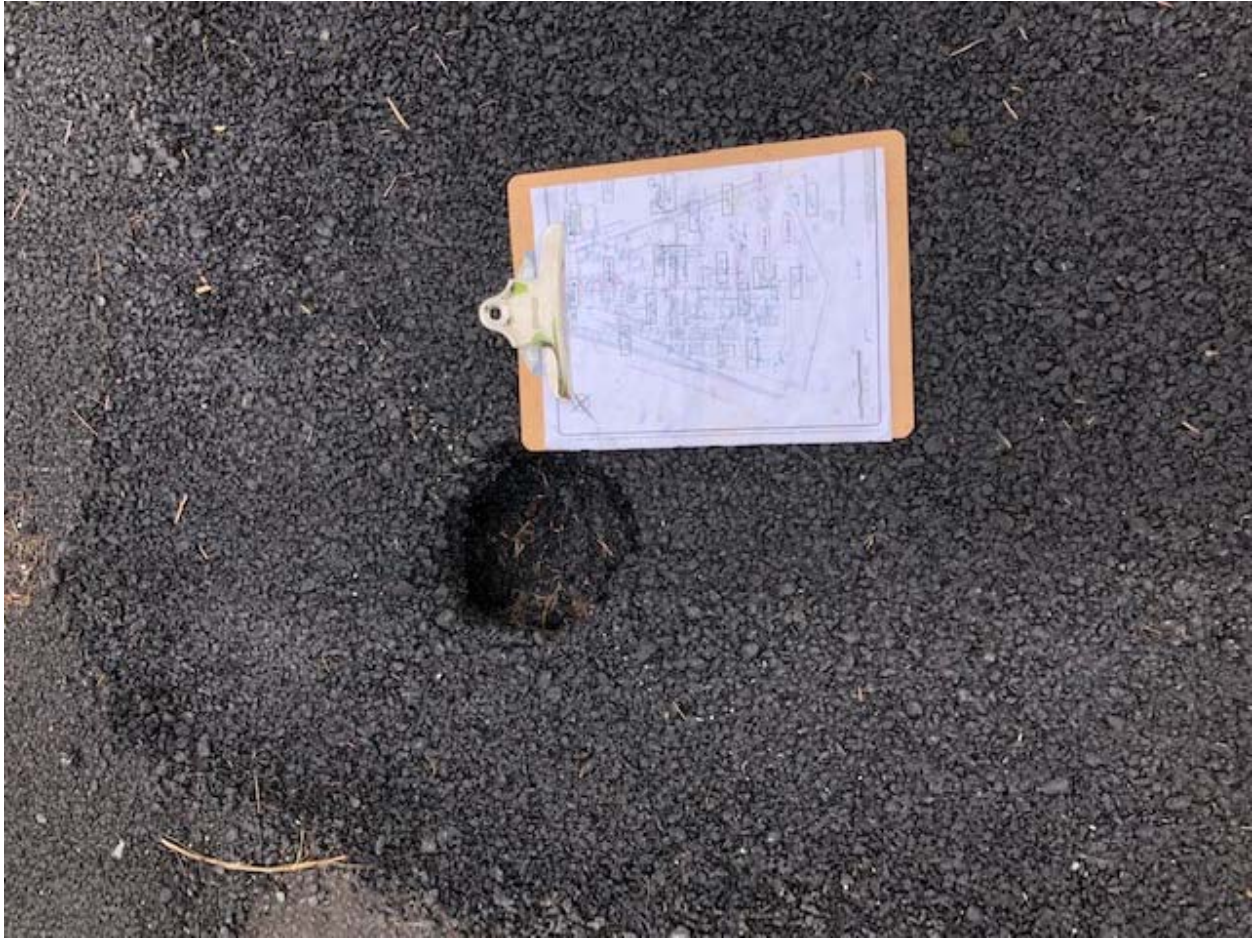
Representative Photos of Potholes in Parking Lot – June 30, 2020

inspection the parking area was observed to be good condition with 3 small to midsize potholes observed at random locations across the parking lot. Representative photos of the observed potholes are attached for reference.

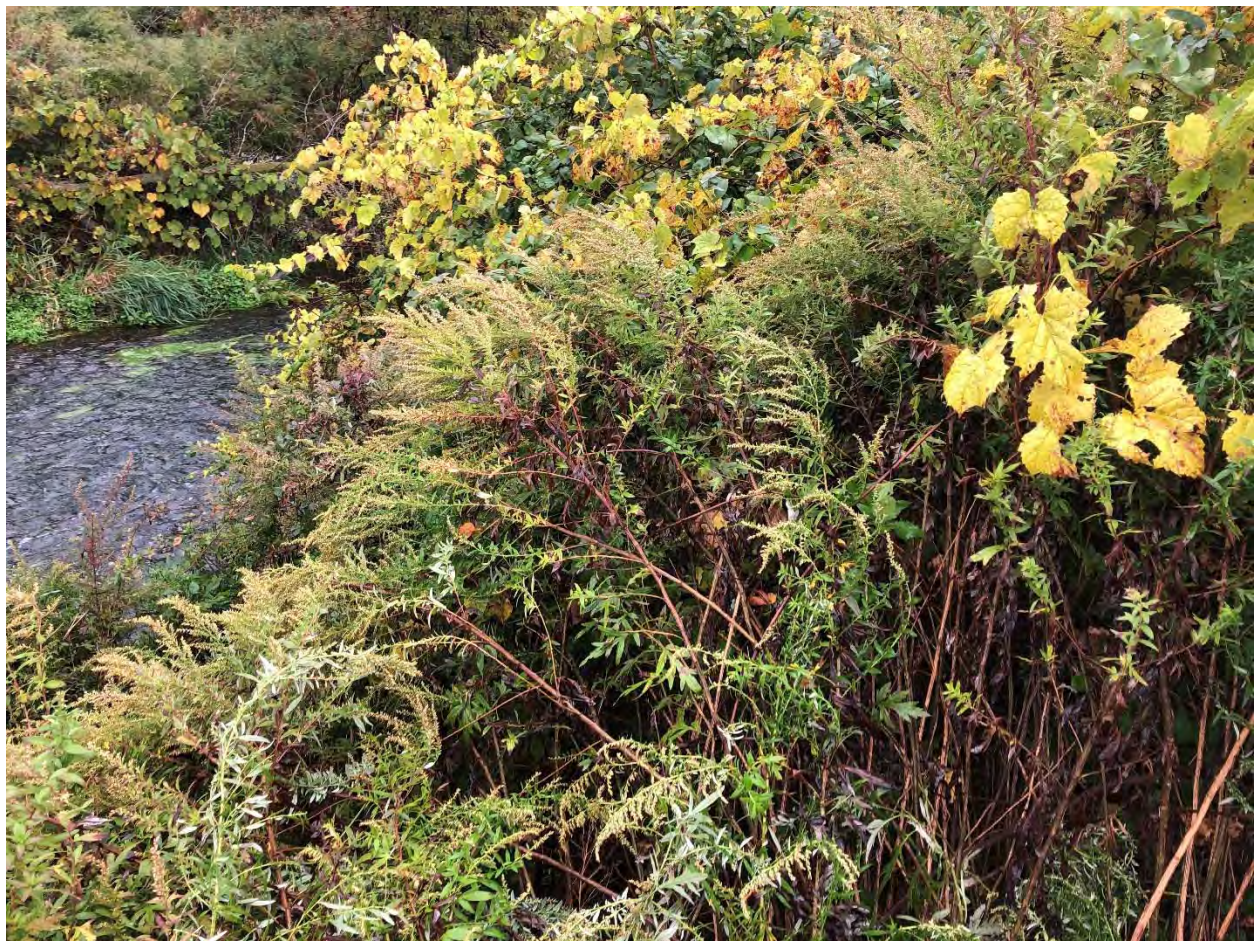
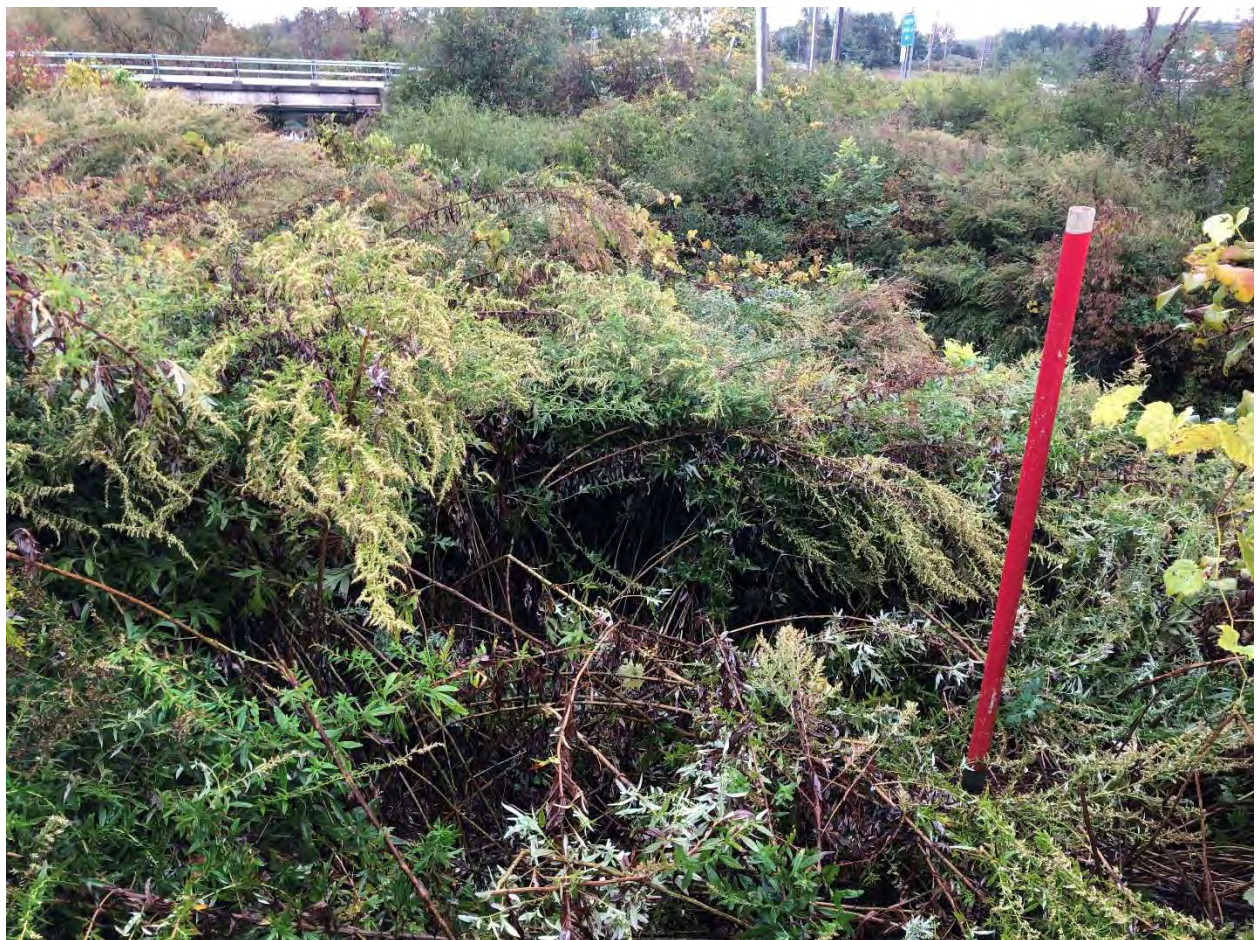
Representative Stream Bank Photos – October 12, 2020

- The interim cover along the West Branch of the Ramapo River was evaluated as a part of a site inspections performed on October 12, 2020. The interim cover remains in good condition. The cover vegetation is stable, well vegetated, and there are no signs of erosion. Representative photos are attached. The quarterly inspection was delayed by two weeks due to a scheduling error.

STATUS	COMMENTS
IRM COVER AND SILT FENCE			
A. General condition of cover material	<u>Good</u>		Riverbank cover in good condition, no signs of erosion, no white material showing. Extremely high vegation on riverbank. (pictures included).
B. Settlement of covered area	<u>Adequate</u>		Potholes present in parking lot area, although pavement cover generally remains intact. (pictures included). 14 total potholes.
C. General condition of silt fence	<u>N/A</u>		Silt fence has been removed from stream bank per NYSDEC approval on January 12, 2016.

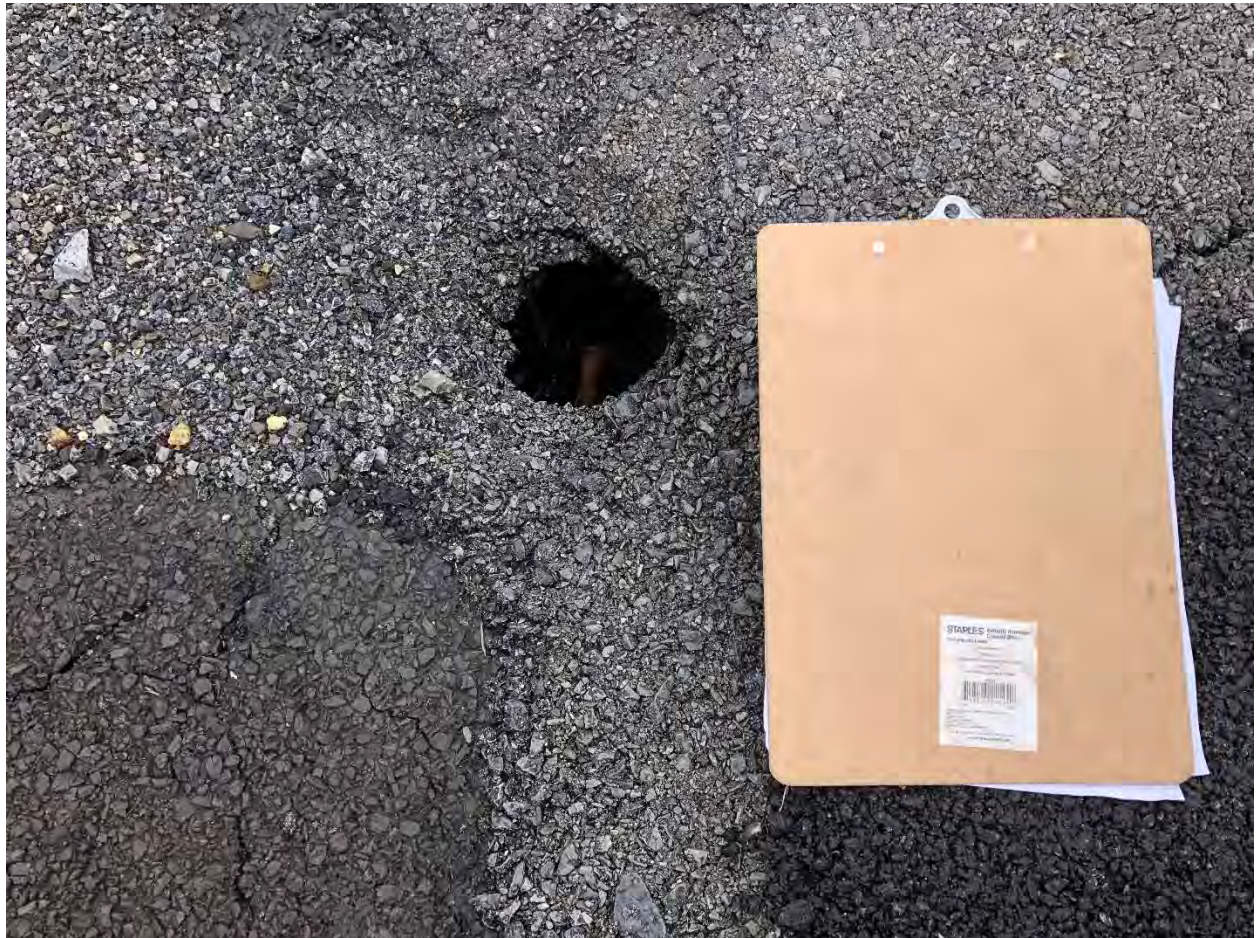
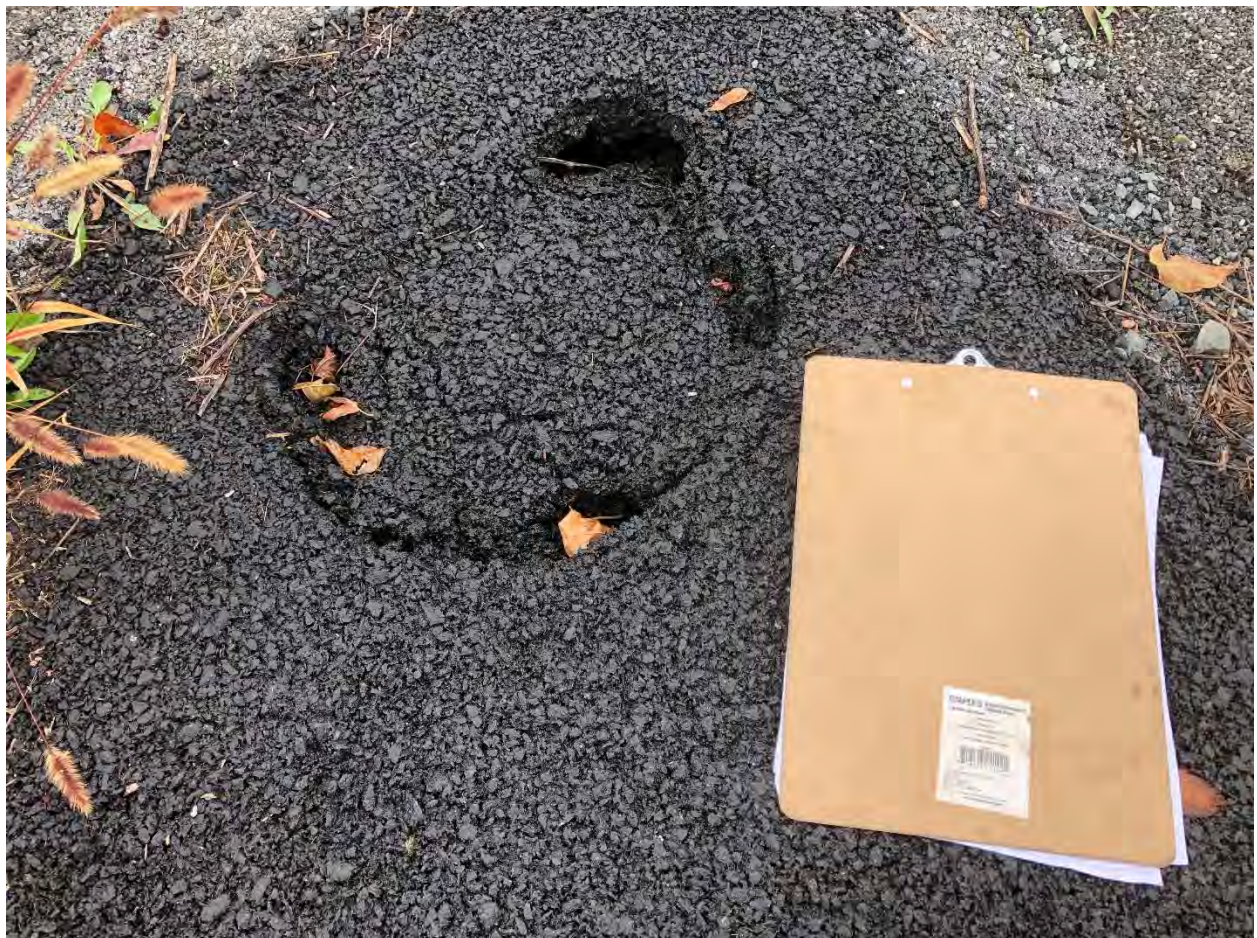
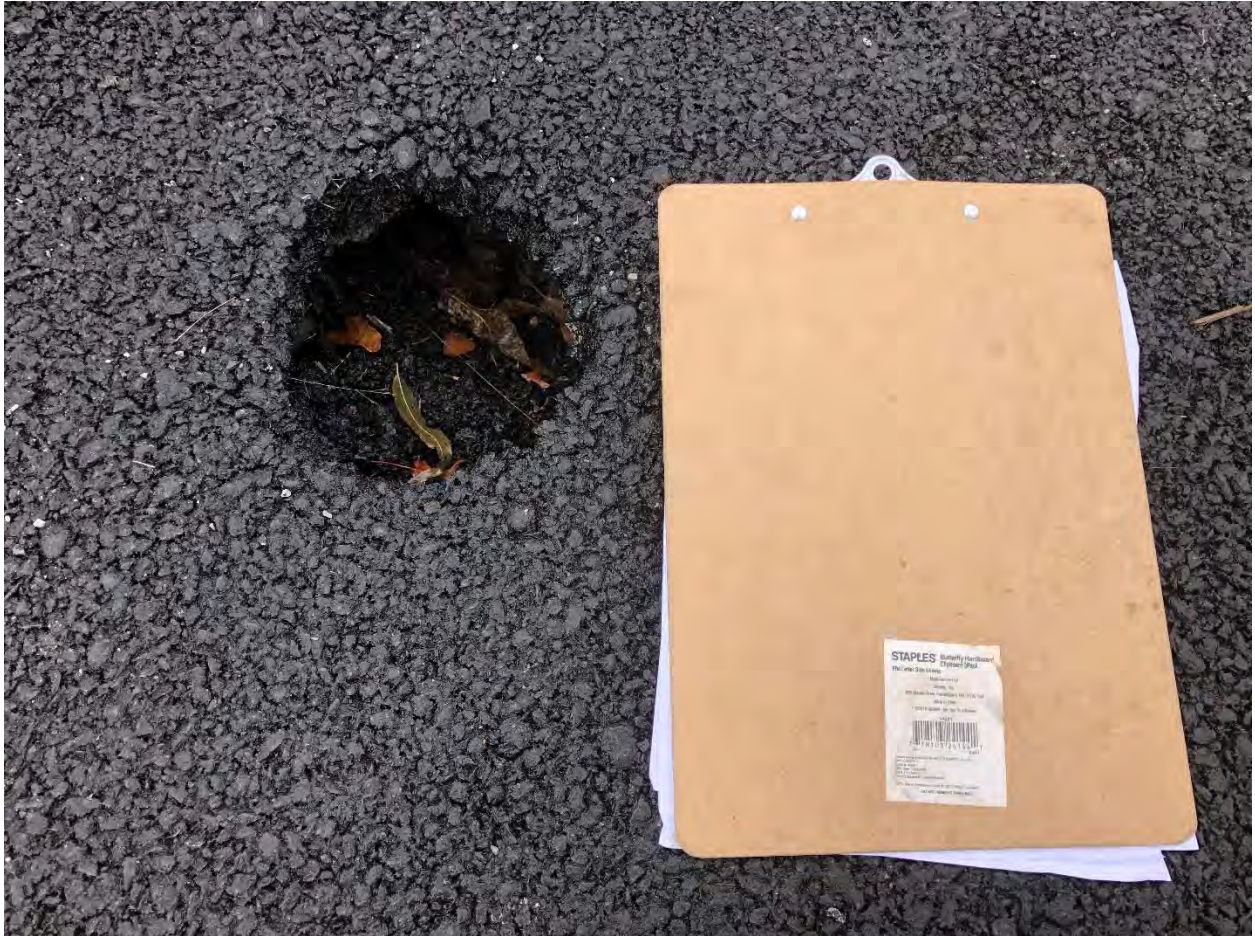
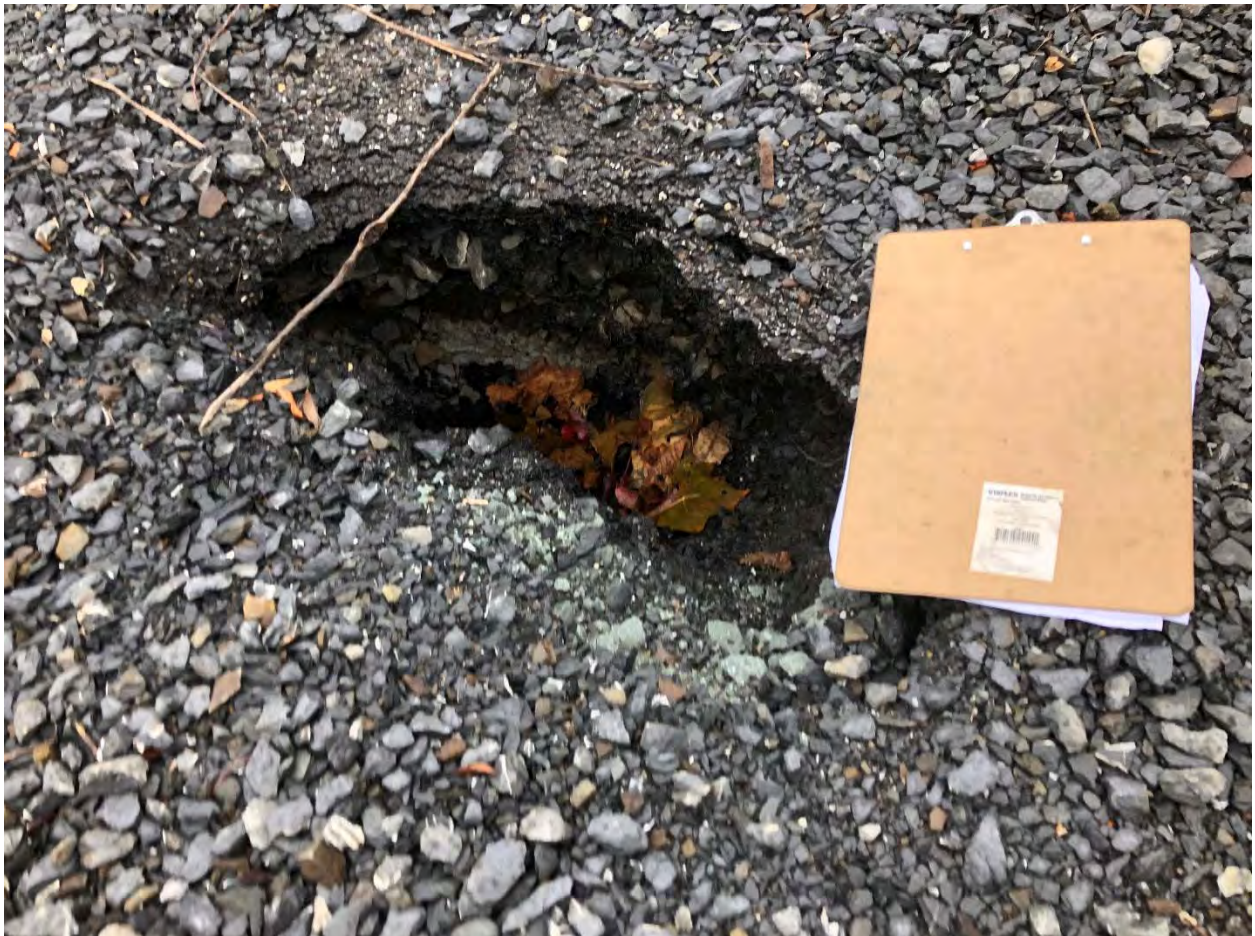
Representative Photos of Potholes in Parking Lot – October 12, 2020

- The parking lot pavement remains generally intact and functioning as a cover. Pothole repairs were last made by ELT-Harriman, LLC in June 2020. During the October 12, 2020 inspection the parking area was observed to be good condition with 14 small to midsize potholes observed at random locations across the parking lot. Representative photos of the observed potholes are attached for reference.
