Re: Quarterly Progress Report – 1st Quarter 2020
Harriman Inactive Waste Disposal Site #336006

Former Nepera Plant - Harriman, NY: Quarterly Well Inspection Report

**RIVERBANK INSPECTION FORM
WEST BRANCH OF THE RAMAPO RIVER
MAYBROOK AND HARRIMAN TRUST
HARRIMAN, NEW YORK**

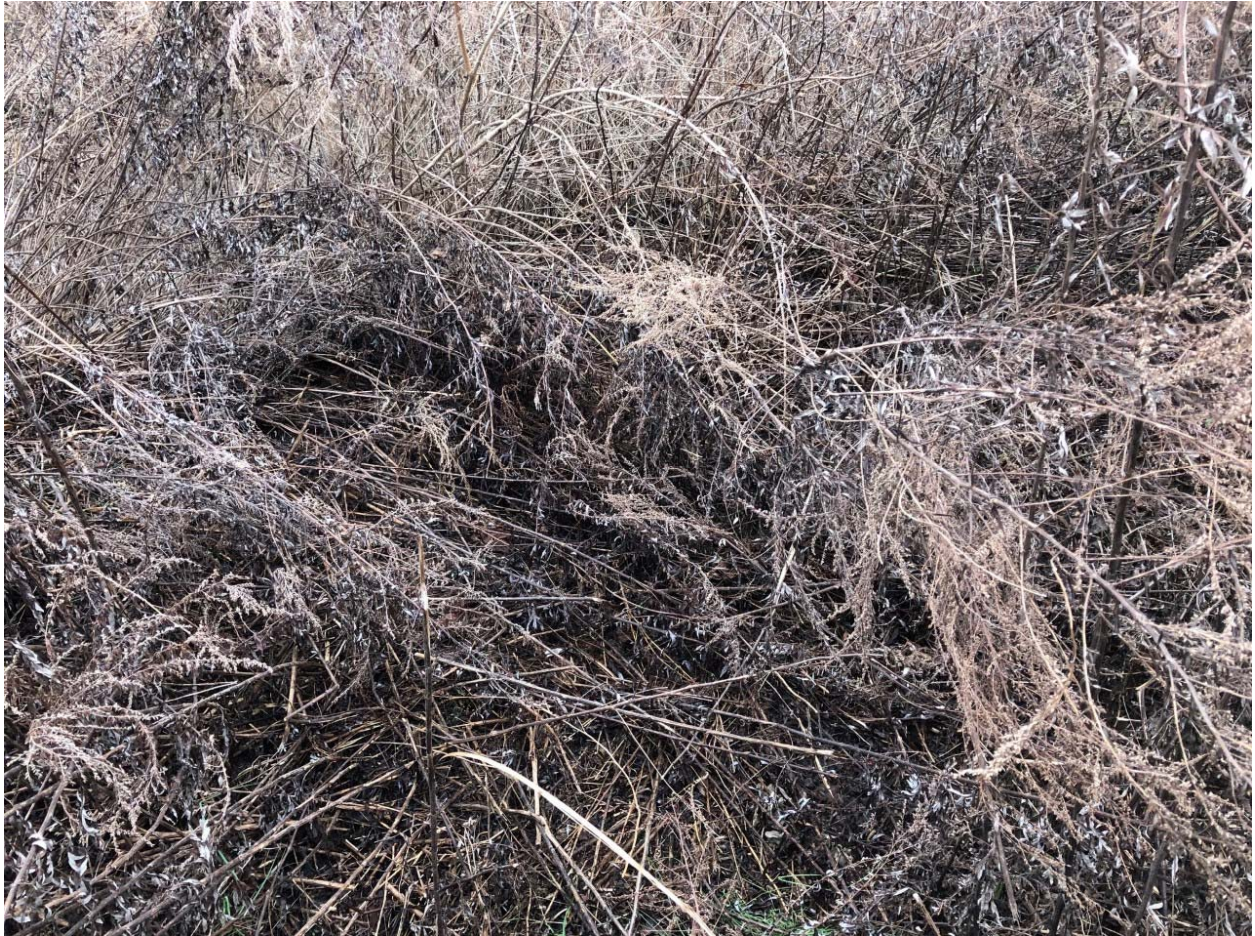
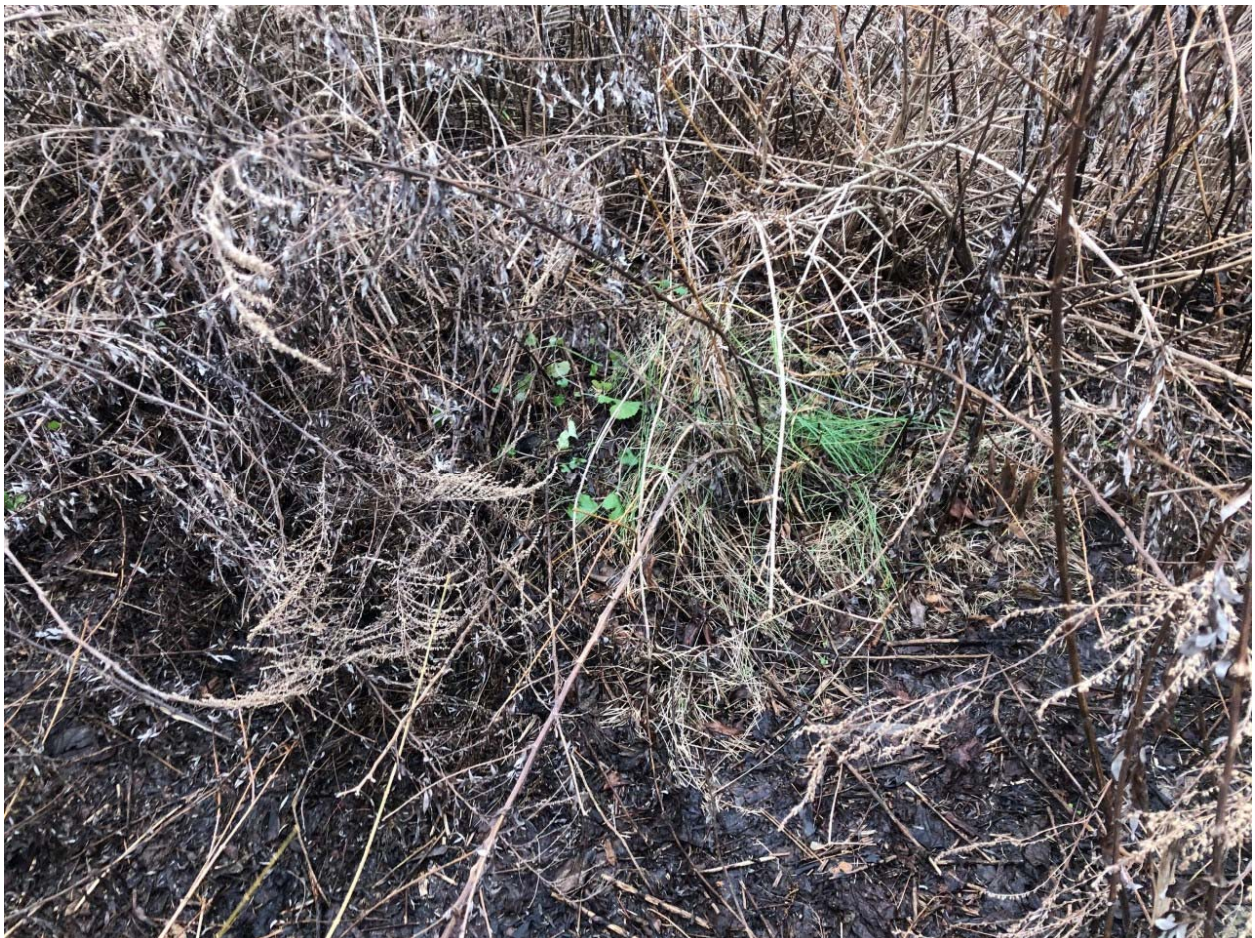
Representative Stream Bank Photos – December 31, 2020

- The interim cover along the West Branch of the Ramapo River was evaluated as a part of a site inspections performed on December 28, 2020. The interim cover remains in good condition. The cover vegetation is stable, well vegetated, and there are no signs of erosion. Representative photos are attached.

STATUS	COMMENTS
IRM COVER AND SILT FENCE			
A. General condition of cover material	<u>Good</u>		Riverbank cover in good condition, no signs of erosion, no white material showing. (pictures included).
B. Settlement of covered area	<u>Adequate</u>		Potholes present in parking lot area, although pavement cover generally remains intact. (pictures included). 20 total potholes.
C. General condition of silt fence	<u>N/A</u>		Silt fence has been removed from stream bank per NYSDEC approval on January 12, 2016.

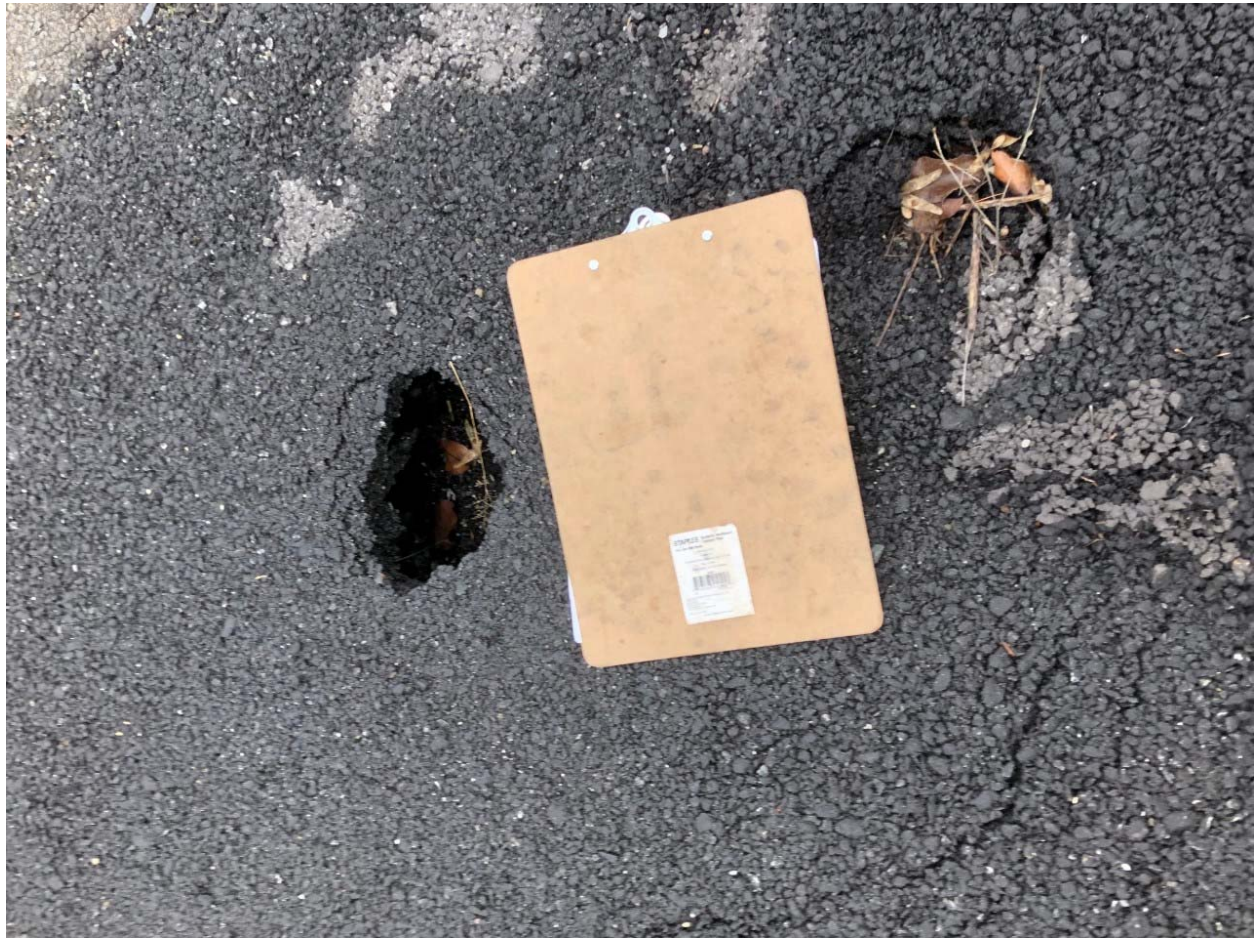
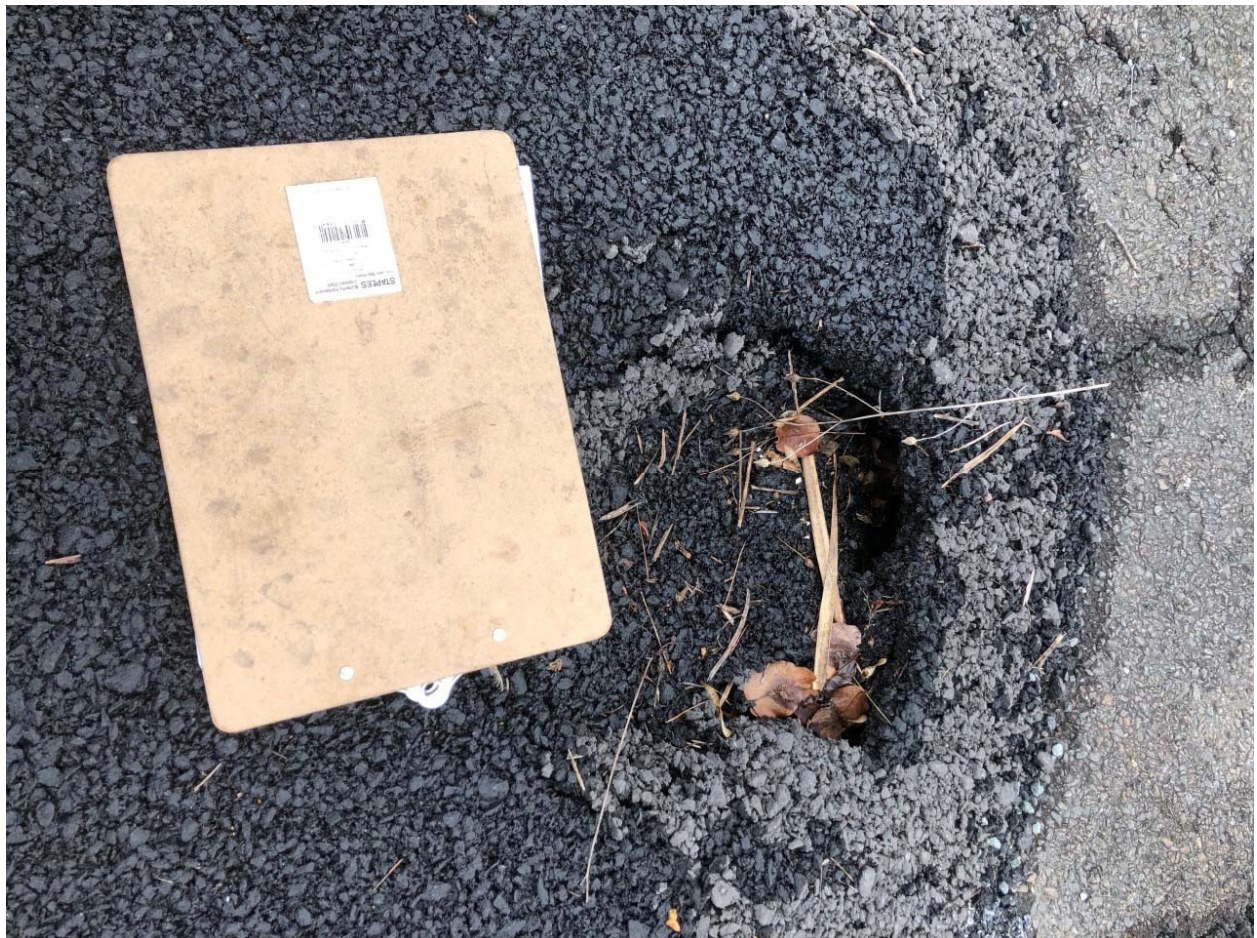
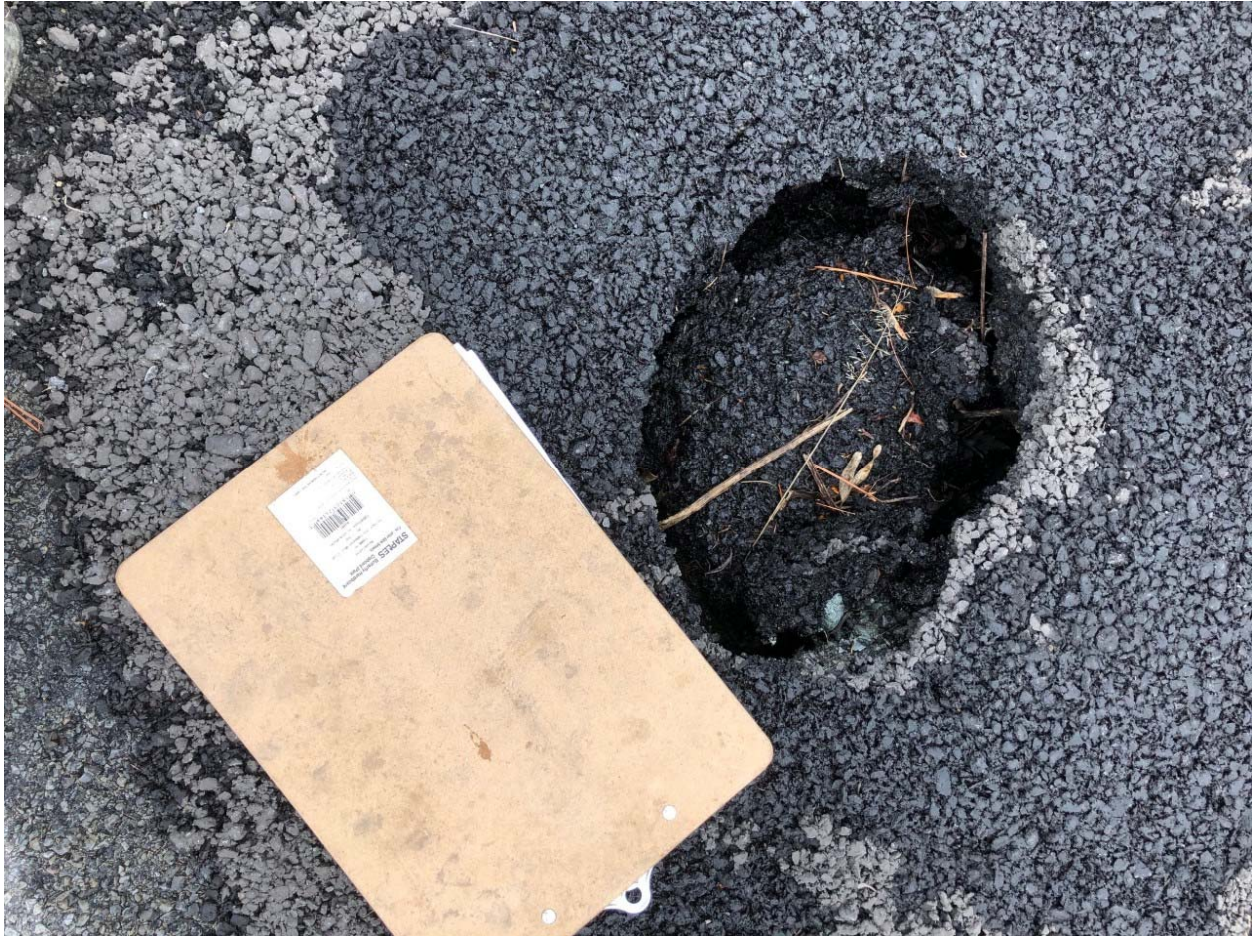
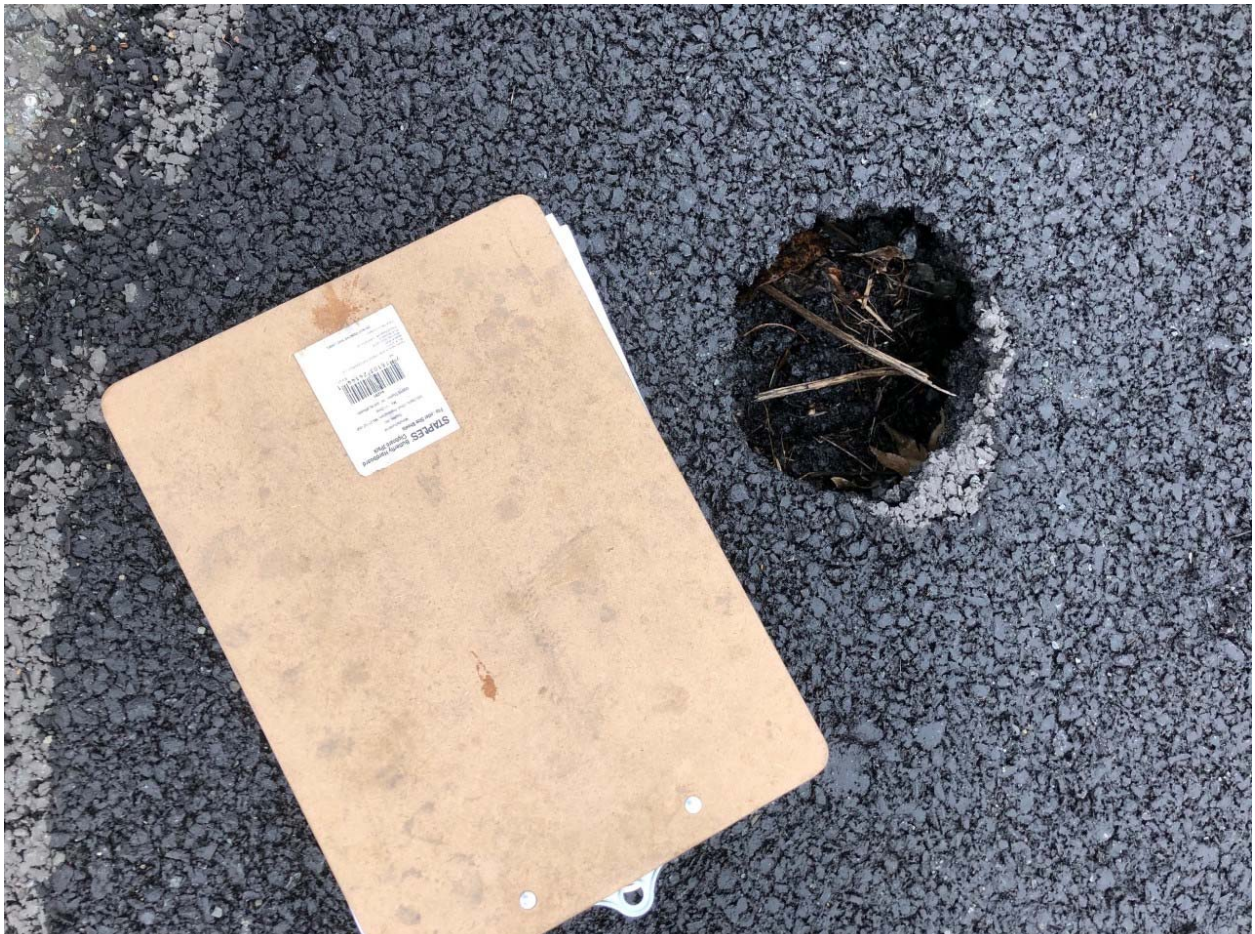
Representative Photos of Potholes in Parking Lot – December 31, 2020

- The parking lot pavement remains generally intact and functioning as a cover. Pothole repairs were last made by ELT-Harriman, LLC in June 2020. During the December 28, 2020 inspection the parking area was observed to be good condition with 20 small to midsize potholes observed at random locations across the parking lot. Representative photos of the observed potholes are attached for reference.
