Re: Quarterly Progress Report – 1<sup>st</sup> Quarter 2023  
Harriman Inactive Waste Disposal Site #336006

**RIVERBANK INSPECTION FORM  
WEST BRANCH OF THE RAMAPO RIVER  
MAYBROOK AND HARRIMAN TRUST  
HARRIMAN, NEW YORK**

## Former Nepera Plant - Harriman, NY: Quarterly Well Inspection Report

SITE FENCE INSPECTION FORM  
MAYBROOK AND HARRIMAN TRUST  
HARRIMAN, NEW YORK

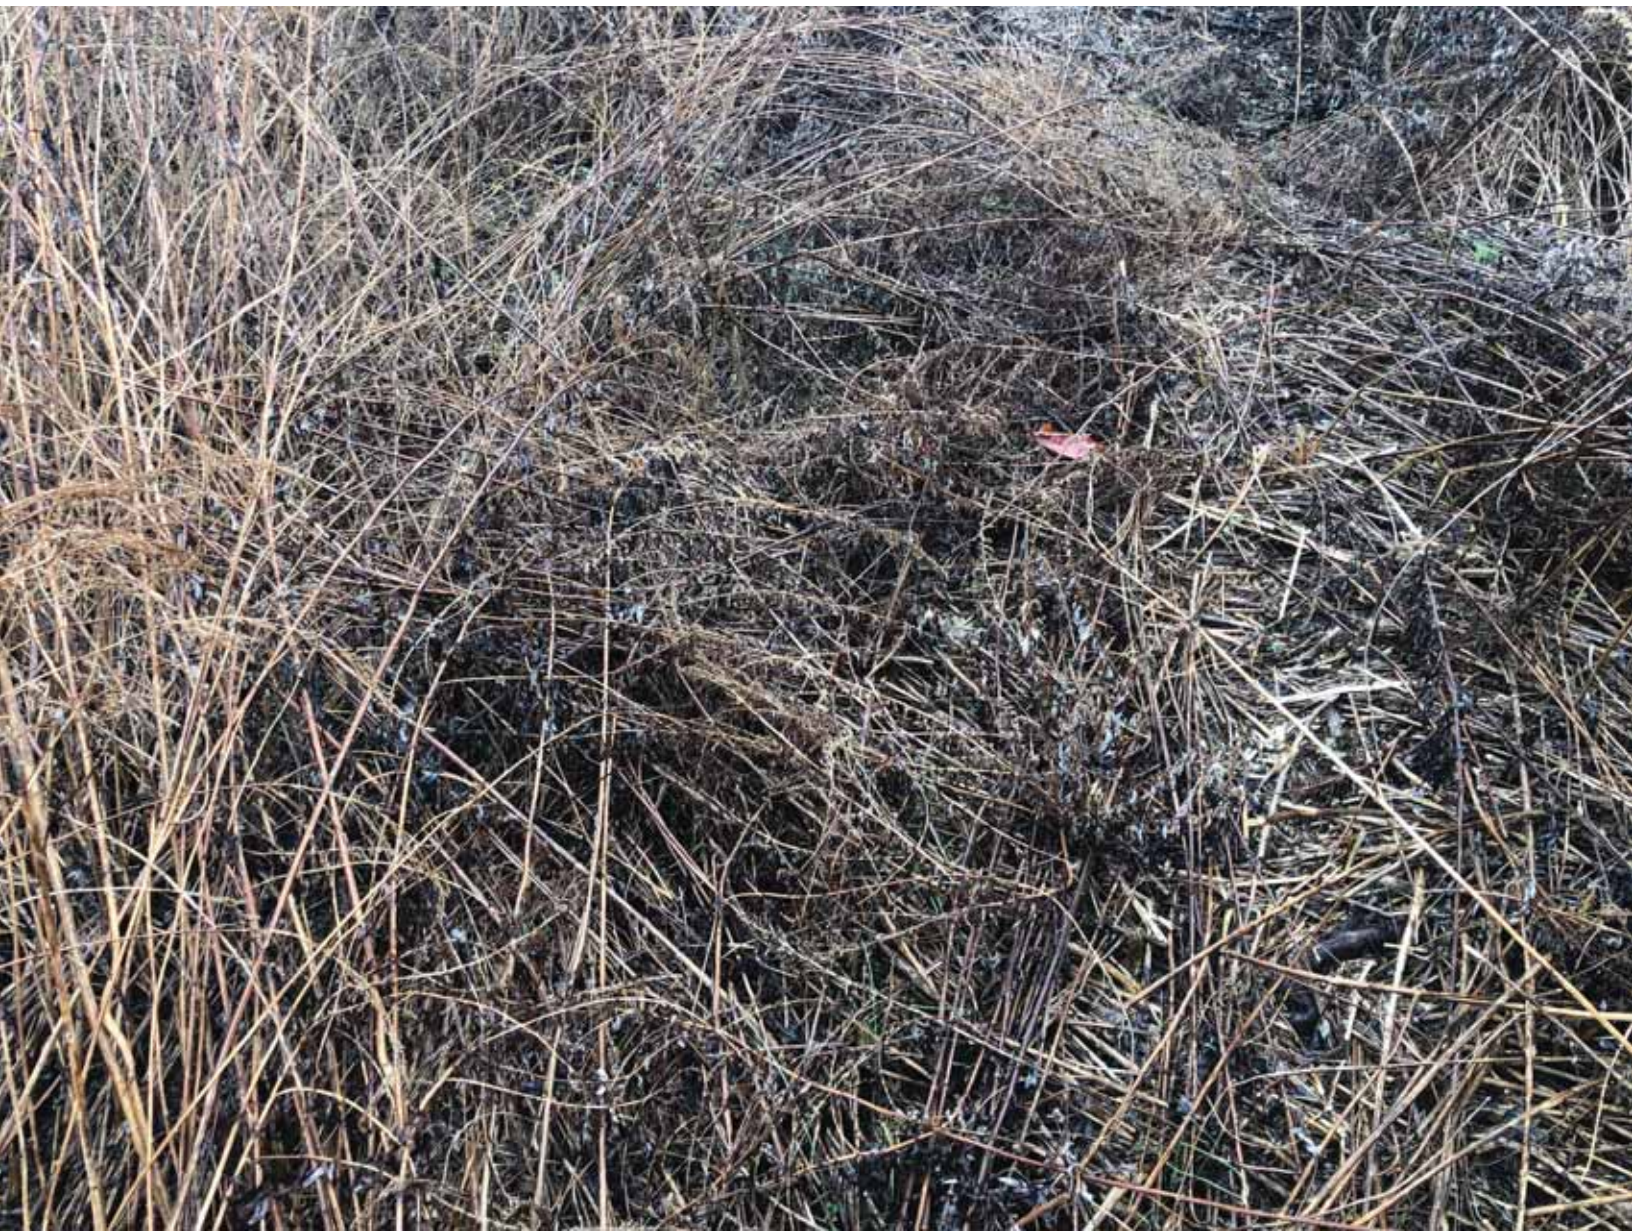
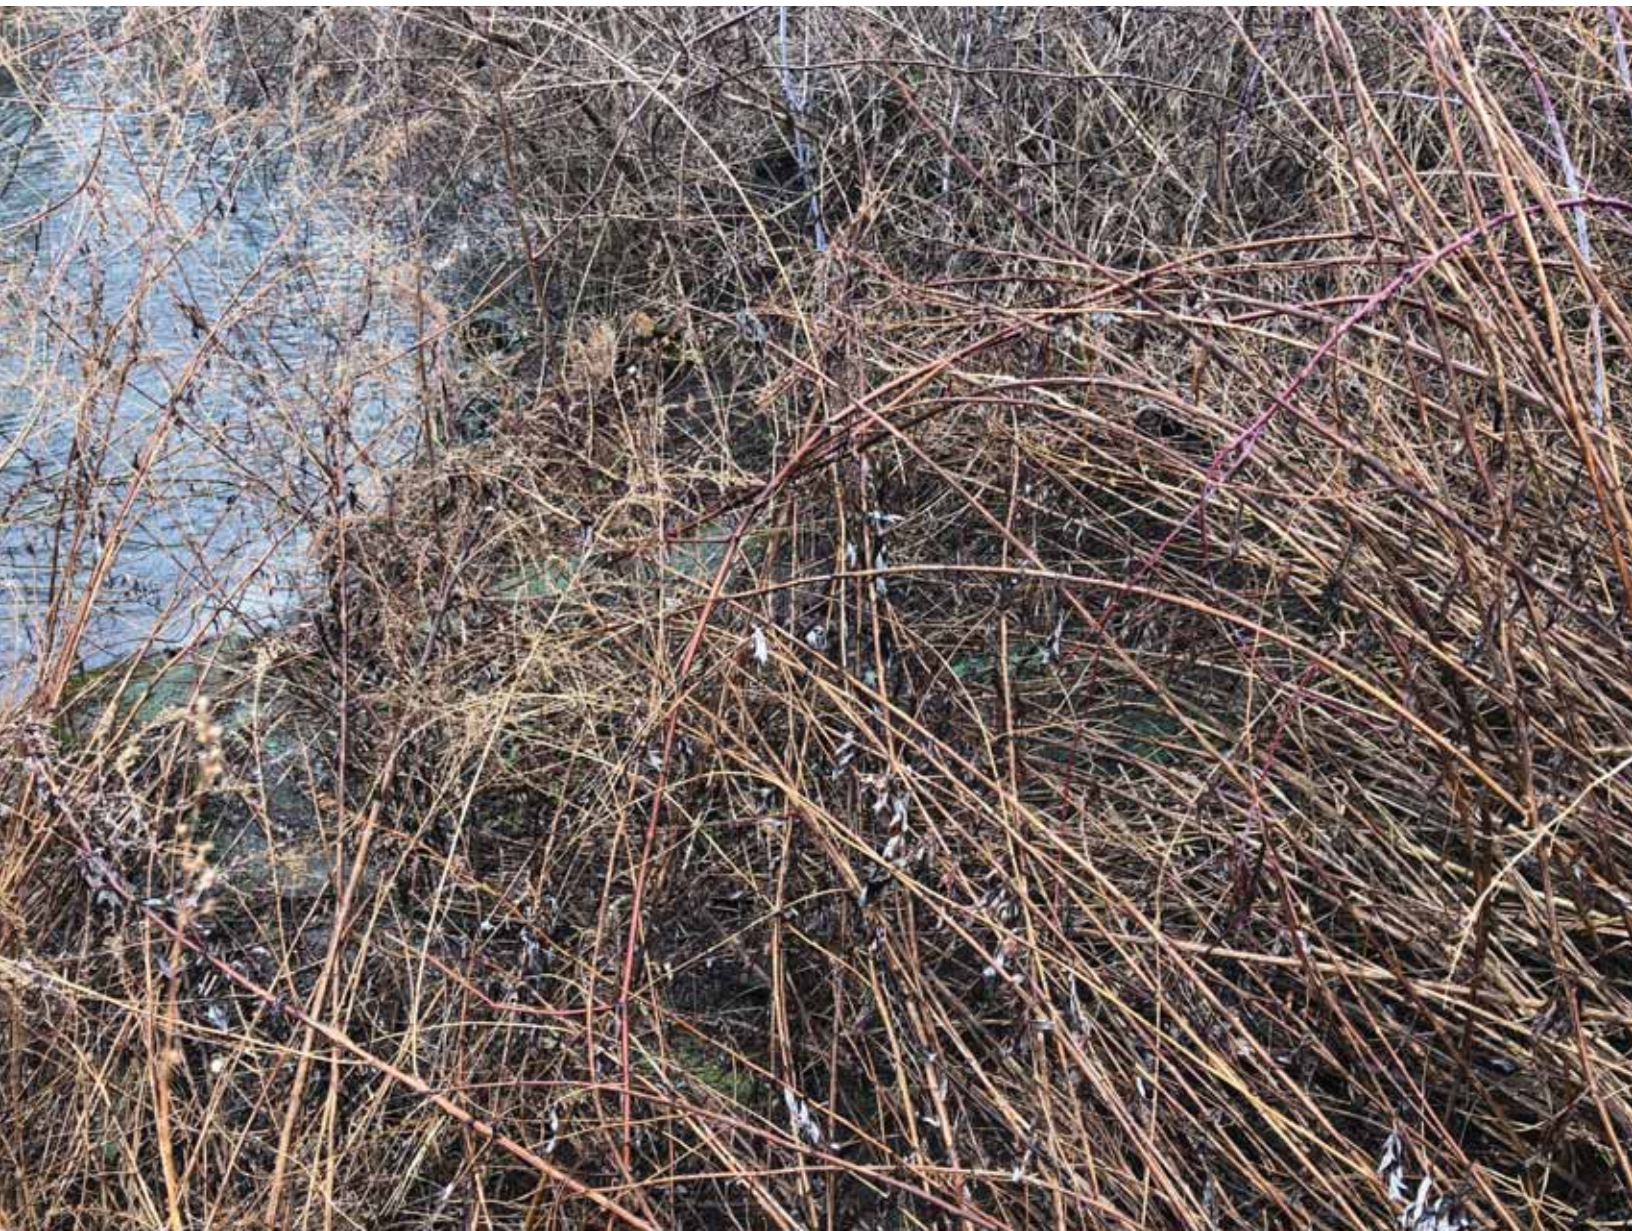
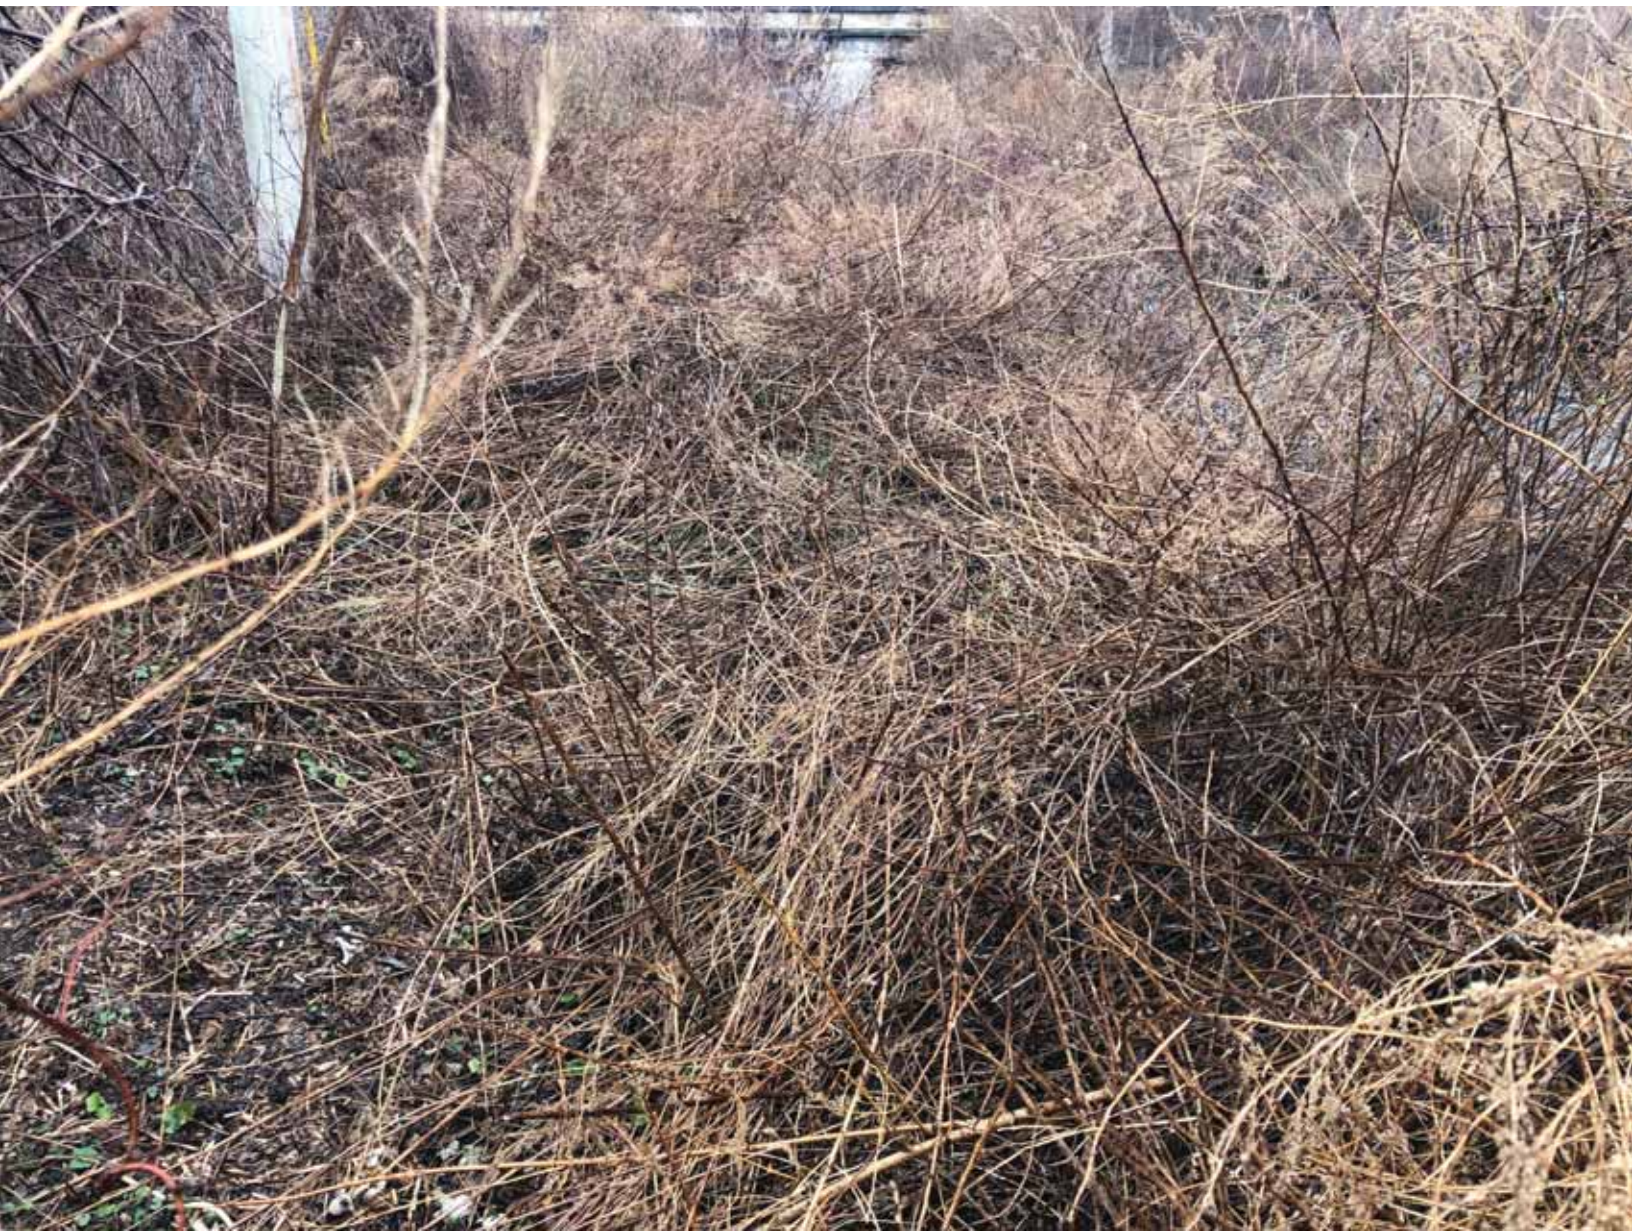
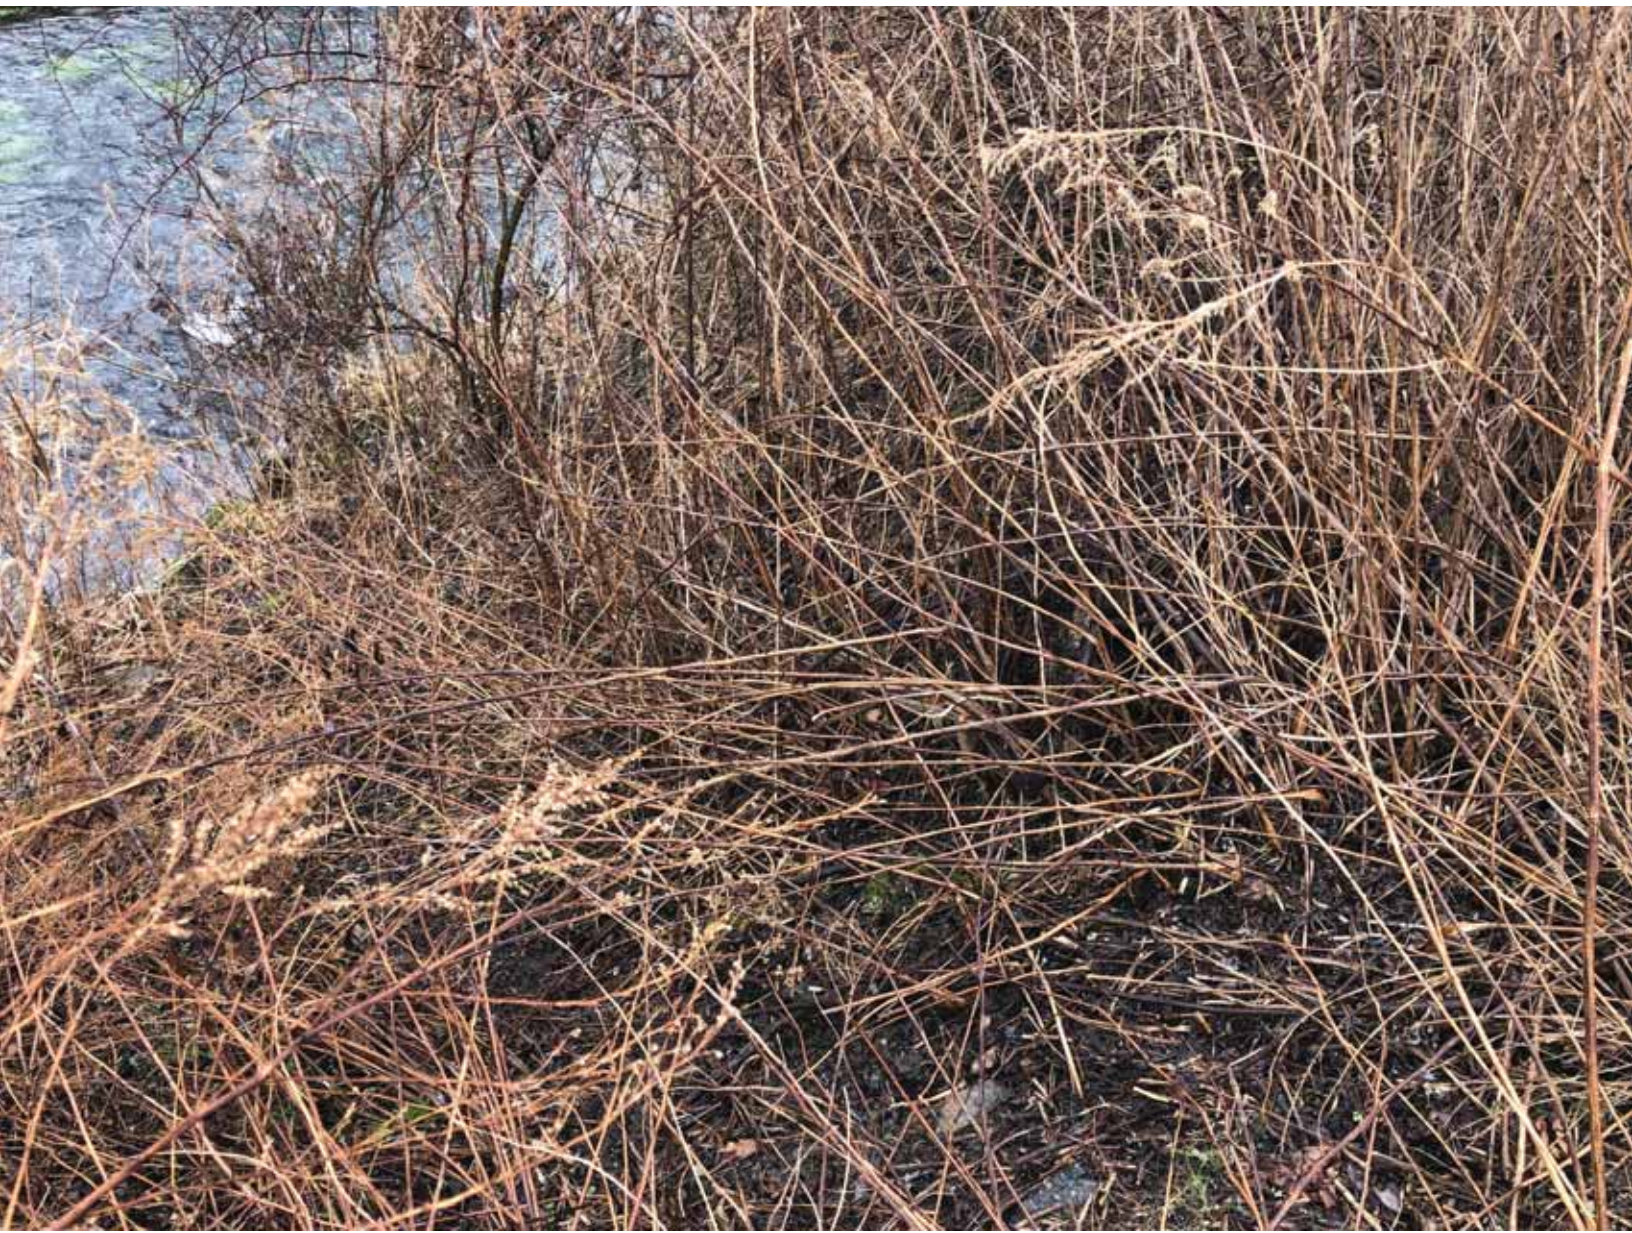
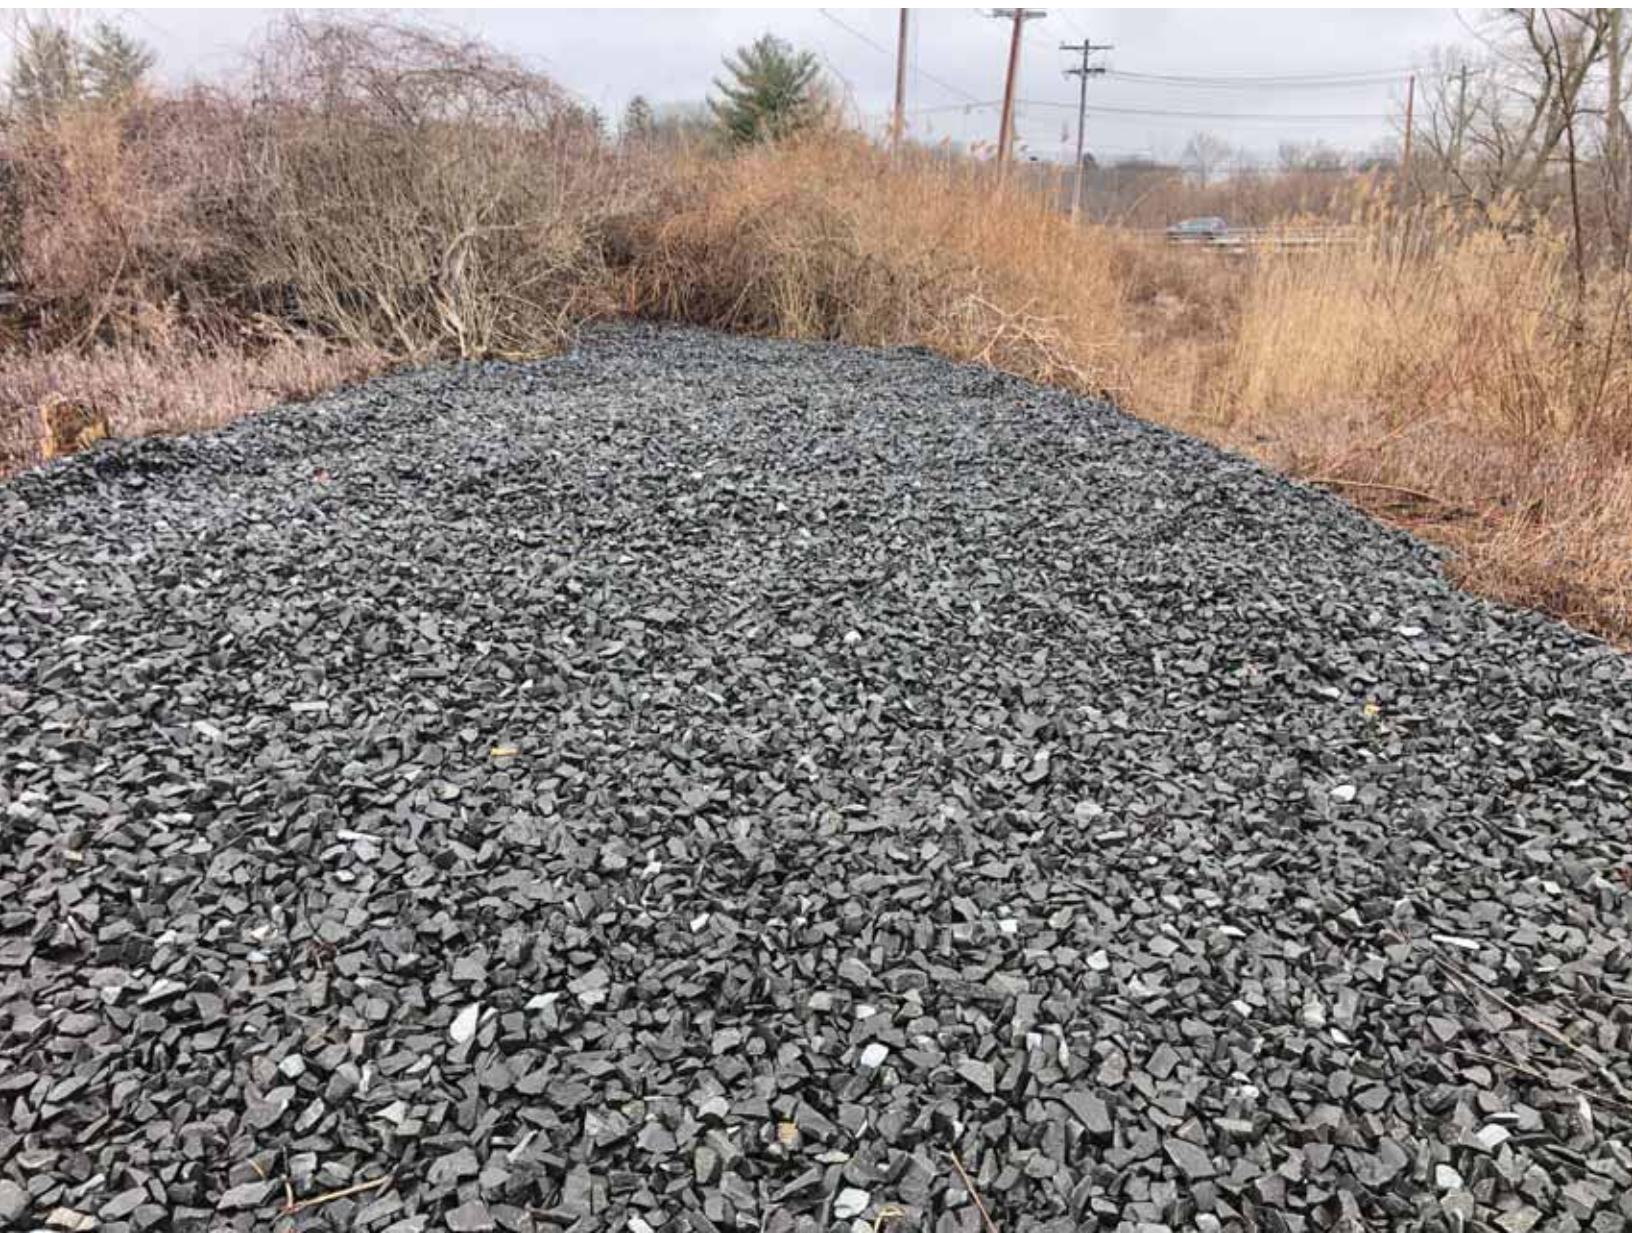
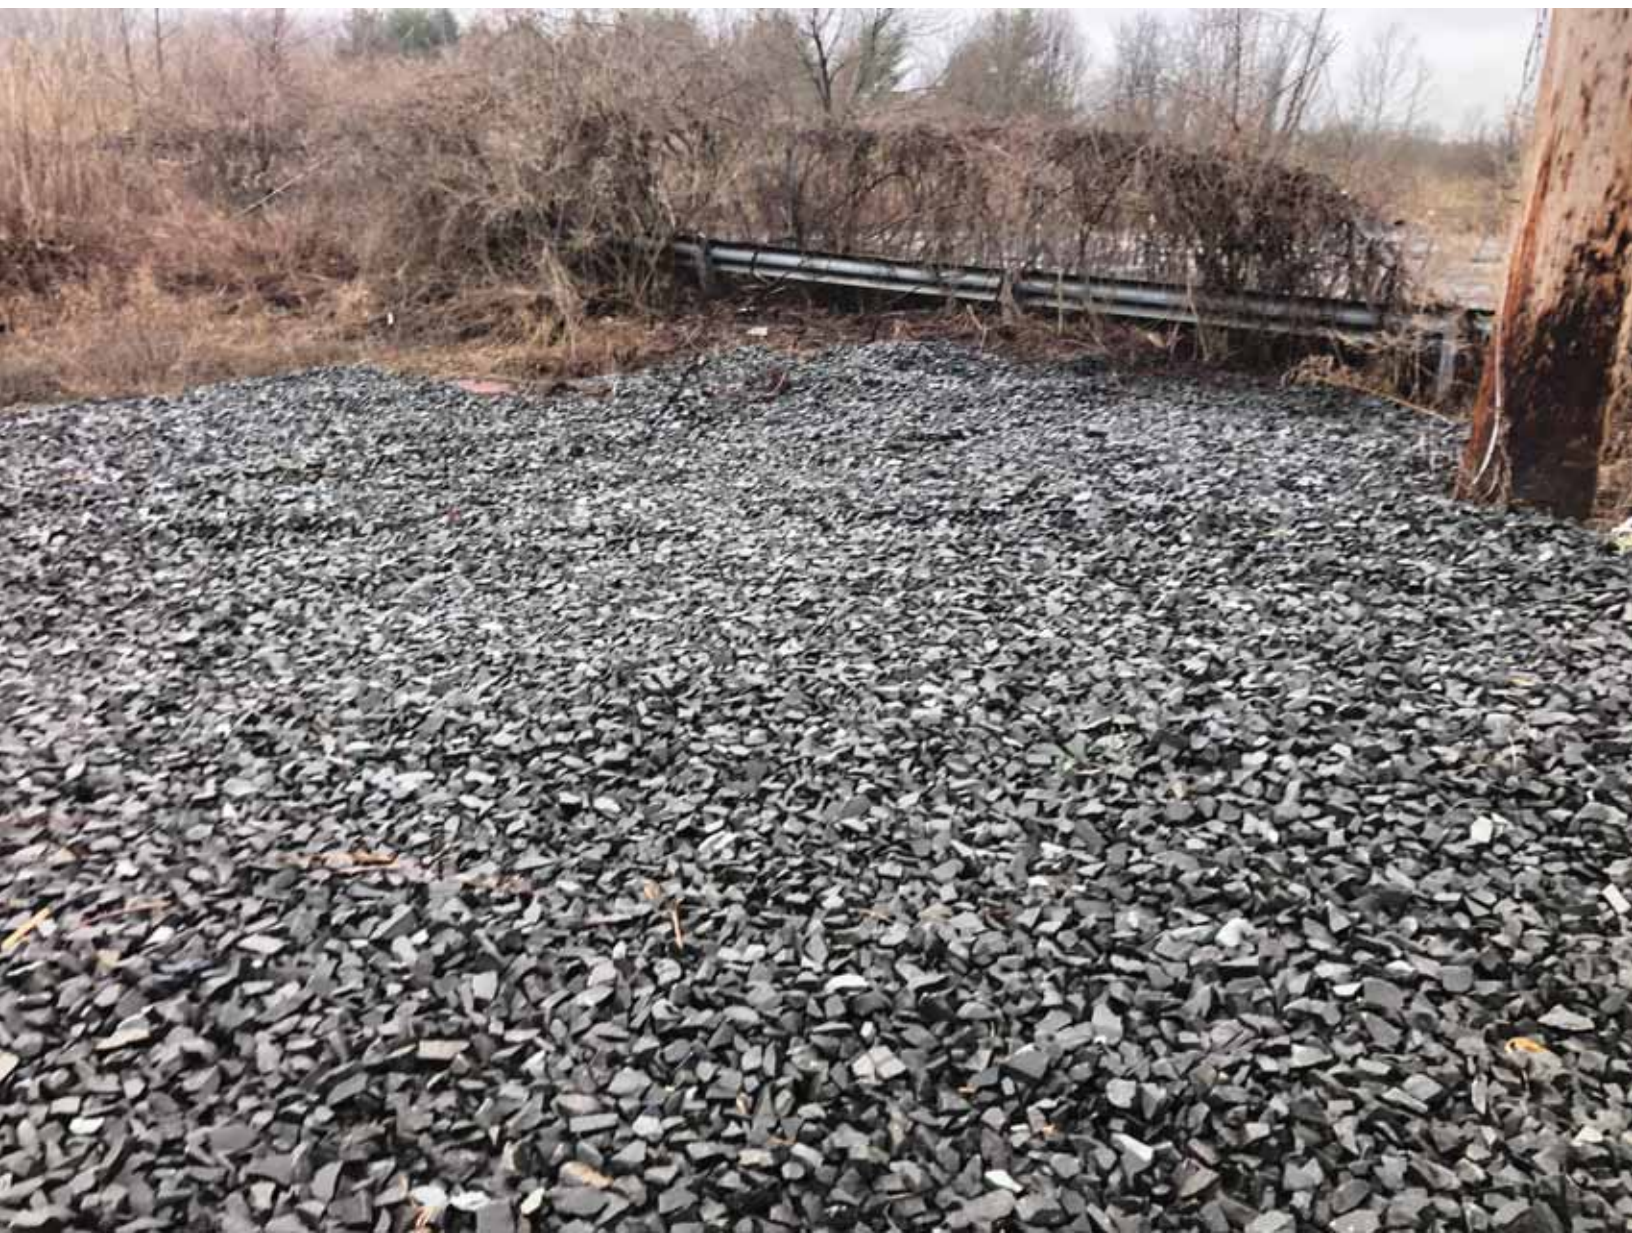
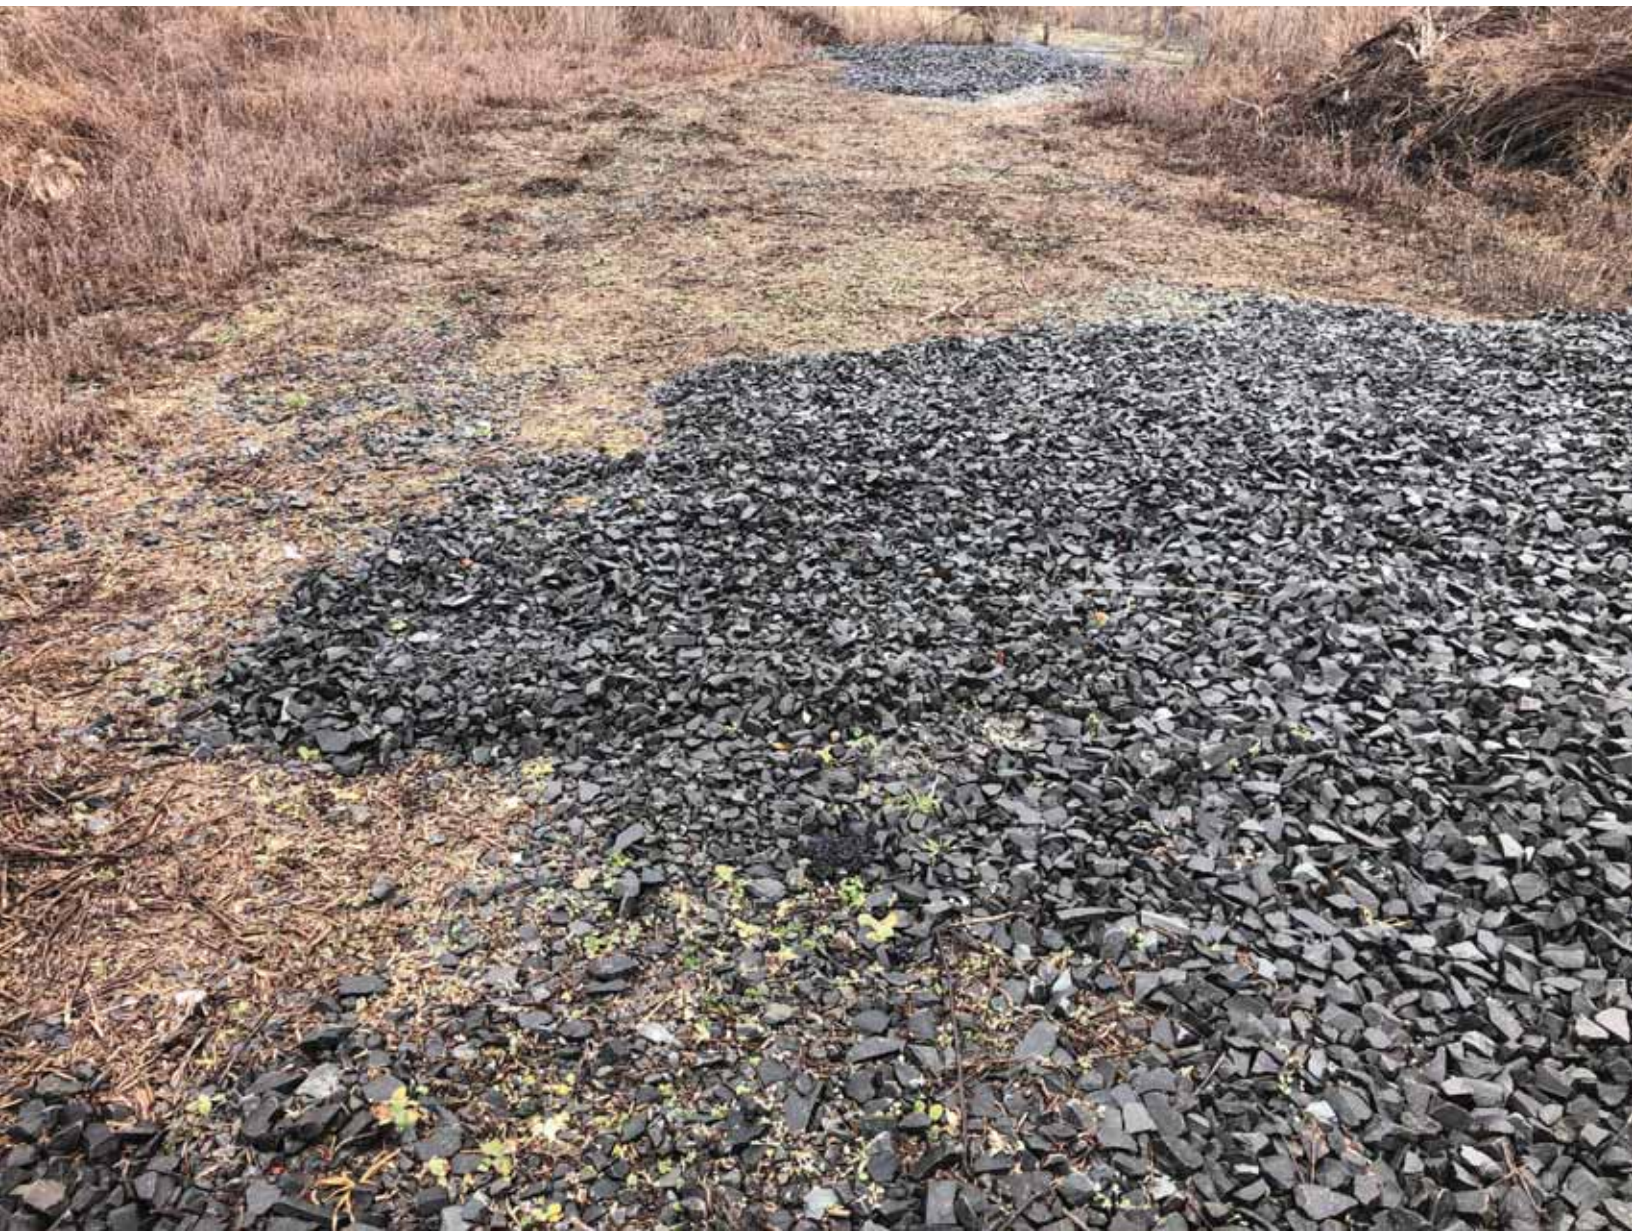
The interim cover along the West Branch of the Ramapo River was inspected on March 11, 2023 and representative photos of this area are provided as Attachment 1. The interim cover remains in good condition. The cover vegetation is stable, well vegetated, and there are no signs of erosion.

Riverbank cover in good condition, no signs of erosion, no white material showing. High vegetation in area. (pictures included).

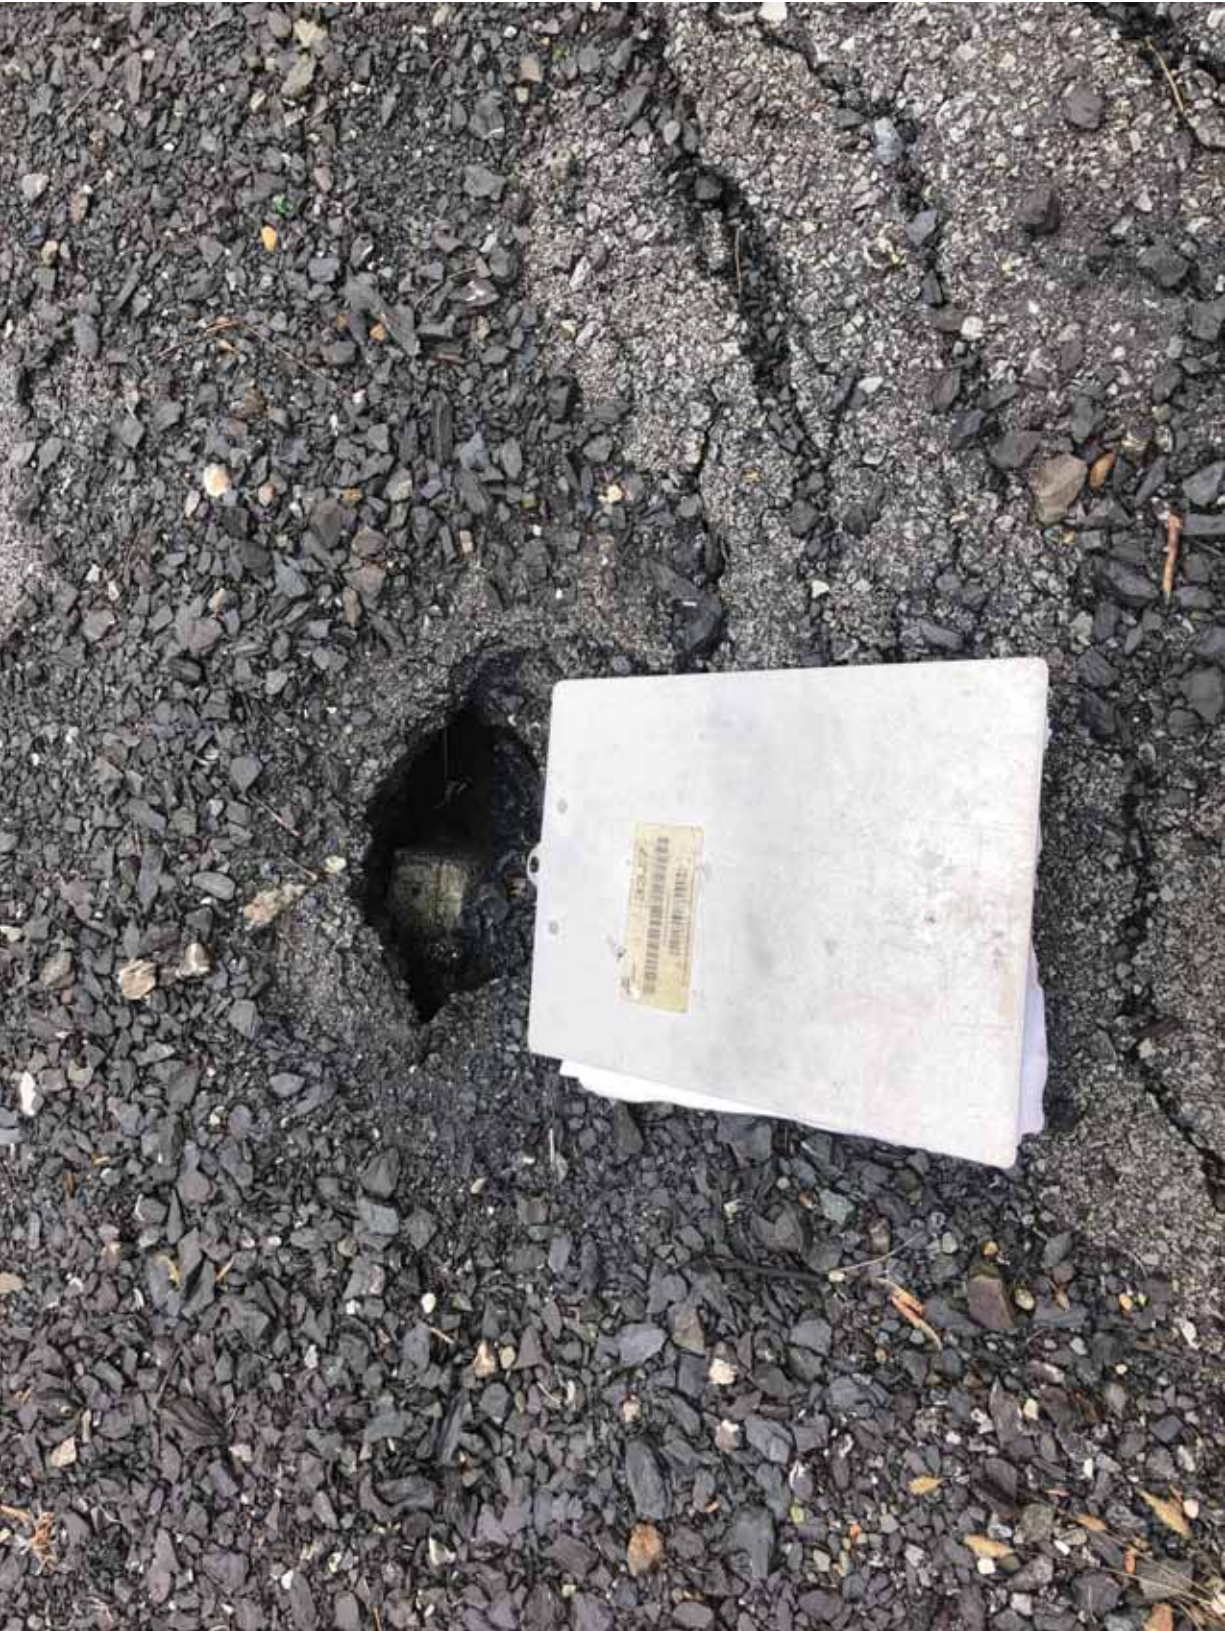
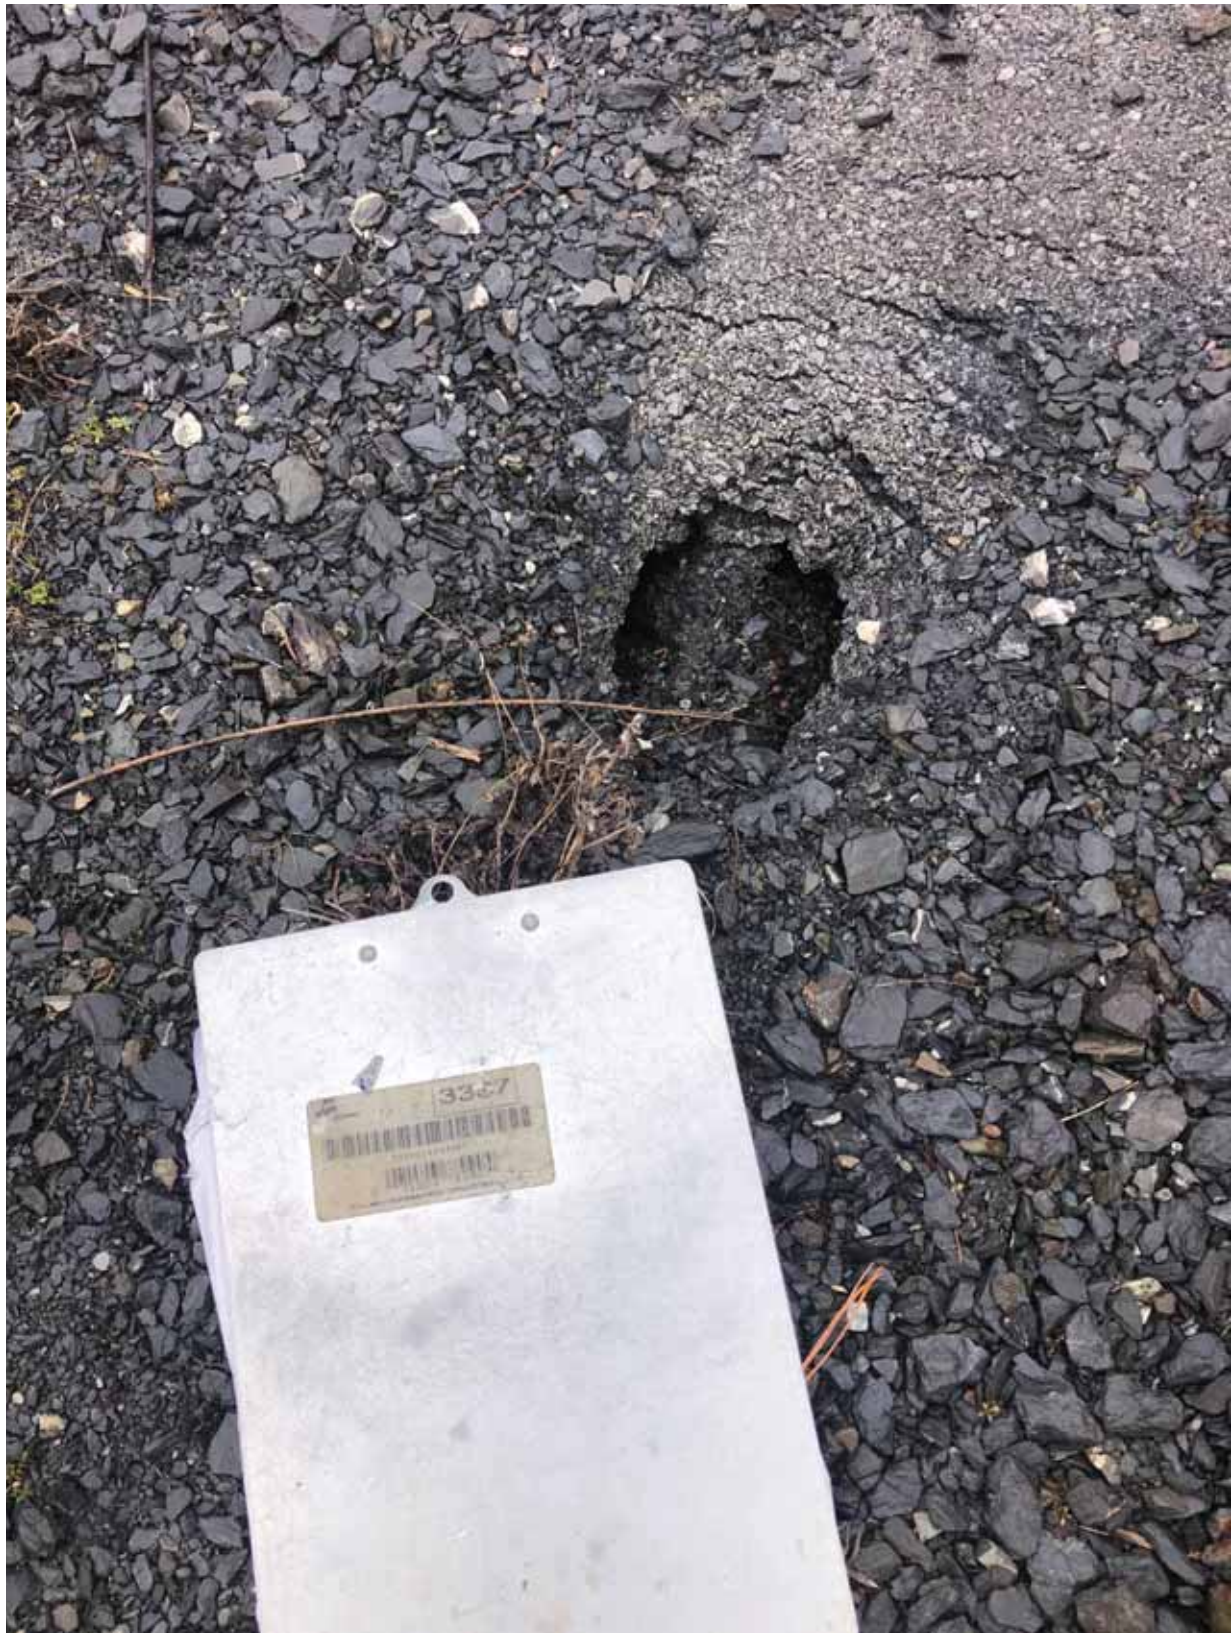
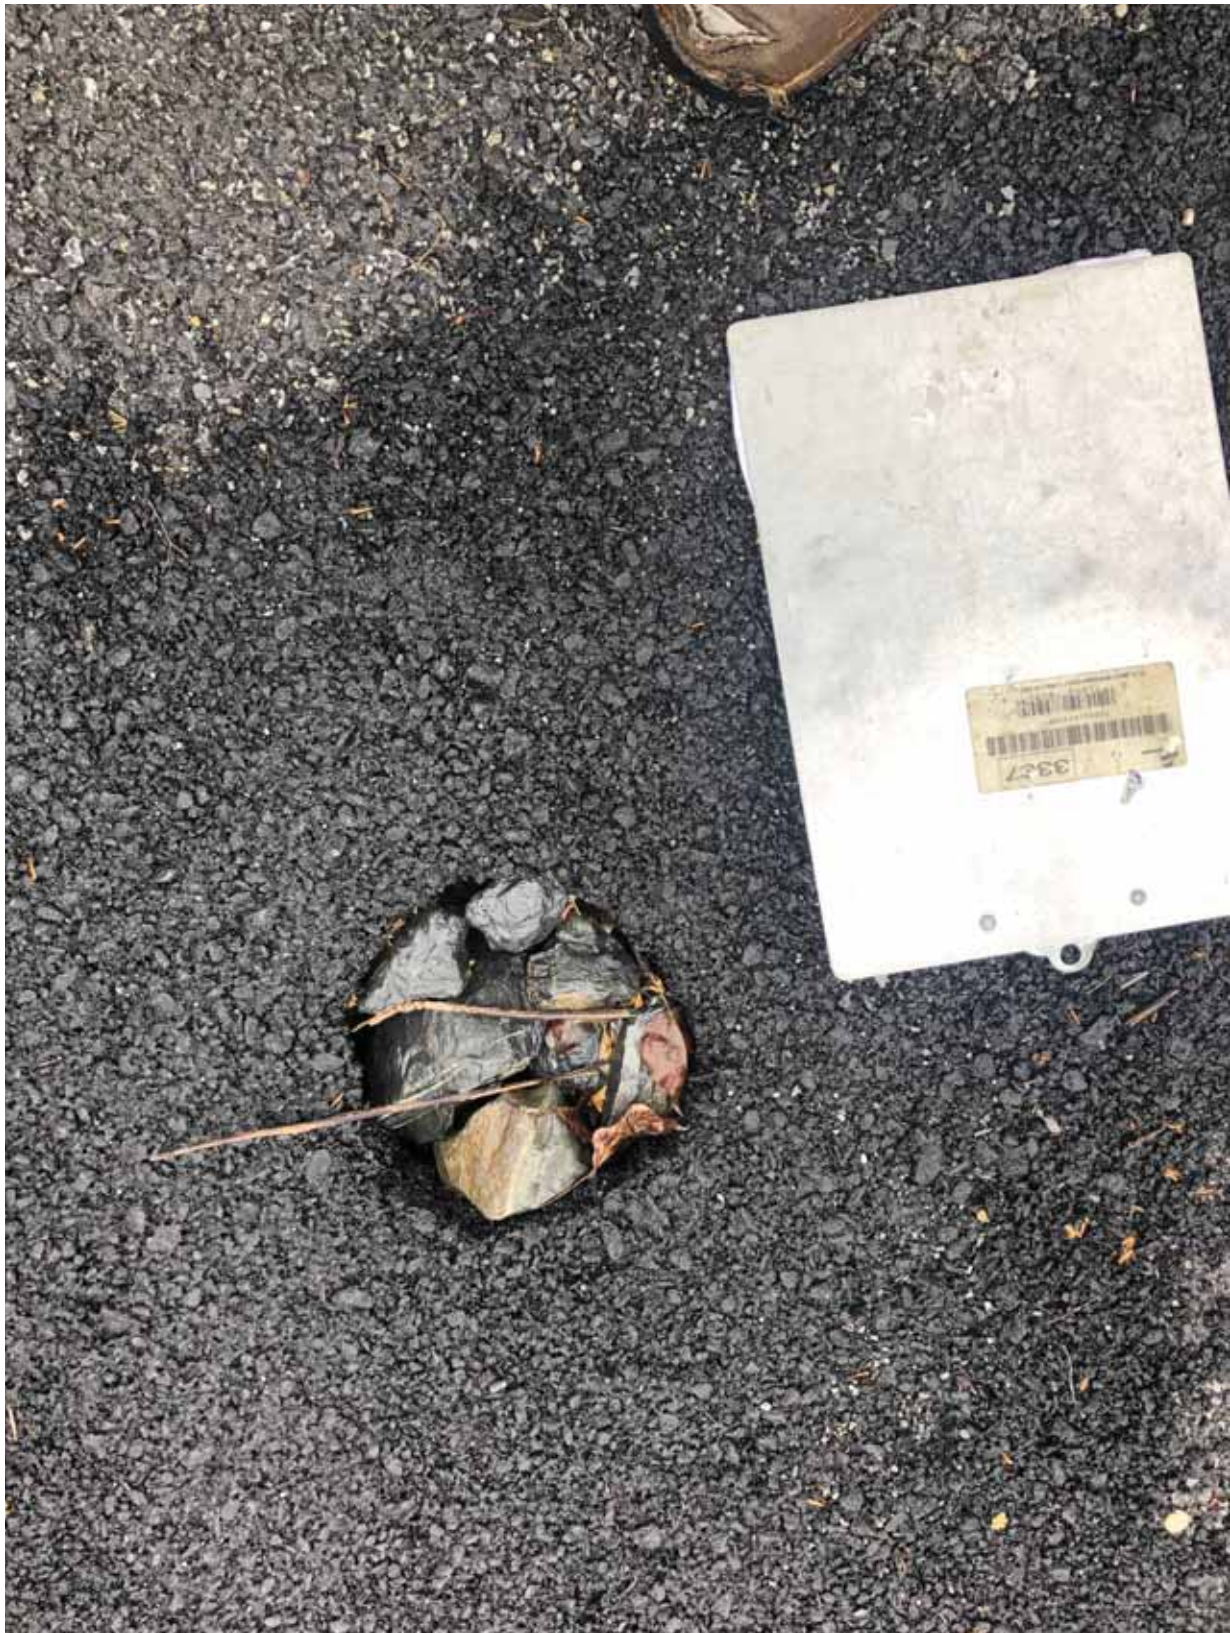
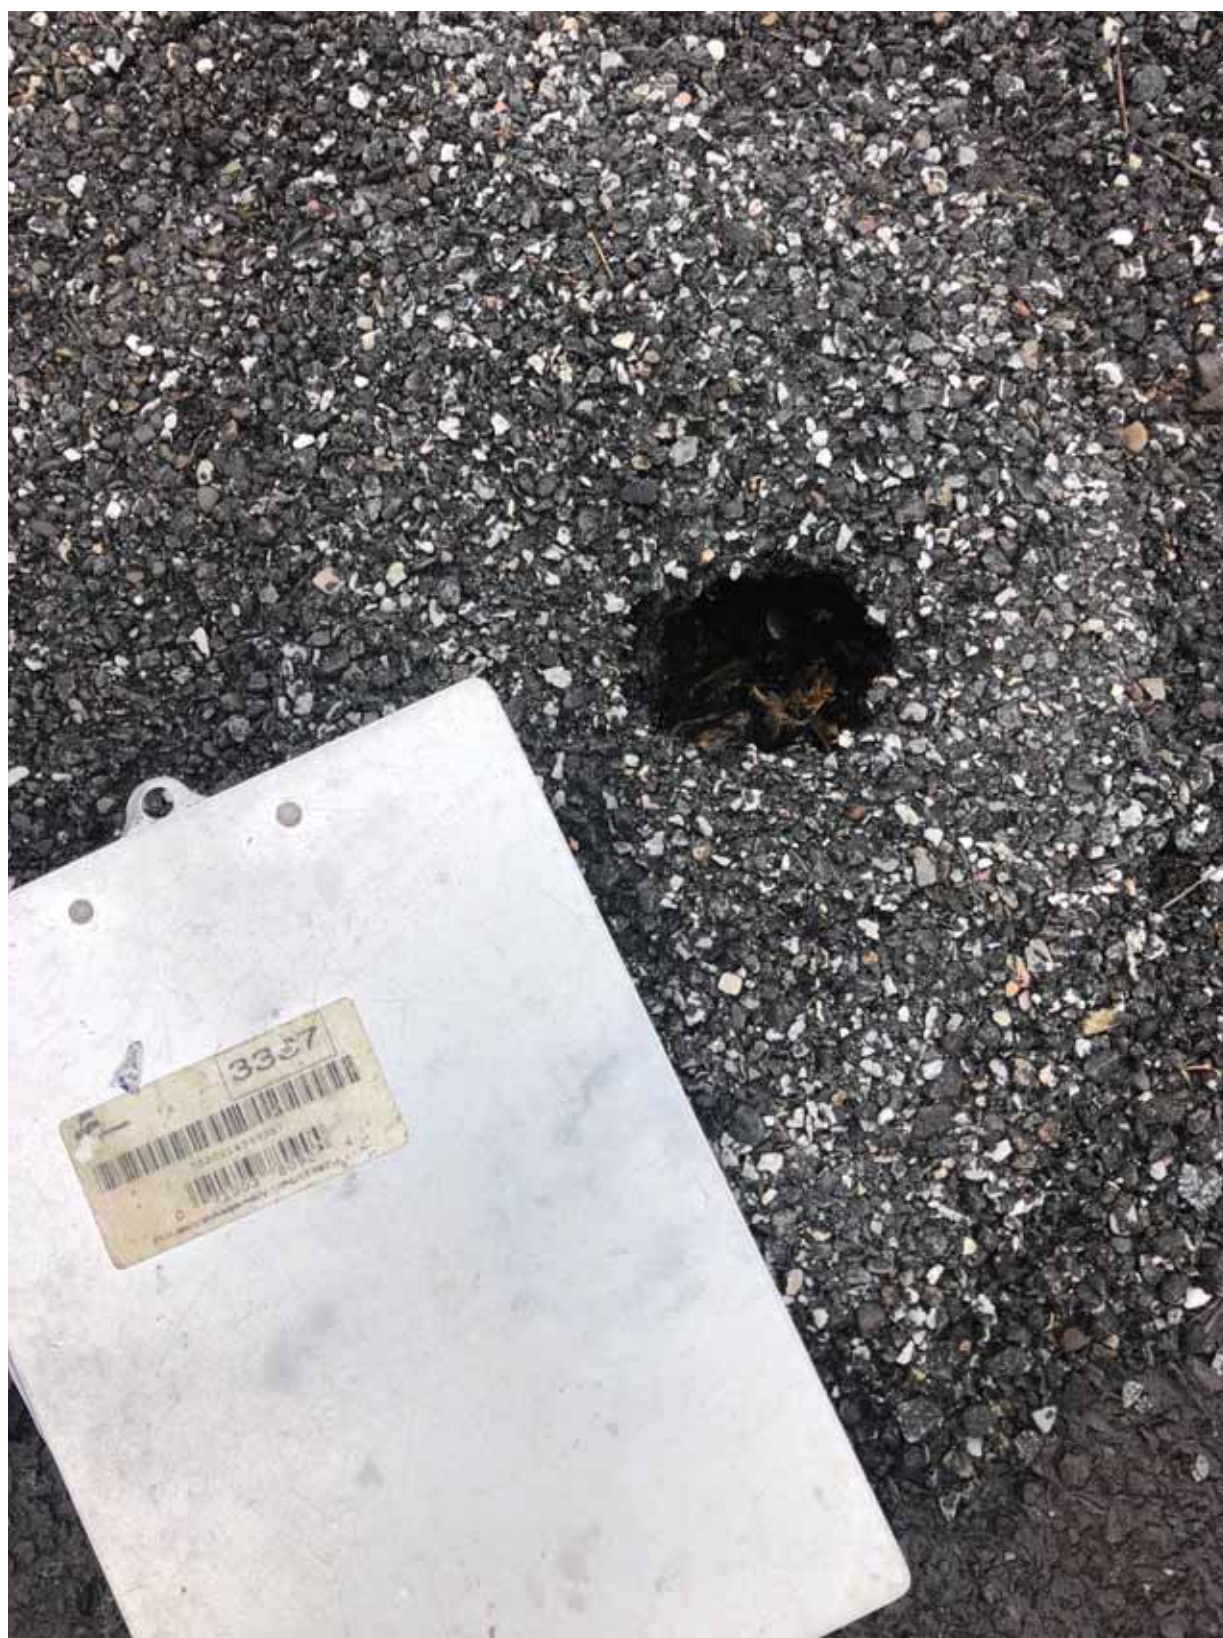
The parking lot pavement remains generally intact and functioning as a cover. Quarterly maintenance activities were performed on March 10, 2023 and the parking lot was inspected on March 11, 2023. Representative photos of the parking lot conditions are provided as Attachment 2.

Potholes present in parking lot area, although pavement cover generally remains intact. (pictures included). 4 total potholes.
