Re: Quarterly Progress Report – 1<sup>st</sup> Quarter 2023  
Harriman Inactive Waste Disposal Site #336006

**RIVERBANK INSPECTION FORM  
WEST BRANCH OF THE RAMAPO RIVER  
MAYBROOK AND HARRIMAN TRUST  
HARRIMAN, NEW YORK**

## Former Nepera Plant - Harriman, NY: Quarterly Well Inspection Report

SITE FENCE INSPECTION FORM  
MAYBROOK AND HARRIMAN TRUST  
HARRIMAN, NEW YORK

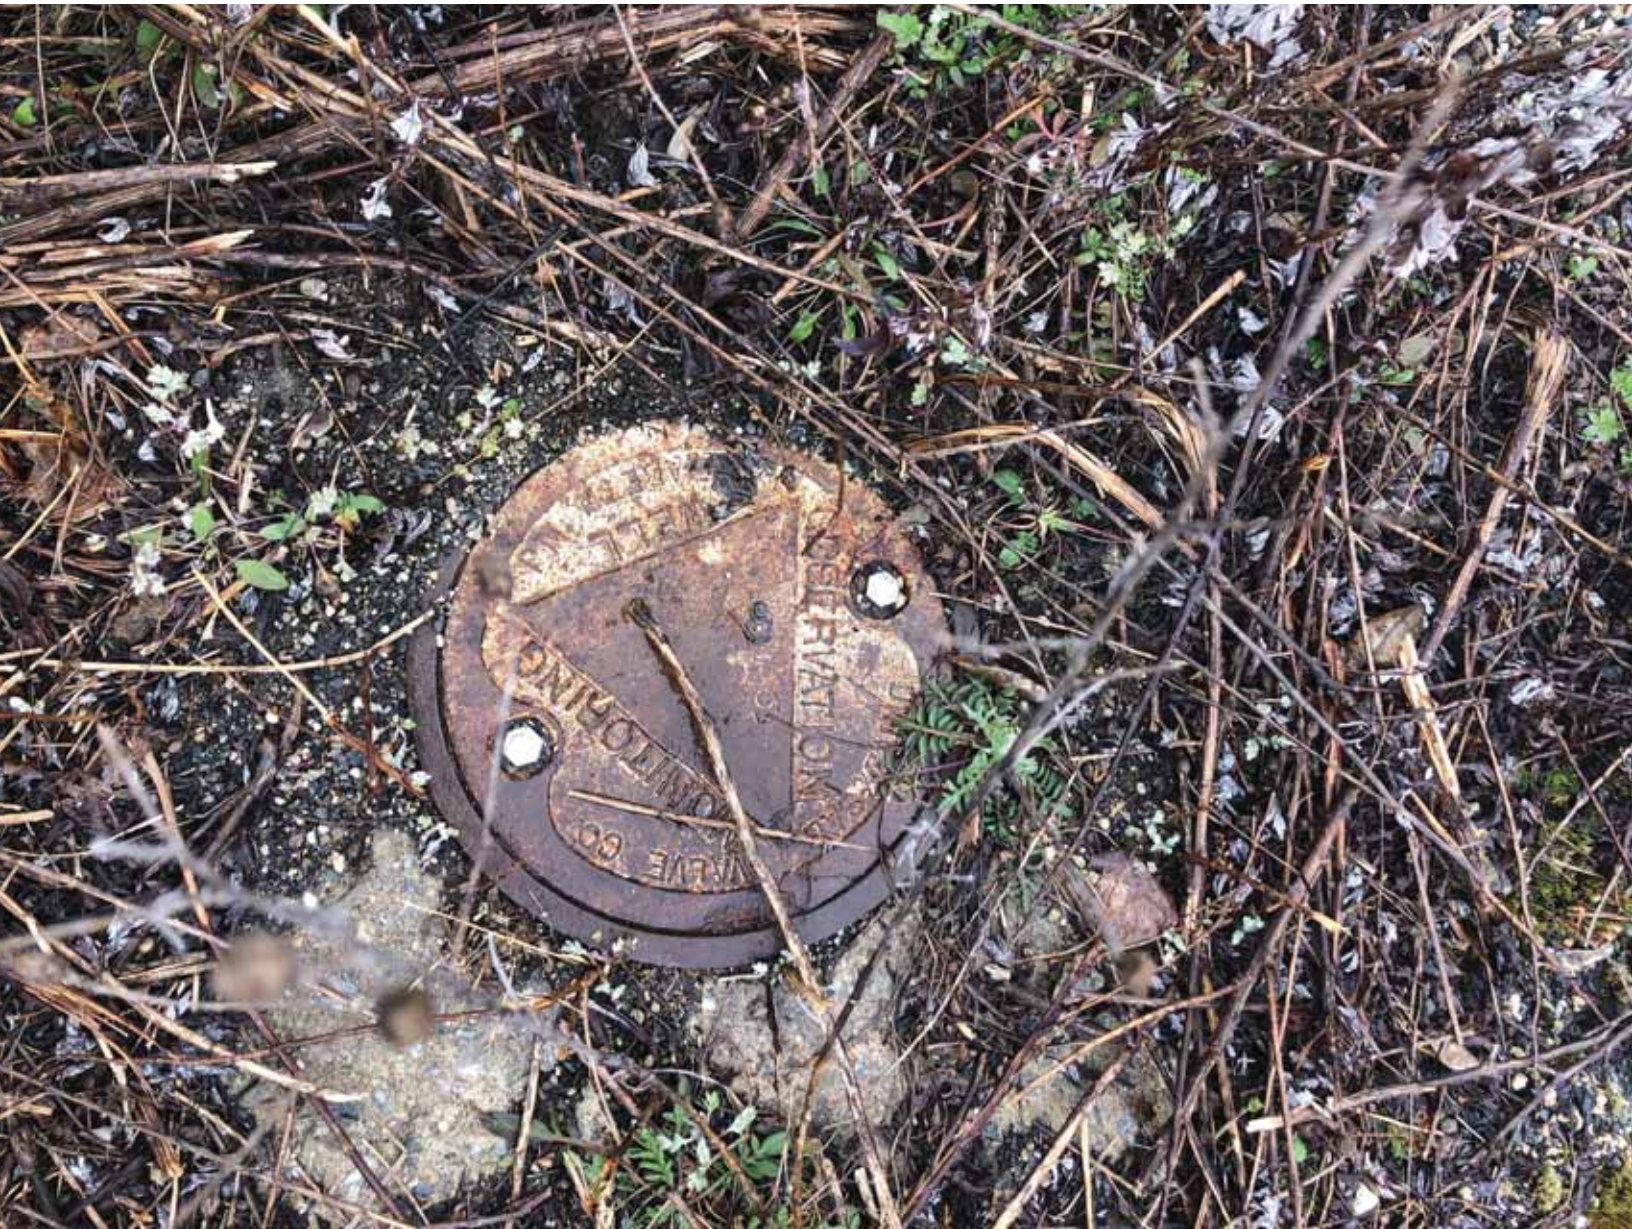
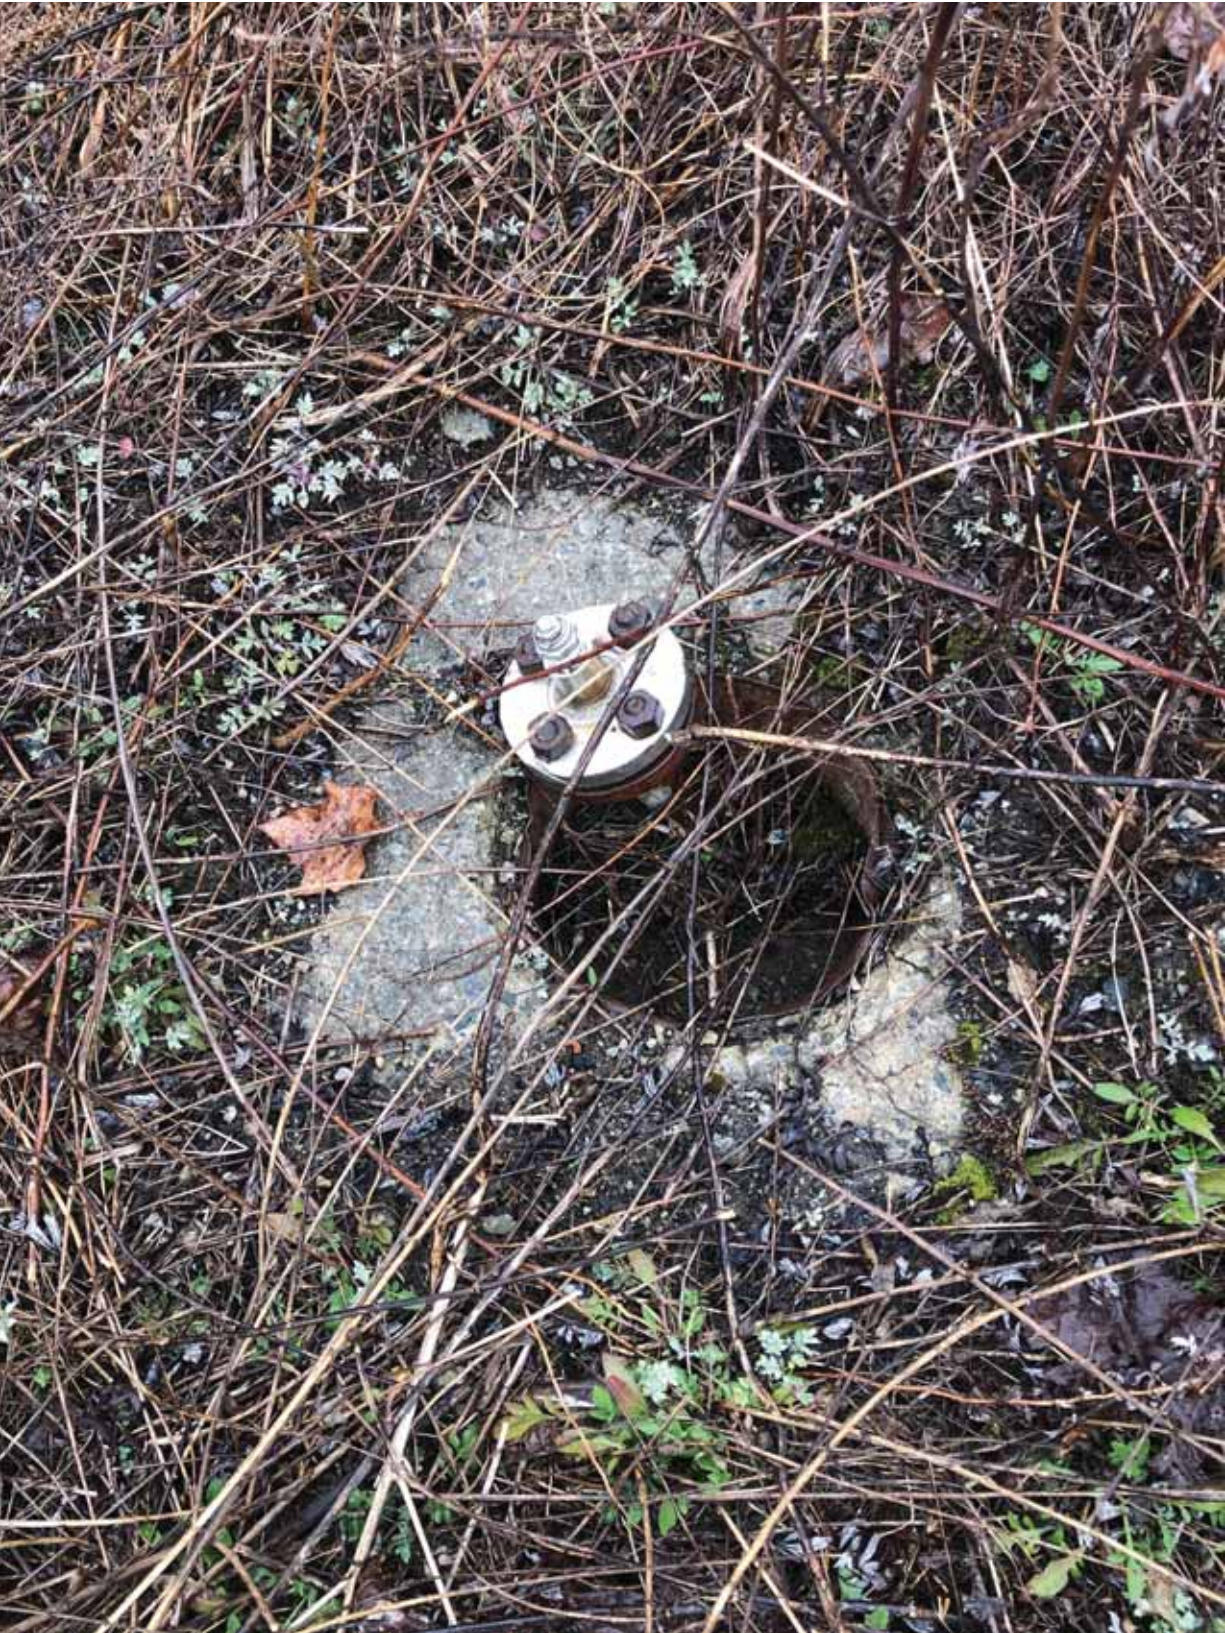
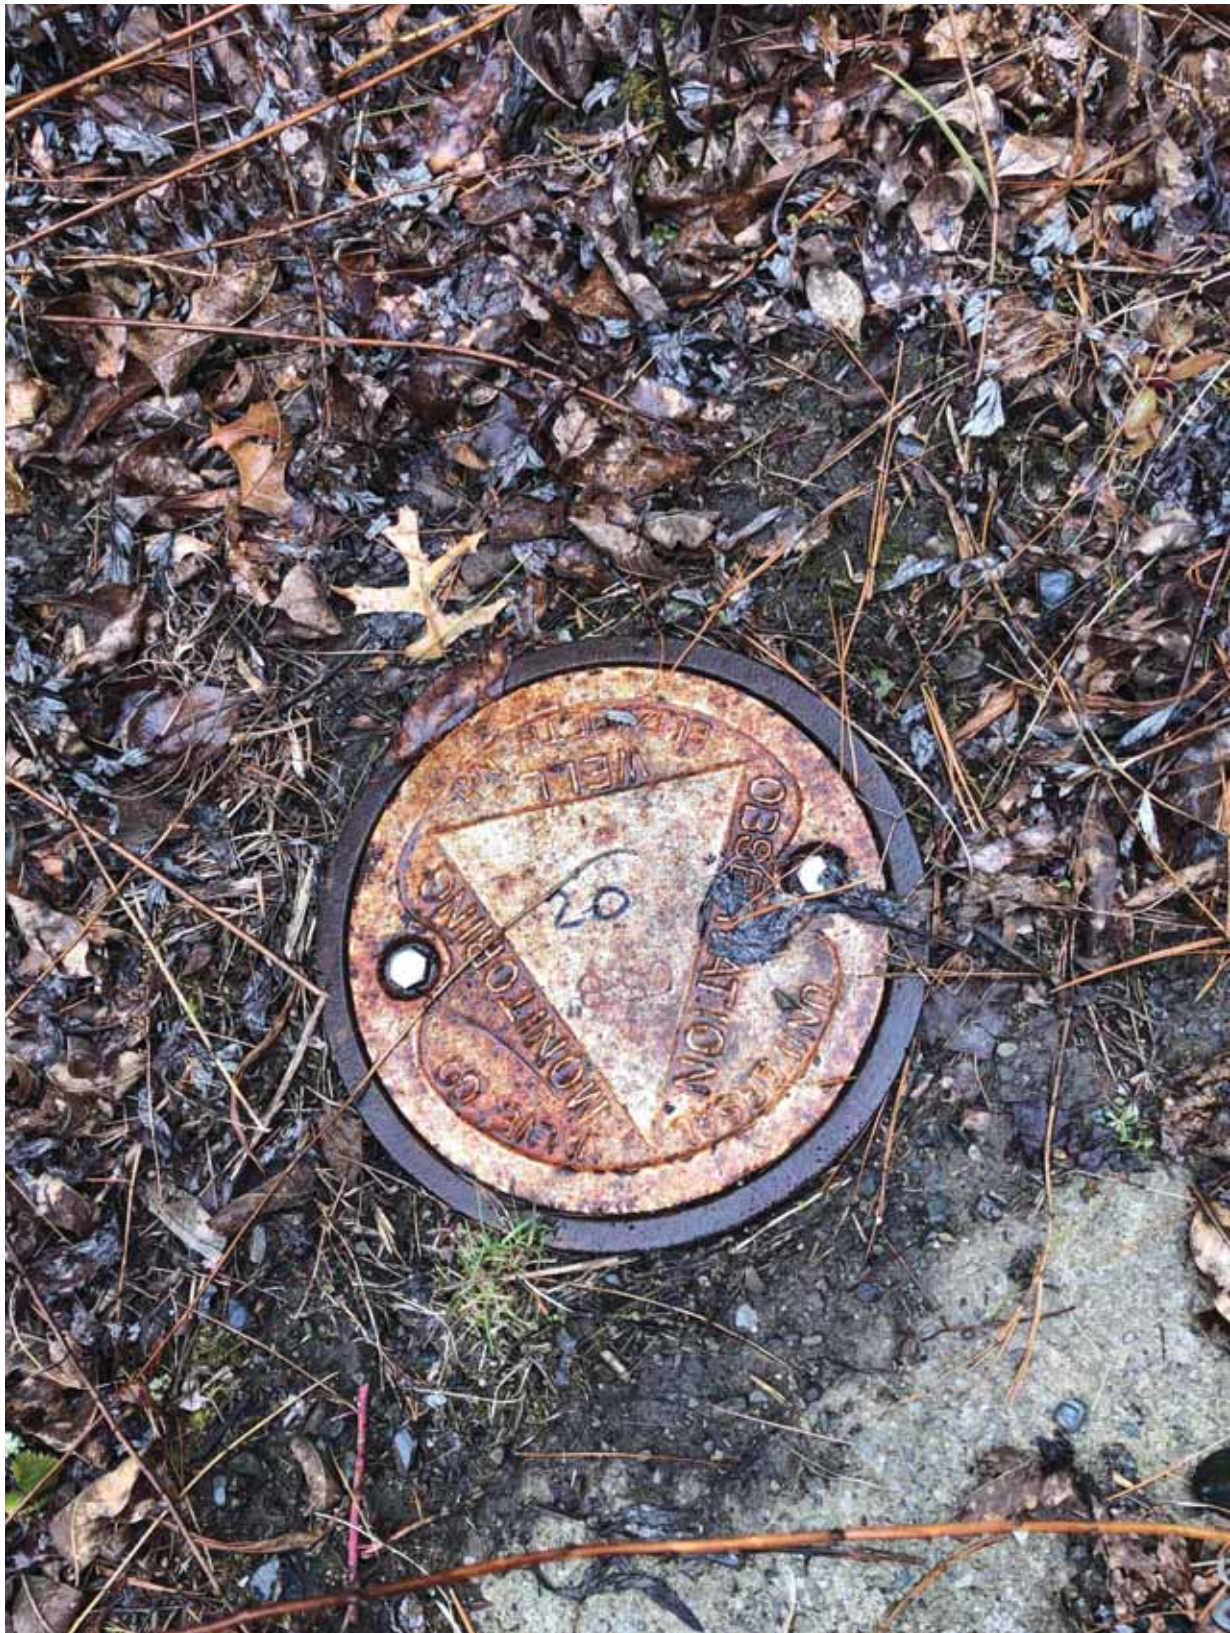
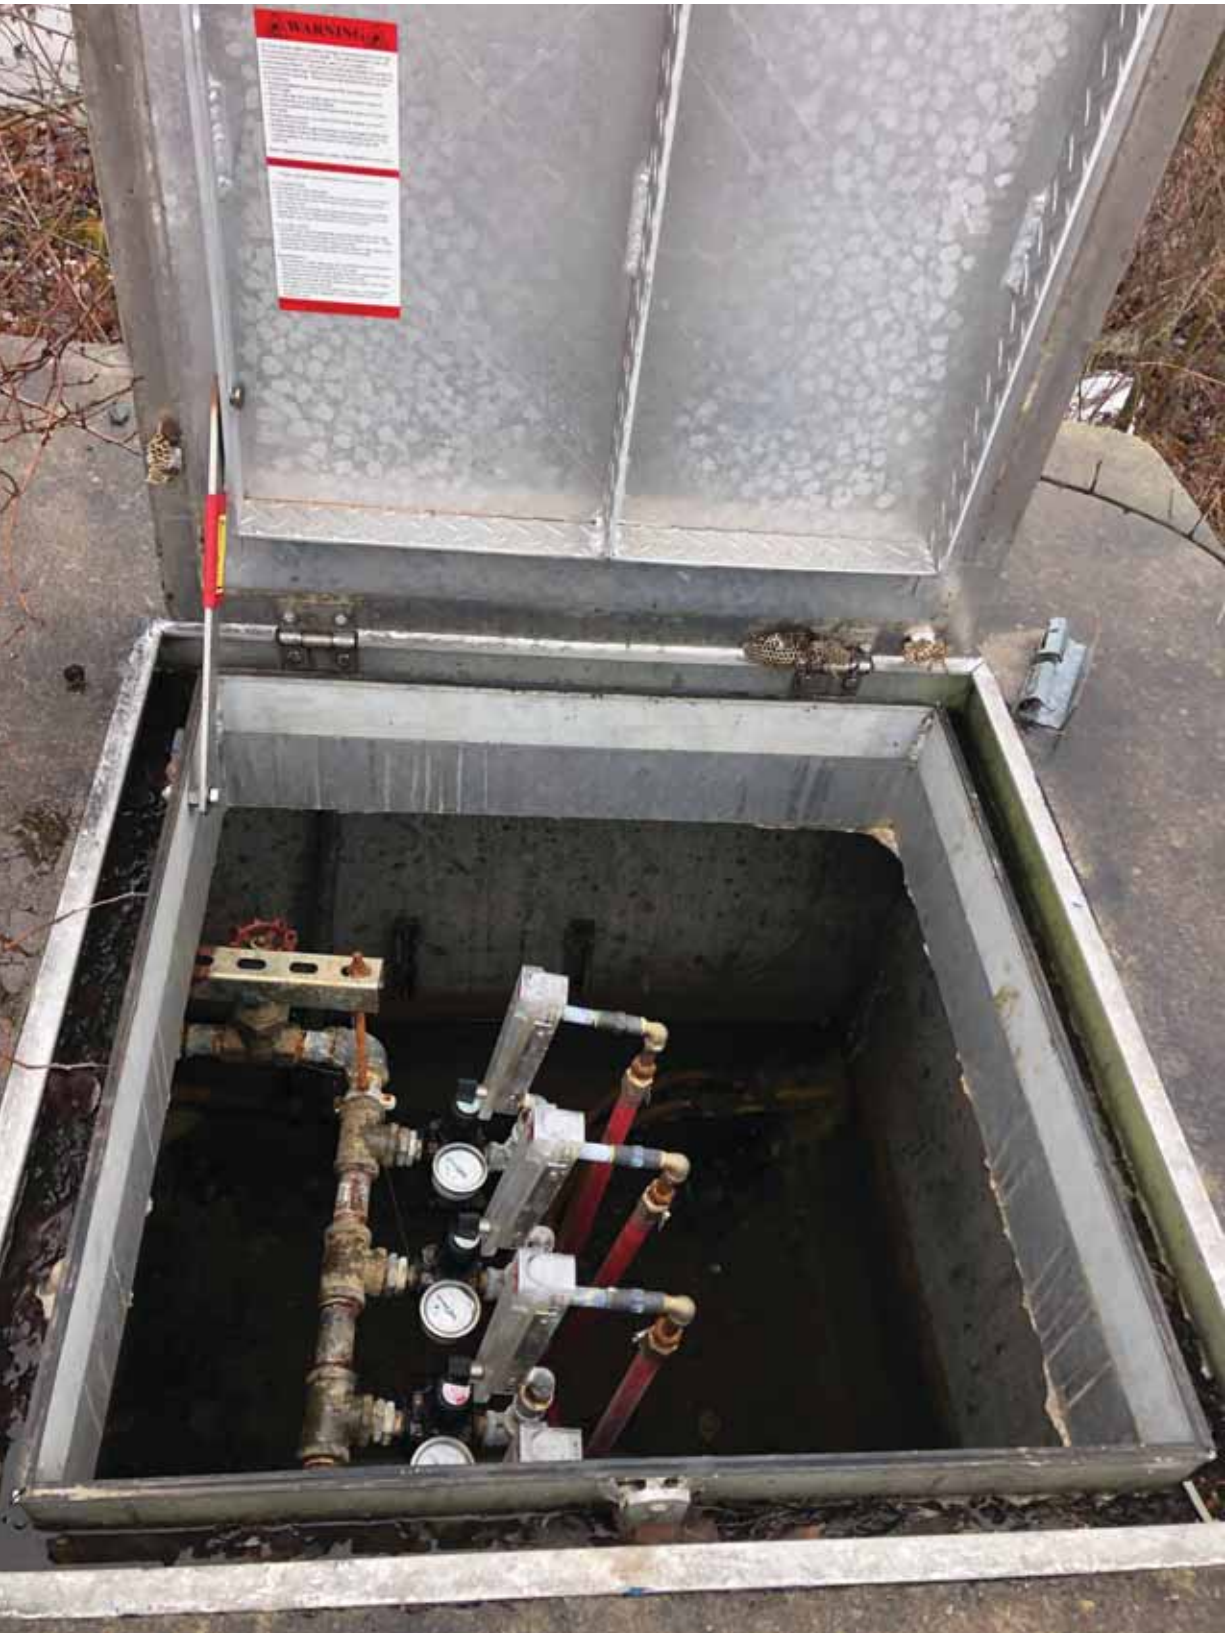
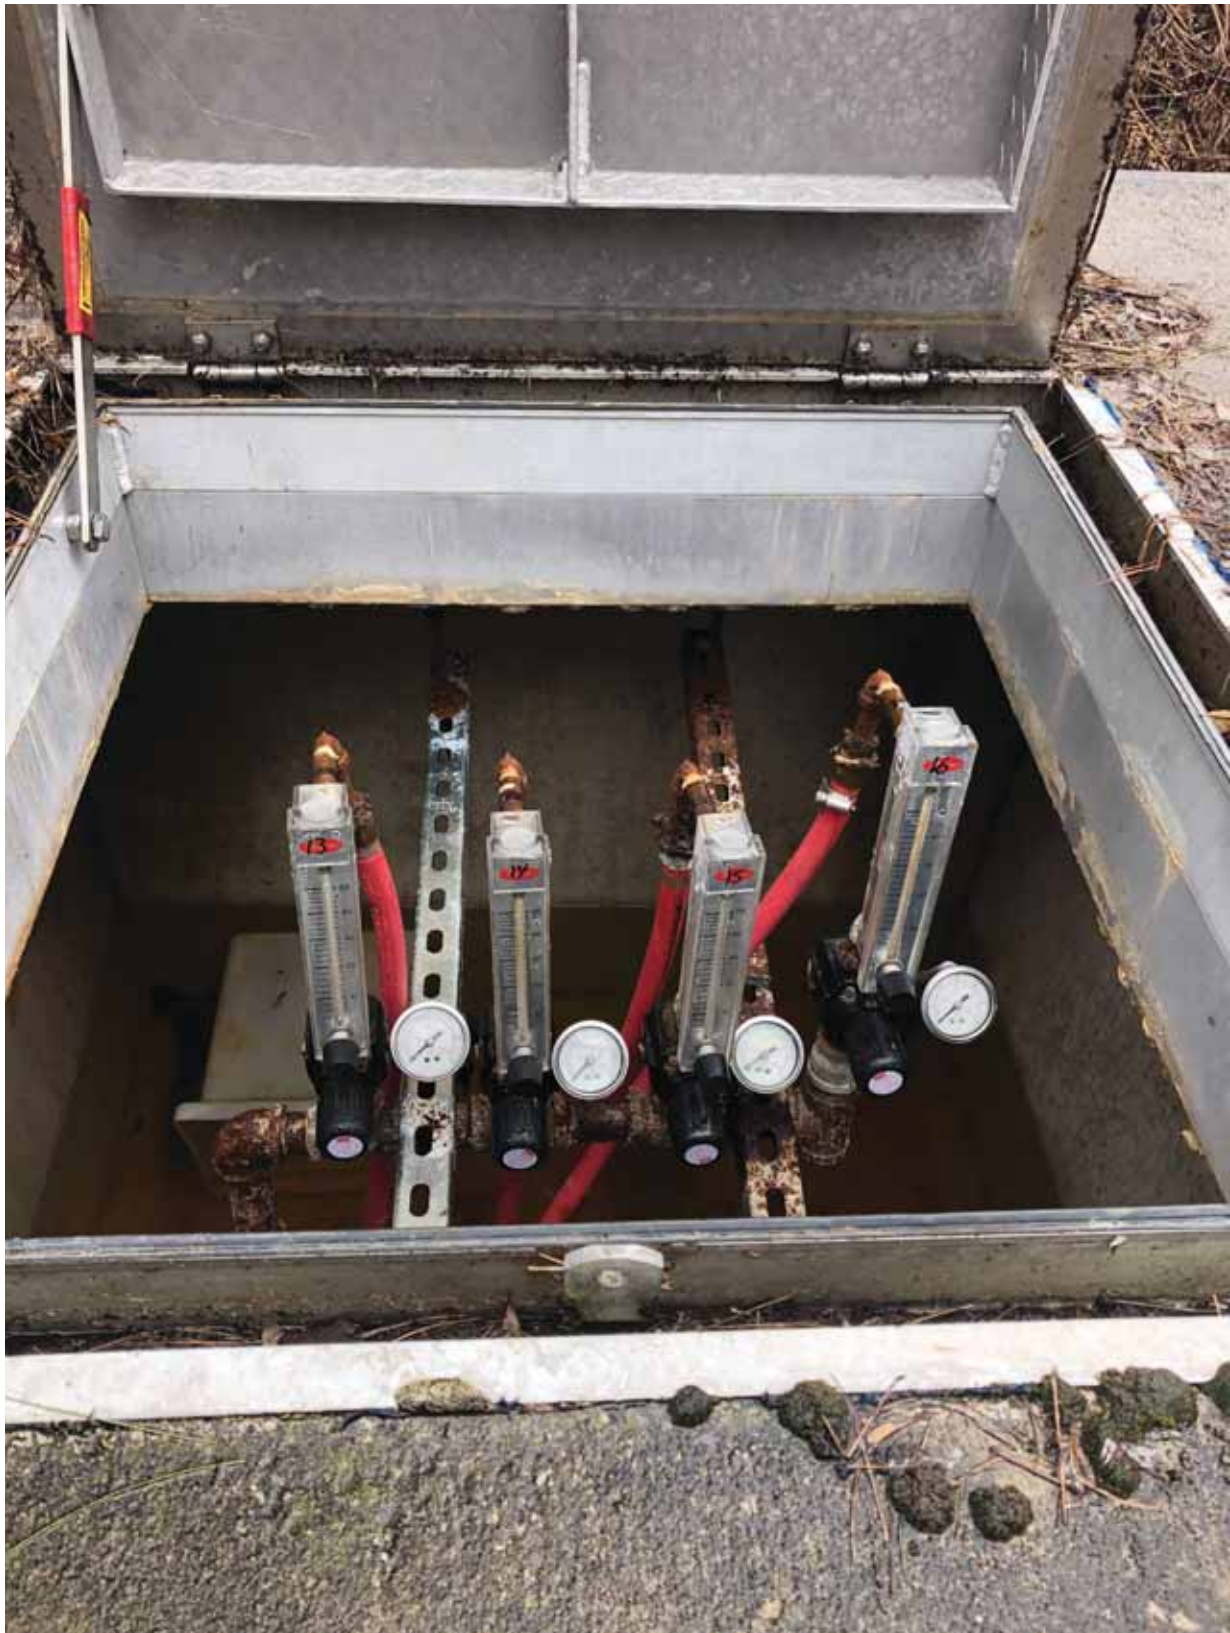
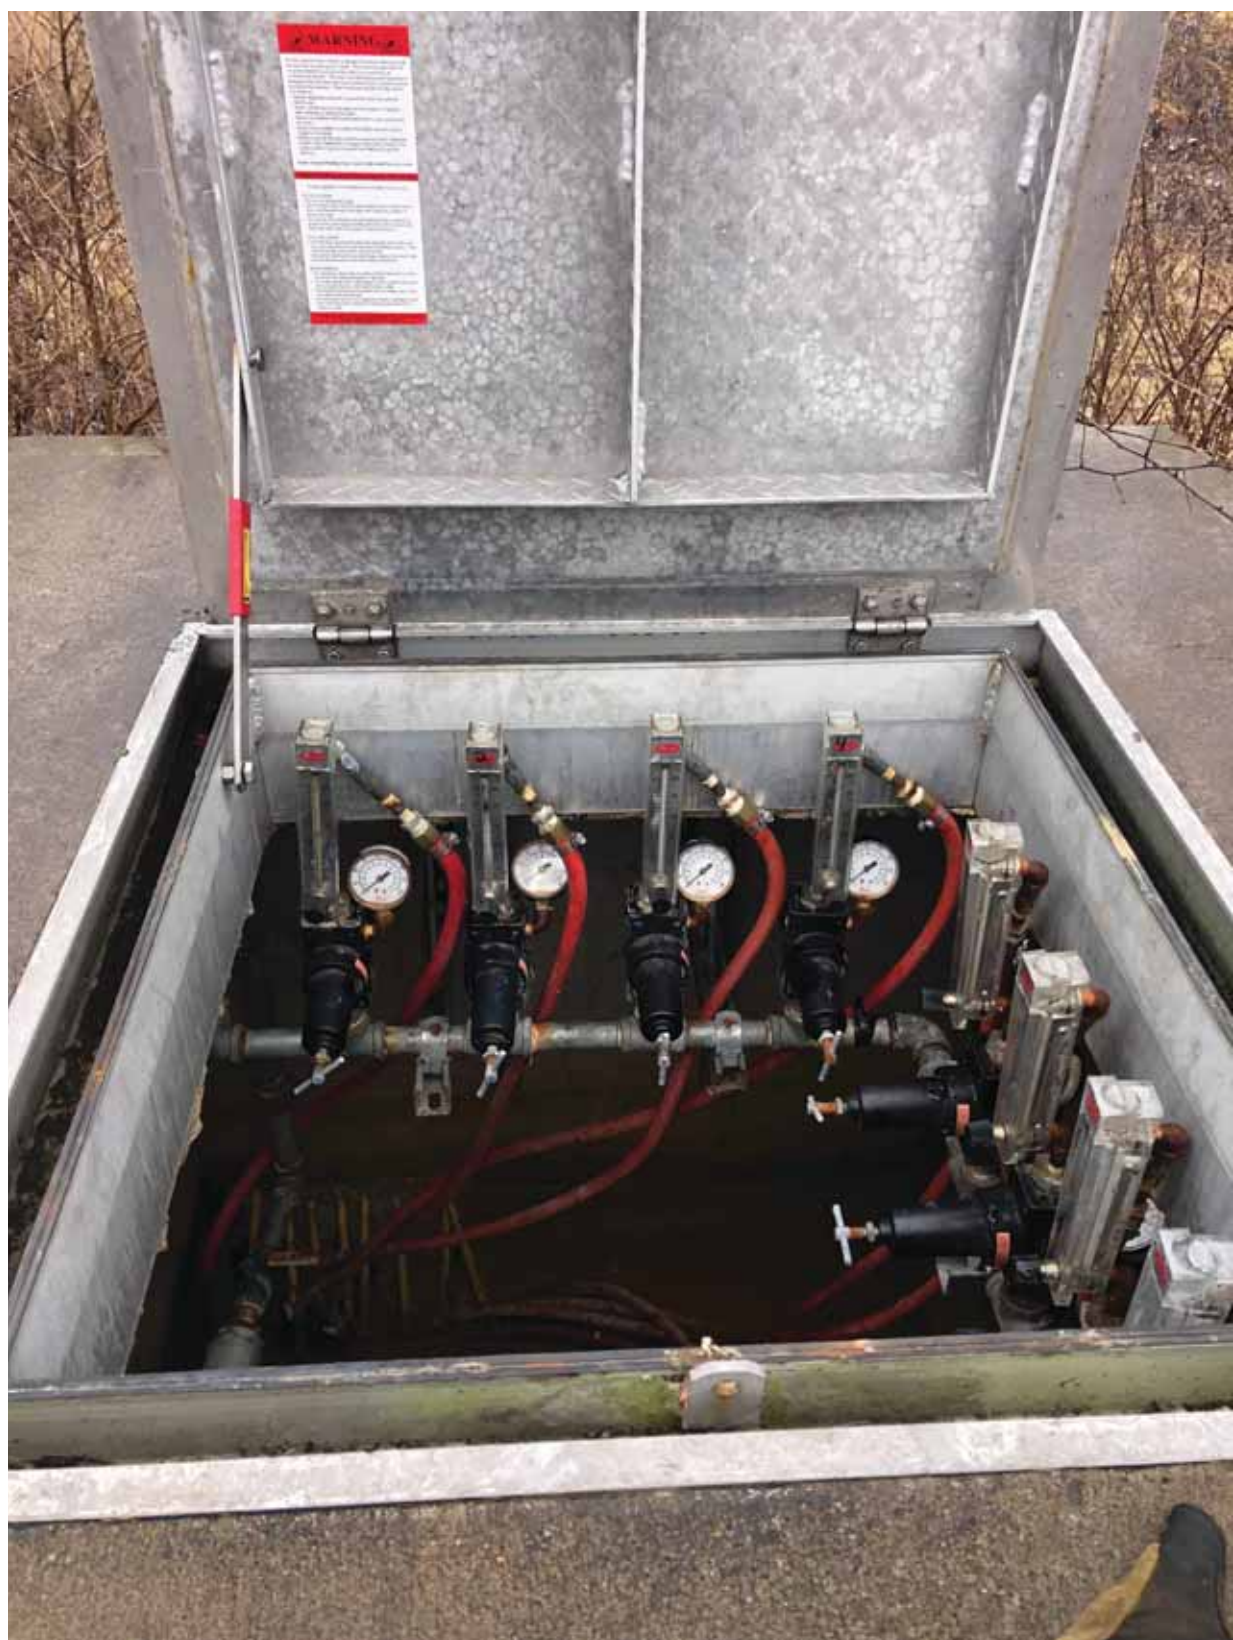
| | STATUS | COMMENTS |
|---|---|---|
| A. AREA F | GOOD | No subsidence of ground, no visible signs of impacted soil, area vegetated, (see pictures). |
| B. BUILDING 53 AREA | GOOD | No subsidence of ground, no visible signs of impacted soil, area vegetated, (see pictures). |
