Re: Quarterly Progress Report – 1<sup>st</sup> Quarter 2023  
Harriman Inactive Waste Disposal Site #336006

**RIVERBANK INSPECTION FORM  
WEST BRANCH OF THE RAMAPO RIVER  
MAYBROOK AND HARRIMAN TRUST  
HARRIMAN, NEW YORK**

## Former Nepera Plant - Harriman, NY: Quarterly Well Inspection Report

SITE FENCE INSPECTION FORM  
MAYBROOK AND HARRIMAN TRUST  
HARRIMAN, NEW YORK

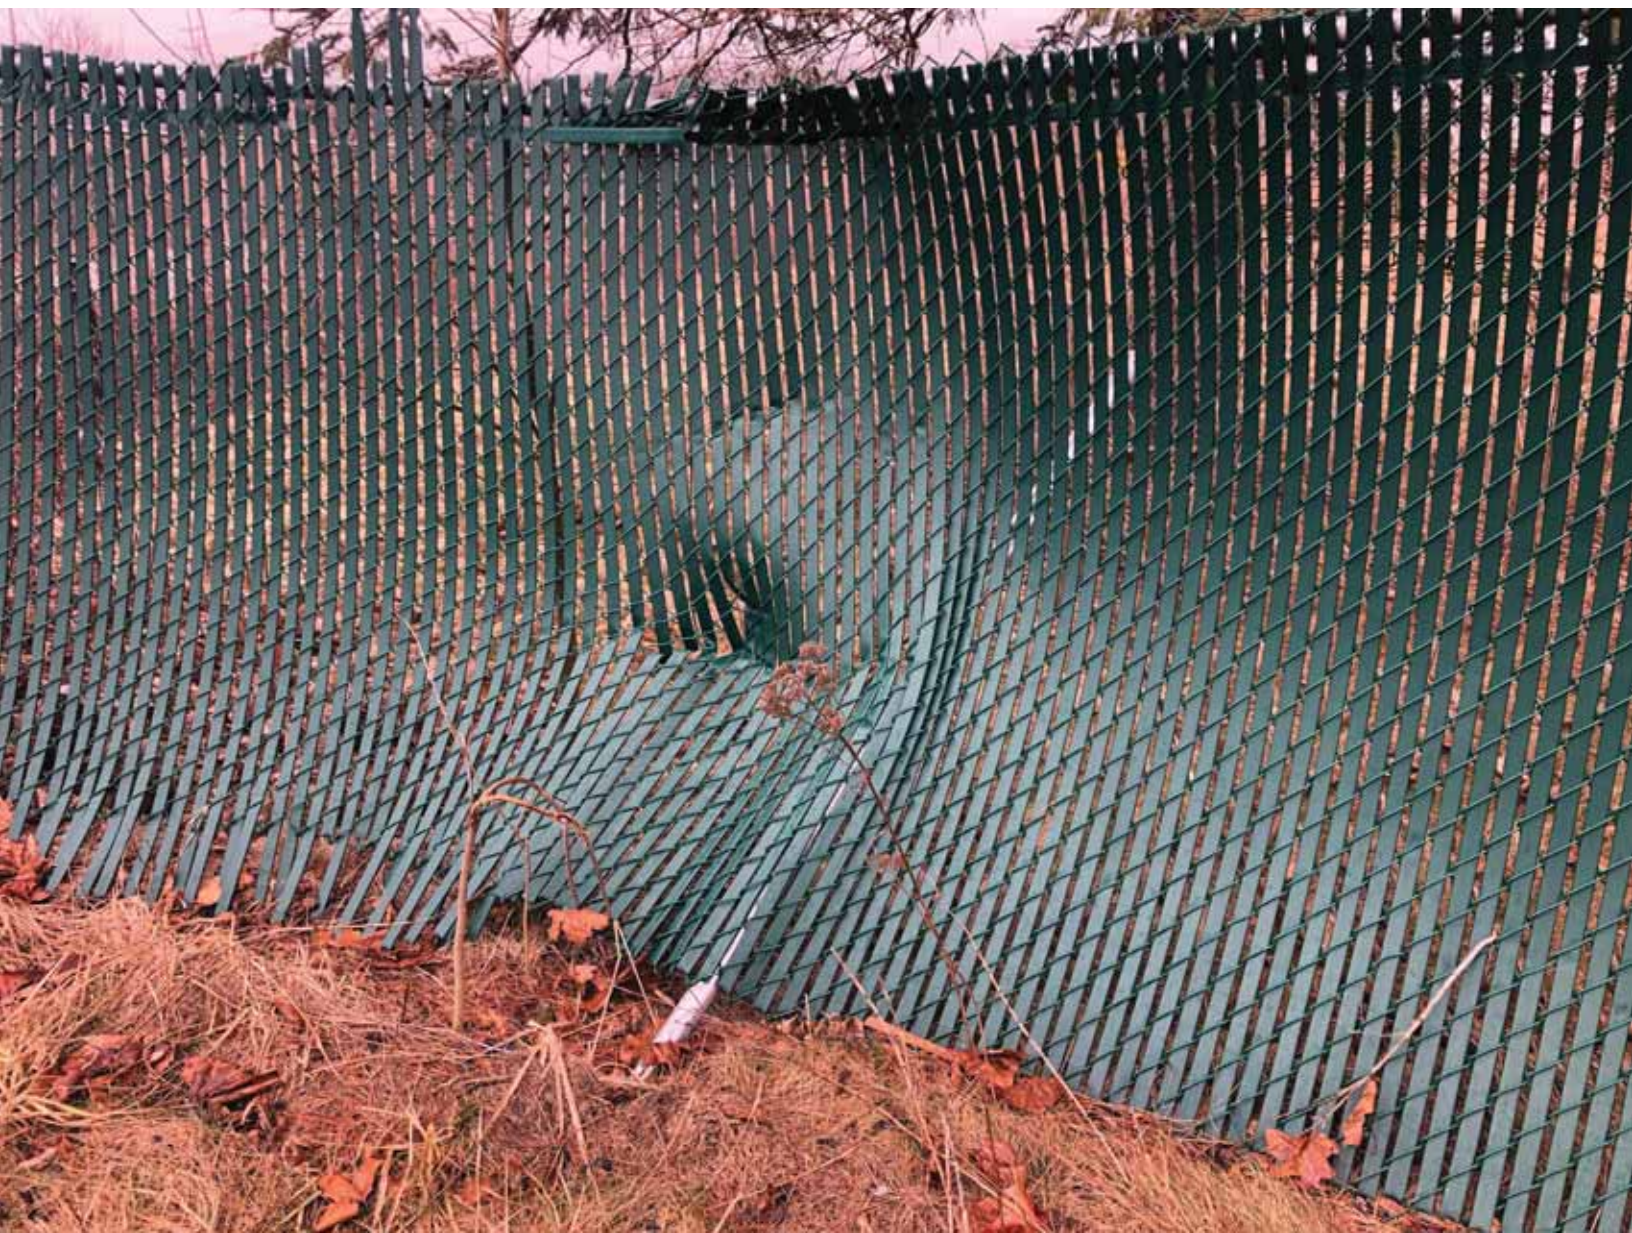
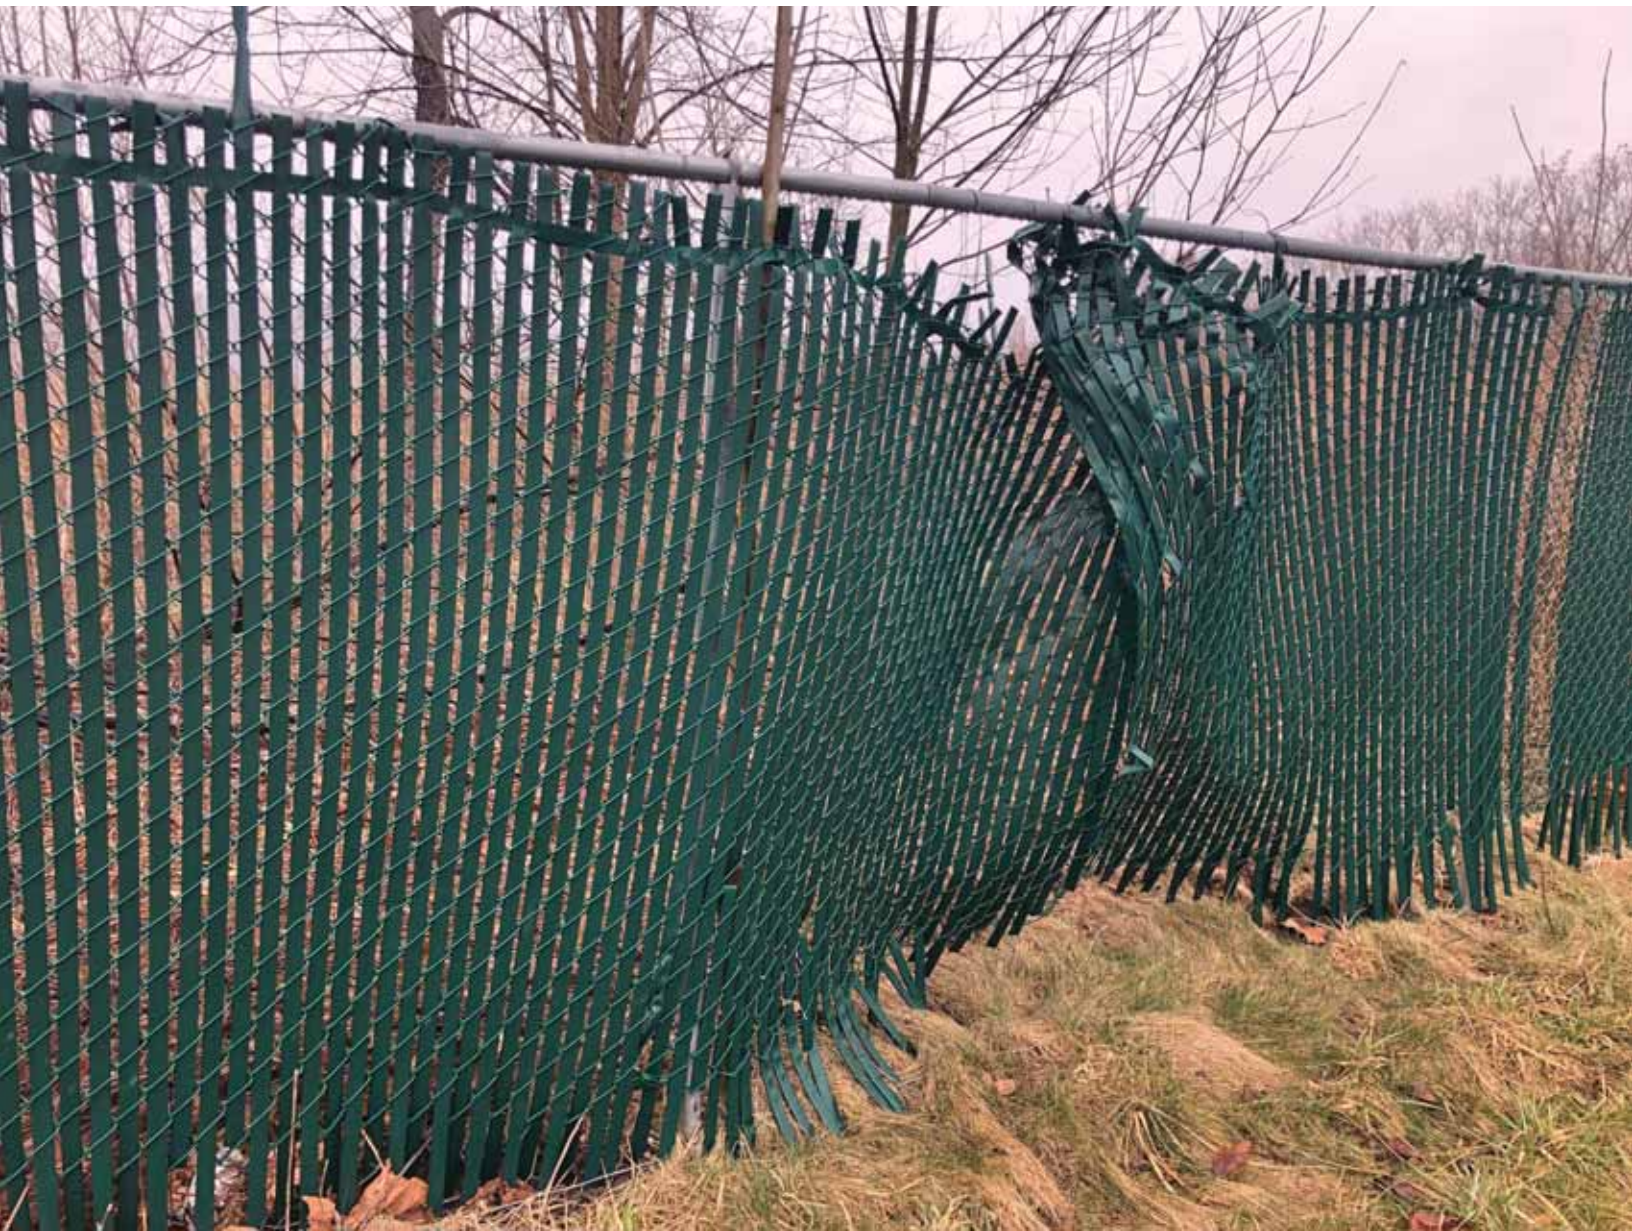
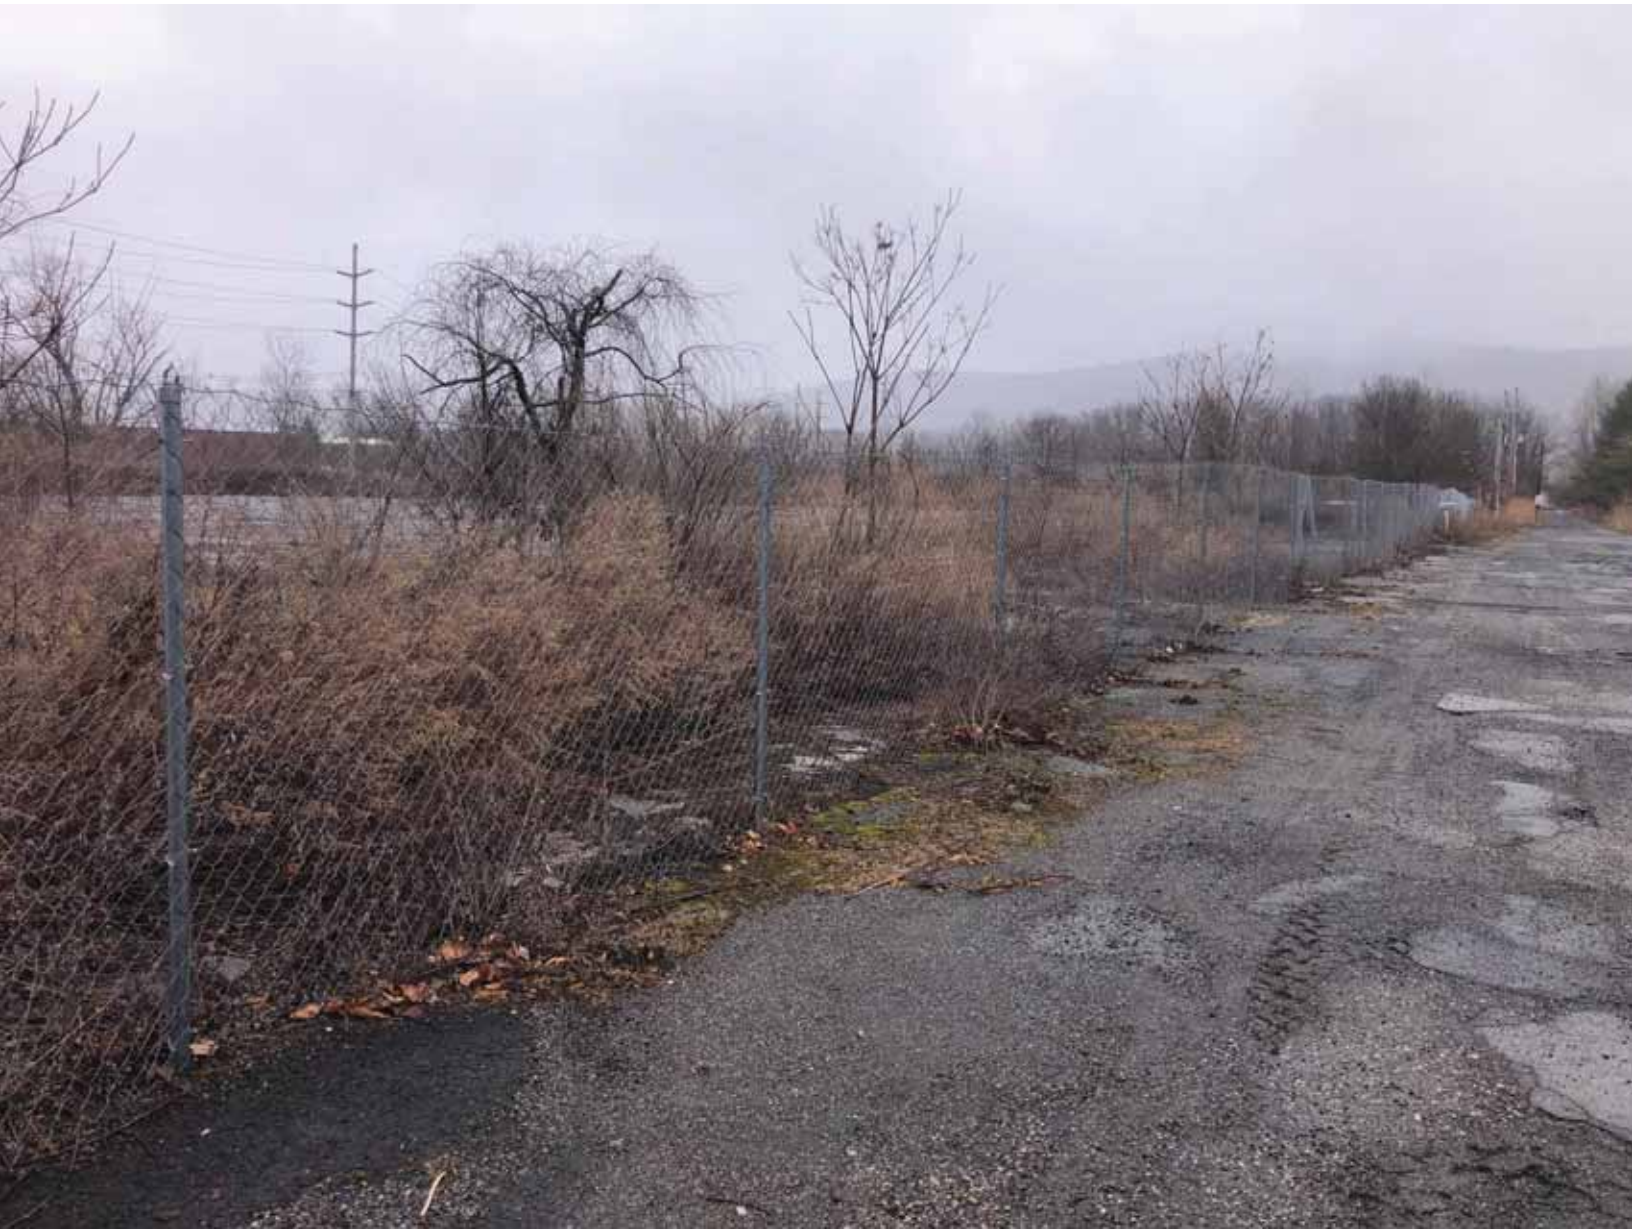
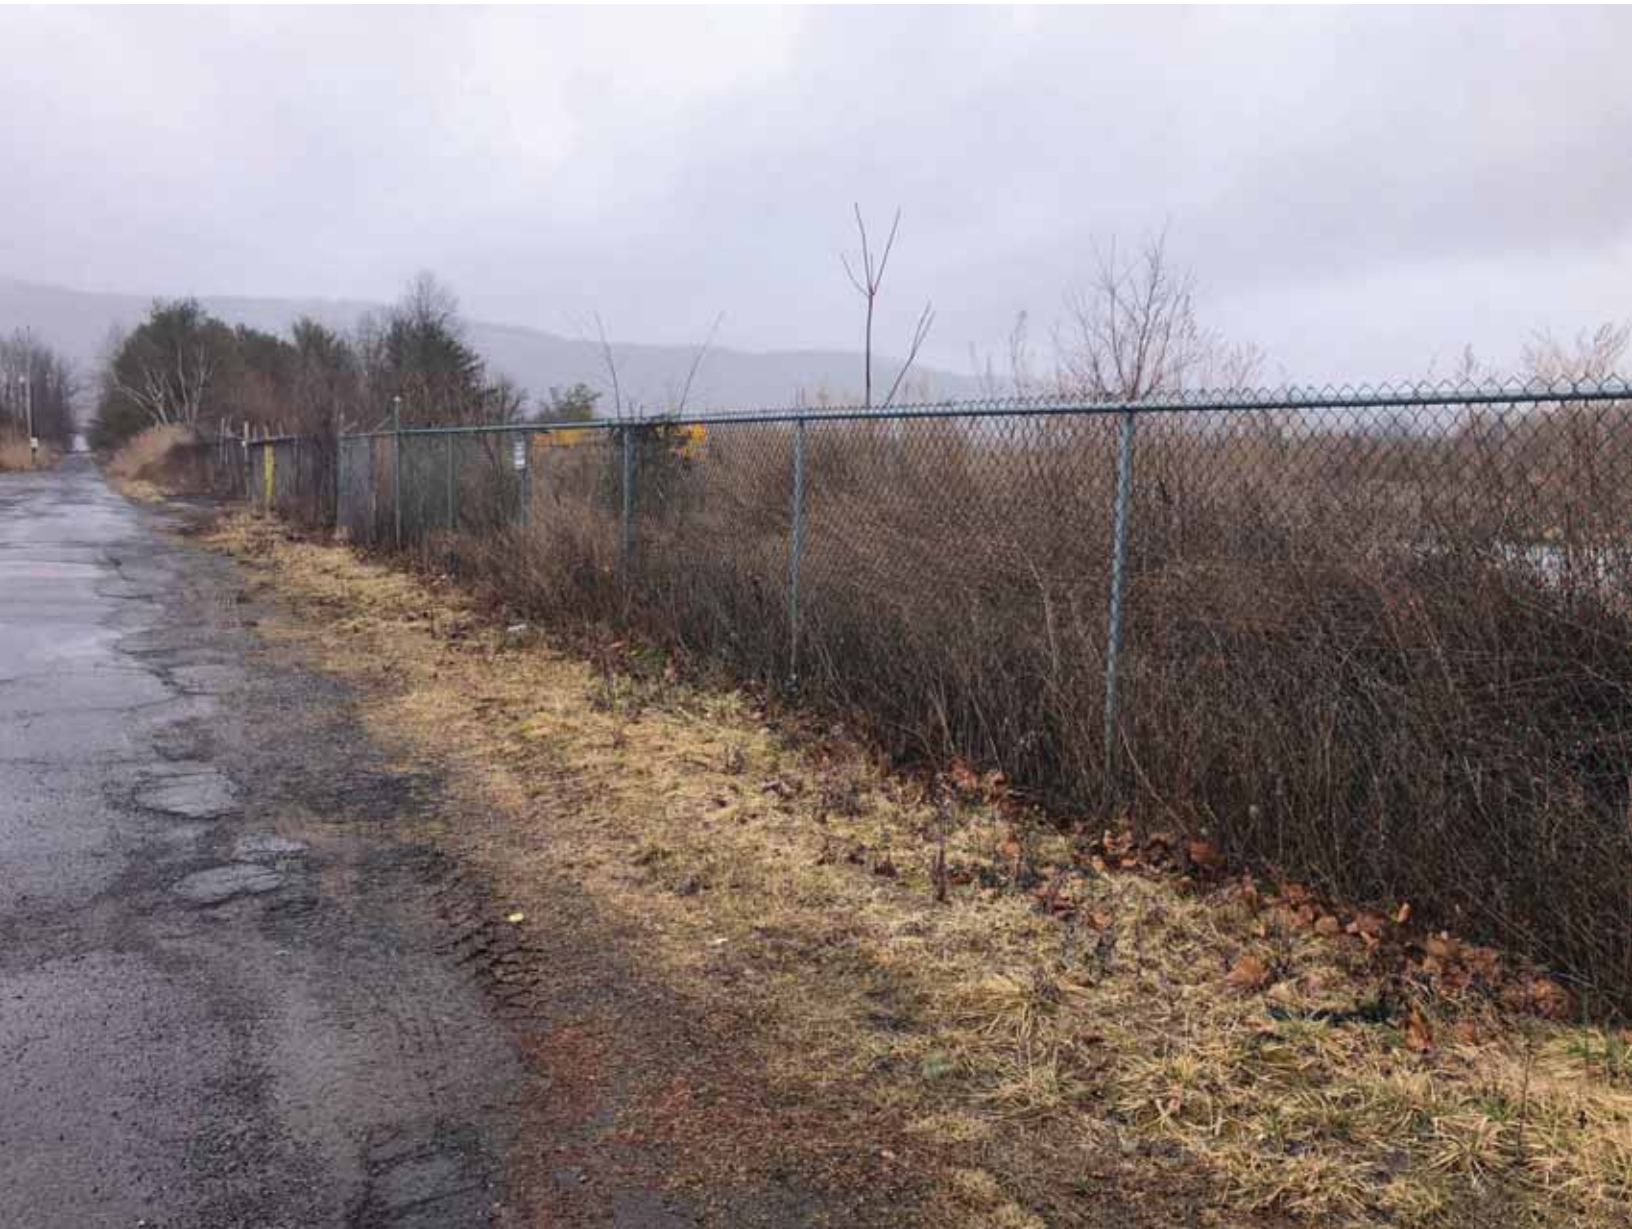
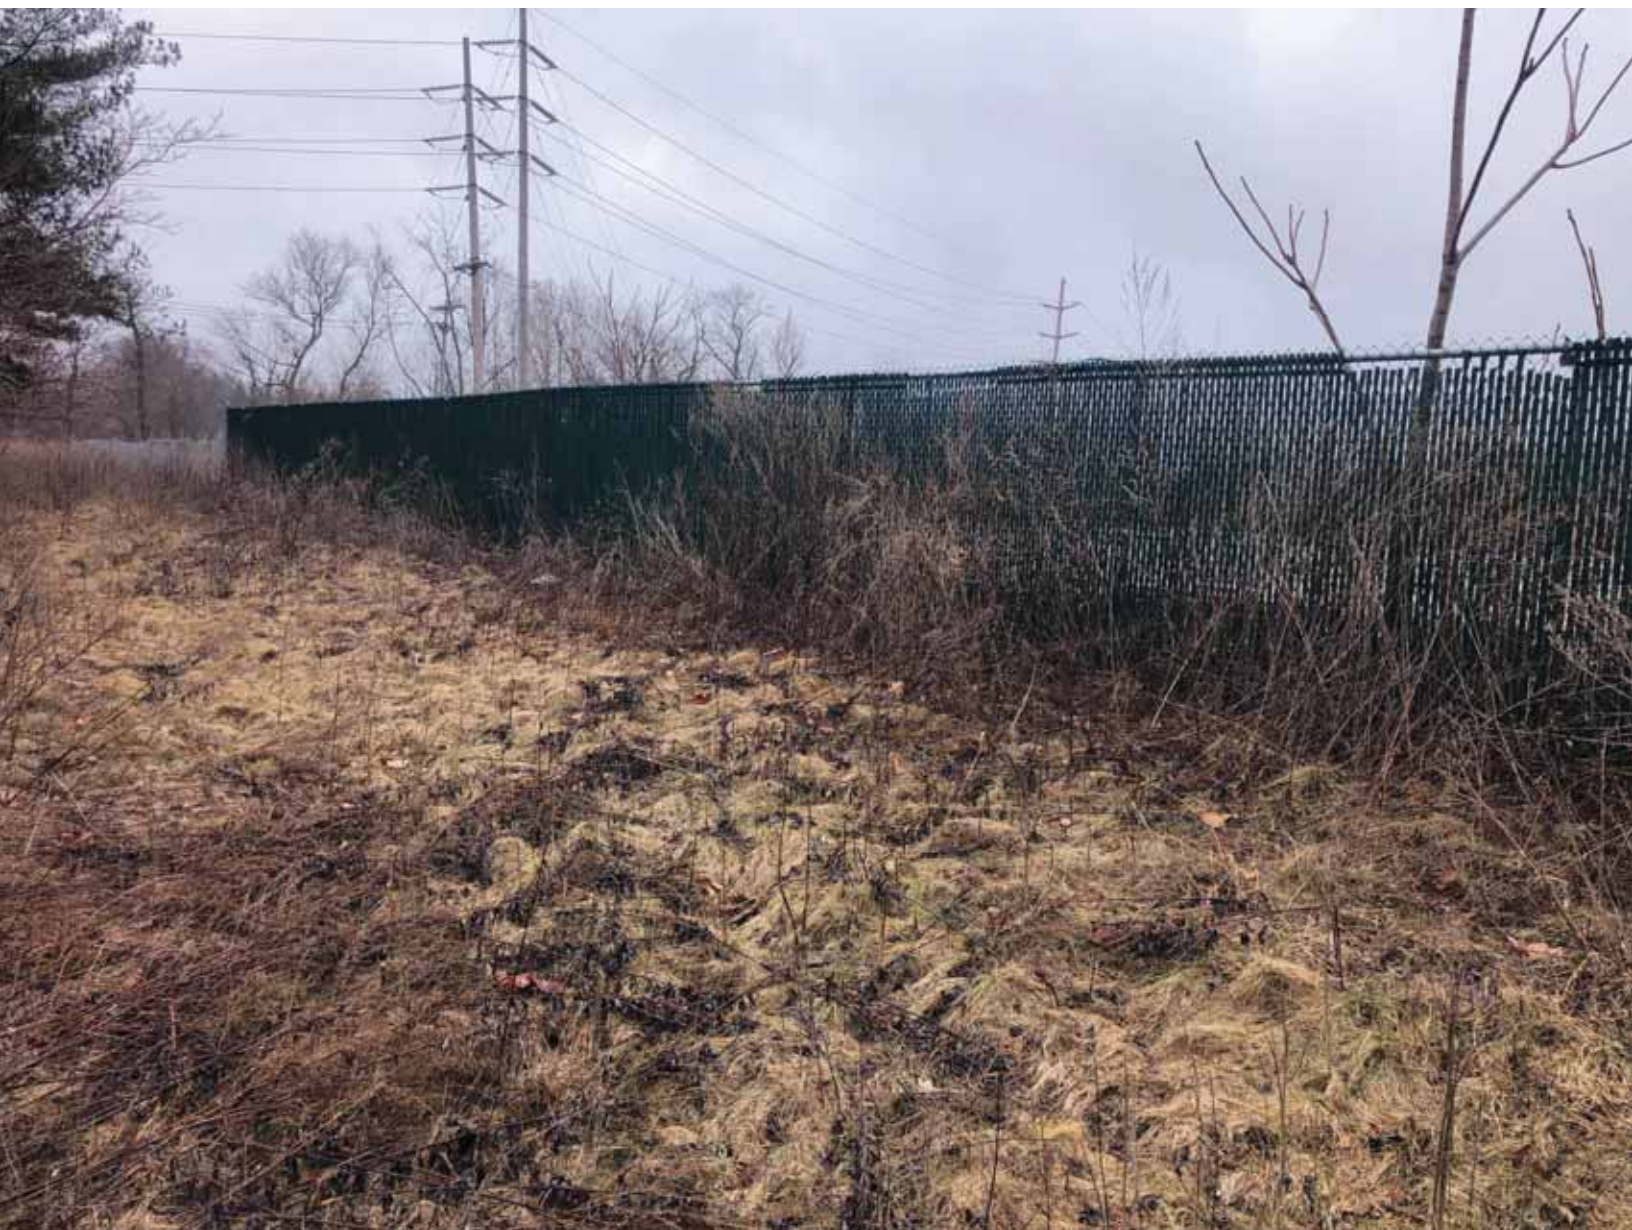
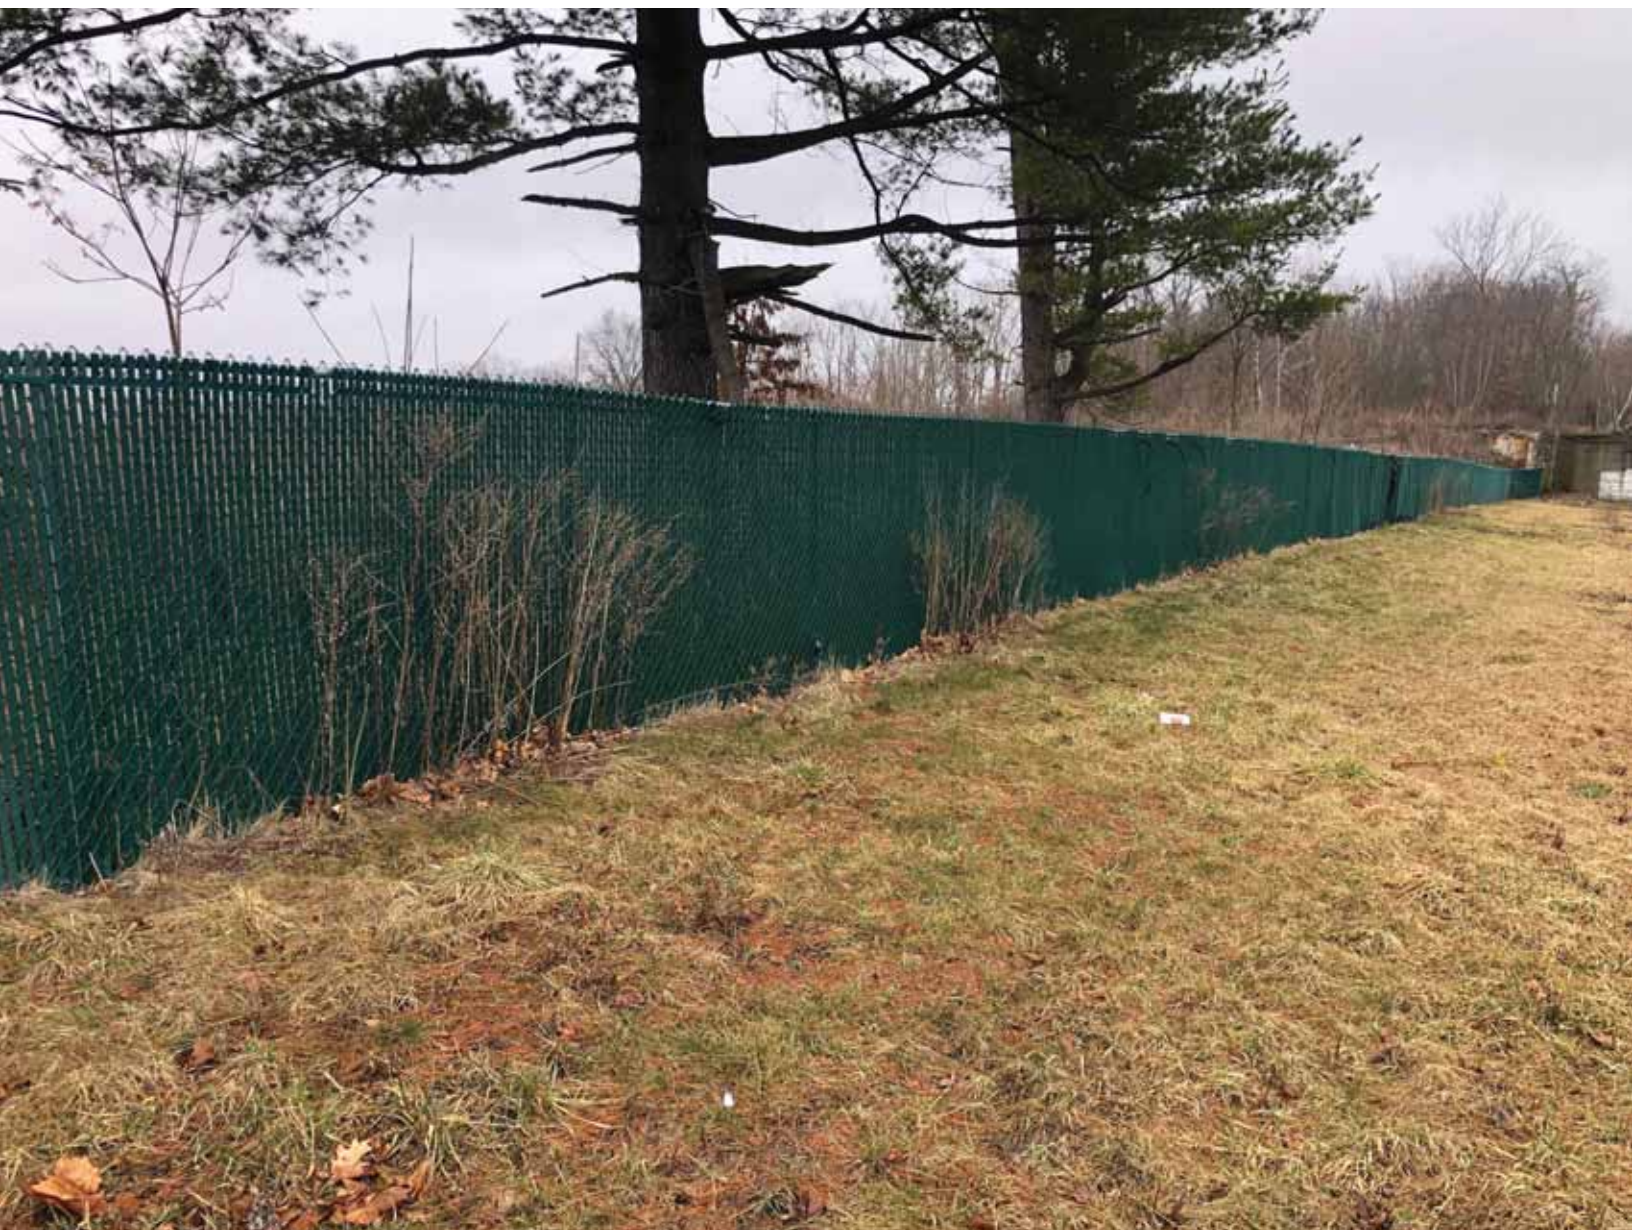
| | STATUS | COMMENTS |
|---|---|---|
| A. Perimeter Fence around NEPERA Facility | <u>GOOD</u> | <u>Fence in good condition, high amount of vegetation growing on southern portion of fence. Two areas damaged.</u> |
| B. Perimeter fence around NEPERA Parking Lot | <u>FAIR</u> | <u>Fence in fair condition, eastern section of fence cut by Orange and Rockland Company for guide lines for utility pole.</u> |
| C. Perimeter fence around lagoon area | <u>FAIR</u> | <u>Fence in fair condition, southern section of fence cut in two areas adjacent to MW-29S.</u> |

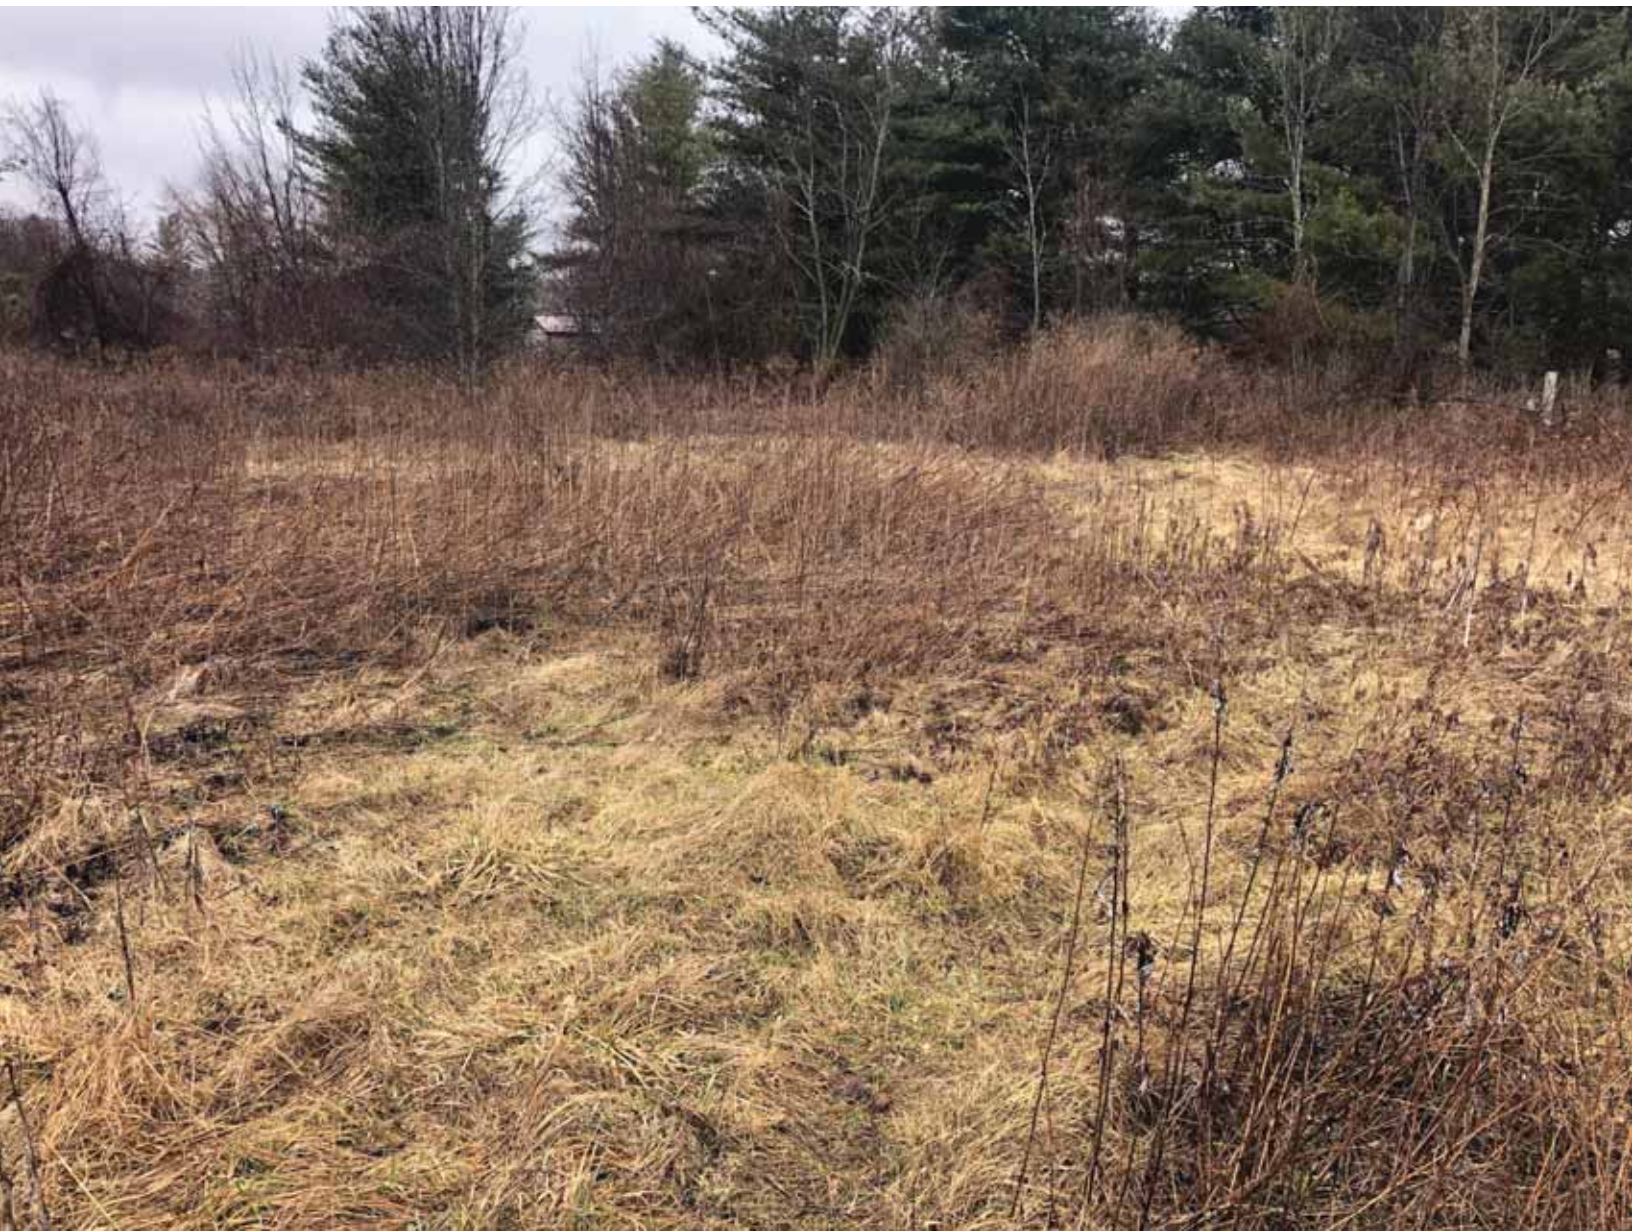
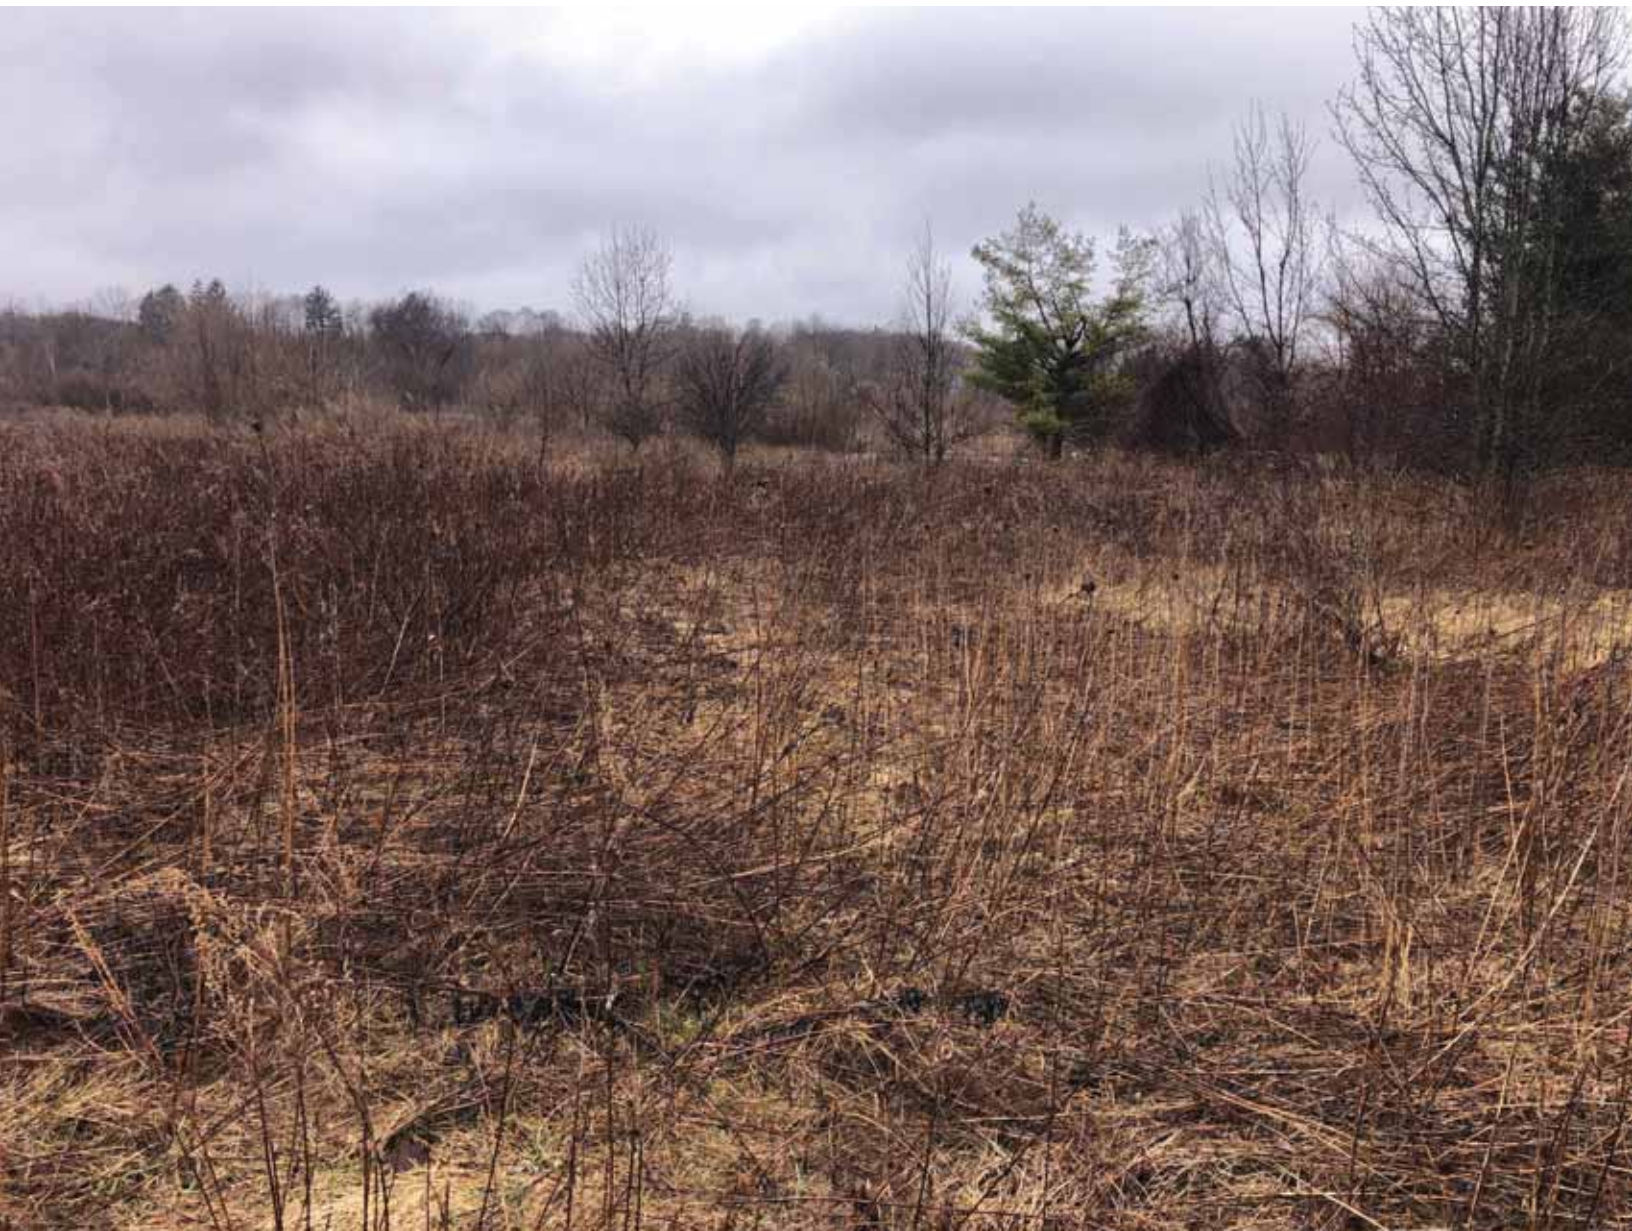
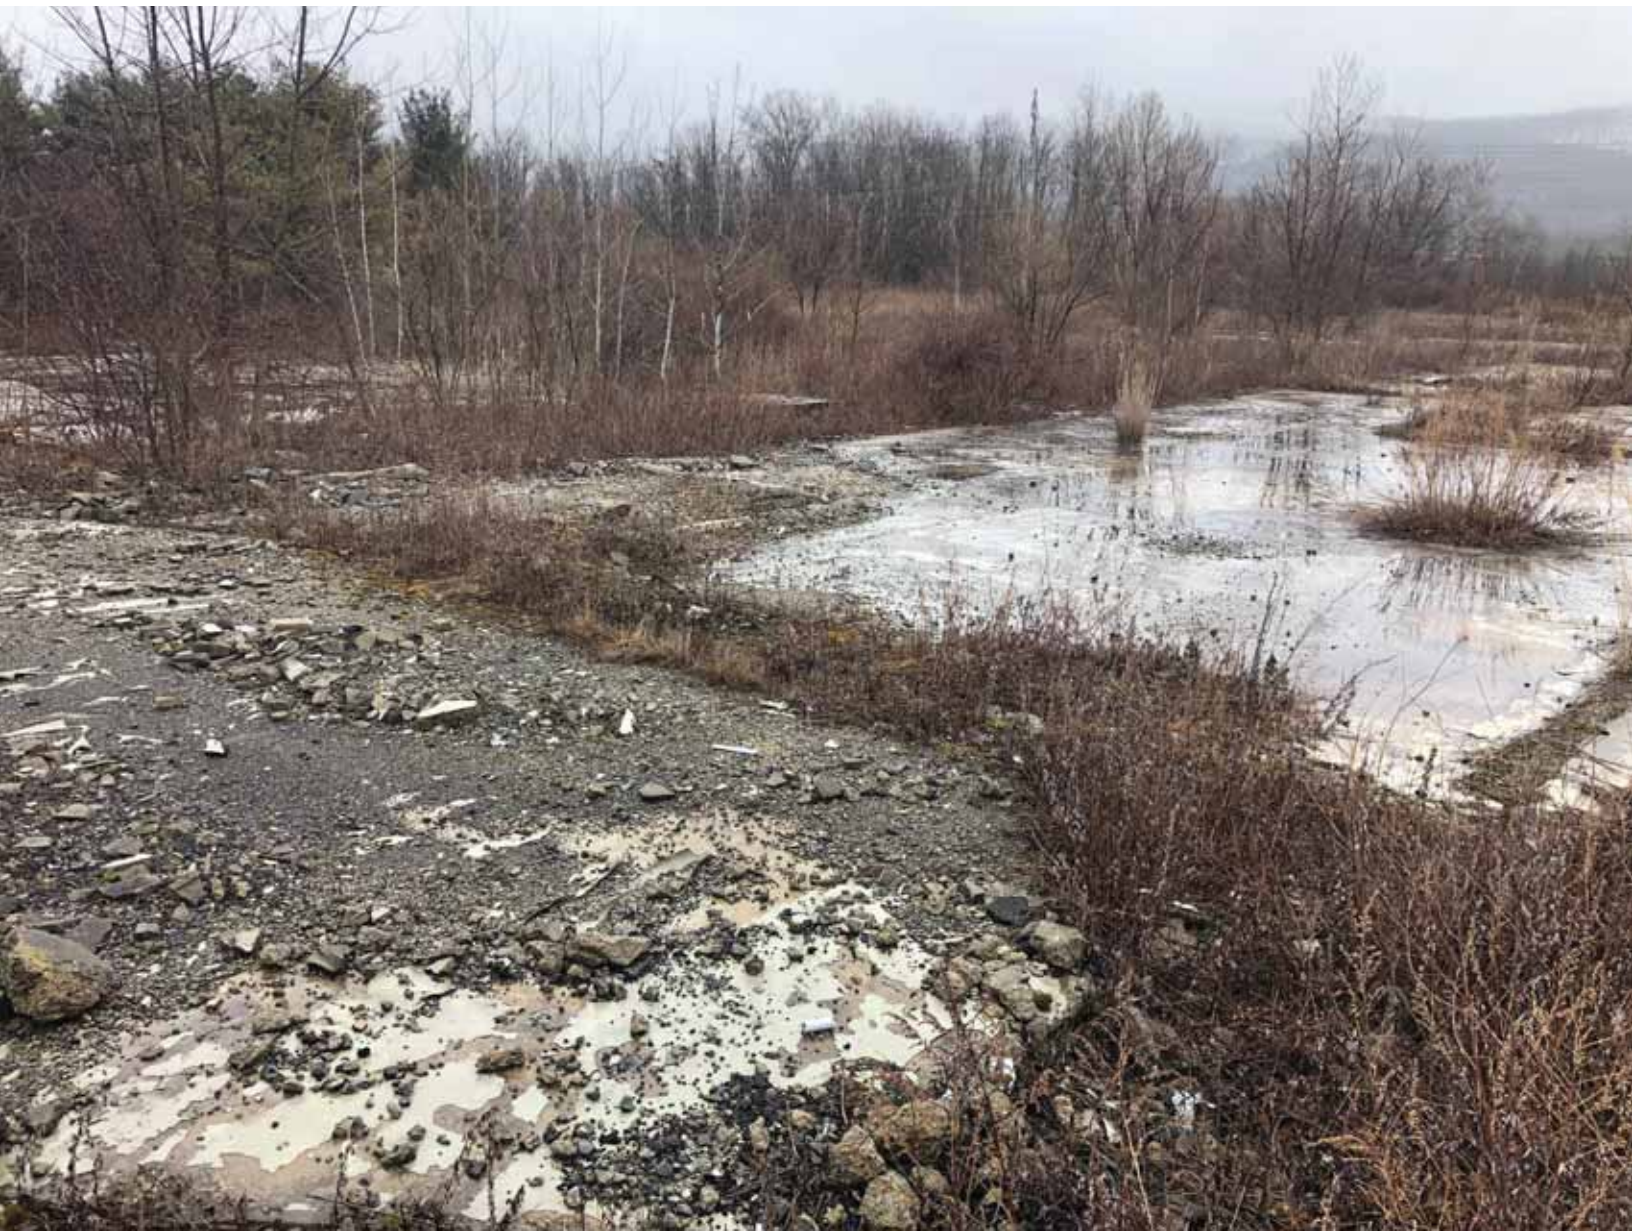
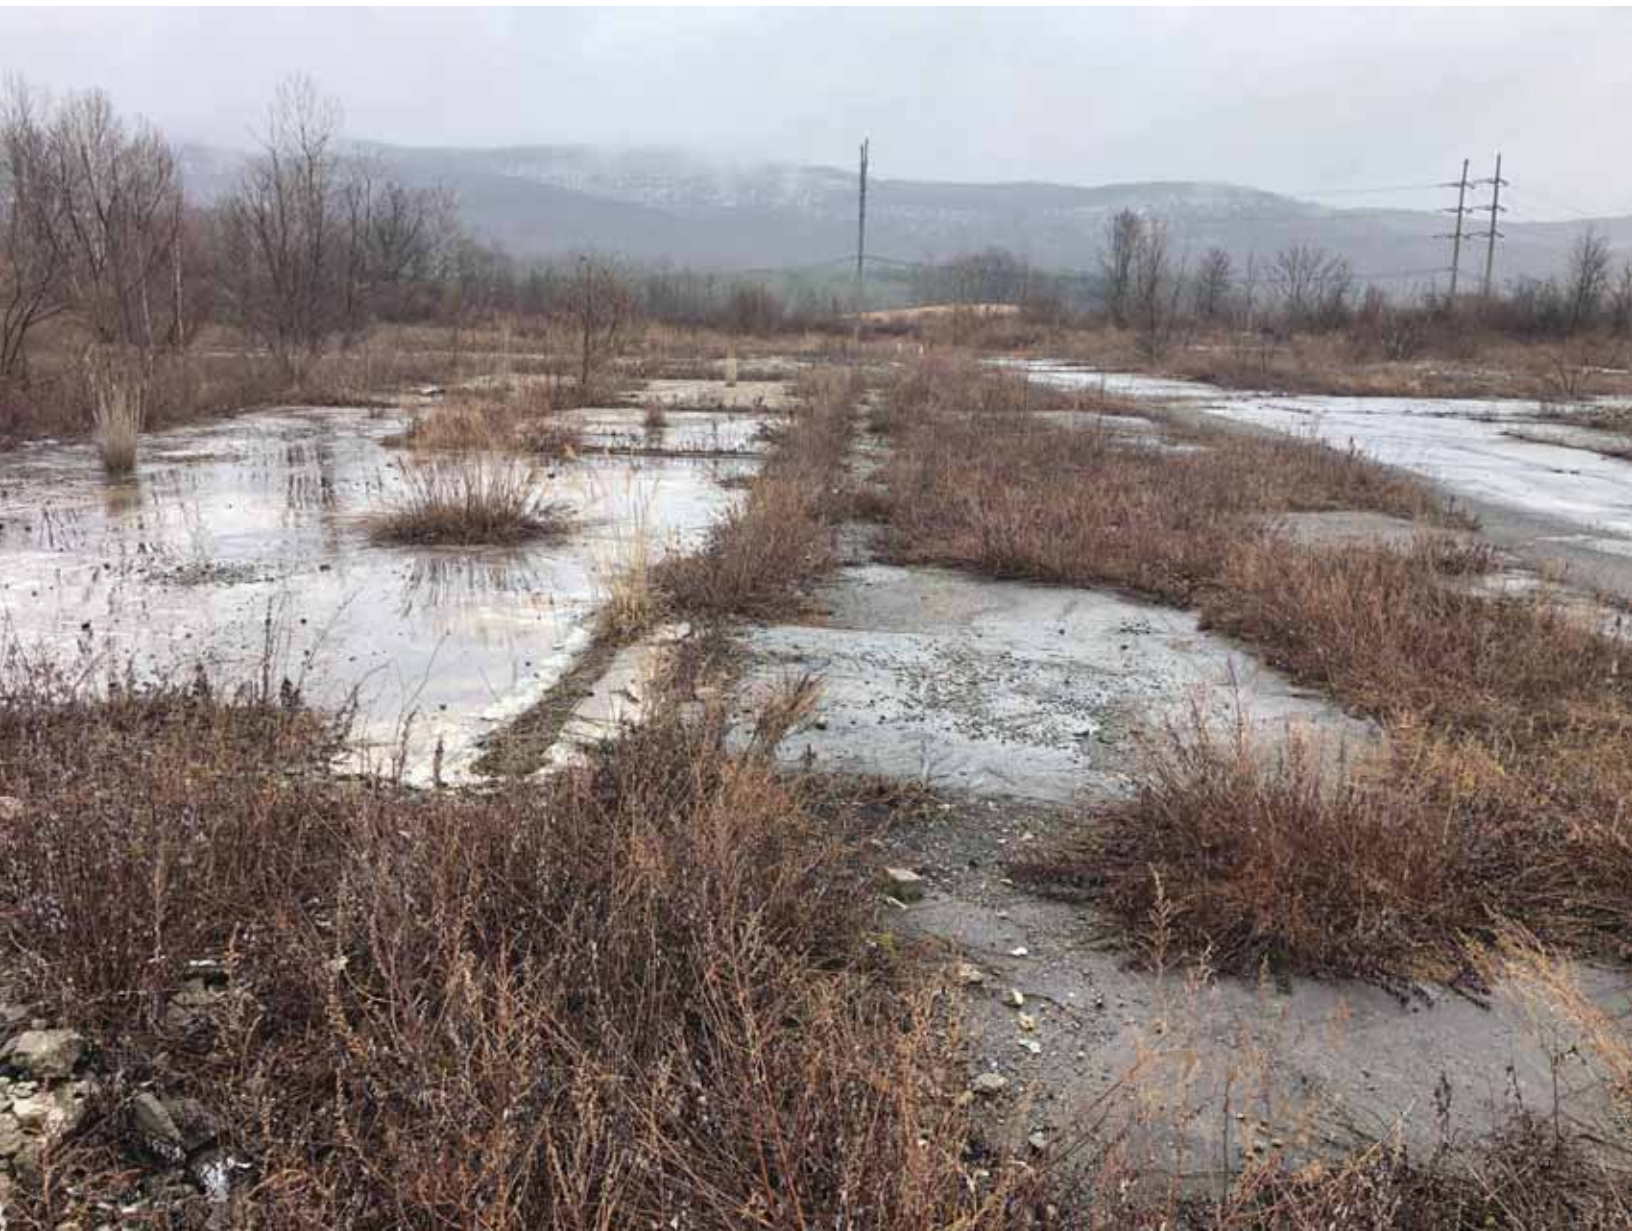
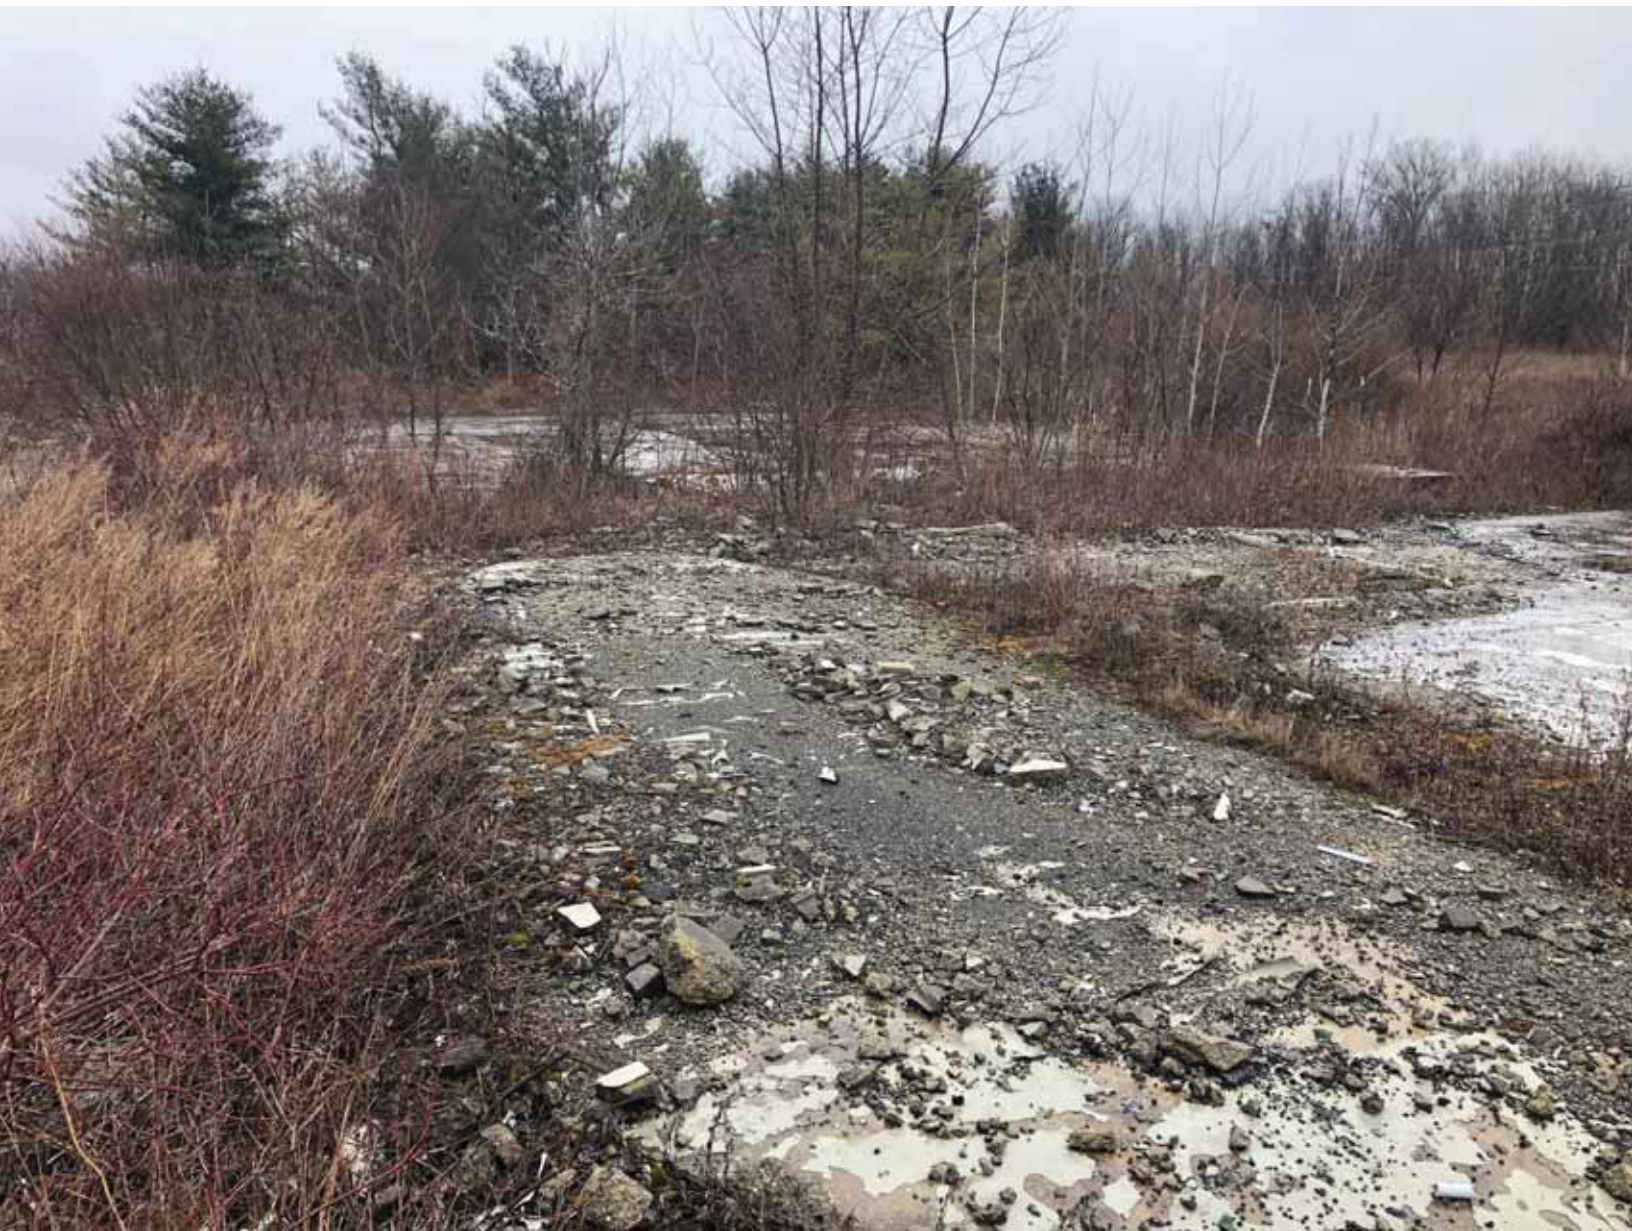
| | STATUS | COMMENTS |
|---|---|---|
| A. AREA F | GOOD | No subsidence of ground, no visible signs of impacted soil, area vegetated, (see pictures). |
| B. BUILDING 53 AREA | GOOD | No subsidence of ground, no visible signs of impacted soil, area vegetated, (see pictures). |
