Re: Quarterly Progress Report – 2<sup>nd</sup> Quarter 2023  
Harriman Inactive Waste Disposal Site #336006

**RIVERBANK INSPECTION FORM  
WEST BRANCH OF THE RAMAPO RIVER  
MAYBROOK AND HARRIMAN TRUST  
HARRIMAN, NEW YORK**

## Former Nepera Plant - Harriman, NY: Quarterly Well Inspection Report

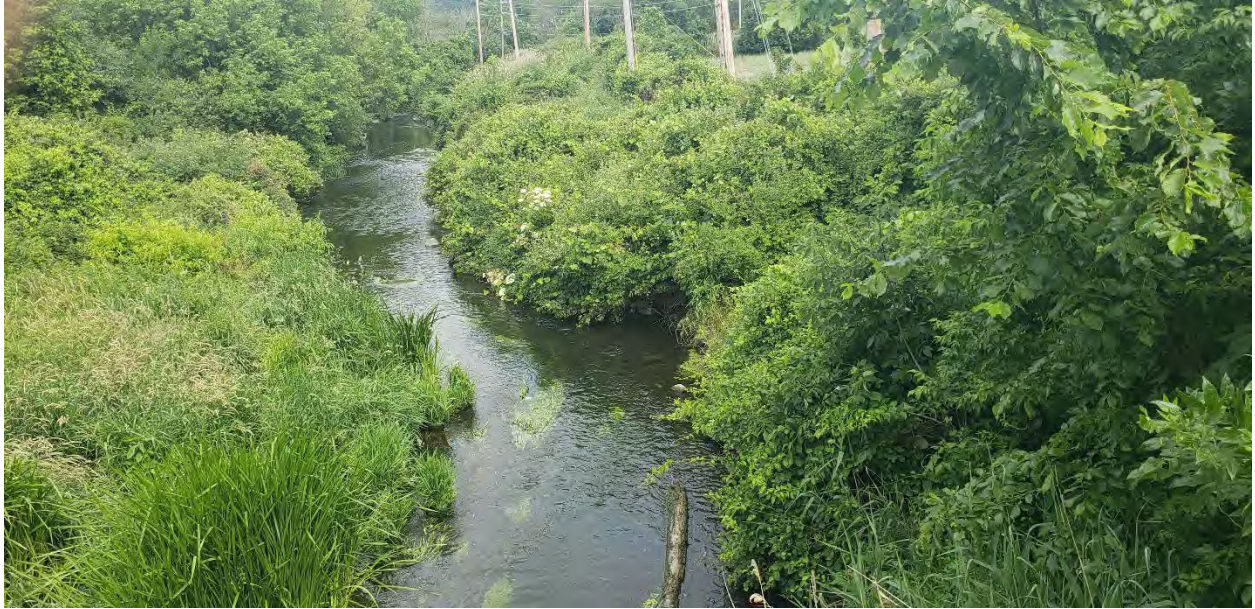
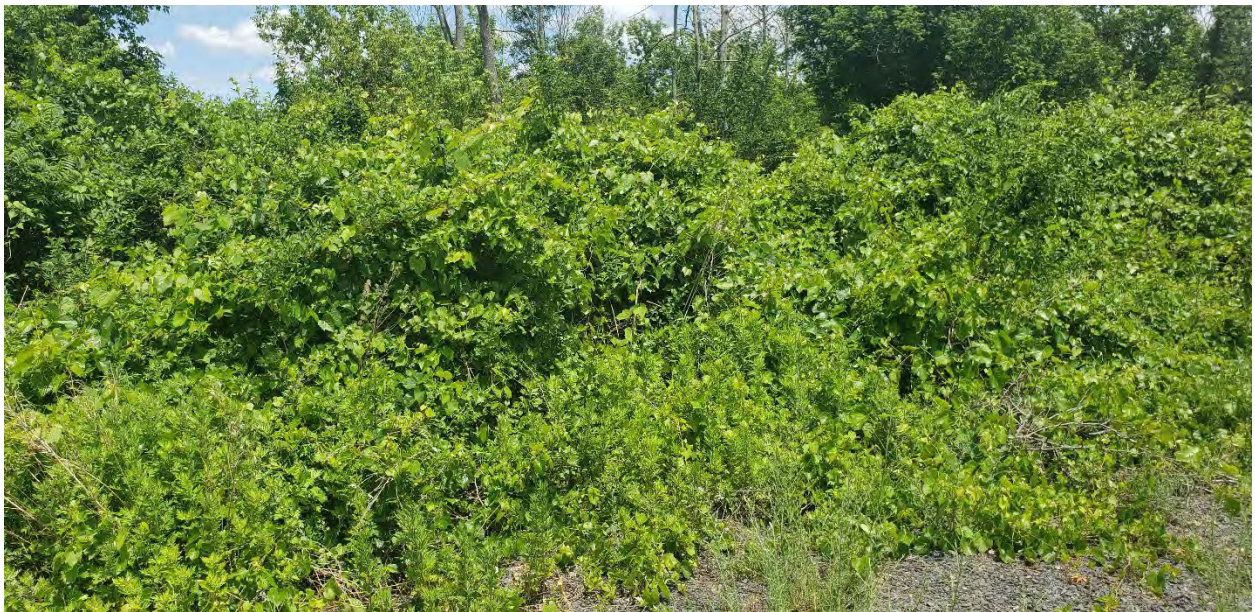
ATTACHMENT 1  
STREAMBANK VEGETATION PHOTOS TAKEN JUNE 21, 2023

The interim cover along the West Branch of the Ramapo River was inspected on June 21, 2023 and representative photos of this area are provided as Attachment 1. The interim cover remains in good condition. The cover vegetation is stable, well vegetated, and there are no signs of erosion.

| A. General condition of cover material | <u>Good</u> | Riverbank cover in good condition, no signs of erosion, no white material showing. High vegetation in area. (pictures included). |

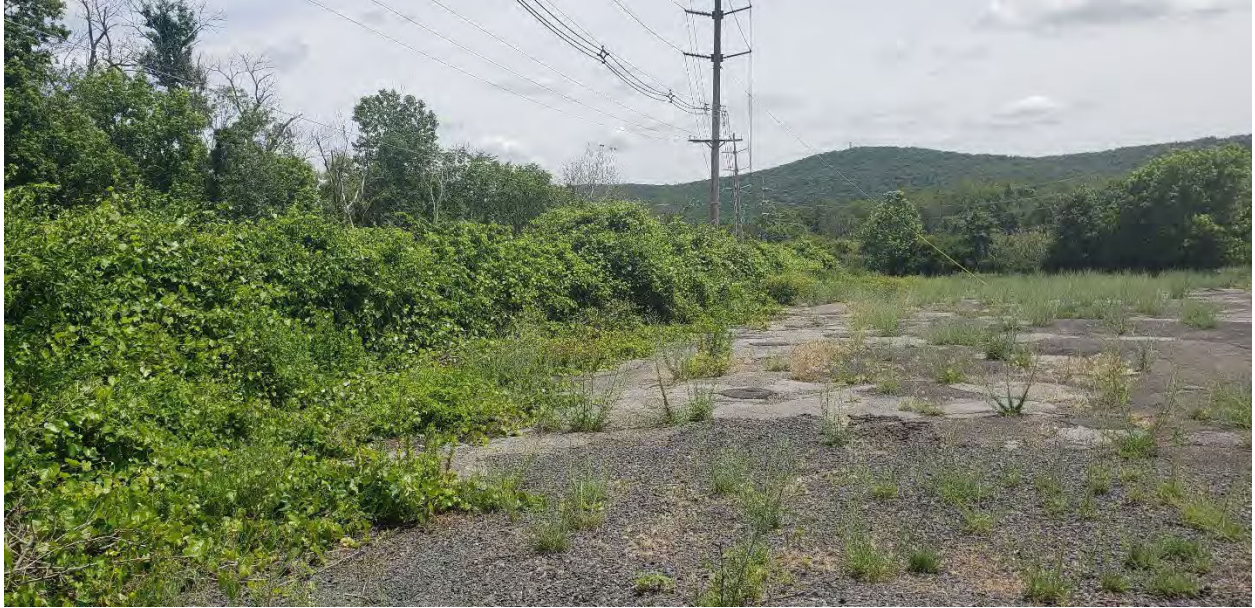
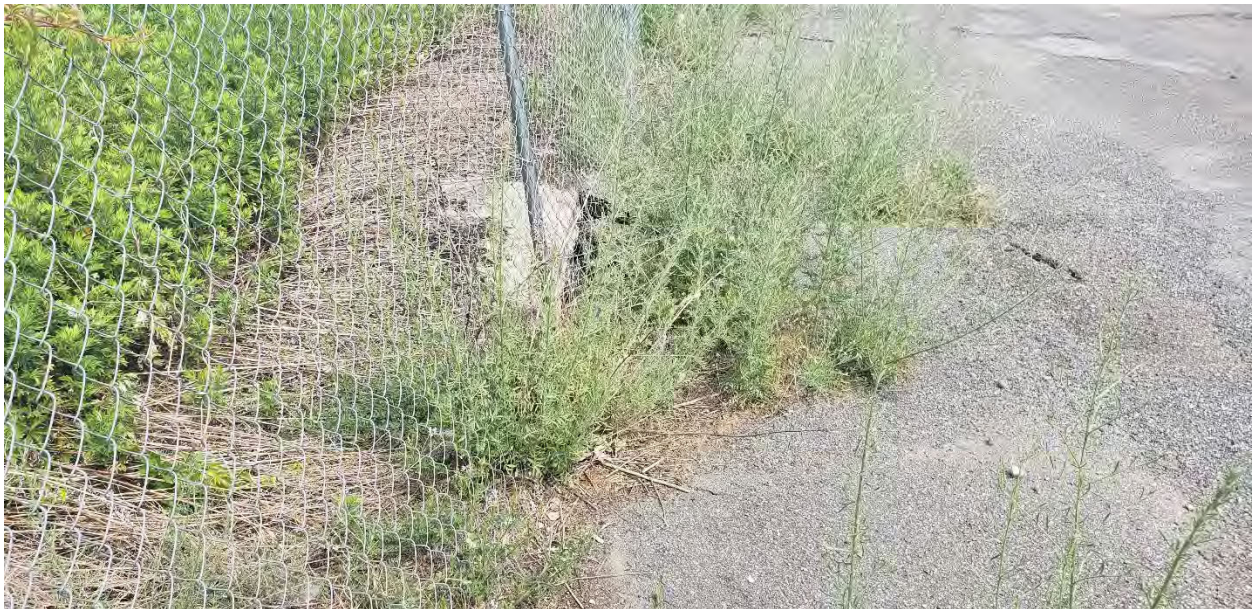
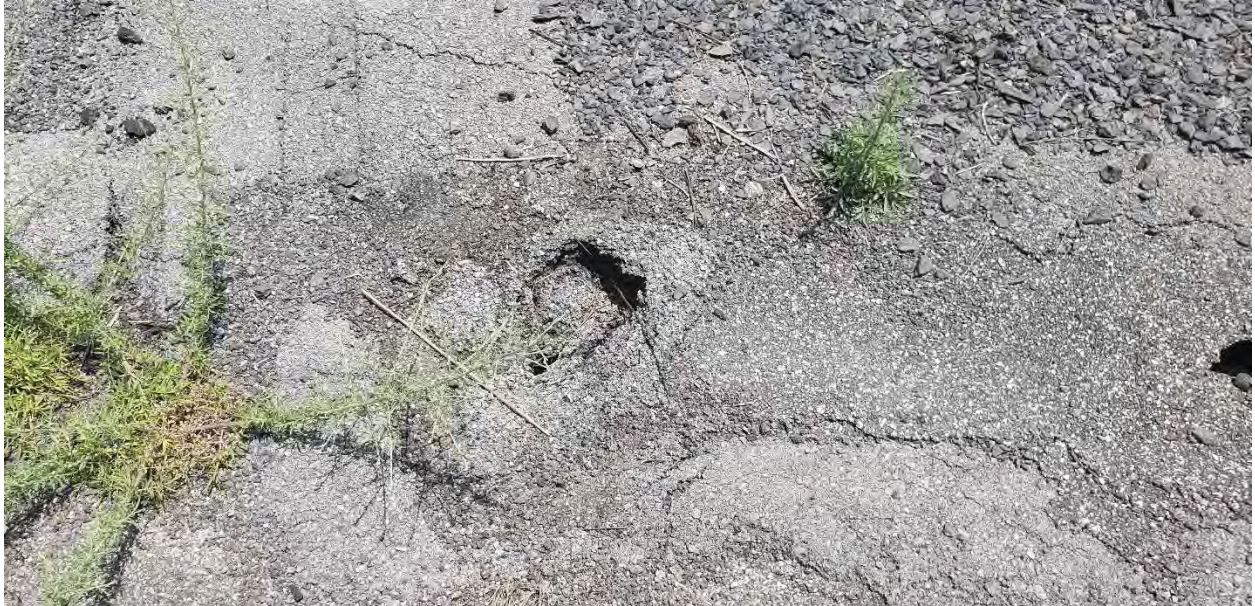
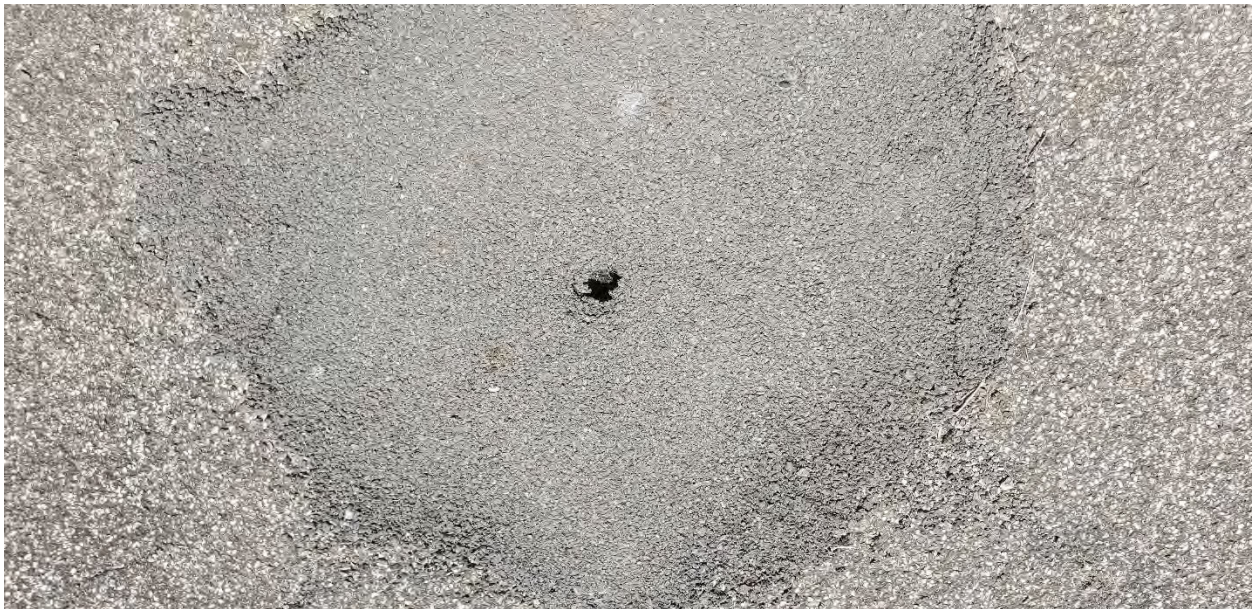
ATTACHMENT 2  
PARKING LOT PHOTOS TAKEN JUNE 21, 2023

The parking lot pavement remains generally intact and functioning as a cover. The parking lot was inspected on June 21, 2023. Representative photos of the parking lot conditions are provided as Attachment 2.

| B. Settlement of covered area | <u>Adequate</u> | Potholes present in parking lot area, although pavement cover generally remains intact. (pictures included). 20 total potholes. |

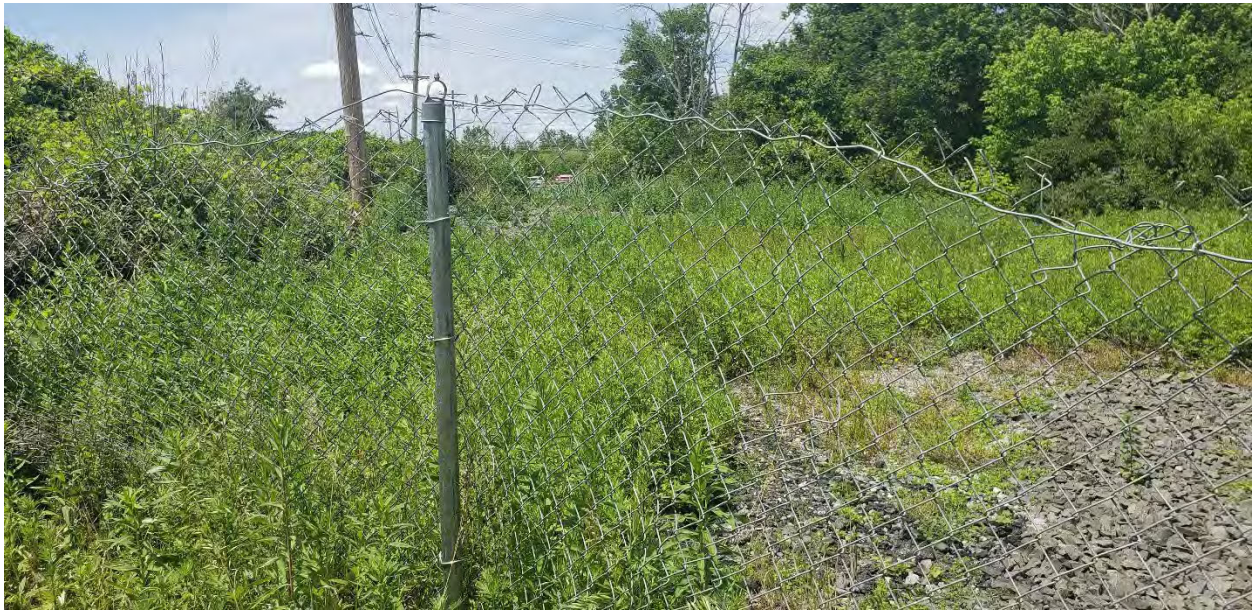
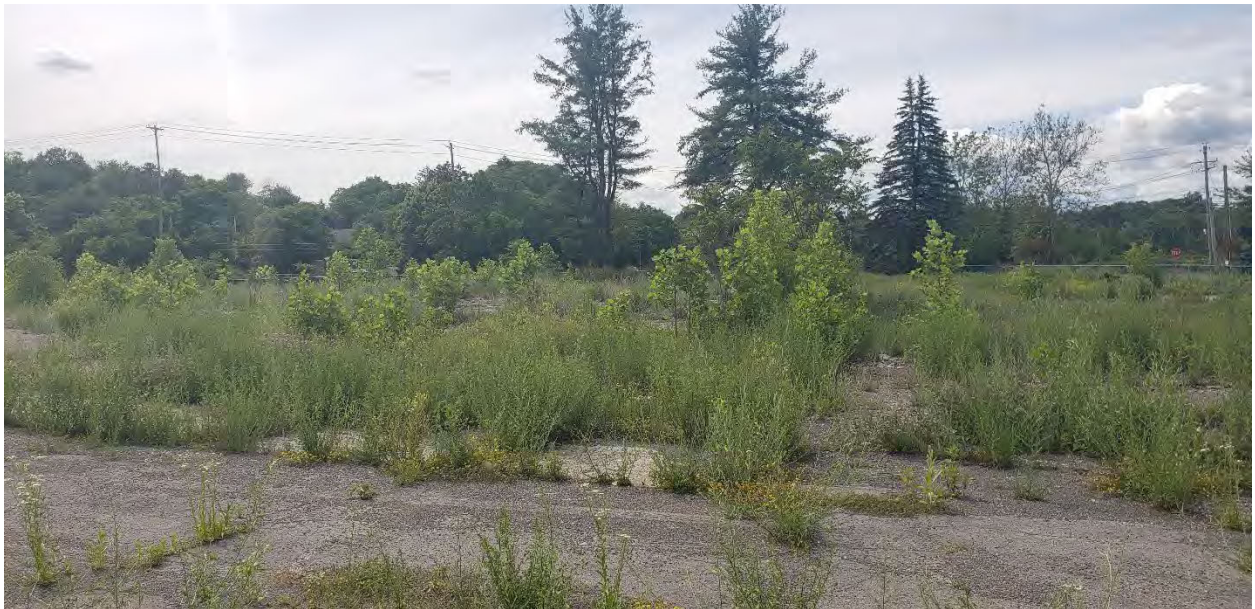
ATTACHMENT 4  
FENCING INSPECTION FORM AND PHOTOS TAKEN JUNE 21, 2023

| | STATUS | COMMENTS |
|---|---|---|
| A. Perimeter Fence around NEPERA Facility | Good | Fence in good condition, high amount of vegetation growing on all portions of the fence that does not border NY-17. Two areas damaged. |
| B. Perimeter fence around NEPERA Parking Lot | FAIR | Fence in fair condition, eastern section of fence cut by Orange and Rockland Company for guide lines for utility pole. |
| C. Perimeter fence around lagoon area | FAIR | Fence in fair condition, southern section of fence cut in two areas adjacent to MW-29S. |
