# Memorandum

October 20, 2023

**Re: Quarterly Progress Report—3rd Quarter 2023; Harriman Inactive Waste Disposal Site  
#336006**

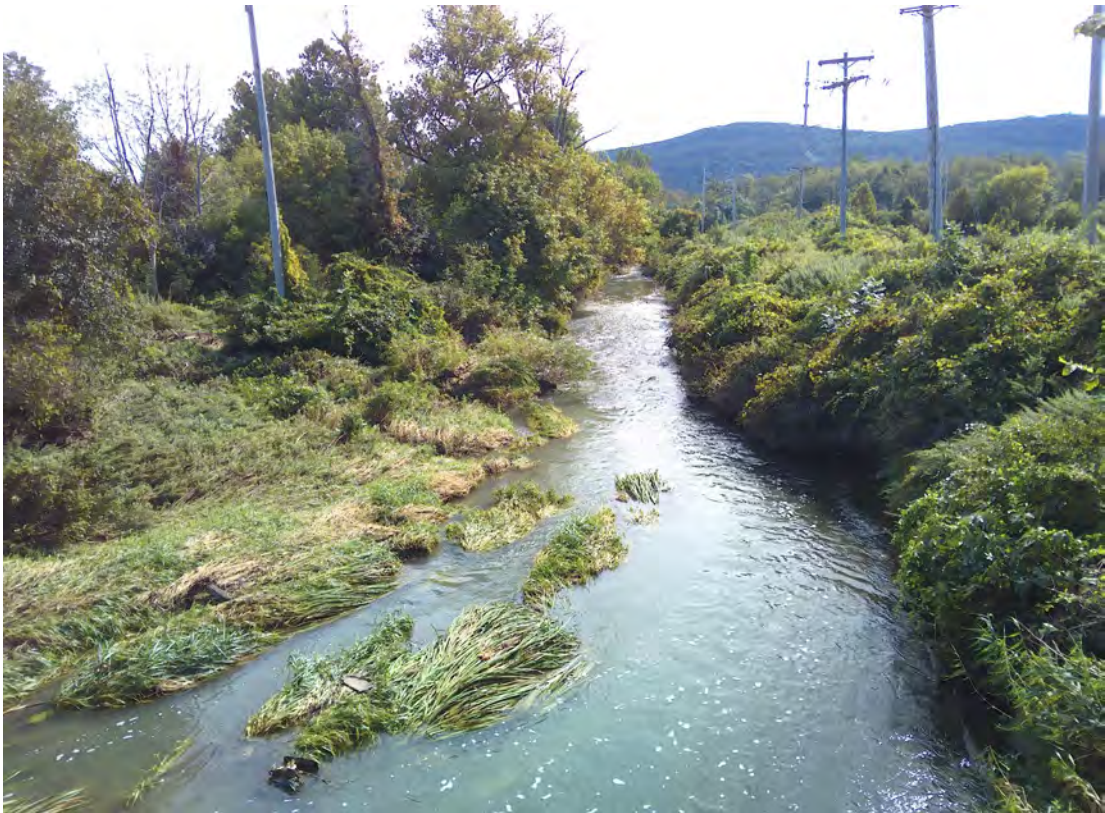
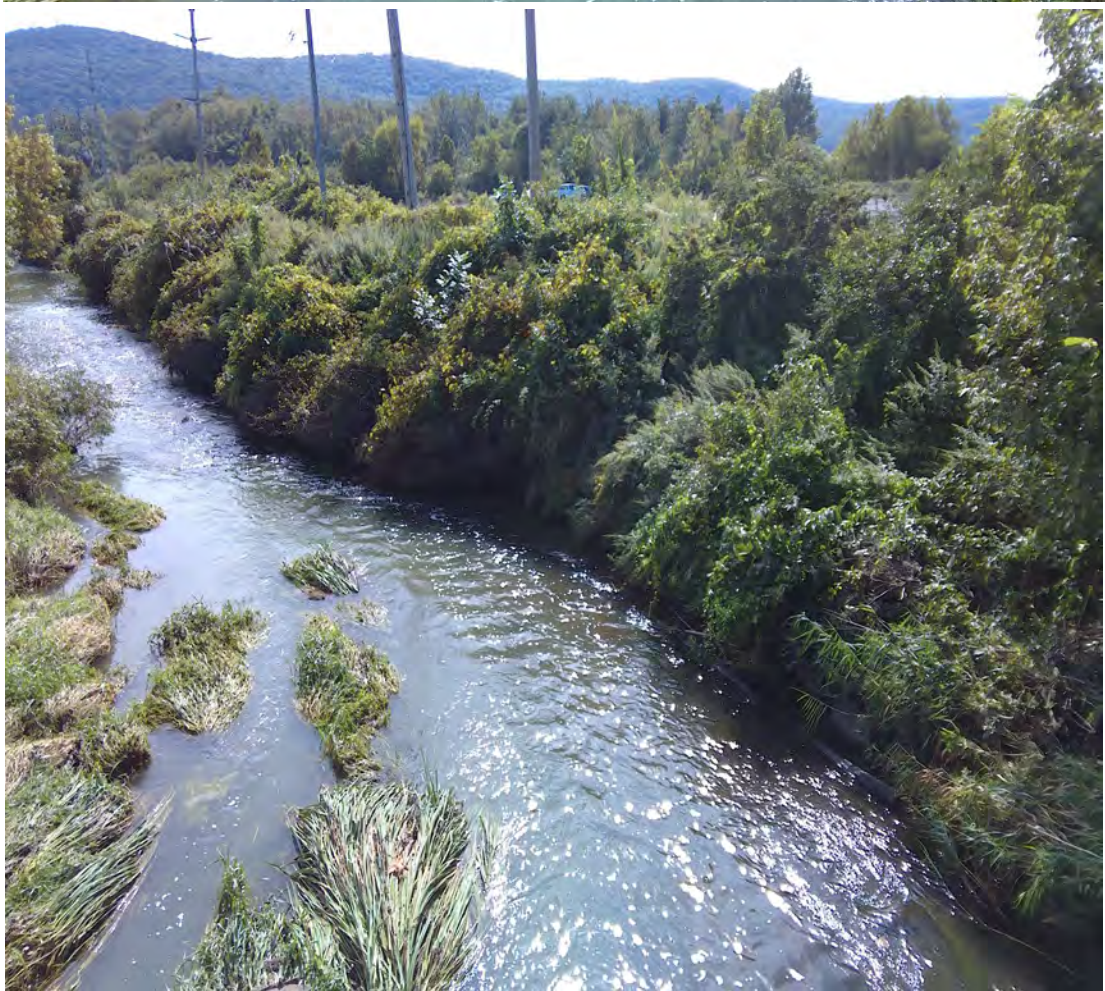
Representative Stream Bank Photos – September 15, 2023

The interim riverbank turf reinforcement mat and vegetative cover system along the West Branch of the Ramapo River was inspected, and representative photographs of this area are provided as Attachment 2. Observations of the cover system show thick, dense vegetation with no significant signs of erosion, and the system is observed to be functioning as designed.

| | <b>STATUS</b> | <b>COMMENTS</b> |
|---|---|---|
| <b>A. General condition of cover material</b> | <u>Good</u> | <u>Riverbank cover in good condition, no signs of erosion, no white material showing. High vegetation covering the area (pictures included).</u> |

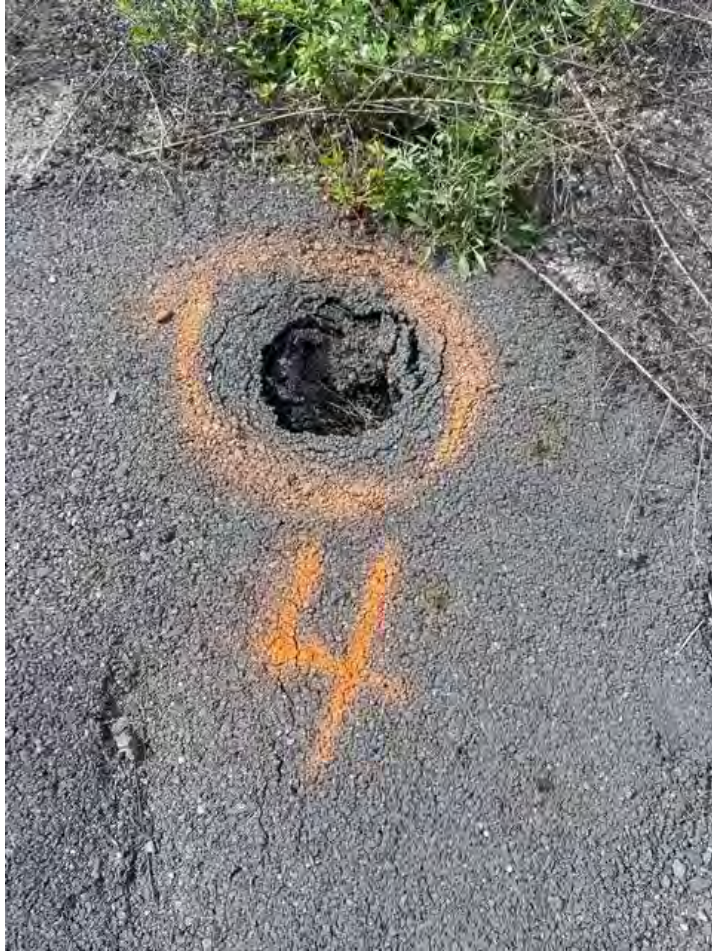
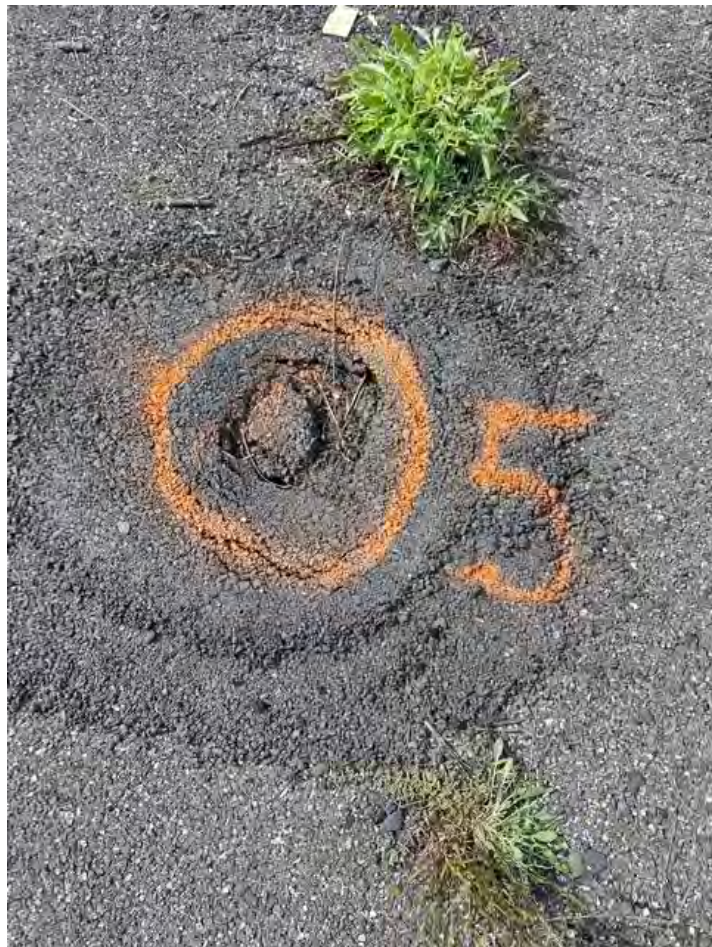
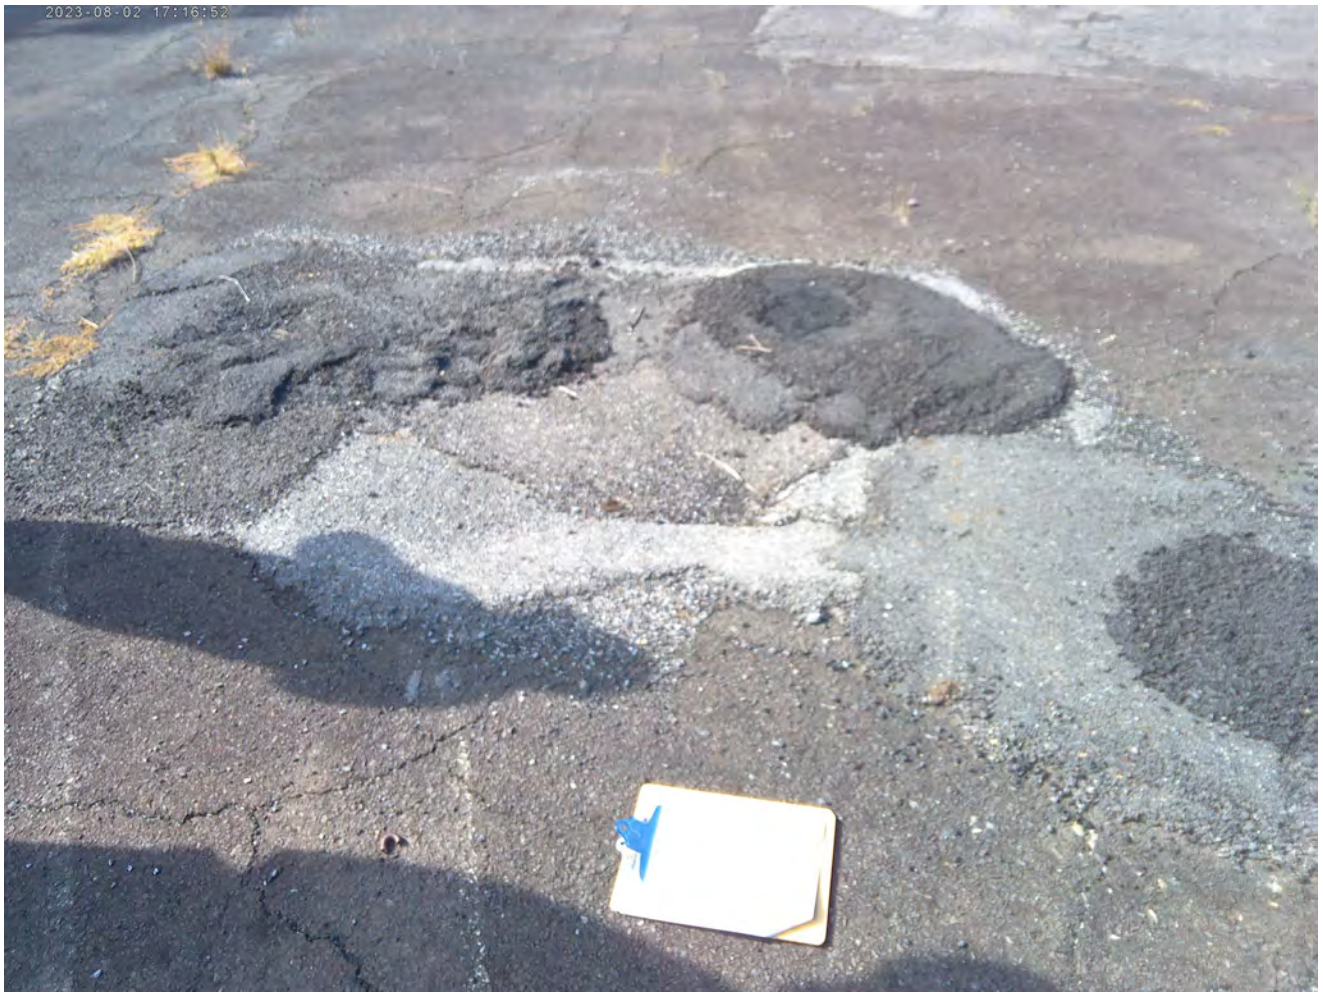
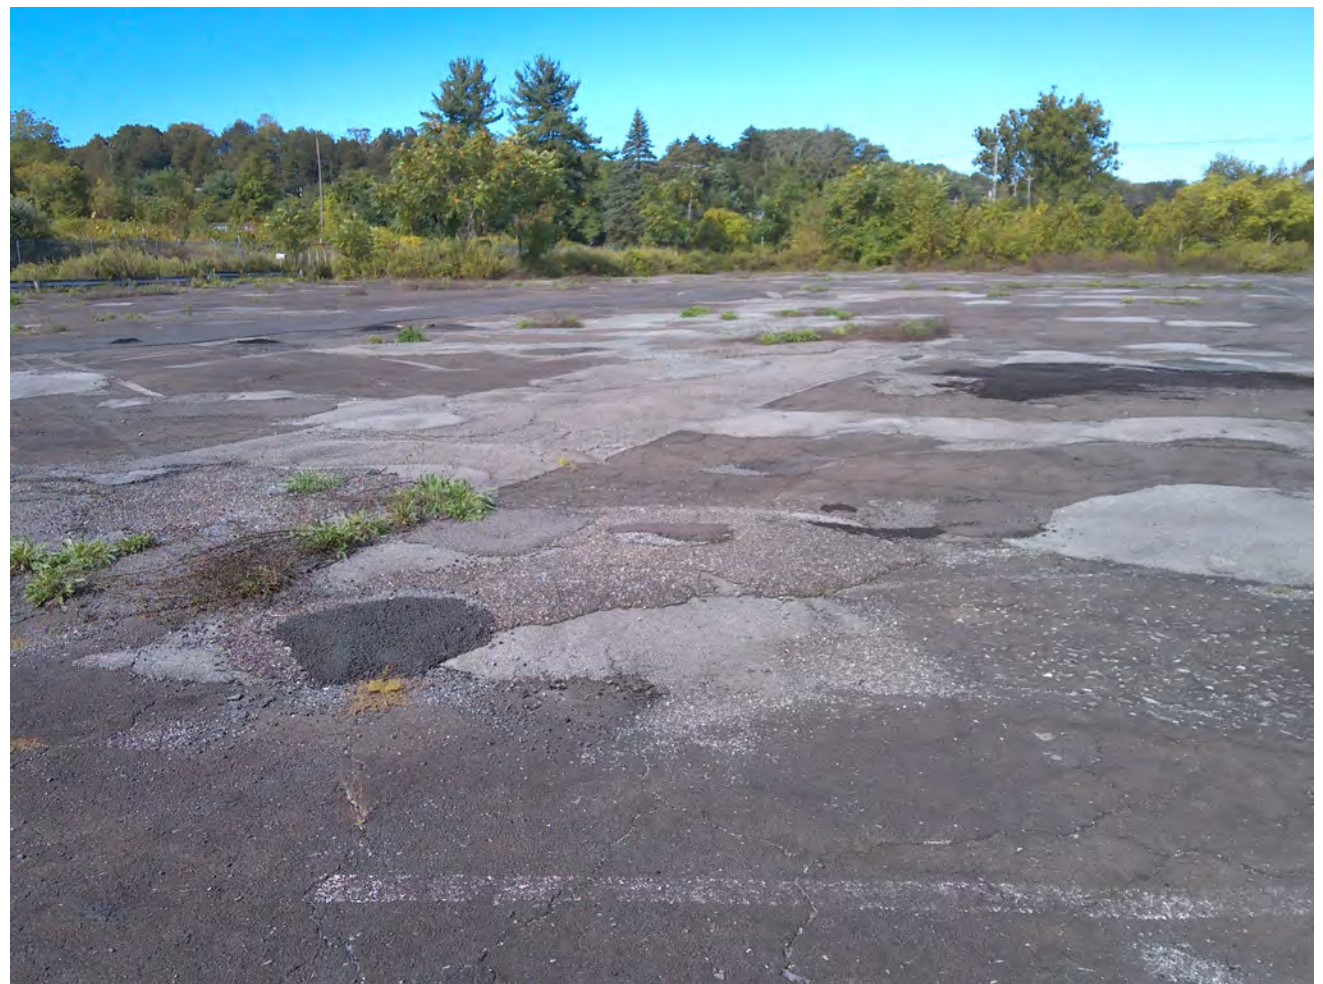
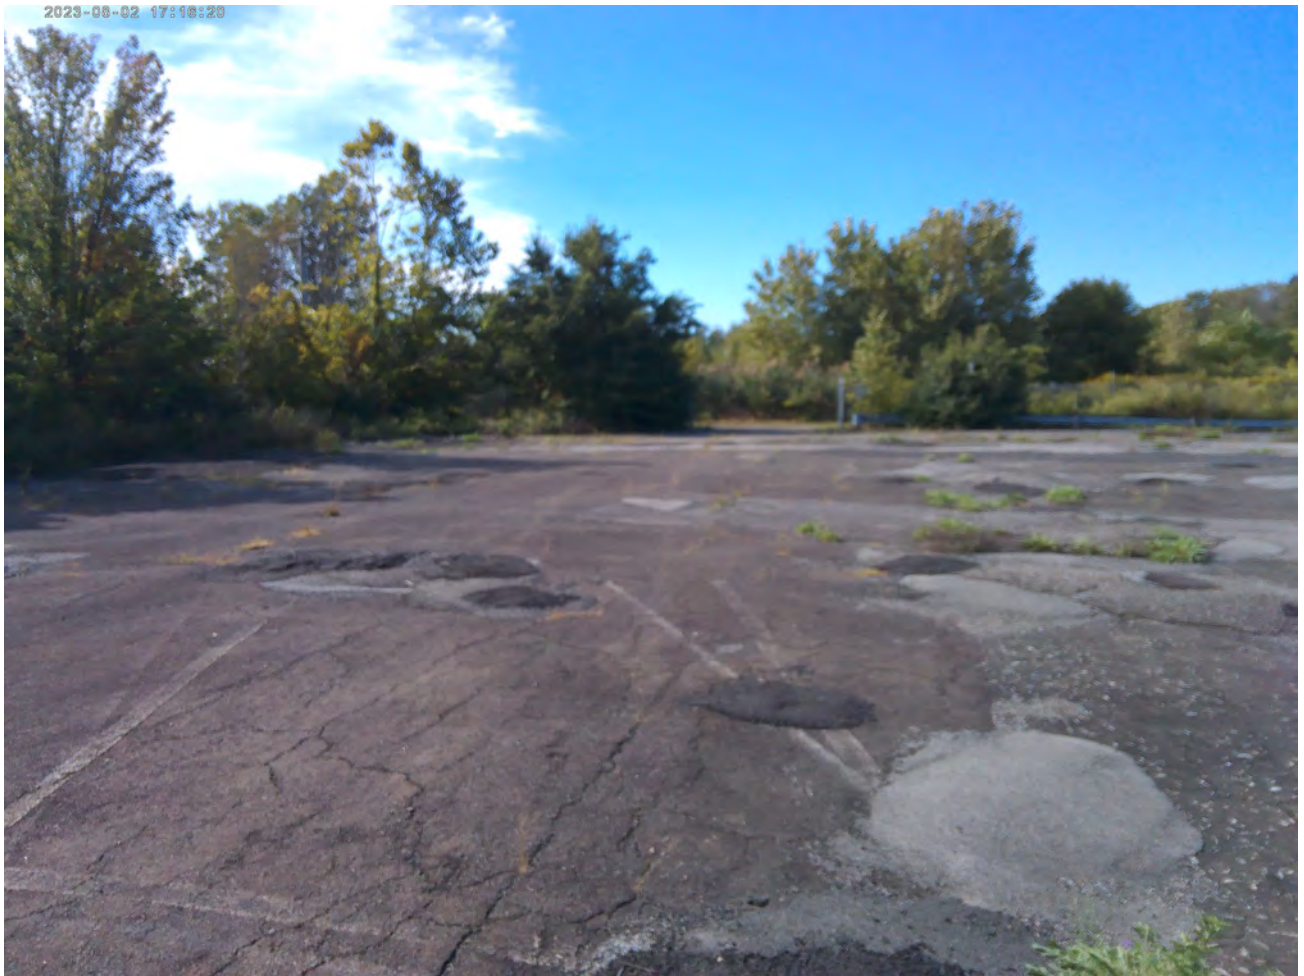
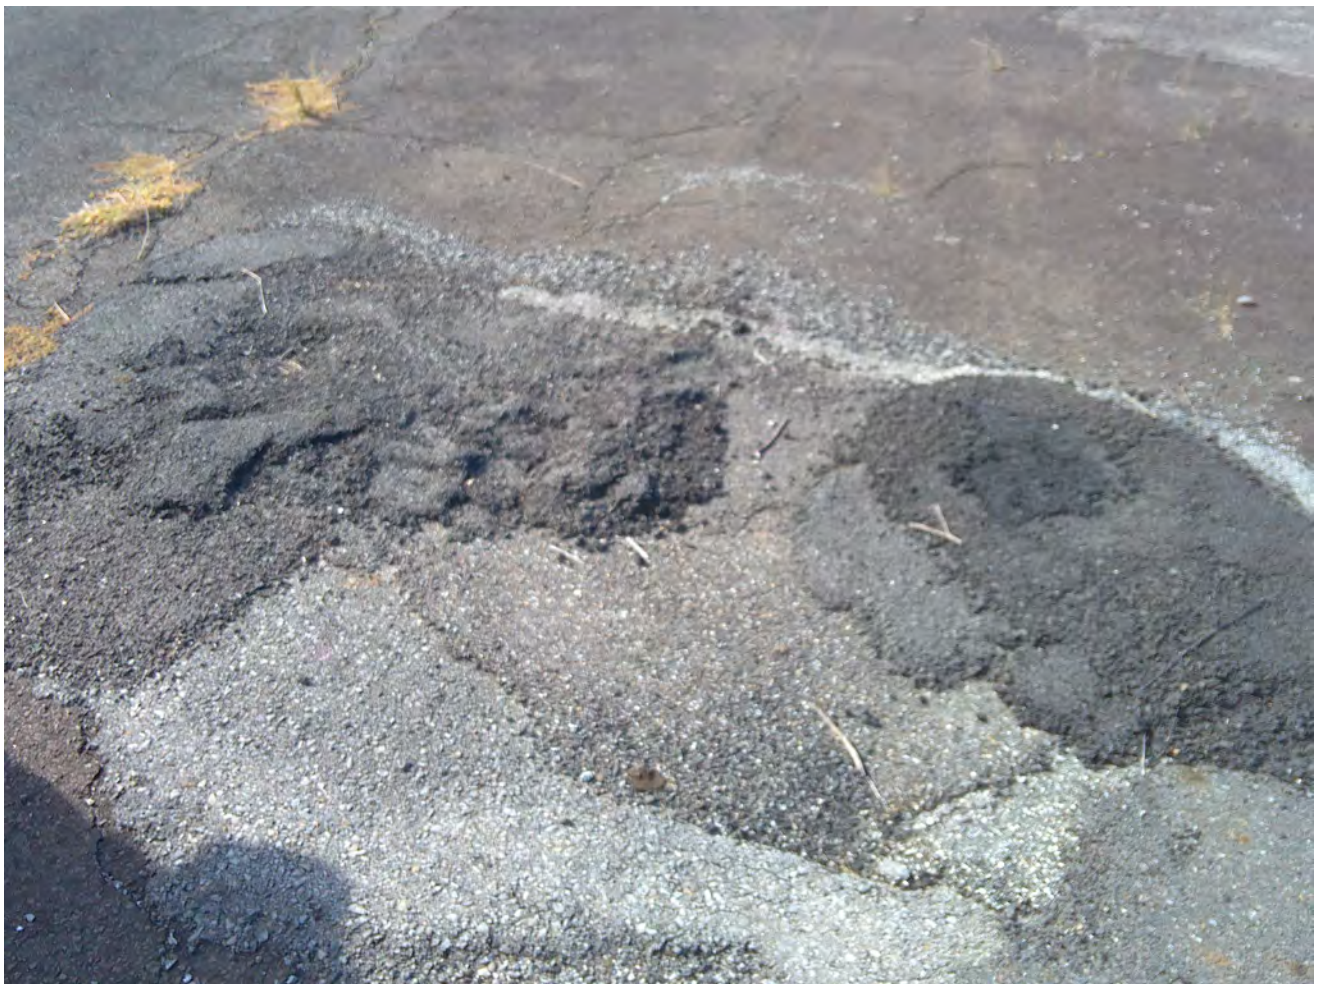
Representative Parking Lot Photos – September 15, 2023

Section 3.4.1 of the ISMP addresses the interim control and integrity of the parking lot asphalt cover. The asphalt continues to provide erosion protection to the area. However, observations during the inspection revealed areas where the surface has deteriorated and is vulnerable to infiltration from precipitation. Representative photographs of the parking lot conditions are shown in Attachment 2. As discussed during the monthly update call with NYSDEC on October 2, 2023, the Corporate Defendants and ELT are revisiting the *Revised, Parking Lot Area Feasibility Study*, last revision dated January 2023, prepared by Cornerstone, PLLC. The intent is to refine and advance this previous study for NYSDEC review to allow for the selection of an appropriate final remedy for this area in the near future.

| | <b>STATUS</b> | <b>COMMENTS</b> |
|---|---|---|
| <b>B. Settlement of covered area</b> | <u>Moderate</u> | <u>Potholes present in the parking lot area and pavement cover remains intact. Approximately 30 potholes (pictures included).</u> |

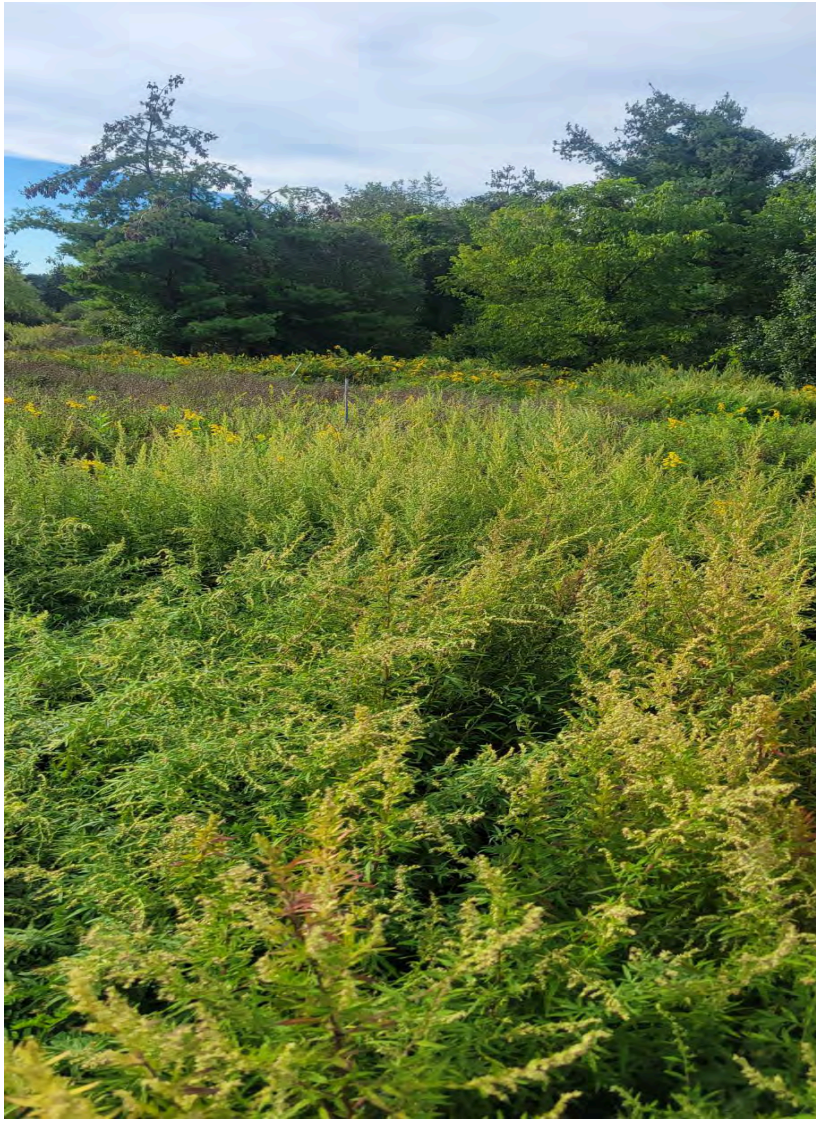
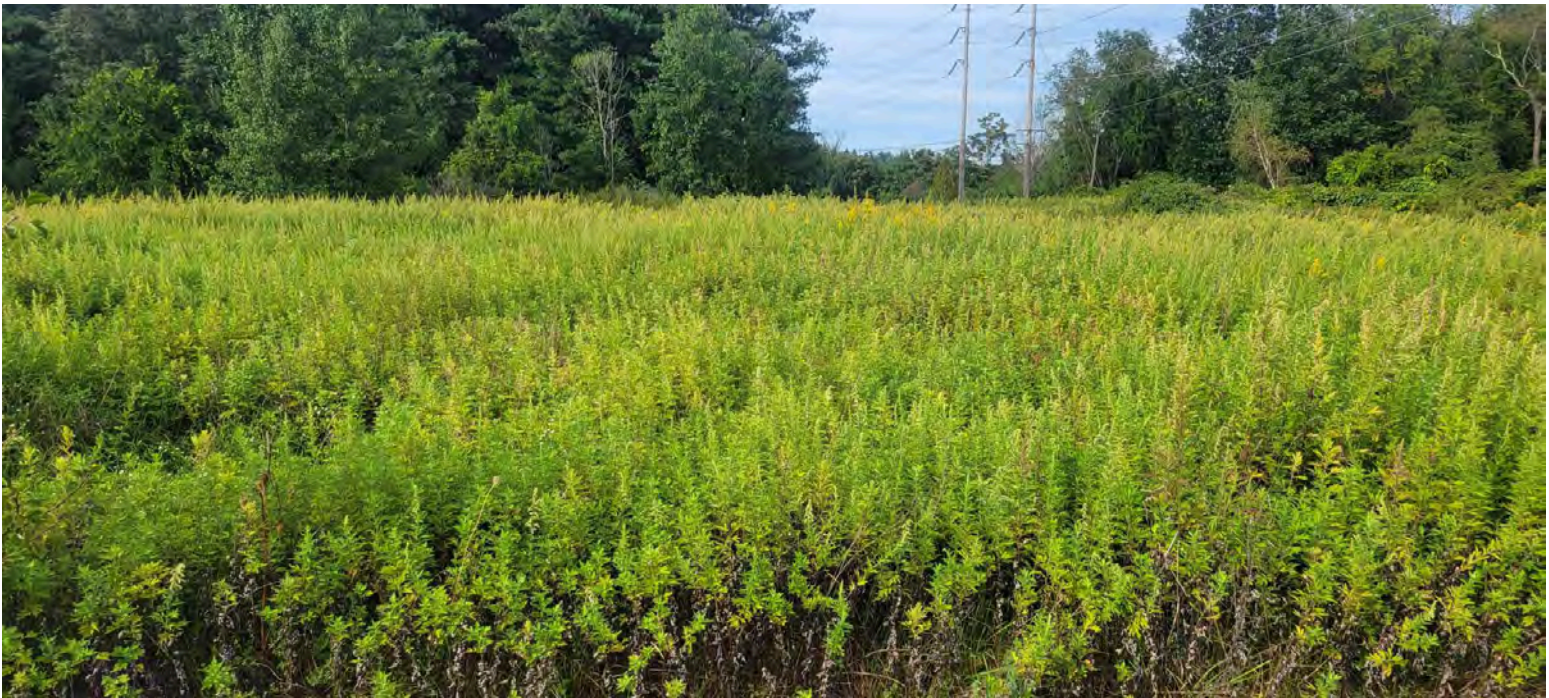
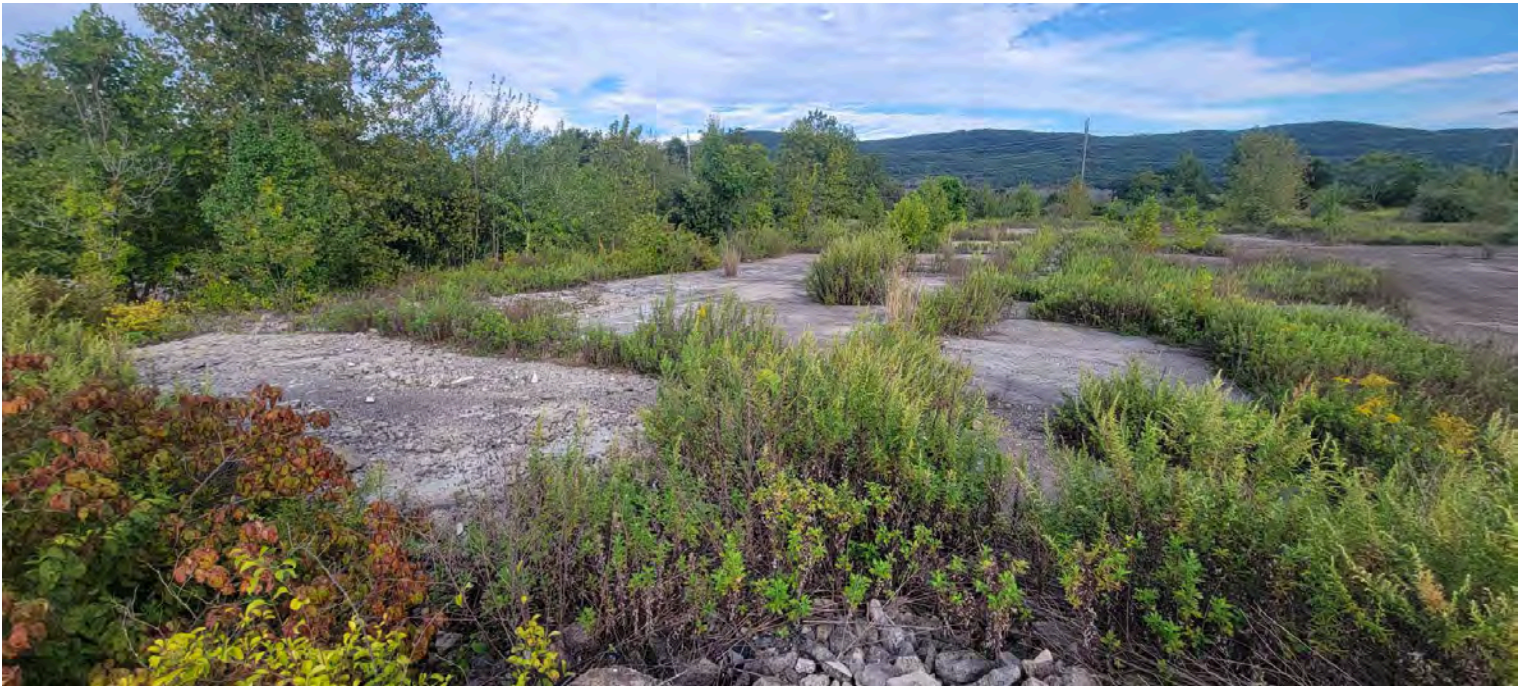
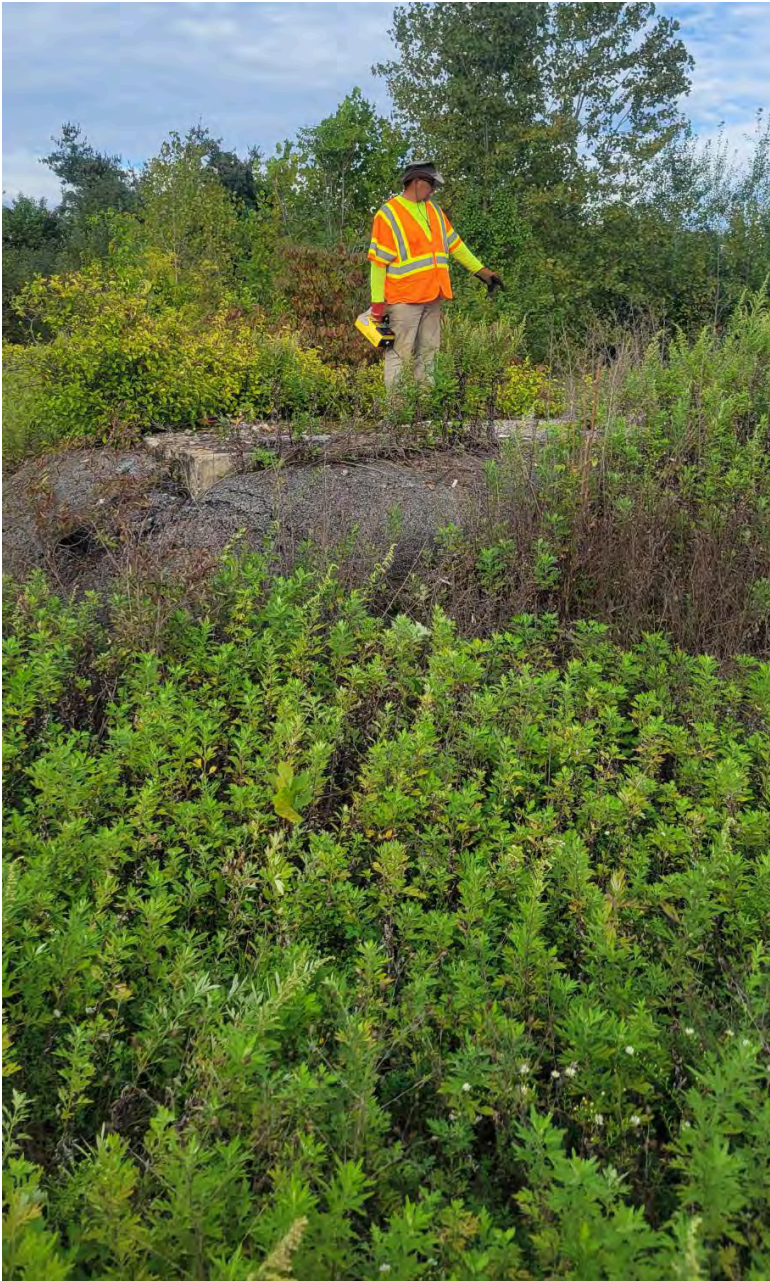
Representative Area F and Building 53 Area Photos – September 15, 2023

Section 3.4.2 of the ISMP requires inspection to evaluate there are no signs of vandalism or erosion. Observations show these areas contain thick, dense vegetation with no visual evidence of disturbance or erosion. Inspection photographs for these areas are included in Attachment 3.

Area F covered heavily in high vegetation.

Building 53 area covered heavily in high vegetation.

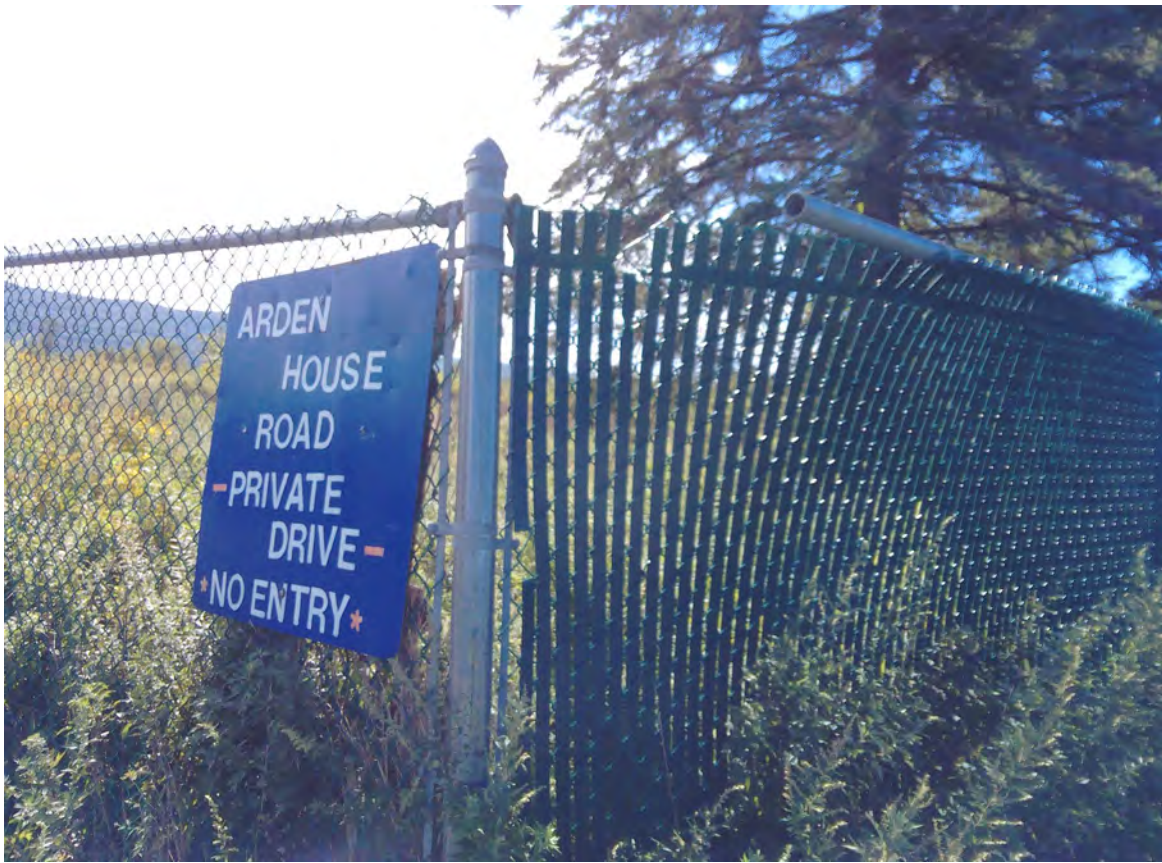
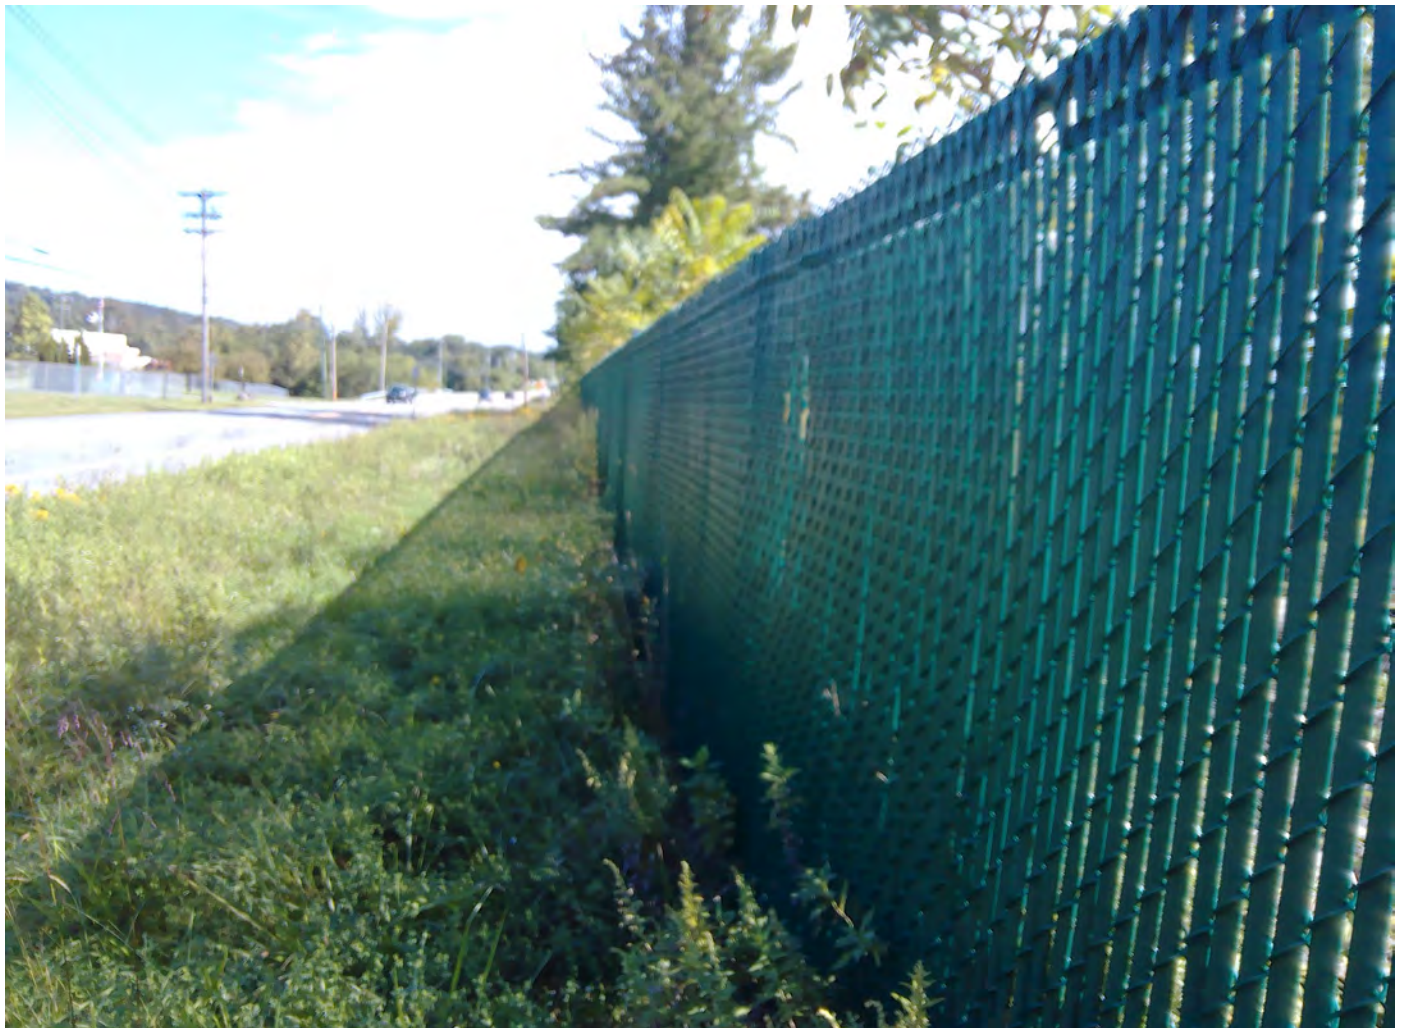
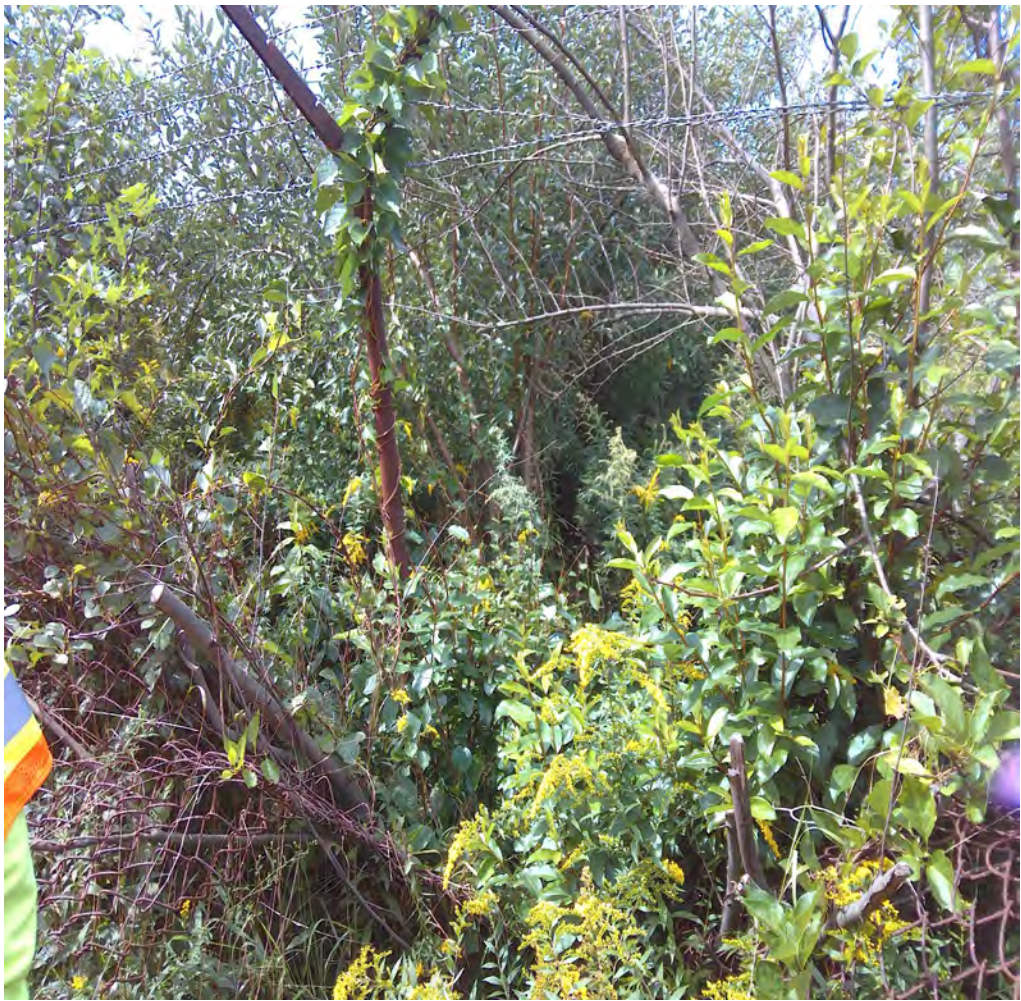
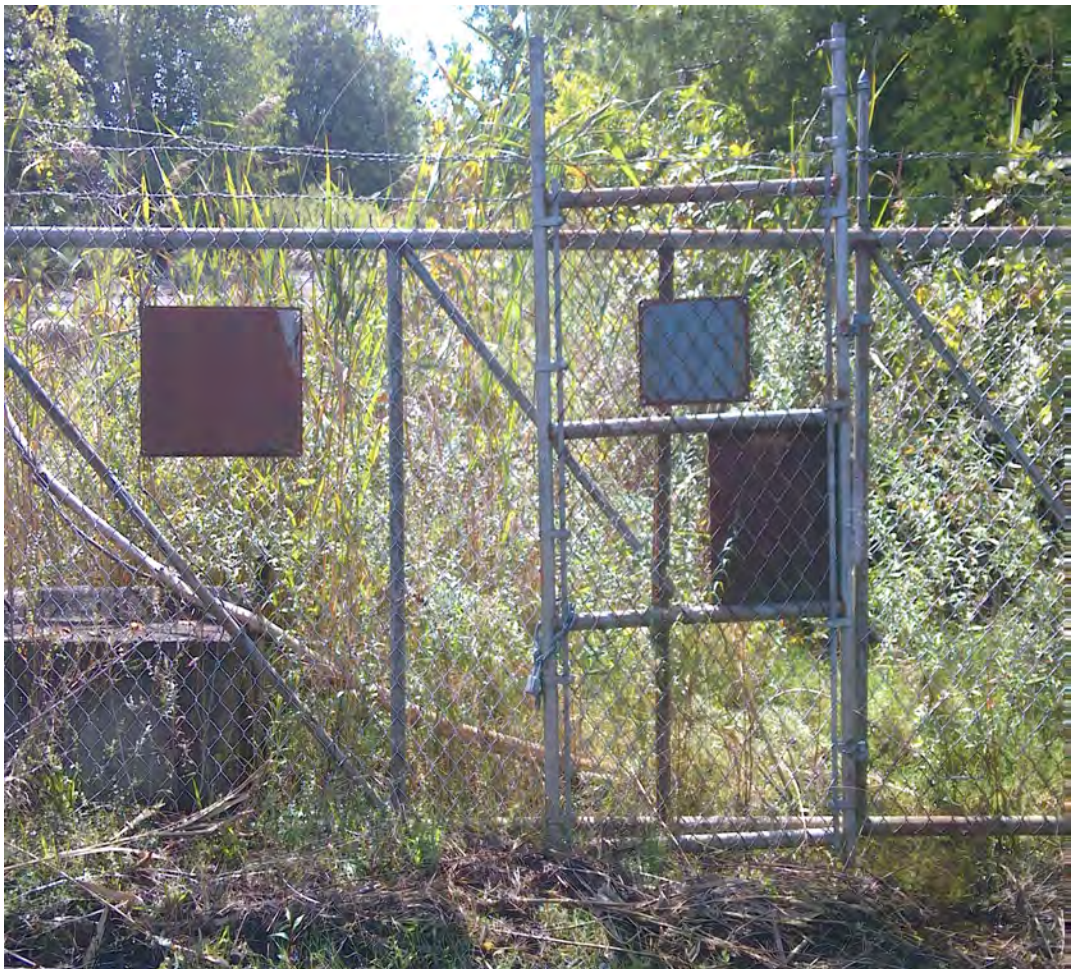
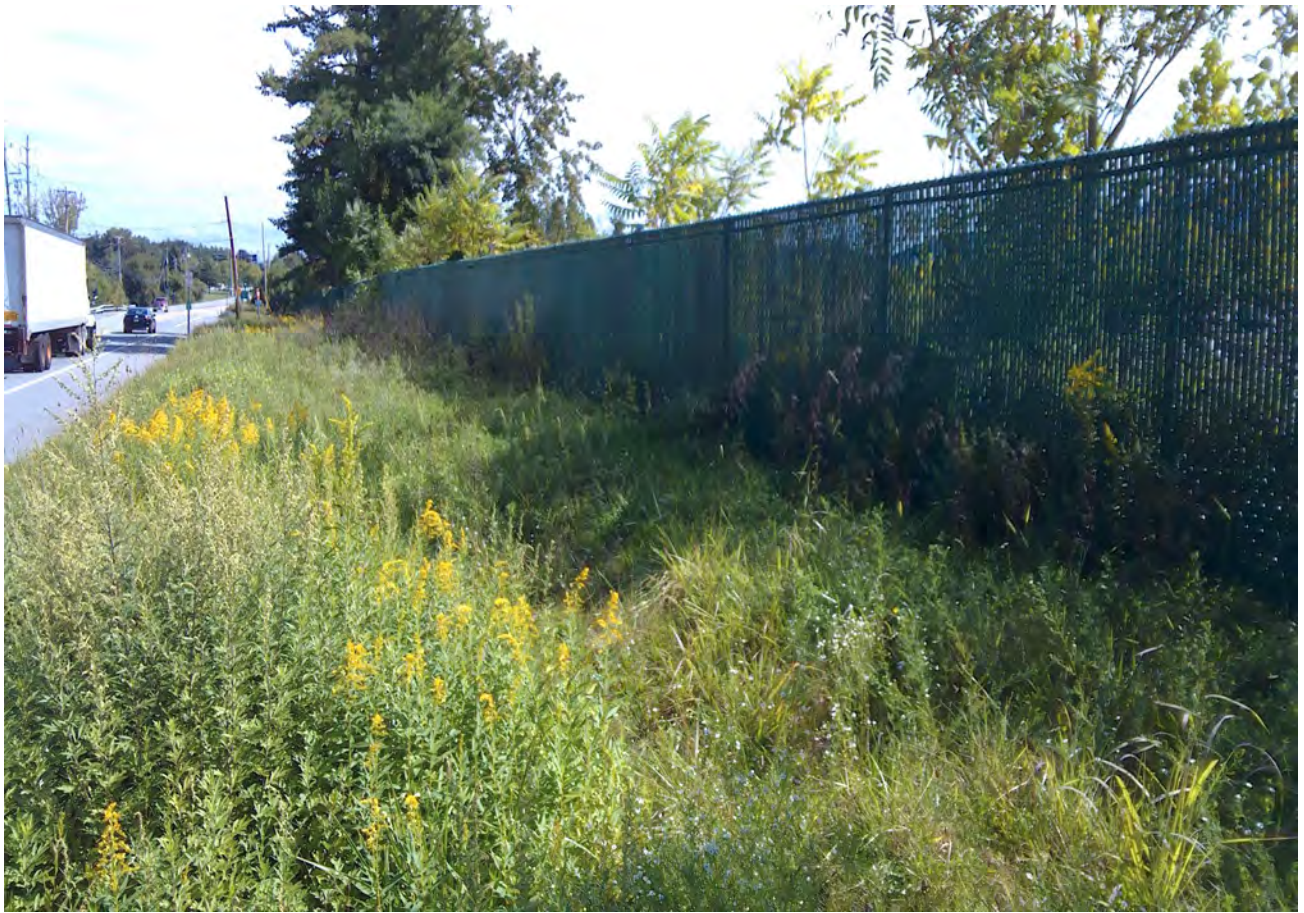
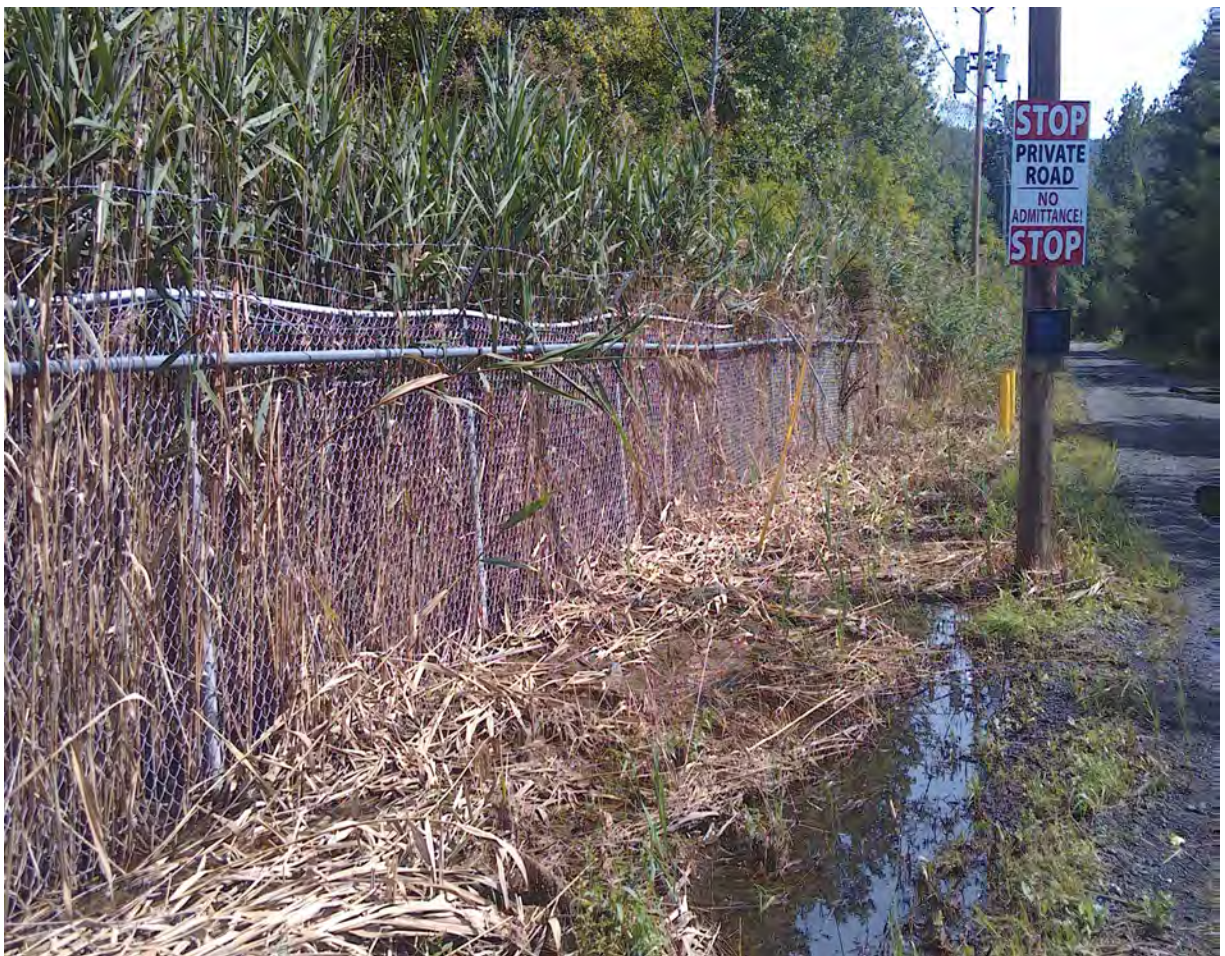
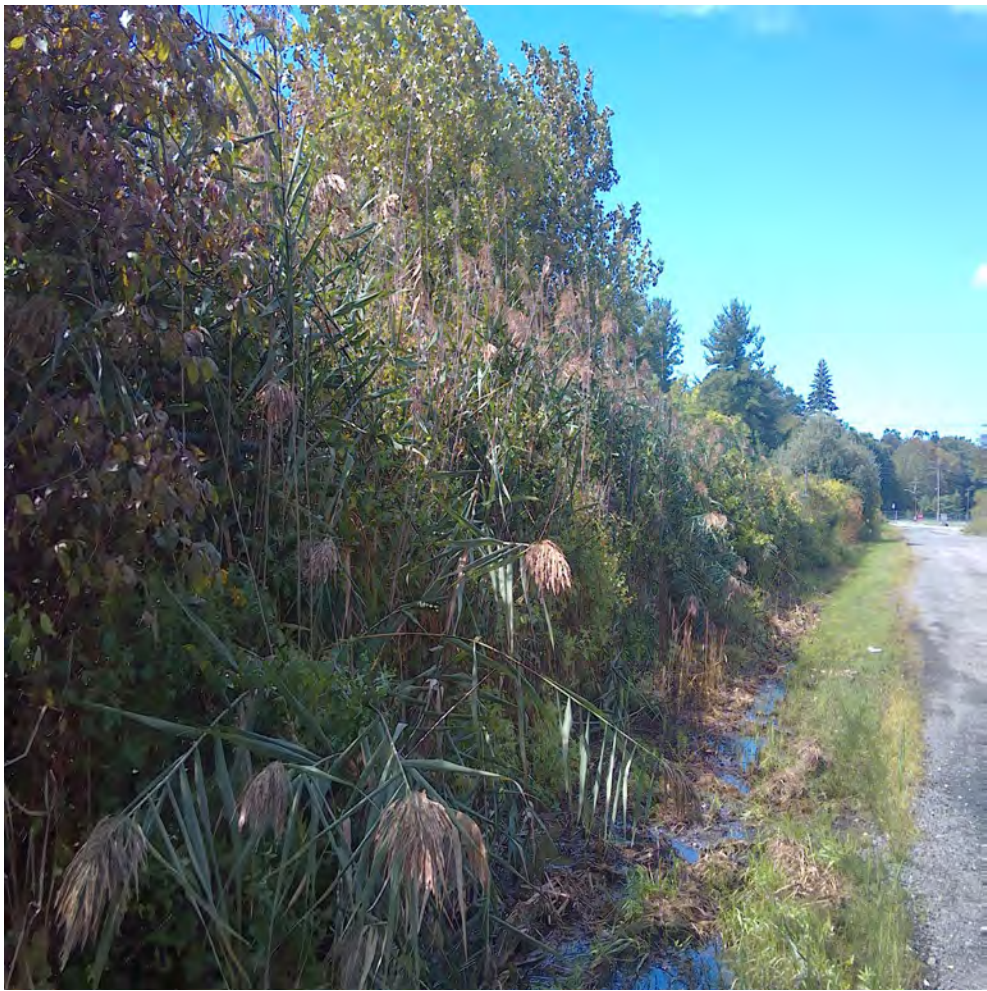
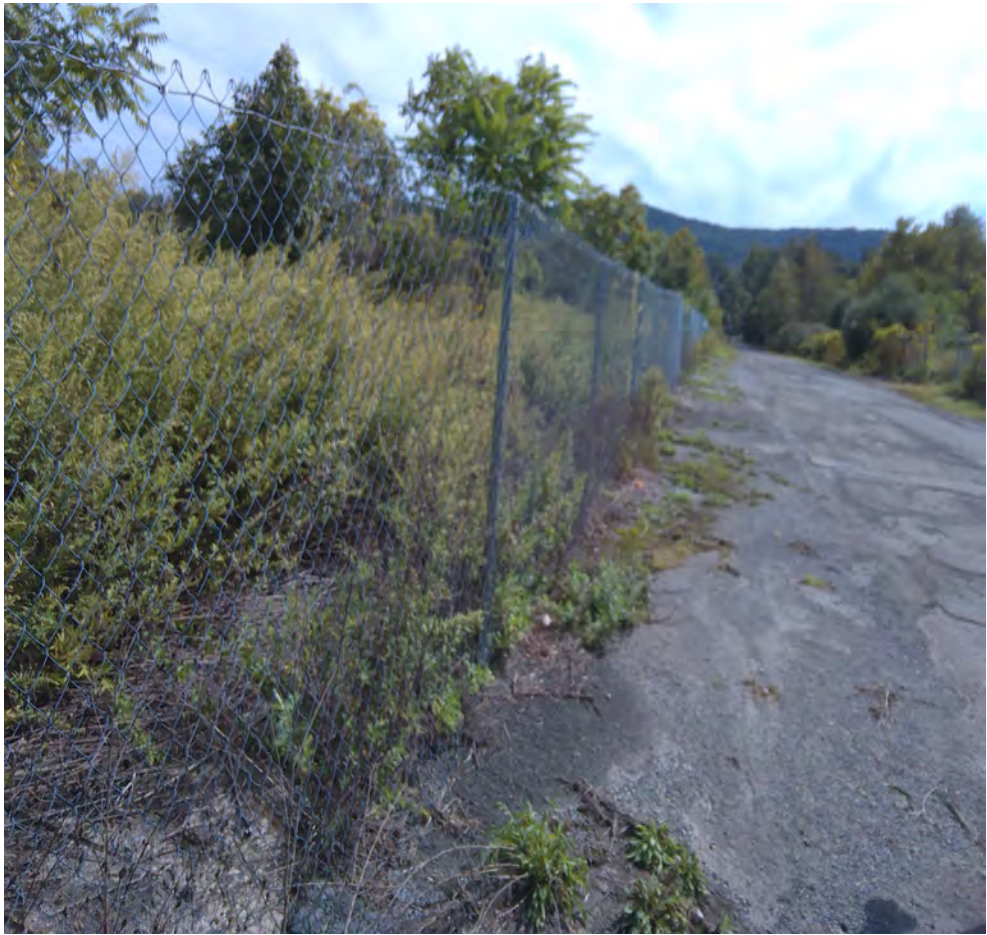
Section 3.4.6 of the ISMP requires visual inspection of the fence and gates to minimize access to the Site by unauthorized personnel. During the site inspection, the entire fence perimeter was visually inspected. It was observed that the perimeter fencing had been damaged in two remote locations. In the locations where damage was observed, there was no evidence of unauthorized entry. Both areas were in areas of dense vegetation and away from routine access areas. All observed gates were secure with locks. Attachment 4 contains photographs of the two damaged areas of the fence.

| | <b>STATUS</b> | <b>COMMENTS</b> |
|---|---|---|
| <b>A. Perimeter Fence around NEPERA Facility</b> | <u>Fair</u> | Most of the fence is generally in good condition. Dense, thick vegetation is providing an acceptable barrier to minimize unauthorized entry. One area of the fence has been identified for repair in November 2023. <u>Inspected gates were locked and secure.</u> |
| <b>B. Perimeter fence around NEPERA Parking Lot</b> | <u>Fair</u> | Fence is in fair condition. One area of the fence has been identified for repair in November 2023. Inspected gates were locked and secure. <u></u> |
| <b>C. Perimeter fence around lagoon area</b> | <u>Fair</u> | Fence in fair condition, southern section of the fence cut in <u>two areas.</u> |
